UNDERWATER BRIDGE INSPECTION REPORT

STRUCTURE NO. 60019

RED LAKE RIVER

AUGUST 29, 2012

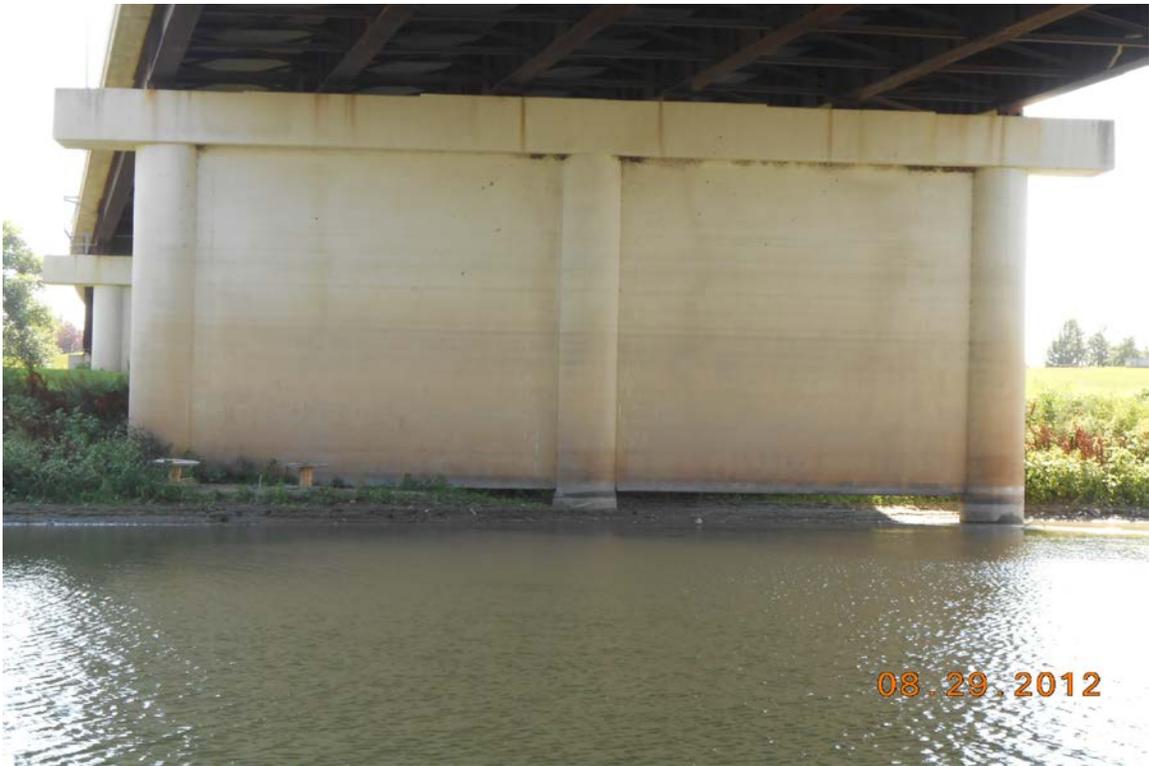
Photograph 2. Overall View of Pier 6, Looking South.

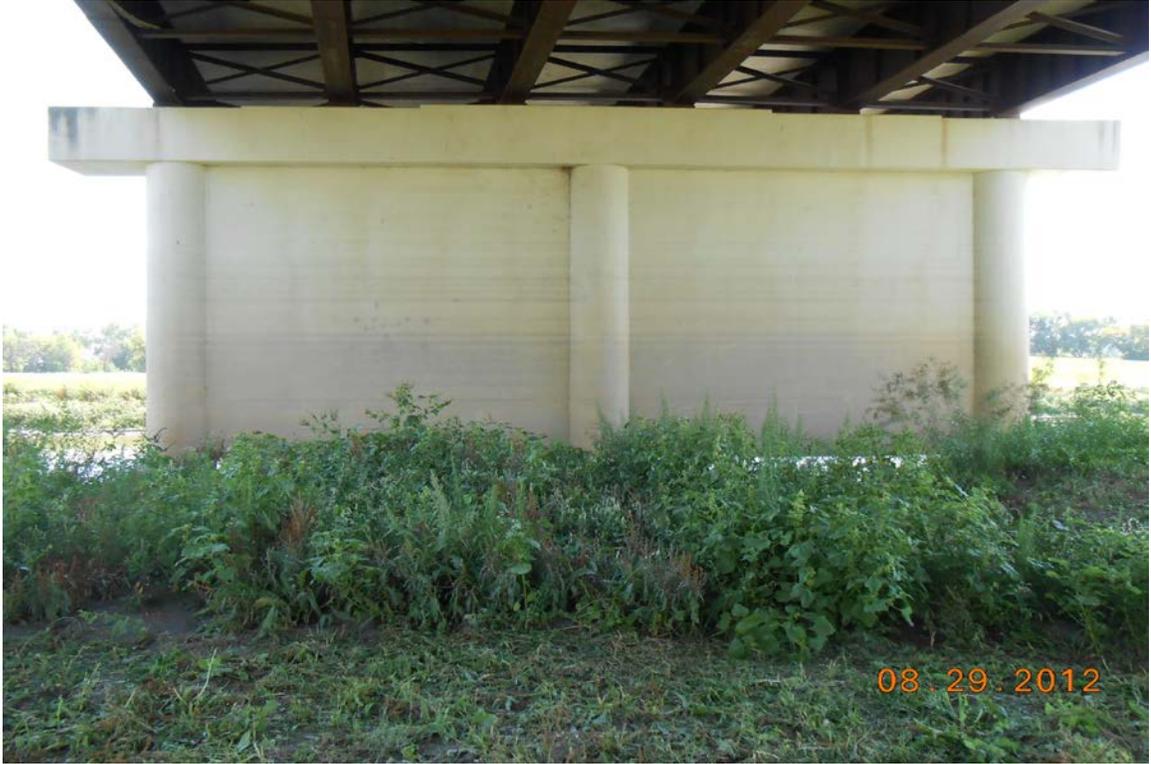
- (A) The concrete surfaces of both piers were found to be smooth and sound with no significant structural defects observed.
- (B) The top of the footing of the upstream column at Pier 7 was exposed along the west and south sides of the column at 2.6 feet below the waterline with a maximum vertical face exposure of 2.9 feet. The footing was found to be undermined during the previous inspection, but the cavity has been filled in with sediment and rock was piled at the upstream nose.
- (C) The footing of the center column of Pier 7 was exposed for a length of 8 feet along the south face and 2 feet along the east face with up to 4.5 feet (full height) of vertical face exposure. The footing was undermined along the south face up to 1.5 feet high by 2 feet deep for a length of 6 feet with 3 piles exposed. The piles were in good condition.

Photograph 3. Overall View of Pier 7, Looking South.

- (A) Monitor the foundation exposure and undermining at Pier 7 during future underwater inspections. Scour countermeasures (similar to what has been installed at the upstream column) should be considered at the middle column of Pier 7 in order to prevent any further undermining of the foundation.

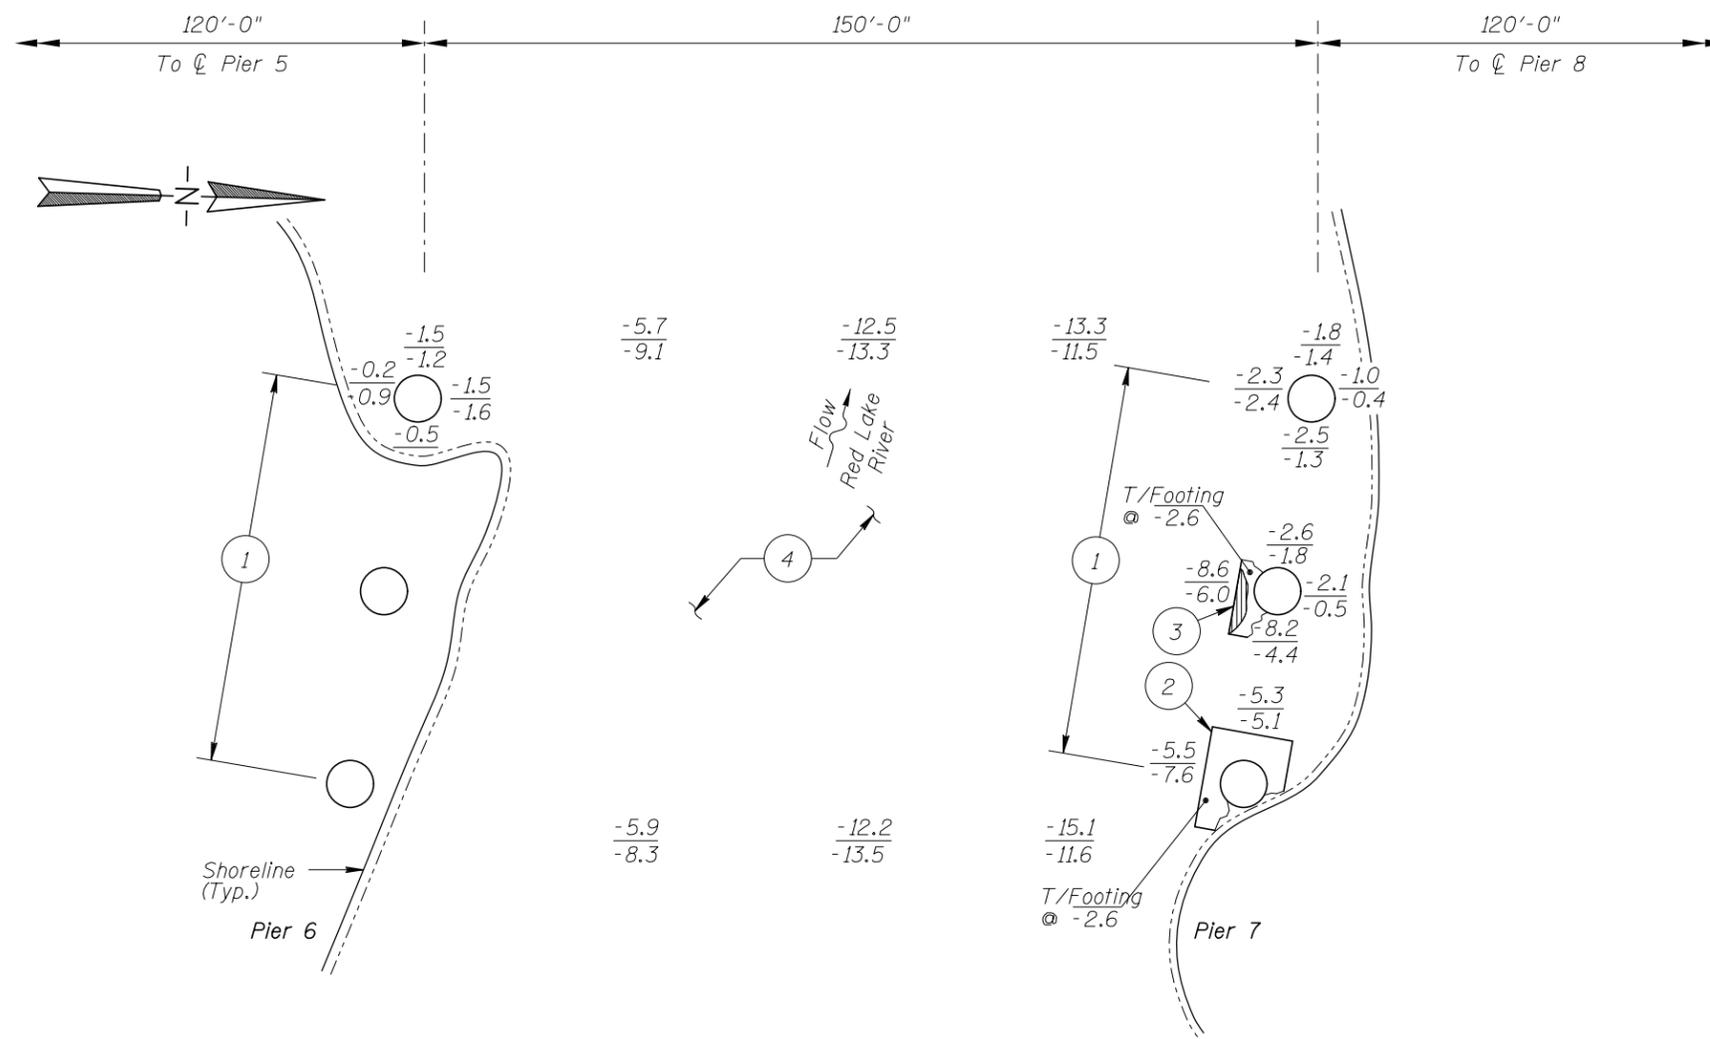
SOUNDING PLAN

- 1 Overall, the concrete of the piers was found to be smooth and sound with no significant deterioration.
- 2 The top of the footing of the upstream column of Pier 7 was exposed along the south and west sides of the column at 2.6 feet below the waterline with a maximum vertical face exposure of 2.9 feet.
- 3 The footing of the center column of Pier 7 was partially exposed along the south face for 8 feet and east face for 2 feet with up to 4.5 feet of vertical exposure. The footing was undermined along the south face up to 1.5 feet high by 2 feet deep for a length of 6 feet with 3 piles exposed. The piles appeared to be in good condition.
- 4 The channel bottom material consisted of clay with up to 2 feet of probe rod penetration around both piers.
