UNDERWATER BRIDGE INSPECTION REPORT

STRUCTURE NO. 63516  
CSAH NO. 13  
OVER THE  
RED LAKE RIVER  
DISTRICT 2 - RED LAKE COUNTY

AUGUST 17, 2012  
PREPARED FOR THE  
MINNESOTA DEPARTMENT OF TRANSPORTATION  
BY  
AYRES ASSOCIATES & COLLINS ENGINEERS, INC.  
JOB NO. 7423

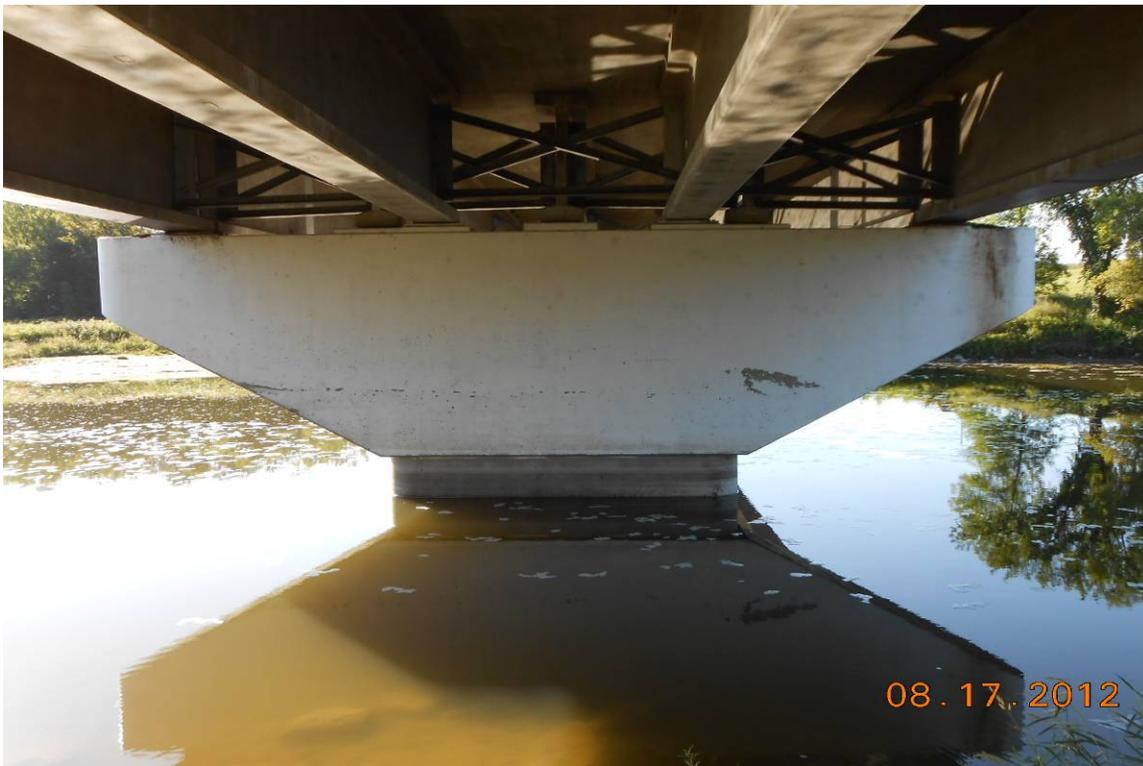
Photograph 2. View of Pier 1, Looking South.

- (A) Heavy timber debris accumulation observed at Pier 1 during previous underwater inspection was no longer present.
- (B) The concrete of Piers 1 and 2 appeared sound and exhibited no notable deficiencies.

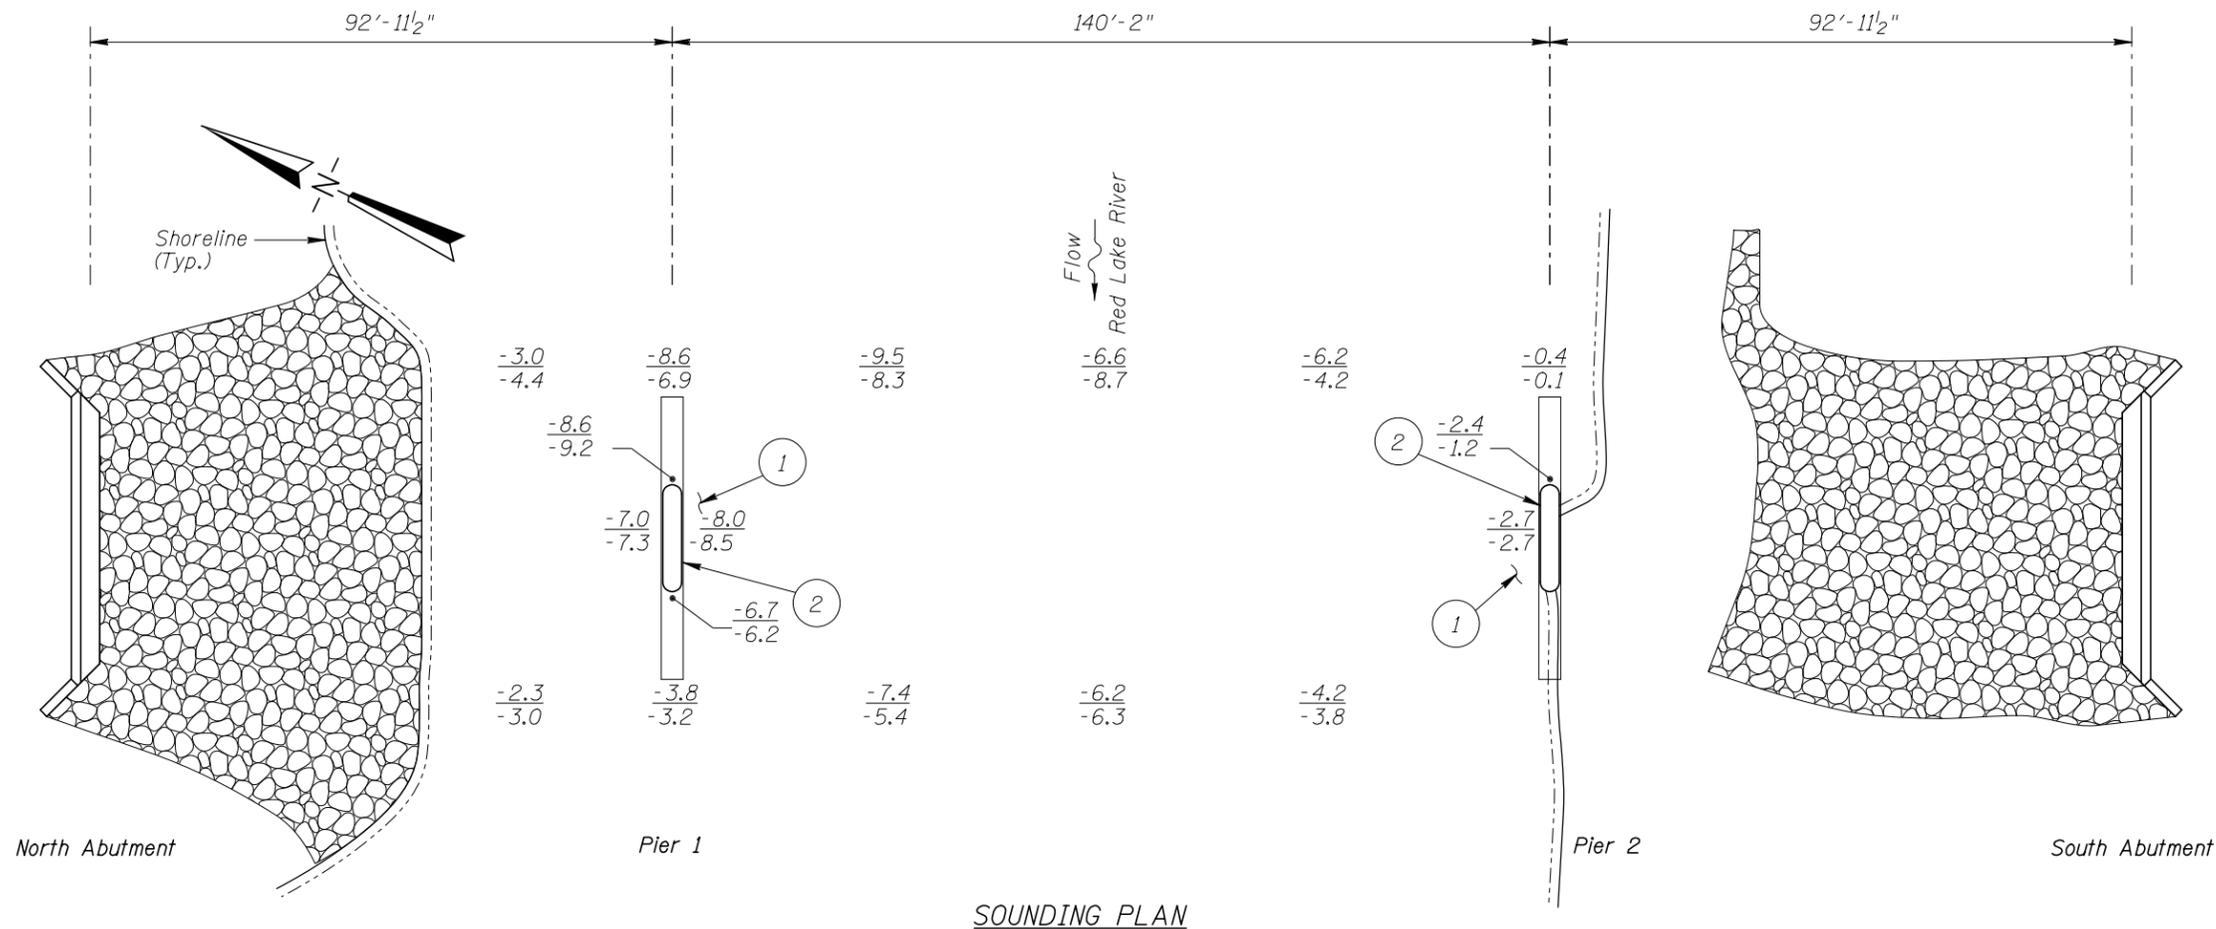
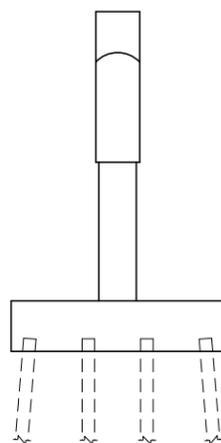
SOUNDING PLAN

- ① The channel bottom consisted of sandy silt and scattered riprap with 1 foot of probe rod penetration around the entire perimeter of both piers.
- ② The concrete above and below the waterline was typically smooth and sound with no defects of structural significance observed.
