UNDERWATER BRIDGE INSPECTION REPORT

STRUCTURE NO. 6676
CSAH NO. 25
OVER THE
RED RIVER OF THE NORTH
DISTRICT 2 - NORMAN COUNTY

JULY 14, 2012
PREPARED FOR THE
MINNESOTA DEPARTMENT OF TRANSPORTATION
BY
AYRES ASSOCIATES & COLLINS ENGINEERS, INC.
JOB NO. 7423

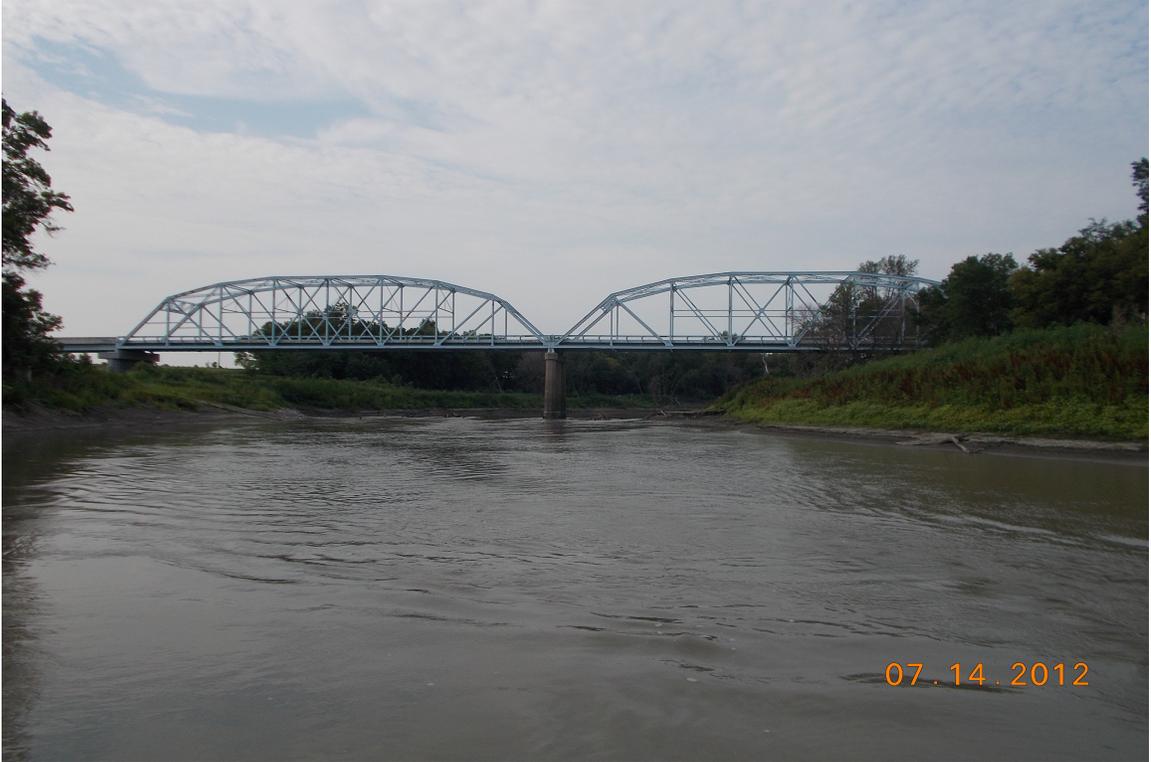
Photograph 1. Overall View of the Structure, Looking South.

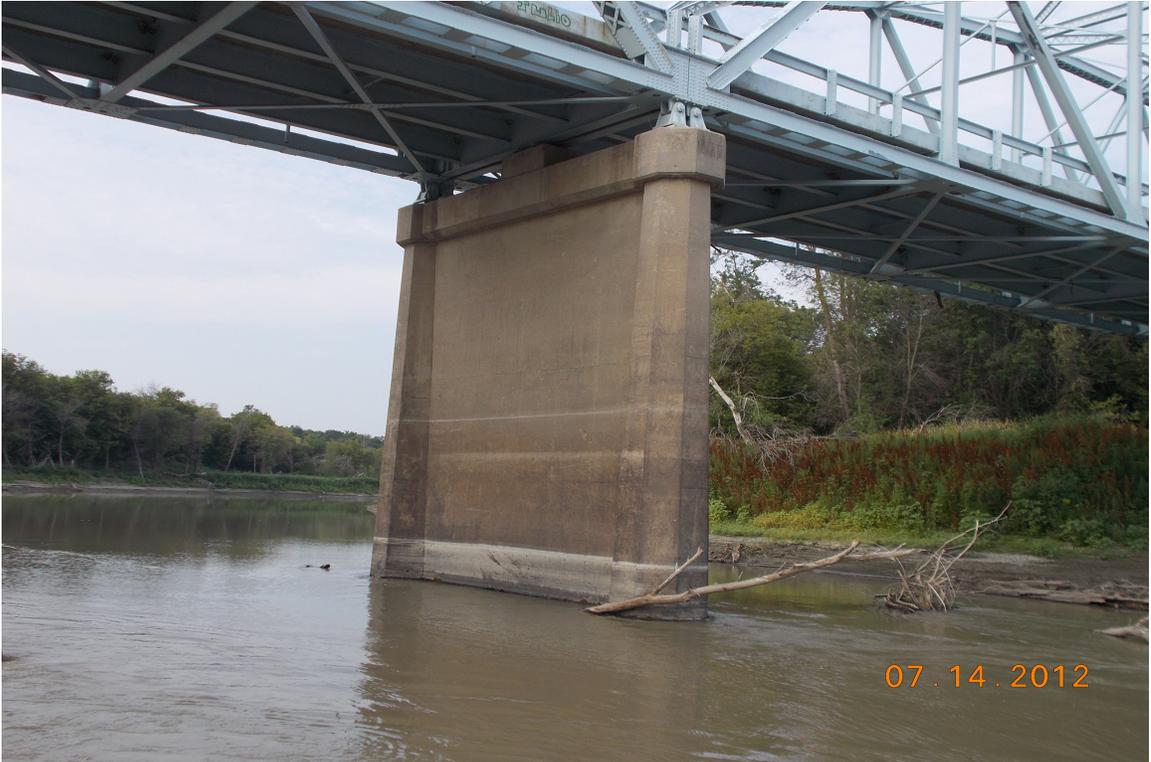
Photograph 2. View of Pier 2, Looking Southwest.

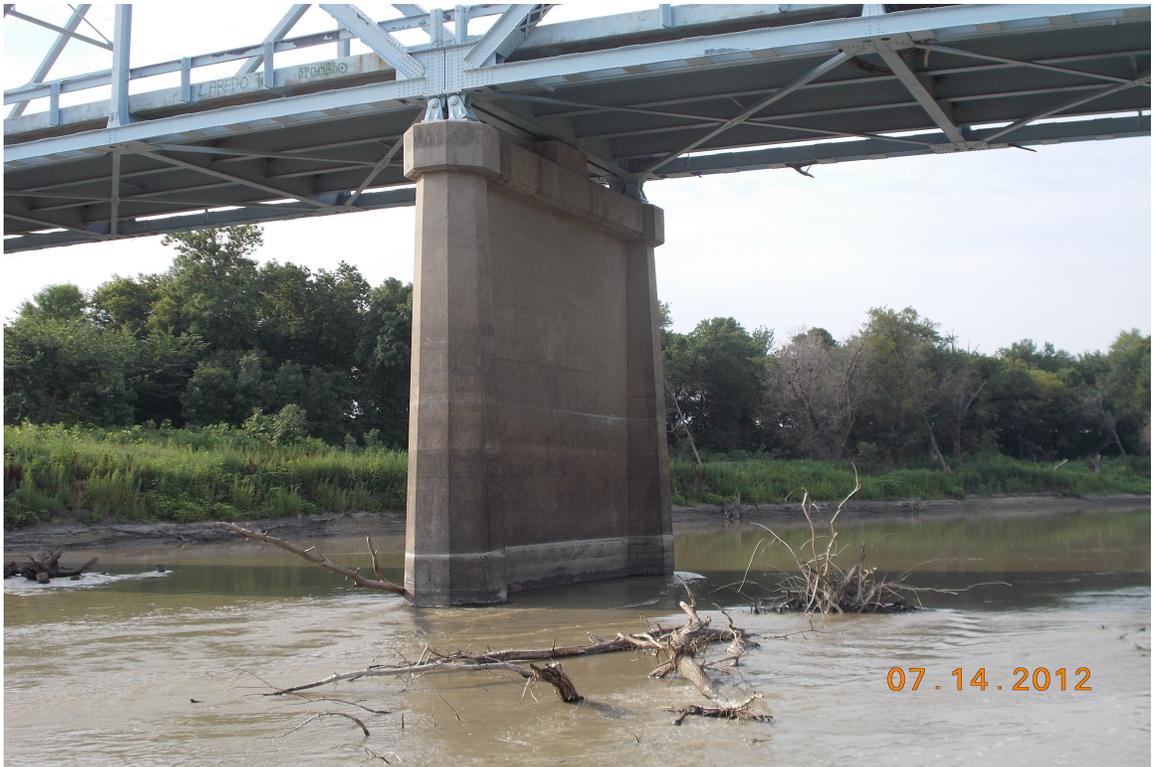
Photograph 3. View of Pier 2, Looking Southeast.

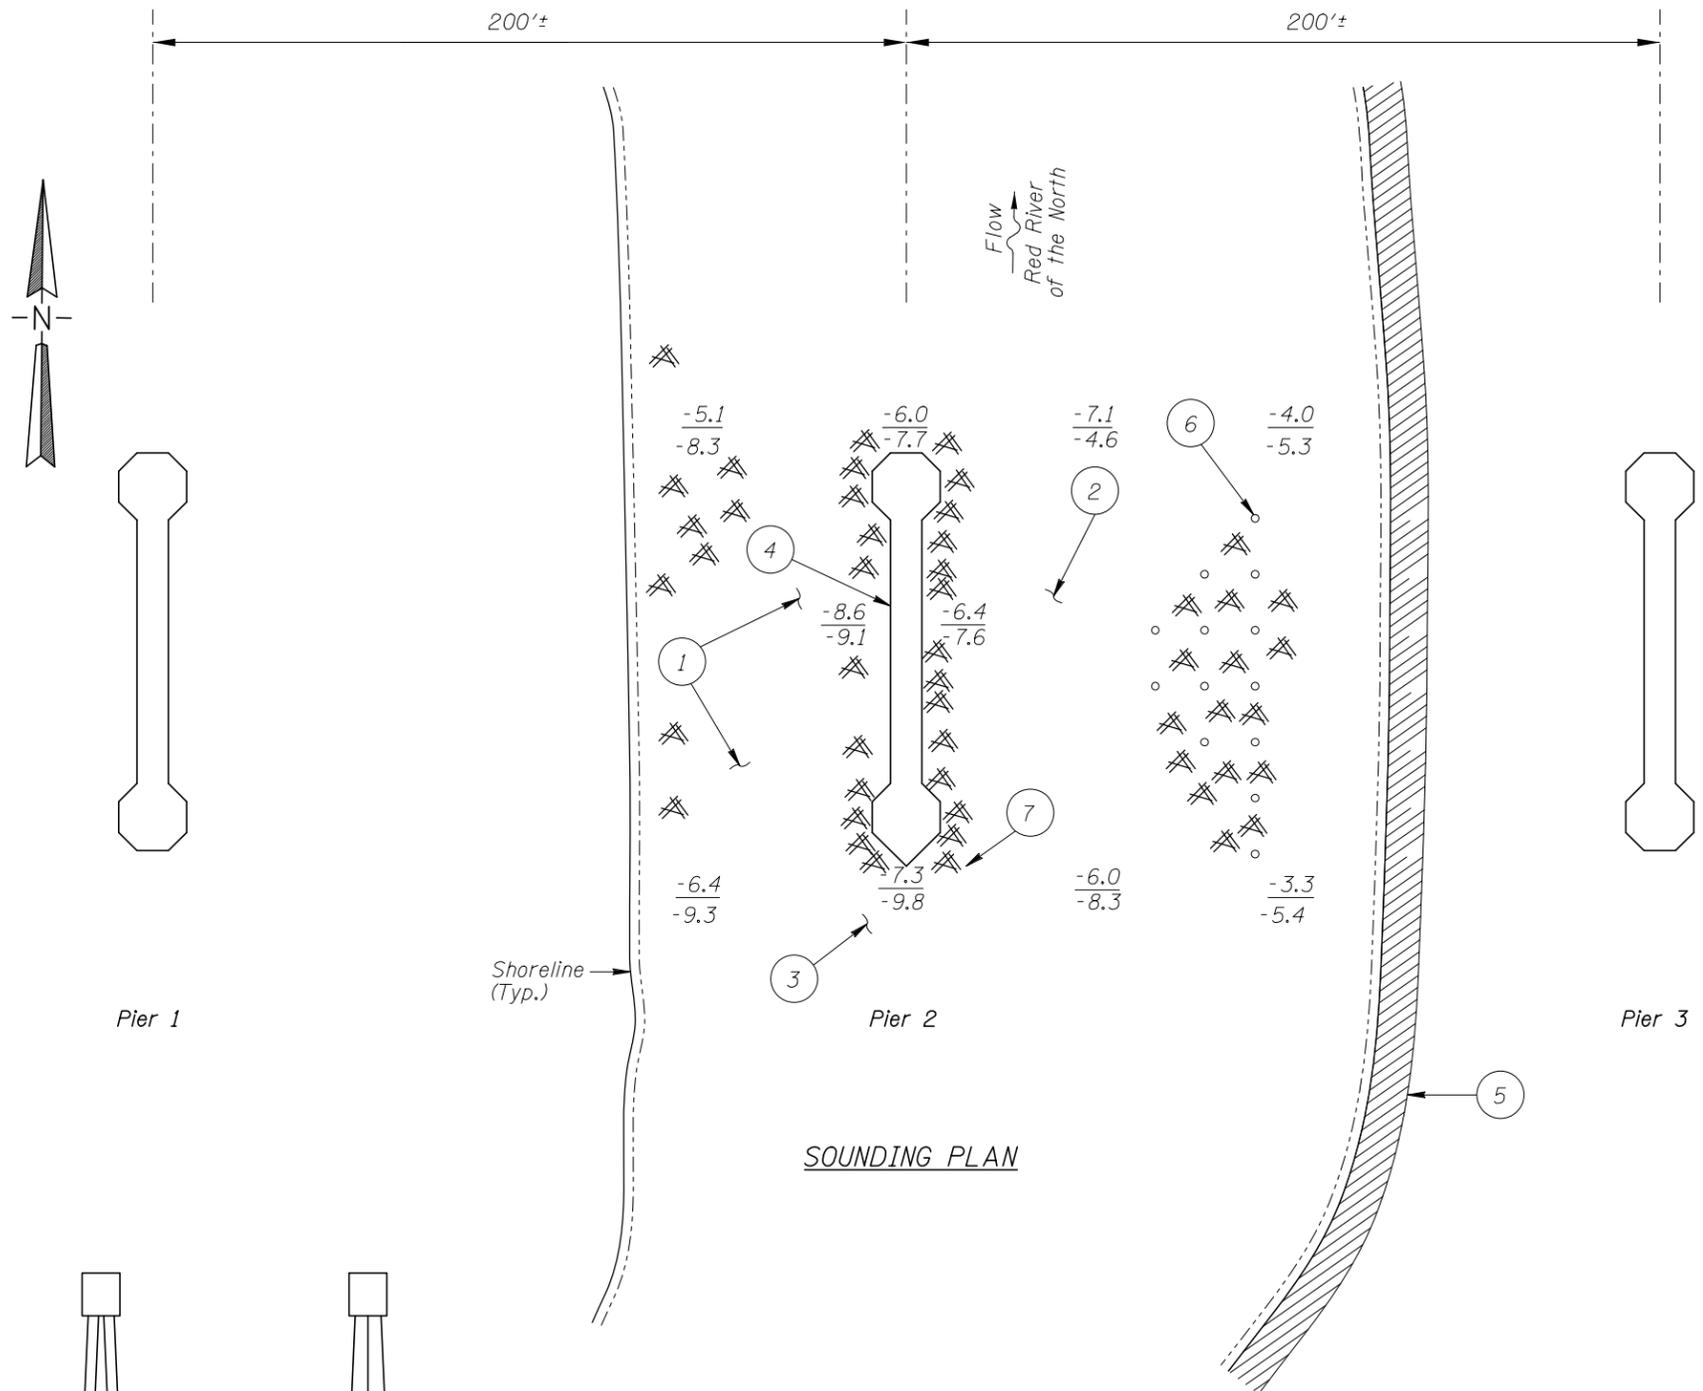
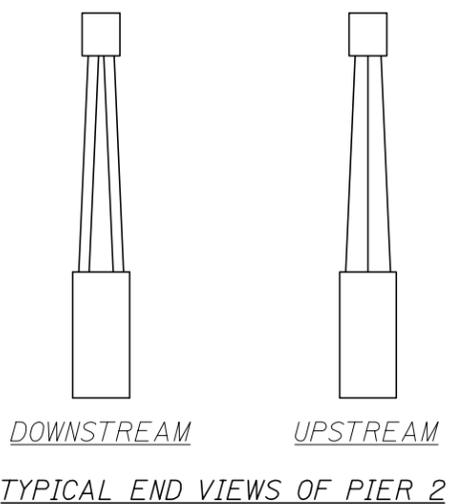
SOUNDING PLAN

- 1 The channel bottom material along the west side of Pier 2 consisted of silt and gravel with up to 6 inches of maximum penetration.
- 2 The channel bottom material along the east side of Pier 2 consisted of clayey silt with up to 12 inches of maximum penetration.

- 3 The channel bottom material at the upstream nose of Pier 2 consisted of hard clay with 2 to 4 inches of maximum penetration.
- 4 The concrete surfaces of Pier 2 were smooth and sound. Random minor areas of poor consolidation and section loss with up to 1/2 inch maximum penetration and no exposed reinforcing steel were present. Intermittent voids/honeycombing were observed at the waterline of Pier 2 typically measuring 12 inches by 12 inches with 2 inches of penetration.

- 5 Heavy bank erosion was located along the entire eastern shoreline in the vicinity of the bridge, having 10 foot vertical banks, loss of soil, and exposed tree roots.

- 6 Abandoned timber piles with scattered accumulated timber drift hung up on and throughout piles.
- 7 A light accumulation of timber debris was observed around the entire perimeter of Pier 2.
