UNDERWATER BRIDGE INSPECTION REPORT

STRUCTURE NO. 7097

RED RIVER OF THE NORTH

AUGUST 30, 2012

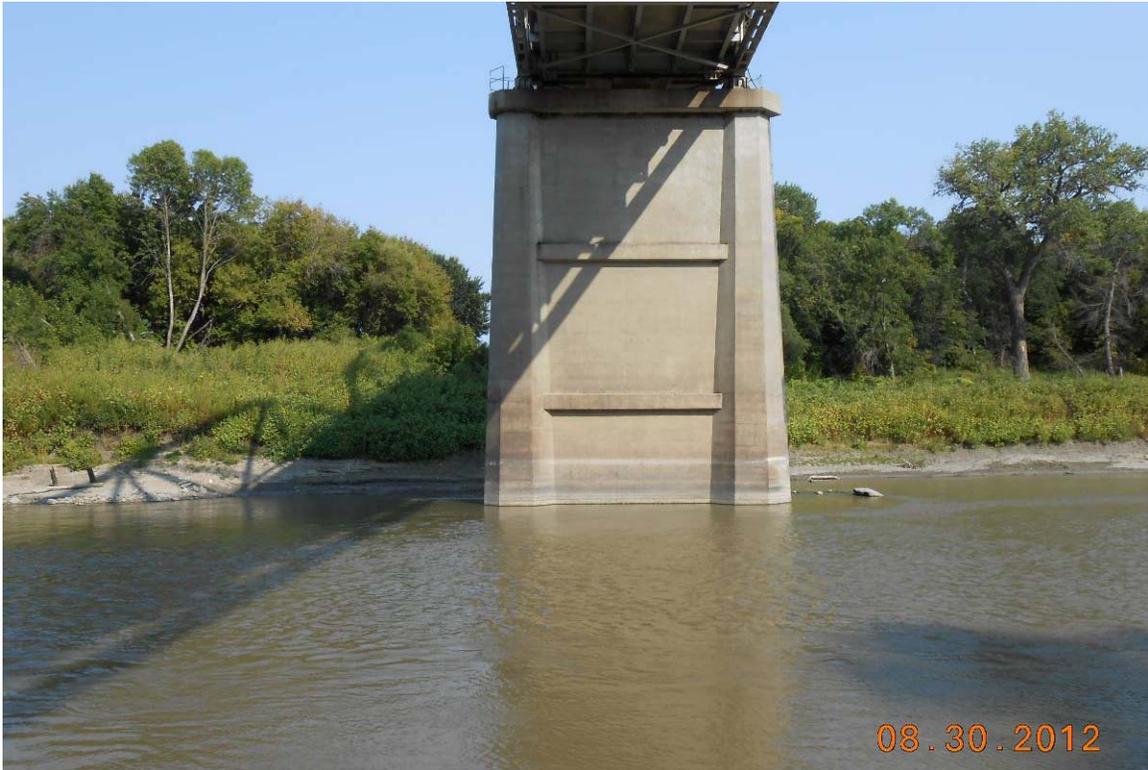
- (A) Moderate to heavy timber debris consisting of logs and branches 2 feet diameter and smaller was observed at the south (upstream) end and along the entire east face of Pier 2. The debris extended from the channel bottom up 3 feet above the waterline, 6 feet off the east face and 10 feet off the upstream nose towards the west.
- (B) Vertical crack up to 1/8 inch wide was located on east and west faces of Pier 2 extending from the strut to the channel bottom at midpoint of the pier.
- (C) The previously reported footing exposure at Pier 2 was not observed.

Photograph 2. View of Pier 2, Looking East.

- (A) Monitor the timber debris, and if found to be increasing in the future, removal operations may become warranted.

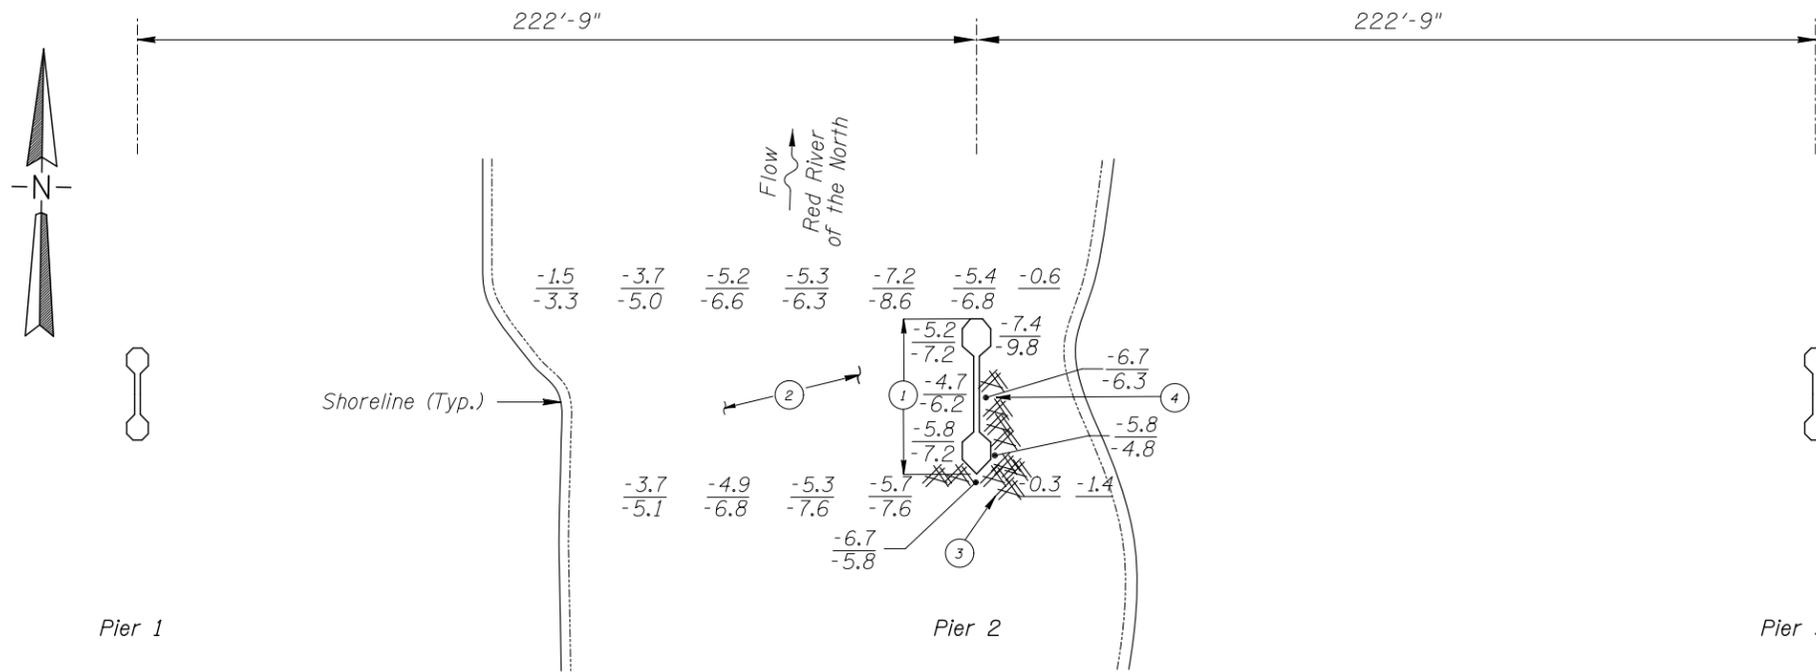
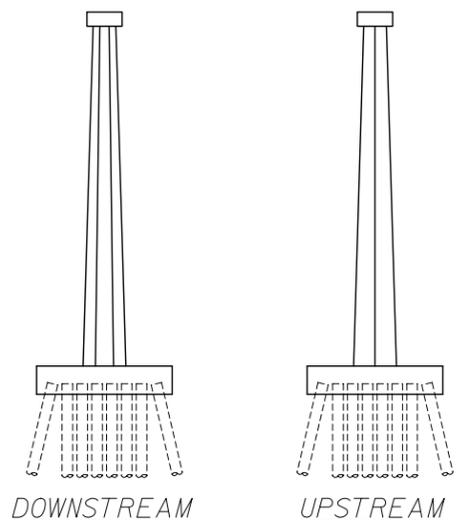
SOUNDING PLAN

- ① Overall, concrete was smooth and sound with no significant defects.
- ② The channel bottom consisted of soft silt with 2 feet of maximum probe rod penetration.
- ③ Moderate to heavy timber debris accumulation consisting of logs and branches 2 feet in diameter and smaller was observed at south end and east face of Pier 2. The debris extended from channel bottom to 3 feet above the waterline, 6 feet off the east face and 10 feet off the upstream nose.
- ④ Vertical crack 1/8 inch wide extending from strut to channel bottom was located at midpoint of pier on east and west faces of Pier 1.

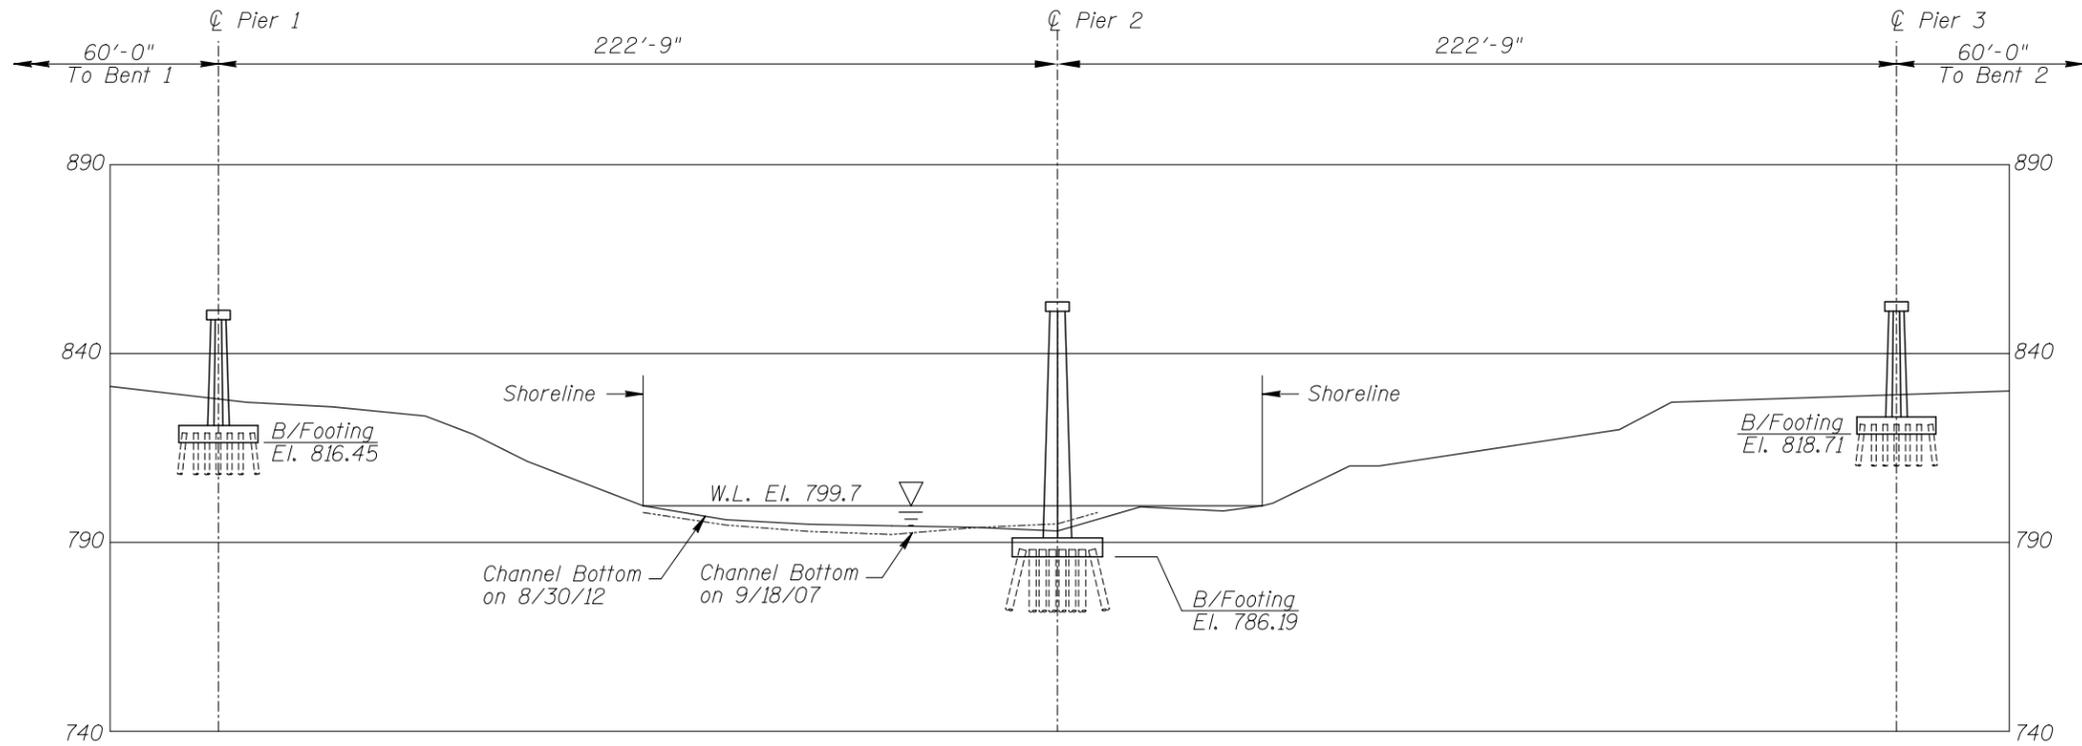
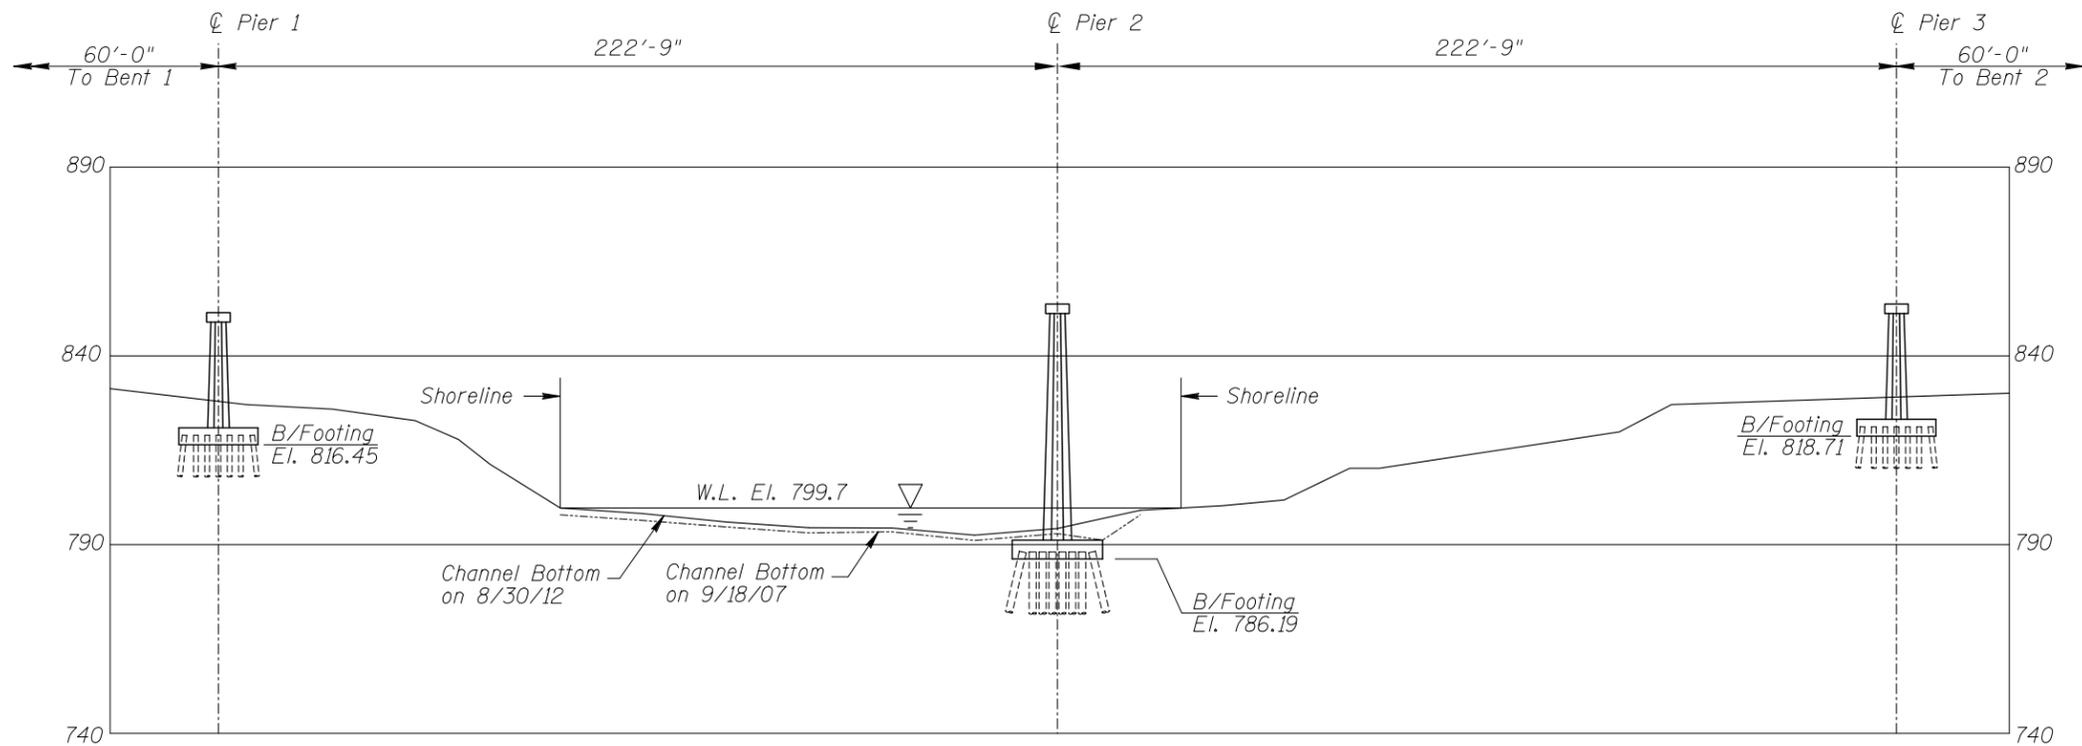
UPSTREAM FASCIA PROFILE

The substructure unit inspected at Bridge No. 7097, Pier 2, was in good condition with no defects of structural significance observed. Channel bottom aggradation has occurred at the bridge site since the last underwater inspection as the water depth soundings indicated the streambed elevation was an average of 2 feet higher and the top of footing at Pier 2 was no longer exposed.
