UNDERWATER BRIDGE INSPECTION REPORT

STRUCTURE NO. 7248

RED LAKE RIVER

AUGUST 17, 2012

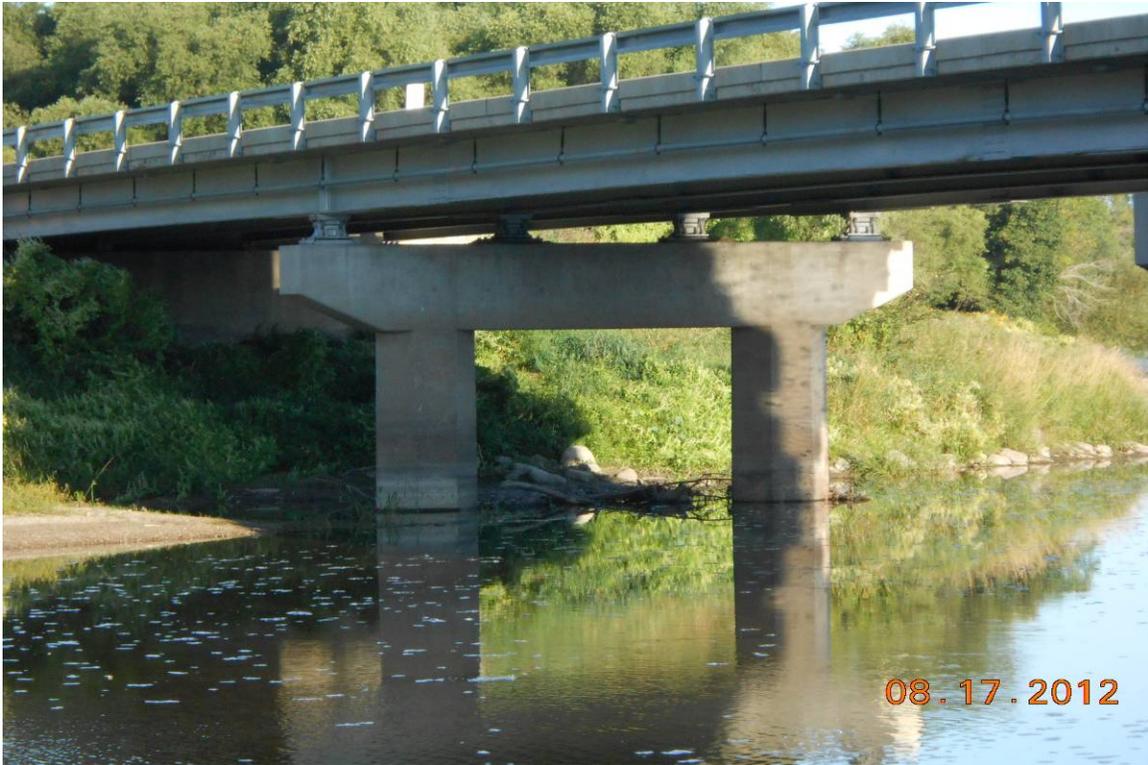
Photograph 2. View of Pier 1, Looking Northwest.

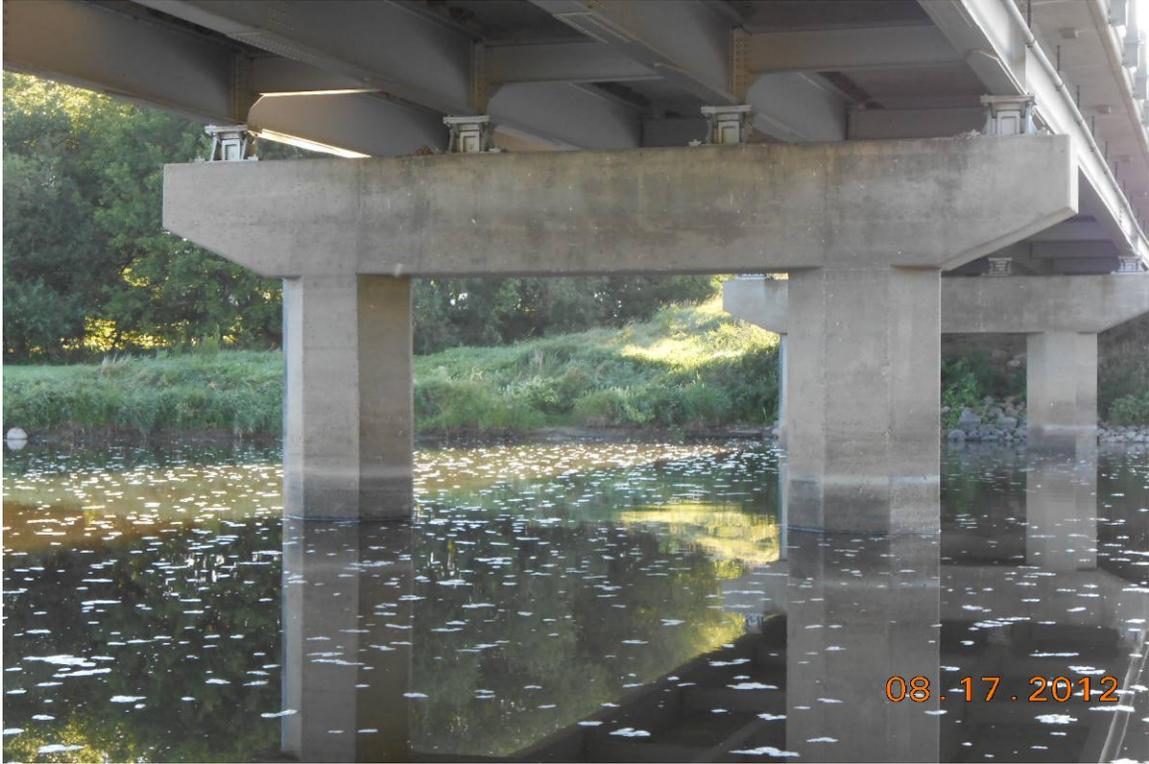
Photograph 3. View of Pier 2, Looking Northeast.

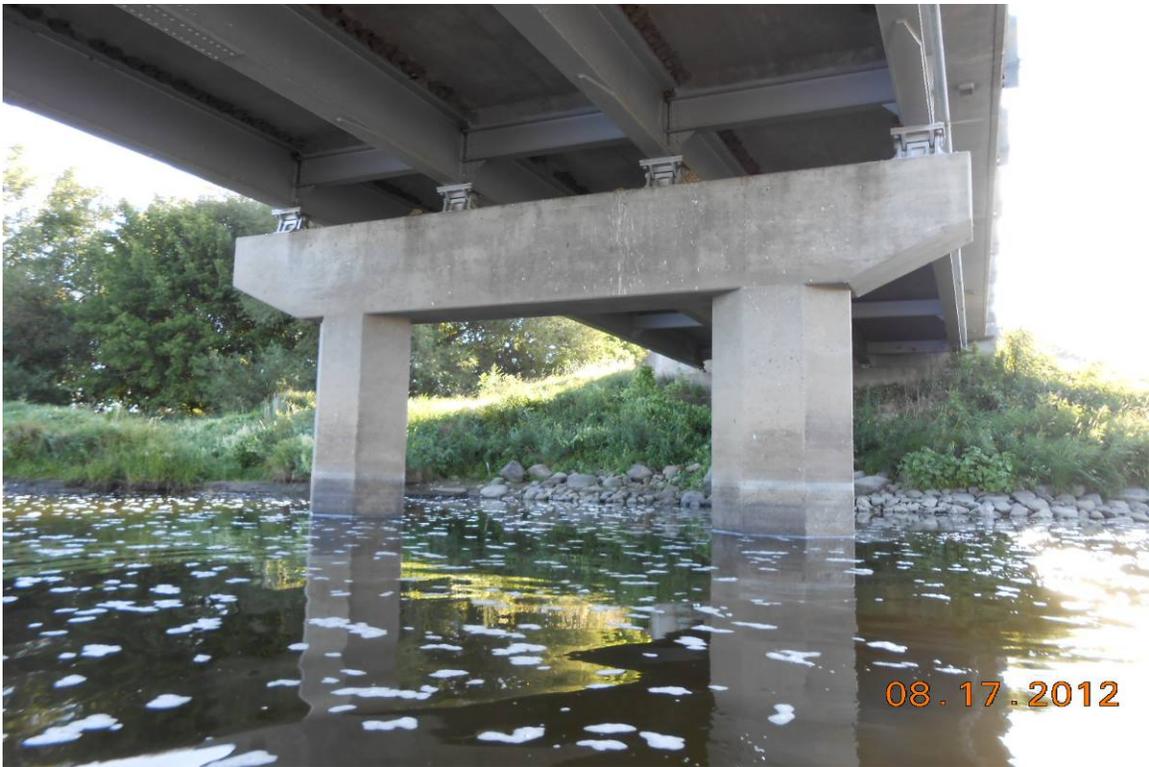
Photograph 4. View of Pier 3, Looking Northeast.

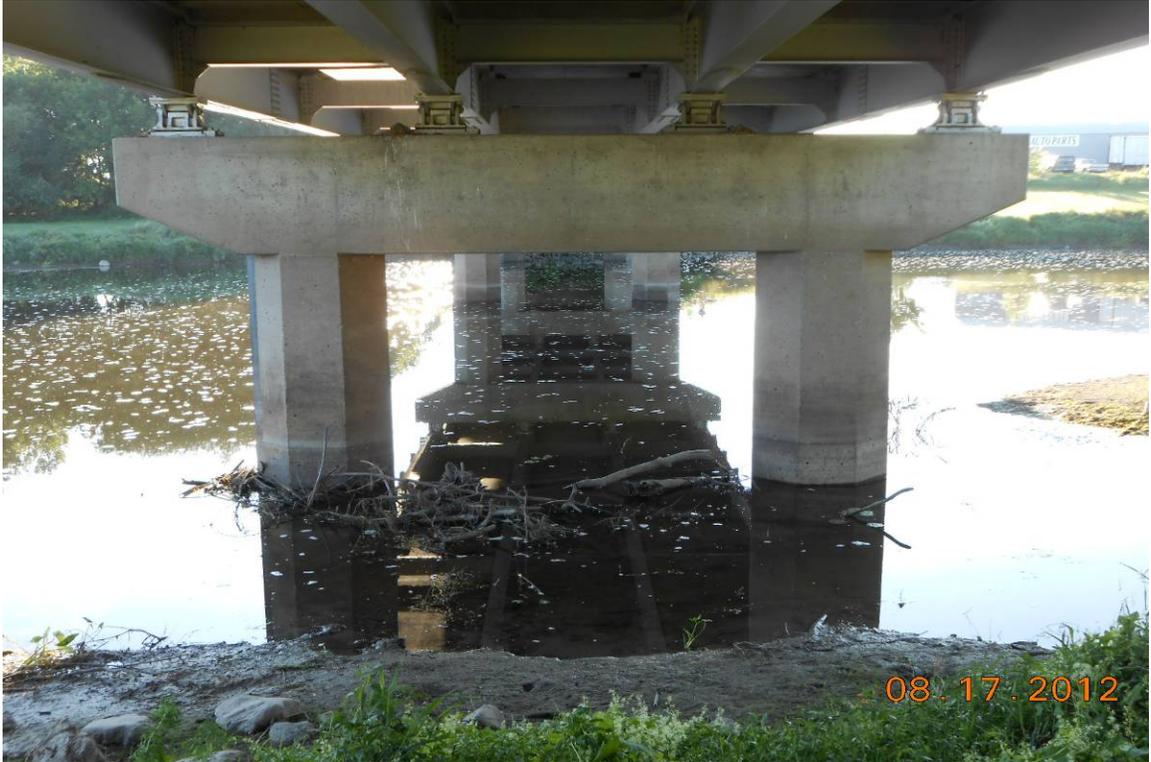
- (A) A scour pocket, 3 feet in radius with a depth of 1 foot, was observed at the upstream nose of Pier 2.
- (B) Light scaling was observed around all columns on all piers from 1 foot above to 3 feet below the waterline with a maximum penetration of 1/4 inch.
- (C) A light accumulation of timber debris consisting of 6 inch diameter or smaller branches was observed at the upstream nose of the upstream column of Pier 1 from the channel bottom up 2 feet.

Photograph 5. View of Timber Debris at Pier 1, Looking East.

- (A) Monitor the accumulations of timber debris at Piers 1 during future inspections.
- (B) Reinspect the submerged substructure units at the normal maximum recommended (NBIS) interval of sixty (60) months.

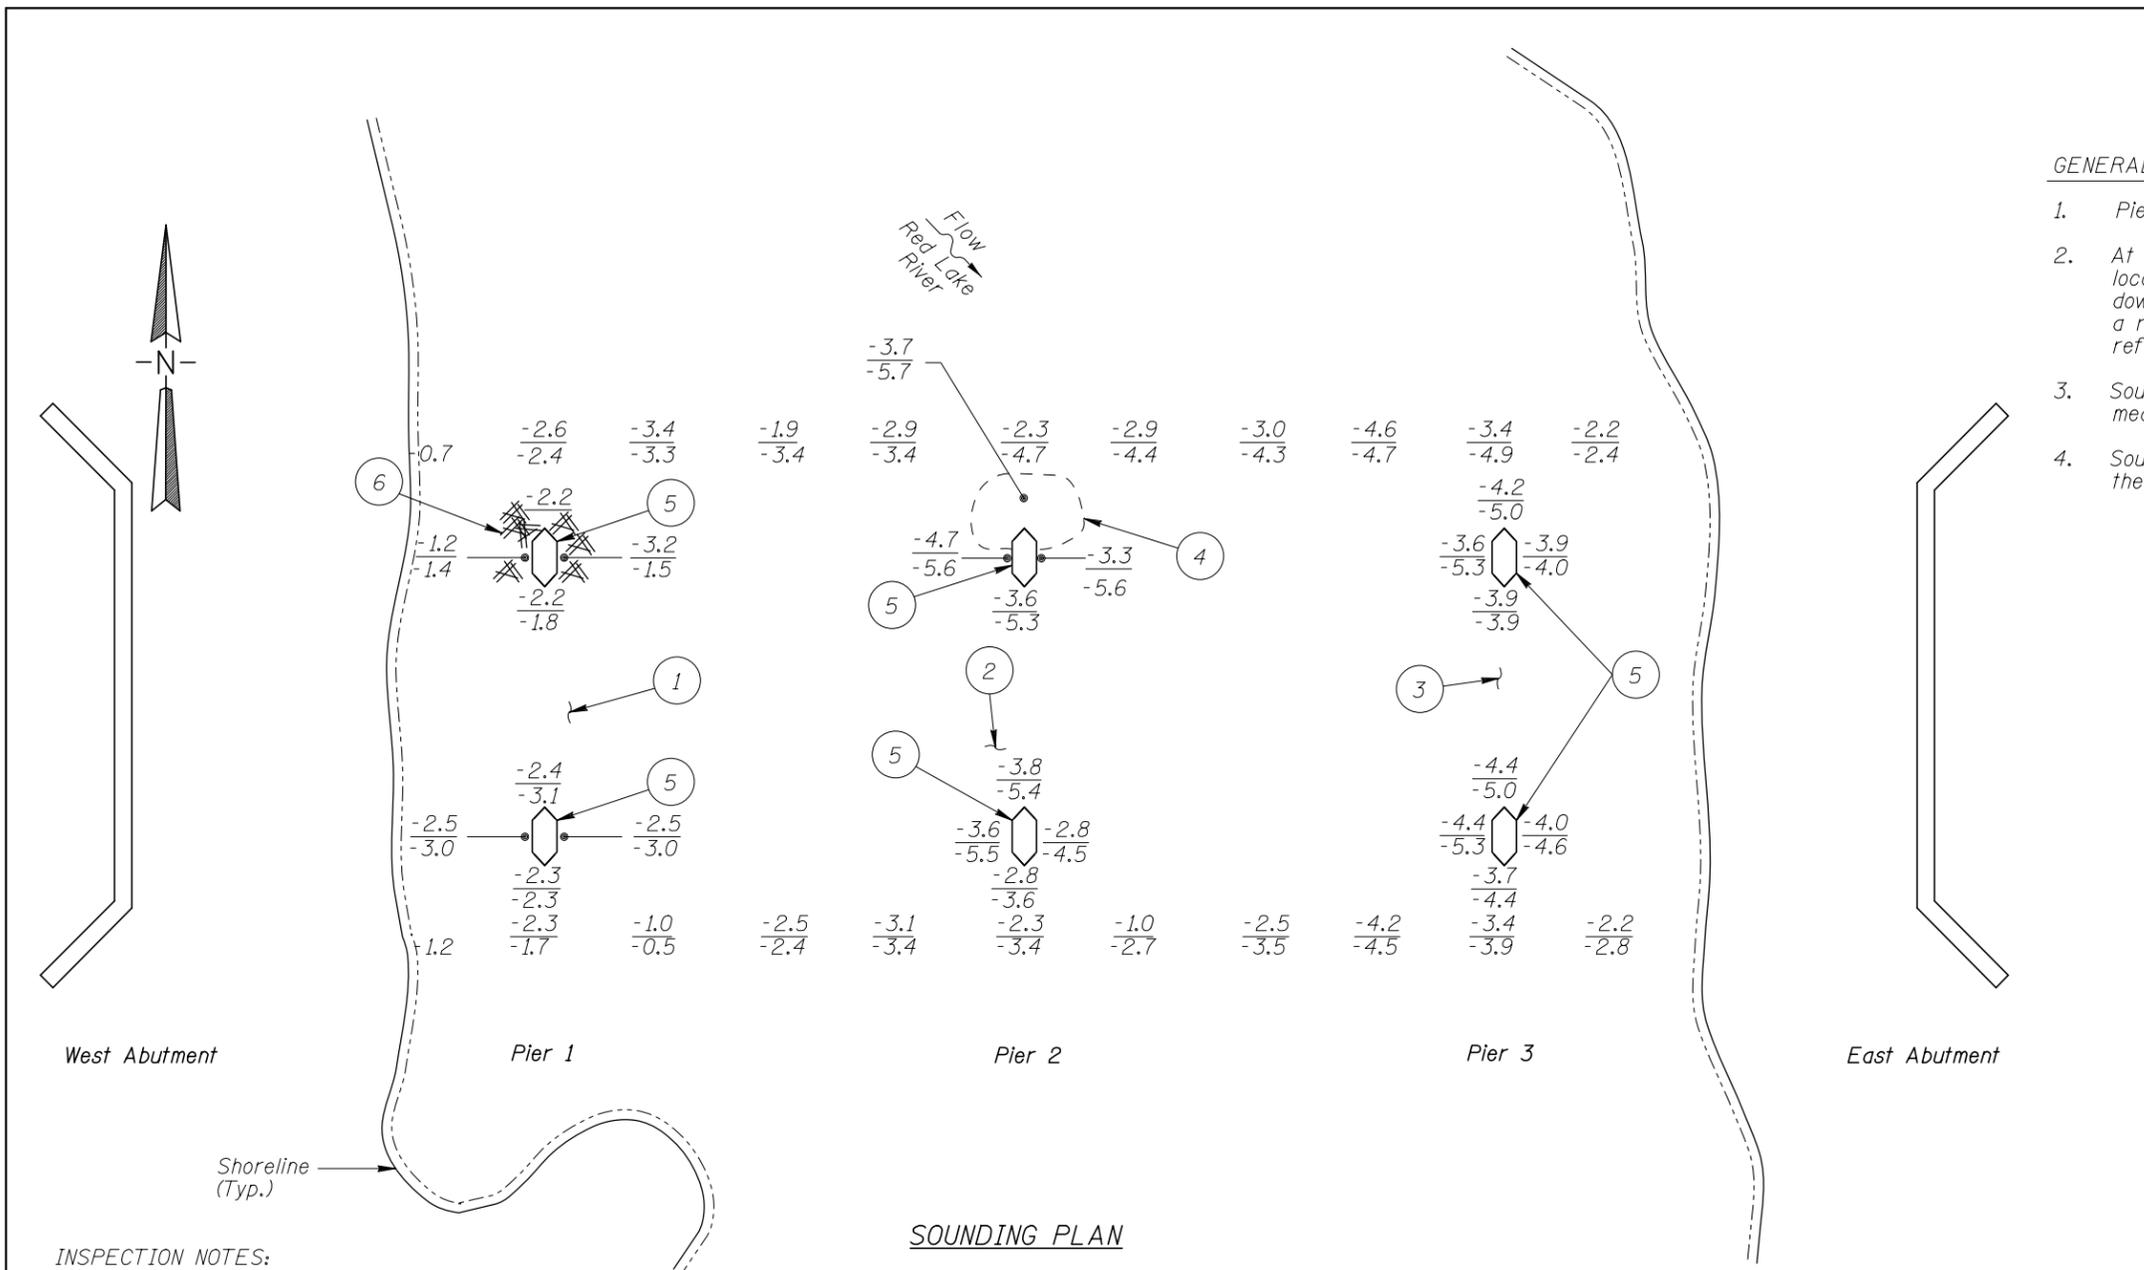
MINNESOTA DEPARTMENT OF TRANSPORTATION UNDERWATER BRIDGE INSPECTION		
STRUCTURE NO. 7248 OVER THE RED LAKE RIVER DISTRICT 2, PENNINGTON COUNTY		
INSPECTION AND SOUNDING PLAN		
Drawn By: JAC		Date: AUGUST, 2012
Checked By: BKS		Scale: NTS
Code: 52210161		Figure No.: I

- The channel bottom material consisted of soft, silty infill with up to 2 feet of probe rod penetration around Pier 1.
- The channel bottom material at Pier 2 consisted of fine sand and random cobbles of up to 1 foot in diameter with up to 1 foot of probe rod penetration.
- The channel bottom material consisted of fairly firm sandy gravel with 3 to 6 inch diameter cobbles and a probe rod penetration of up to 6 inches around Pier 3.
- A scour pocket, 3 feet in radius with a depth of 1 foot, was observed at the upstream nose of Pier 2.
- Light scaling was observed around all columns from 1 foot above to 3 feet below the waterline with 1/4 inch of maximum penetration.
- A light accumulation of timber debris consisting of 6 inch diameter or smaller branches was observed at upstream nose of the upstream column of Pier 1 from channel bottom up 2 feet.
