UNDERWATER BRIDGE INSPECTION REPORT

STRUCTURE NO. 97373
CSAH 37
OVER
HEIR CREEK
DISTRICT 2 - CLEARWATER COUNTY

AUGUST 13, 2012
PREPARED FOR THE
MINNESOTA DEPARTMENT OF TRANSPORTATION
BY
AYRES ASSOCIATES & COLLINS ENGINEERS, INC.
JOB NO. 7423

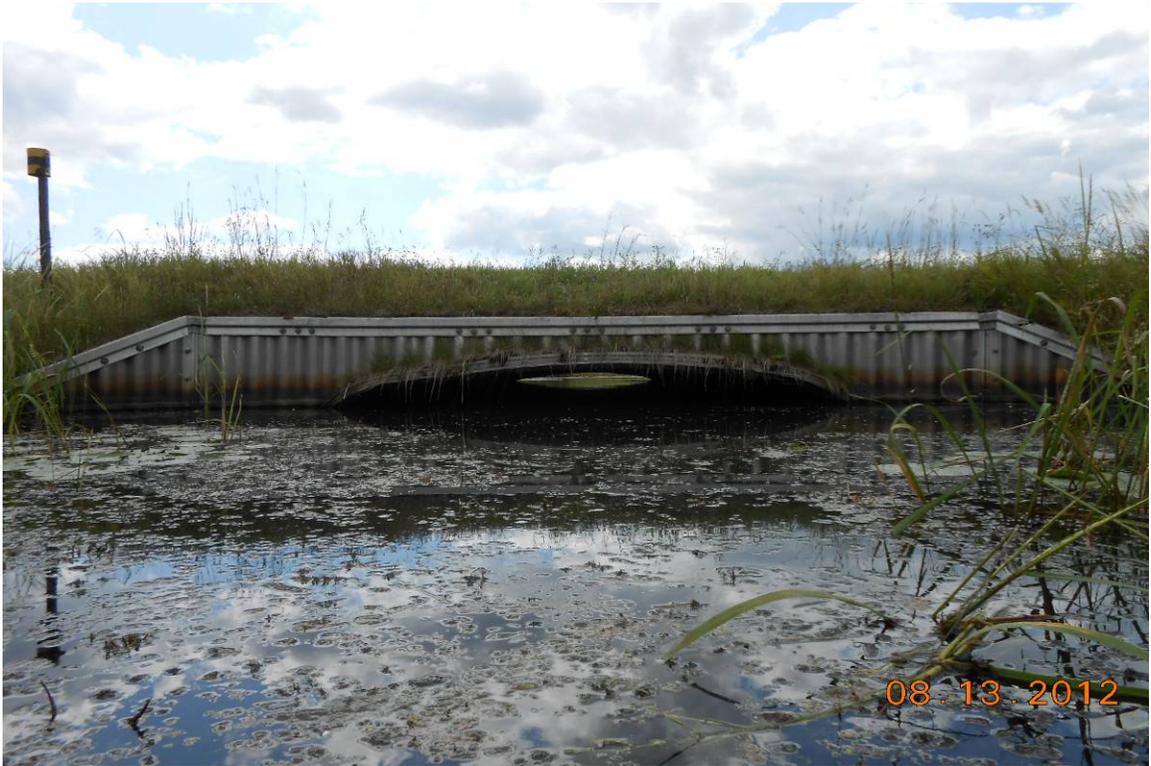
Photograph 1. Overall View of Structure, Looking North.

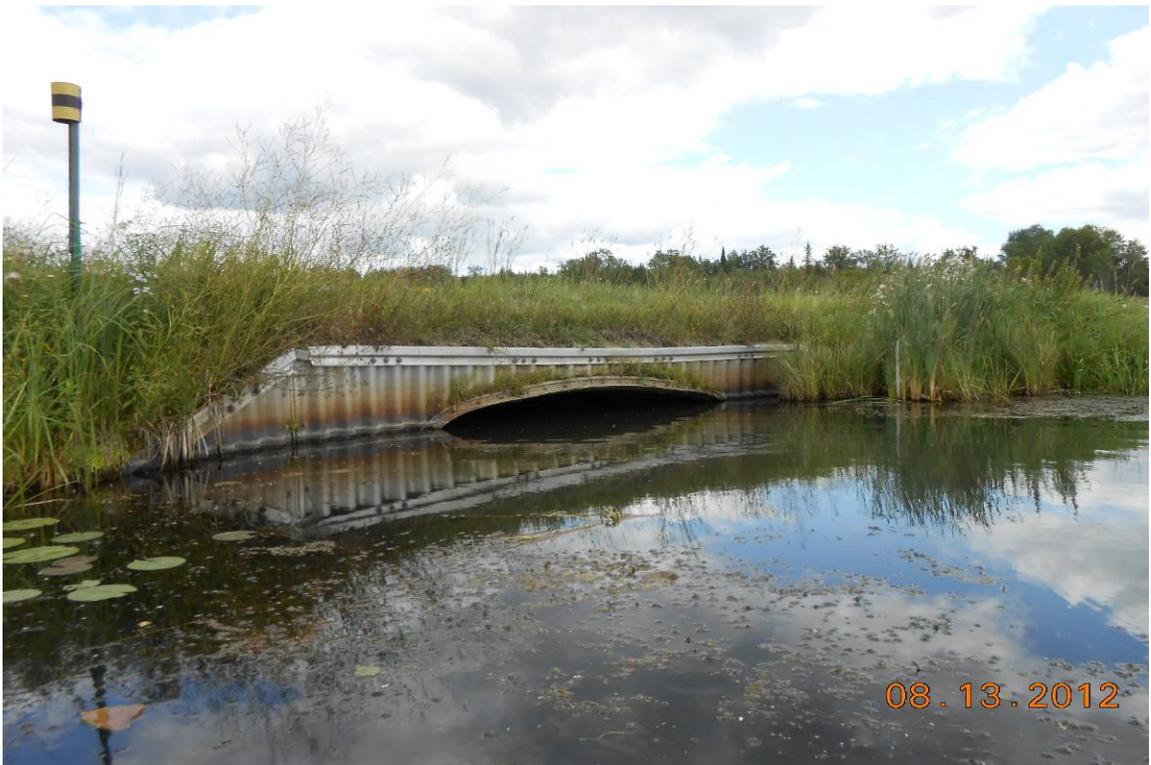
Photograph 2. Overall View of Structure, Looking South.

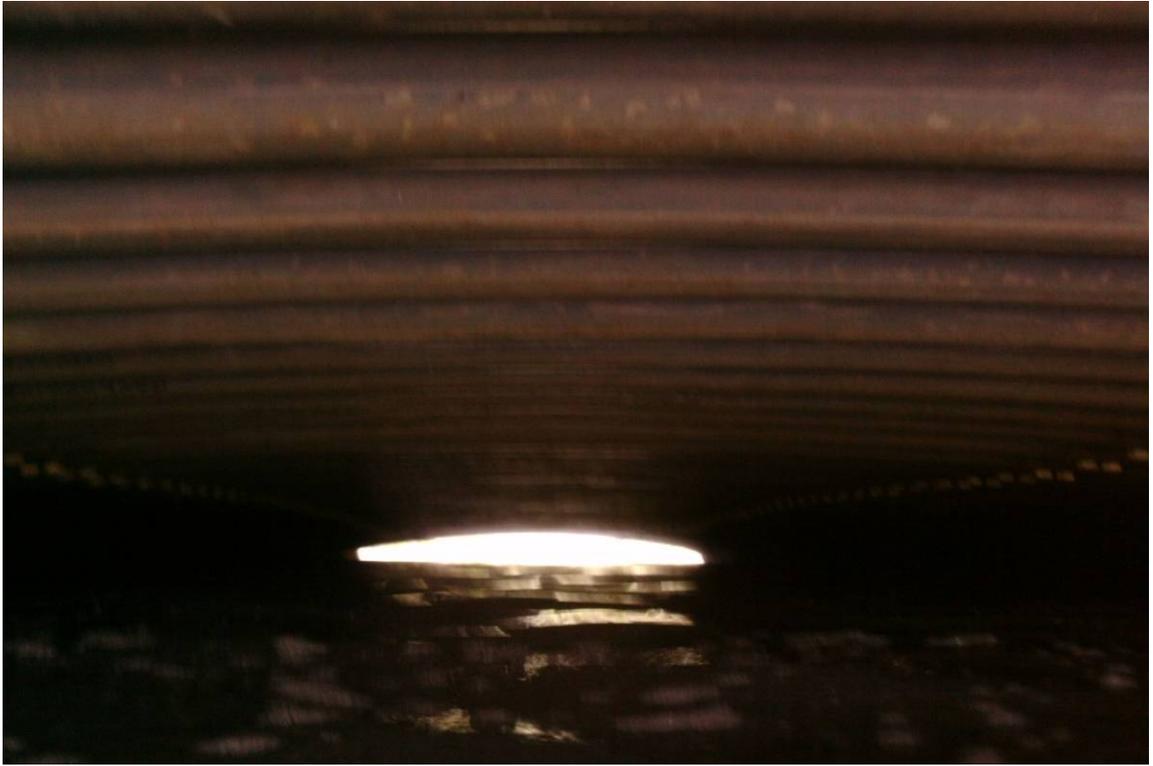
- (A) The corrugated aluminum arch culvert was sound with all joints secure and properly fitted with no gaps, deficiencies, or surface corrosion observed.
- (B) The culvert floor was occasionally covered with up to 3 to 6 inches of silty sand and gravel.
- (C) The channel bottom outside of the culvert consisted of riprap covered with silty sand allowing 6 inches of probe rod penetration.

Photograph 3. View of Interior Top of Culvert, Looking South.

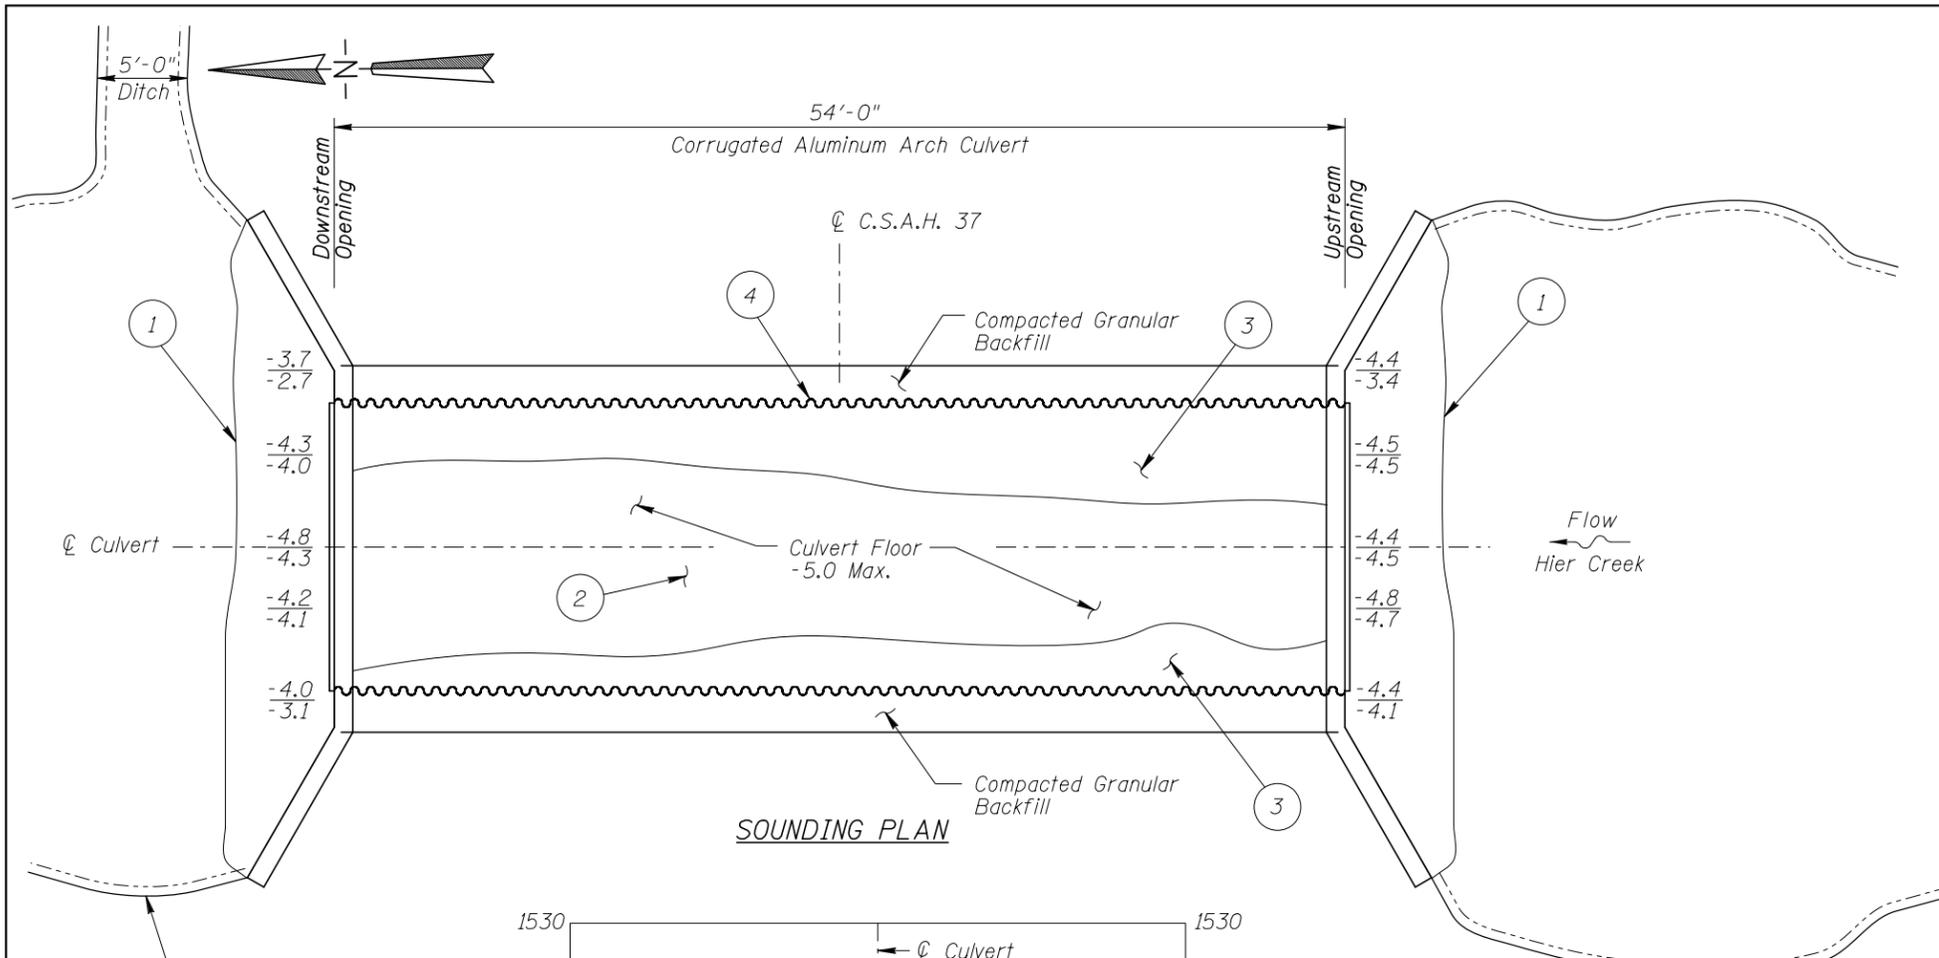
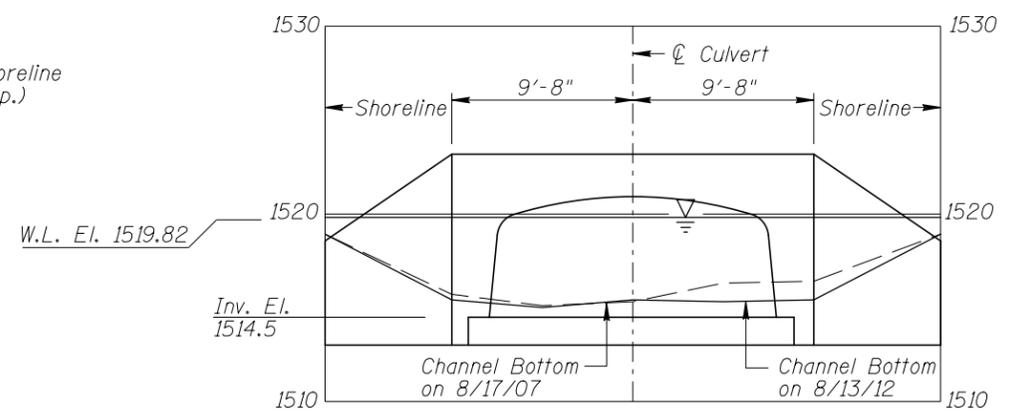
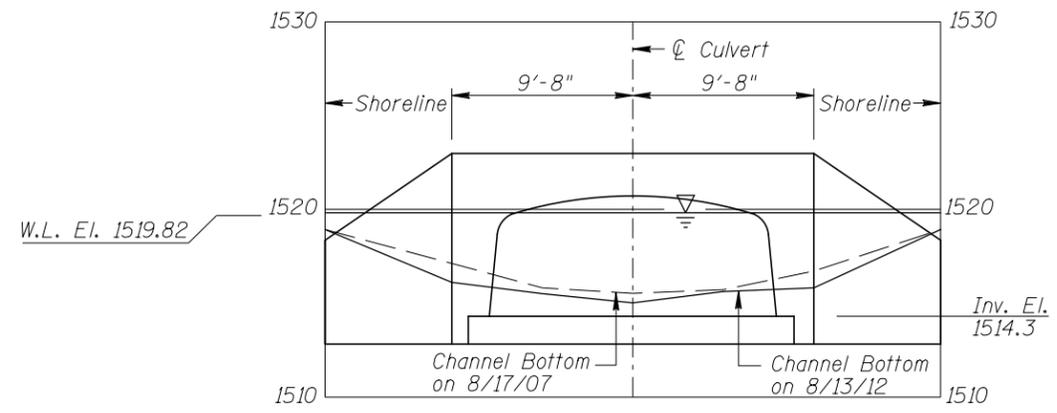
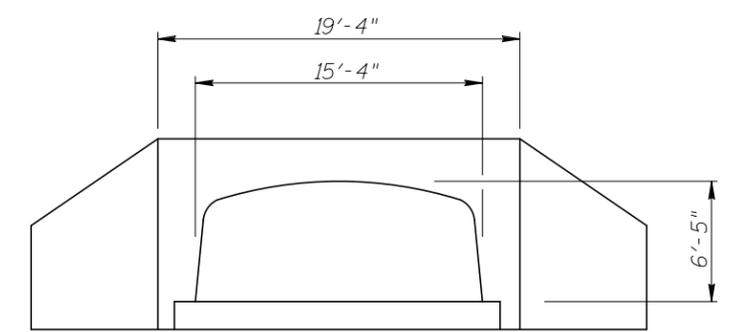
**INSPECTION AND SOUNDING PLAN
UPSTREAM AND DOWNSTREAM
OPENING PROFILES**

- ① The channel bottom consisted of riprap covered with silty sand with 6 inches of probe rod penetration.
- ② Culvert floor was occasionally covered with up to 3 inches of silty, sandy gravel.
- ③ The culvert floor along both walls of the barrel was covered with a 6-inch layer of silty, sandy gravel.
- ④ The corrugated aluminum arch culvert was sound with all joints secure and properly fitted with no gaps and no deficiencies observed.
