UNDERWATER BRIDGE INSPECTION REPORT

STRUCTURE NO. 05525  
CSAH NO. 29  
OVER THE  
MISSISSIPPI RIVER  
DISTRICT 3 - BENTON COUNTY

PREPARED FOR THE  
MINNESOTA DEPARTMENT OF TRANSPORTATION  
BY  
COLLINS ENGINEERS, INC.  
JOB NO. 3512 (CEI 82)

MINNESOTA DEPARTMENT OF TRANSPORTATION  
UNDERWATER BRIDGE INSPECTION

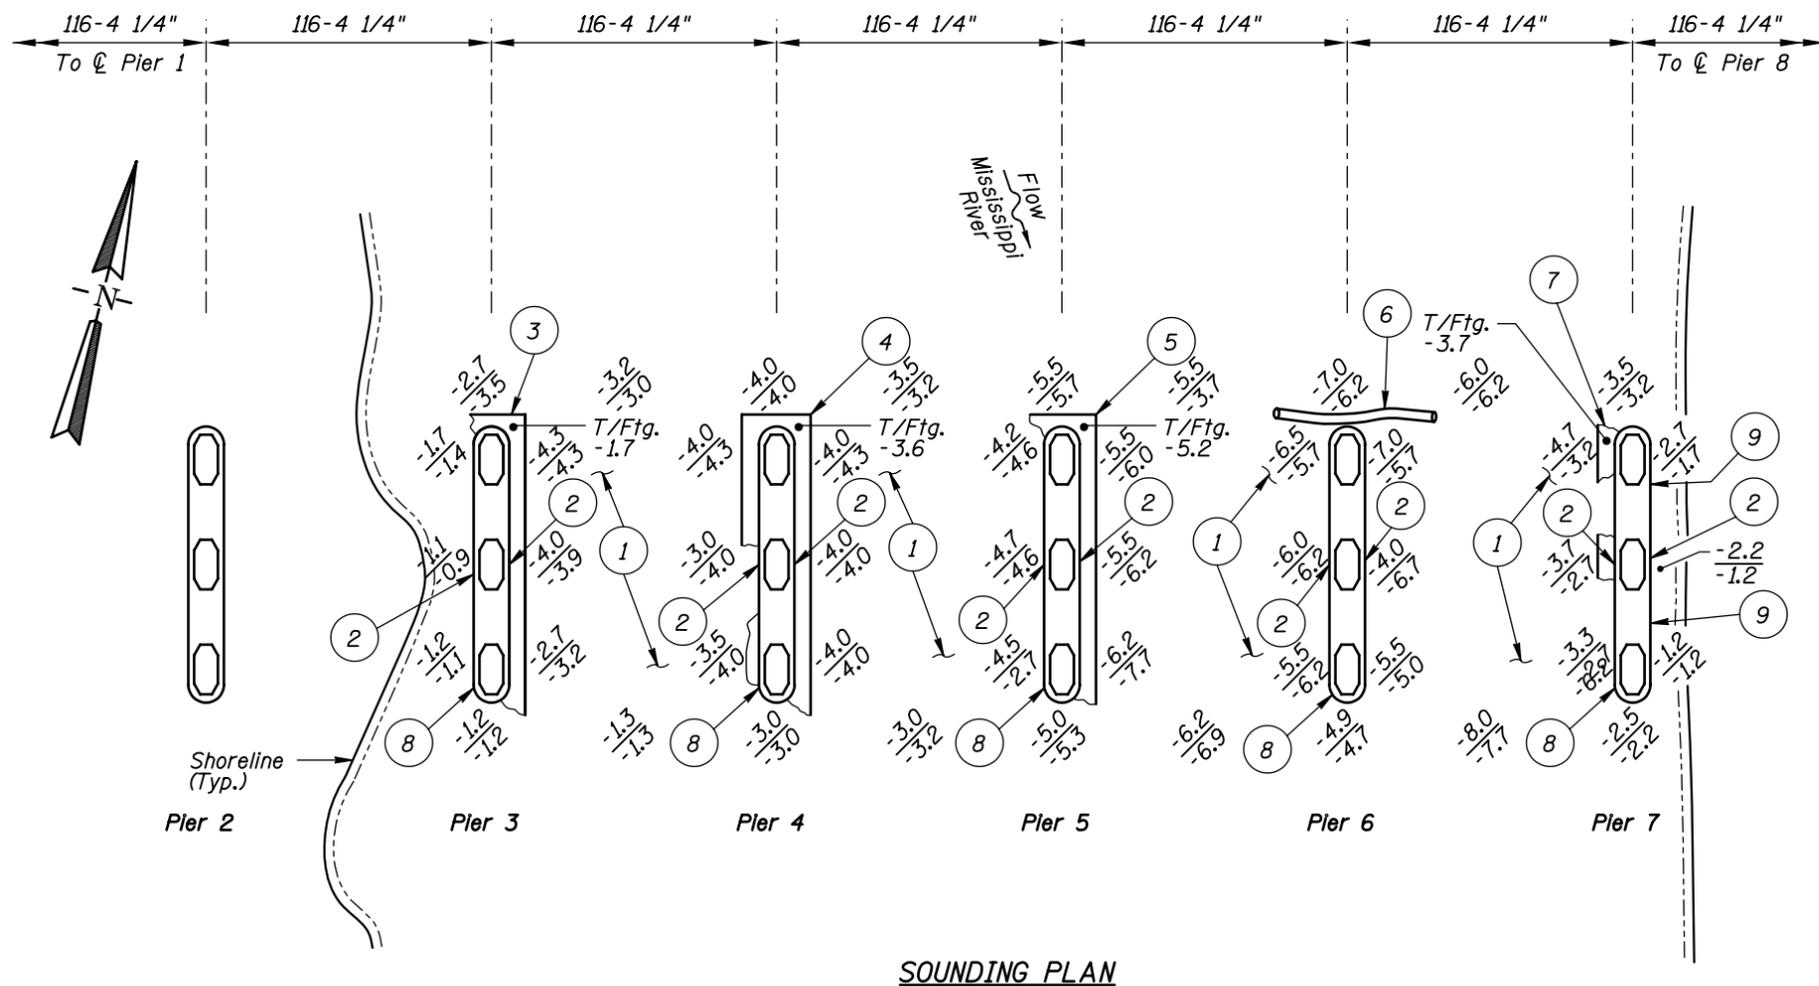
- 1 The channel bottom consisted of 6-inch to 1-foot-diameter rock with sand and with up to 3 inches of probe rod penetration.
- 2 Piers 3 through 7 exhibited a hairline crack on each face at the midpoint of the shaft that extended from the top of the shaft to the channel bottom.

- 3 The footing at Pier 3 was exposed at the upstream nose and along the entire east face with up to 2.6 feet of vertical face exposed at the northeast corner.

- 4 The footing at Pier 4 was exposed along the entire east face, around the upstream nose, and along the upstream half of the west face with up to 5 inches of vertical face exposed.

- 5 The footing at Pier 5 was exposed along the entire east face and around the upstream nose with up to 1 foot of vertical face exposed at the southeast corner.

- 6 A 1-foot-diameter log was observed on the channel bottom at the upstream end of Pier 6.
- 7 Portions of the top of footing at Pier 7 were exposed along the west face with up to 1 foot of vertical face exposed.

- 8 Light scaling was observed around the entire perimeter of all the piers with a maximum penetration of 1/8 inch, extending 1 foot below to 2 feet below the waterline.

- 9 Two hairline cracks were observed on the east face of Pier 7 at the quarter points.

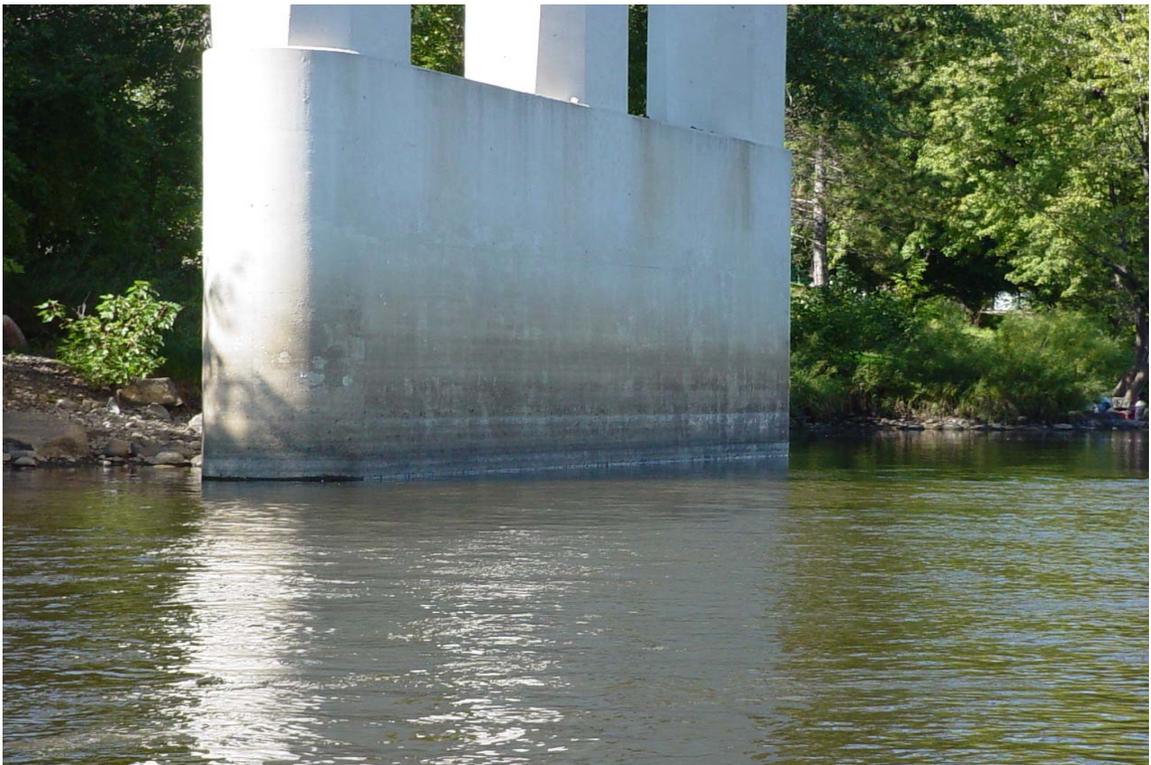
- (C) The footing at Pier 3 was exposed at the upstream nose and along the entire east face with up to 2.6 feet of vertical face exposed at the northeast corner.

Photograph 2. View of Pier 3, Looking Northwest.

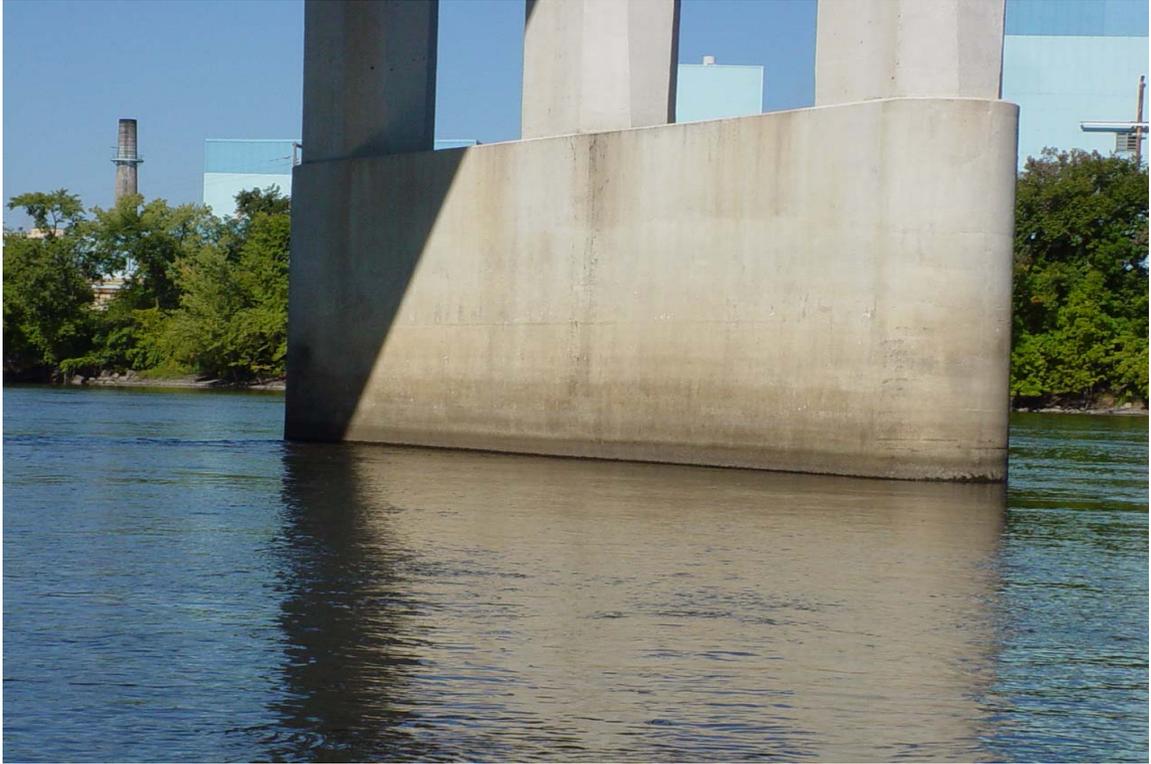
- (D) The footing at Pier 4 was exposed along the entire east face, around the upstream nose, and along the upstream half of the west face with up to 5 inches of vertical face exposed.

Photograph 3. View of Pier 4, Looking Northeast.

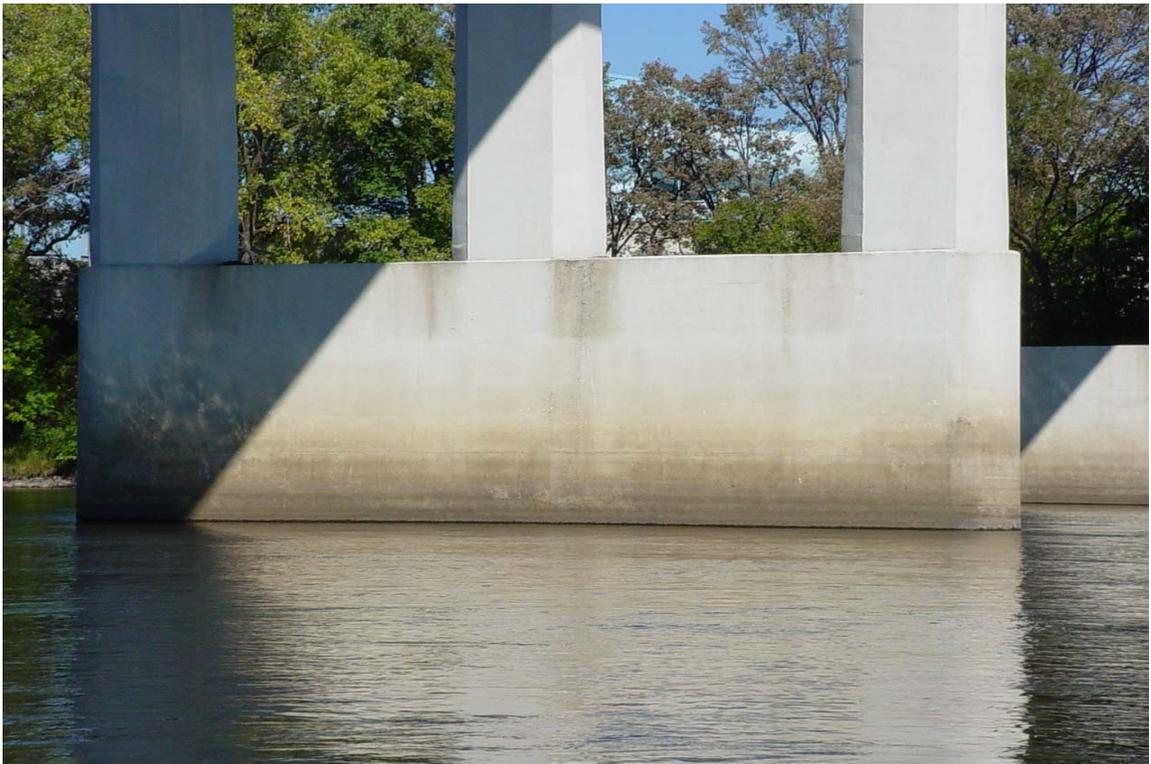
- (E) The footing at Pier 5 was exposed along the entire east face and around the upstream nose with up to 1 foot of vertical face exposed at the southeast corner.

Photograph 4. View of Pier 5, Looking Northeast.

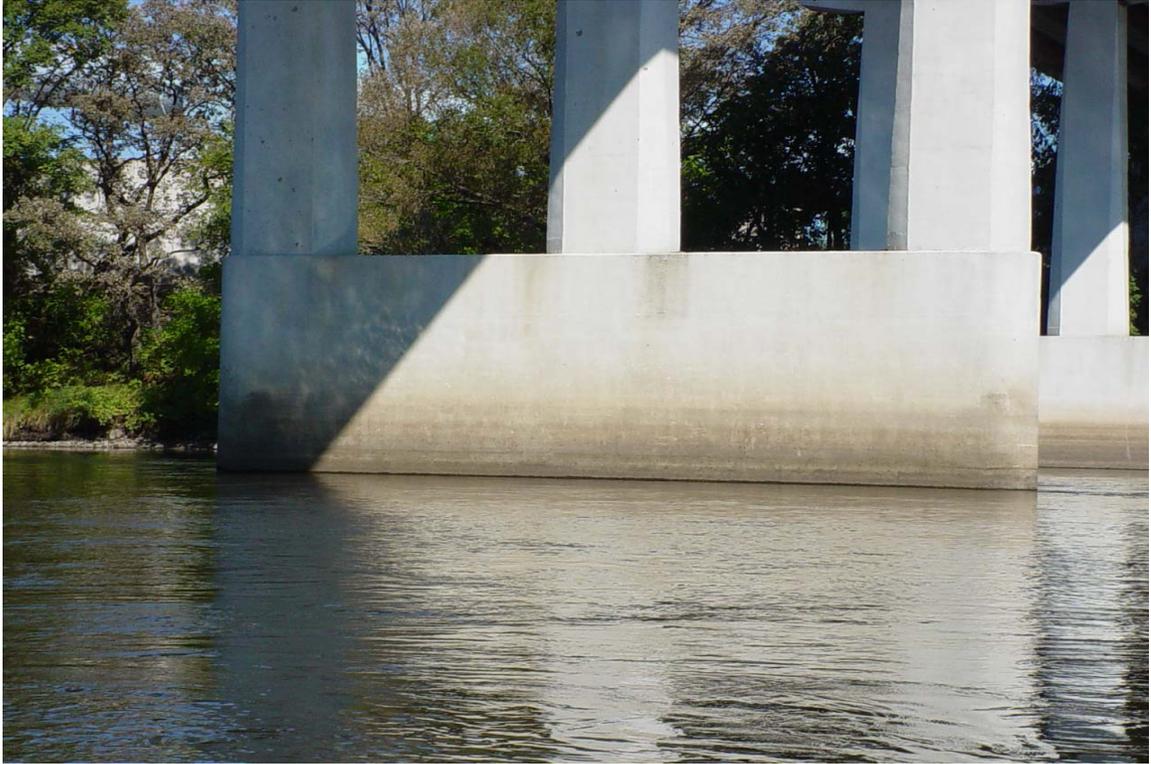
Photograph 5. View of Pier 6, Looking Northeast.

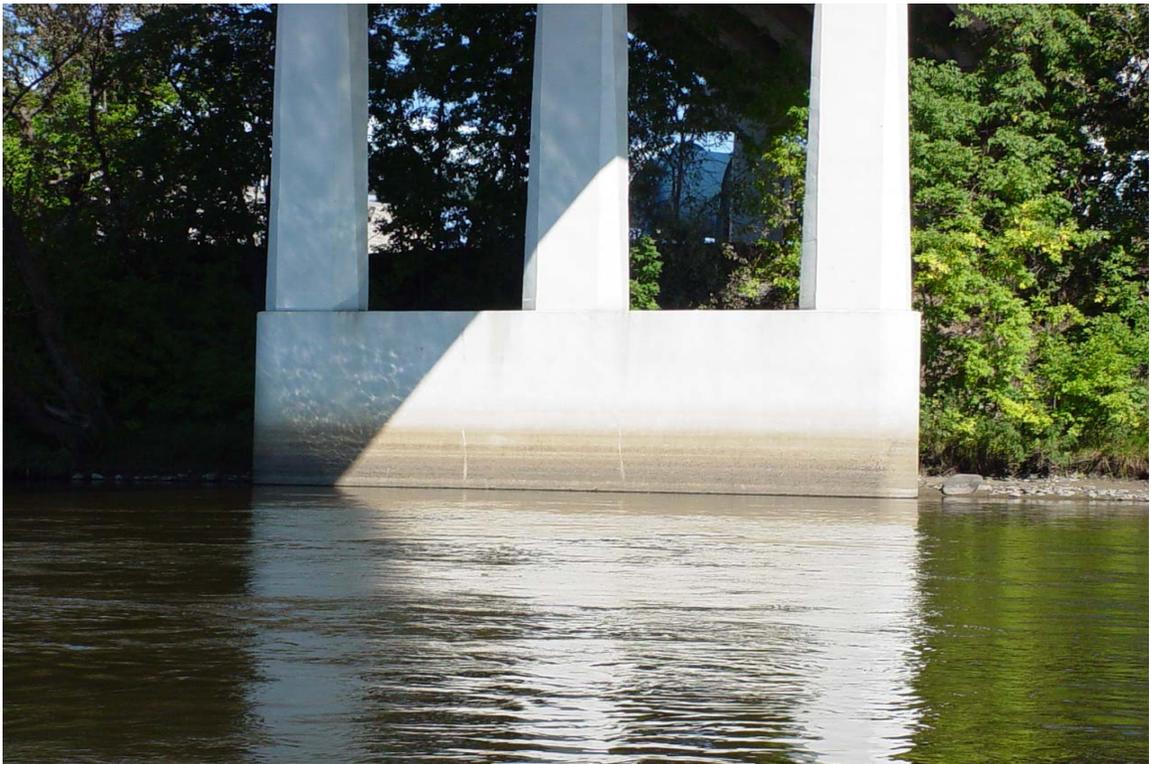
- (F) Portions of the top of footing at Pier 7 were exposed along the west face with up to 1 foot of vertical face exposed.

Photograph 6. View of Pier 7, Looking Northeast.
