UNDERWATER BRIDGE INSPECTION REPORT

STRUCTURE NO. 18501
CSAH NO. 16
OVER THE
PINE RIVER (CROSS LAKE / RUSH LAKE)
DISTRICT 3 – CROW WING COUNTY

PREPARED FOR THE
MINNESOTA DEPARTMENT OF TRANSPORTATION
BY
COLLINS ENGINEERS, INC.
JOB NO. 3512

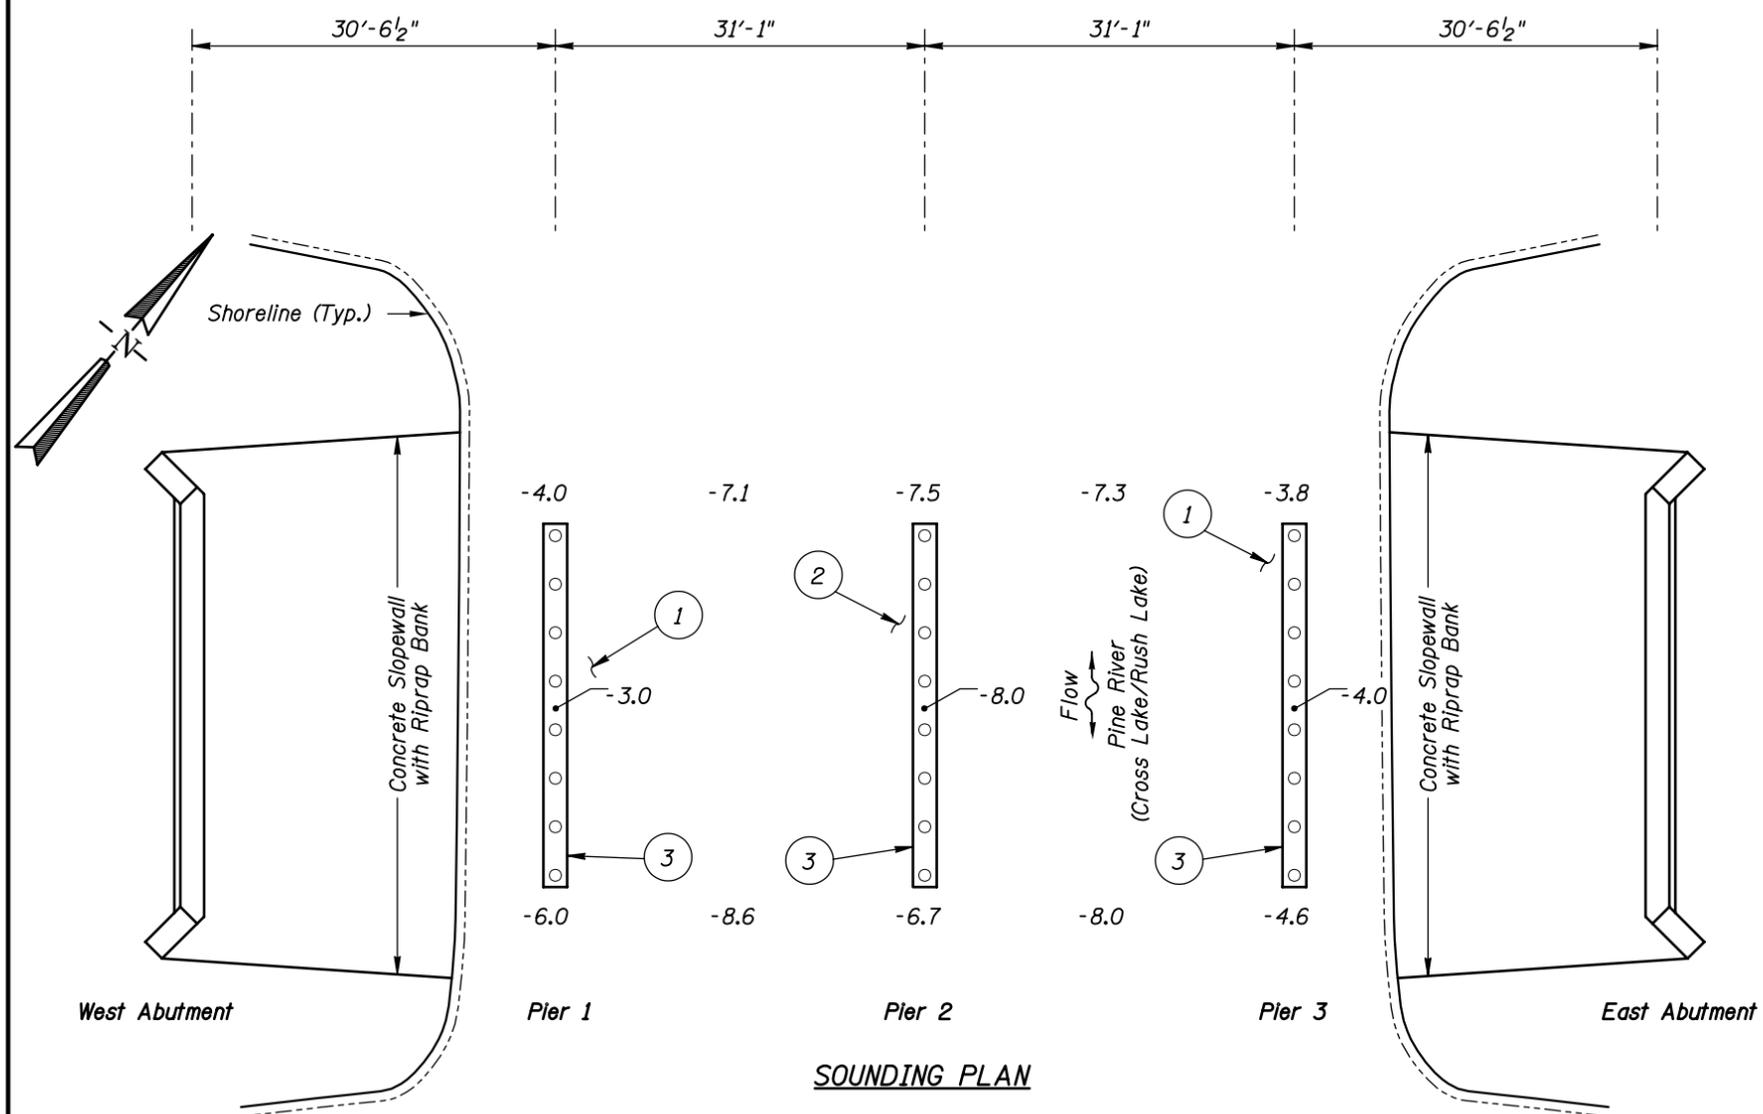
- 1 The channel bottom around Piers 1 and 3 consisted of 1 to 2 foot diameter riprap.
- 2 The channel bottom around Pier 2 consisted of gravel and 4 to 6 inch diameter cobbles with up to 2 inches of probe rod penetration.
- 3 The piles exhibited coating failure covering 15% to 20% of the surface area below the waterline. All piles exhibited a layer aquatic growth from the waterline to the mudline.

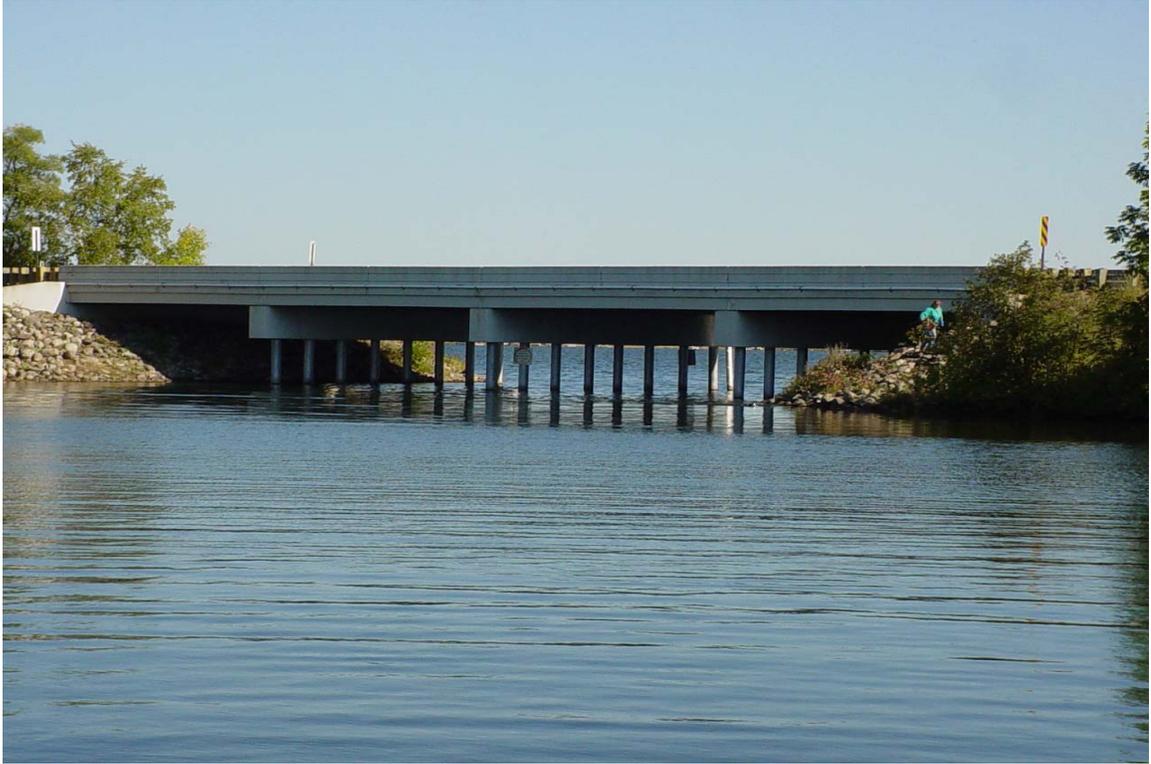
Photograph 1. Overall View of the Structure, Looking Northeast.

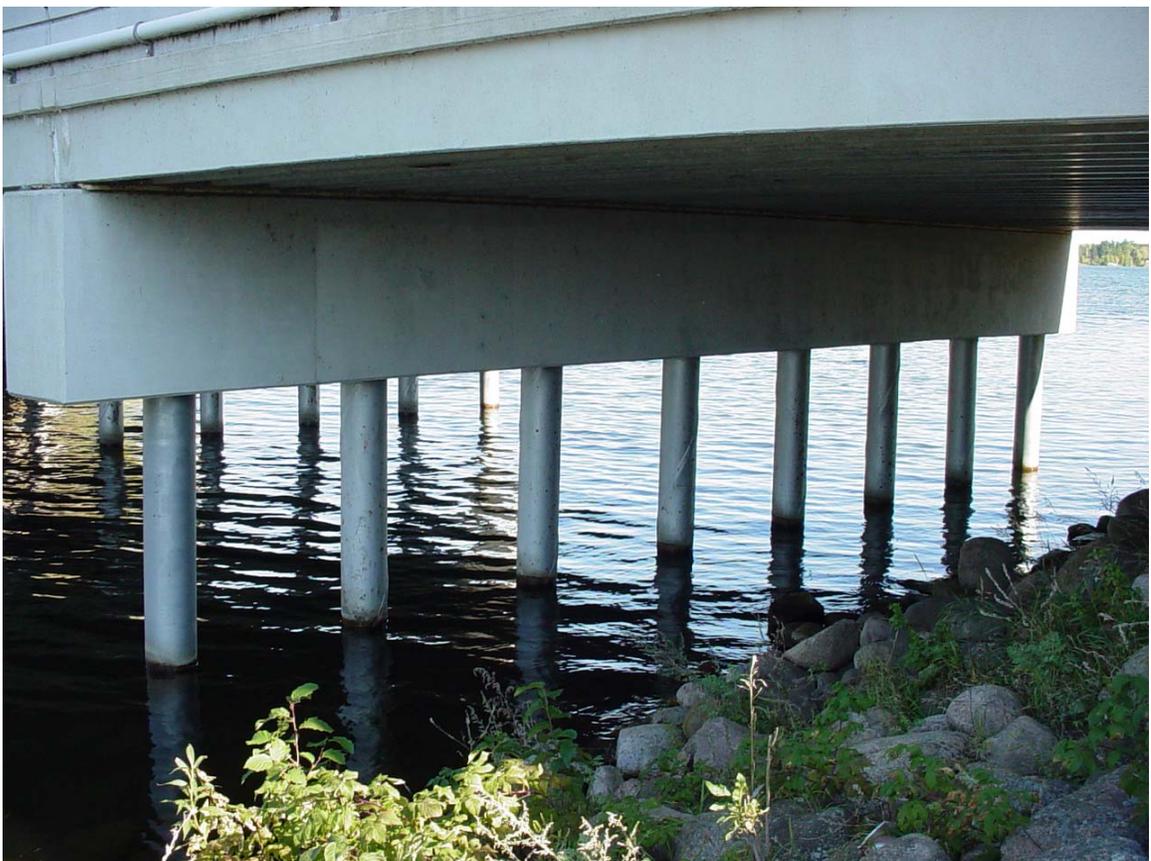
Photograph 2. View of Pier 1, Looking Northeast.

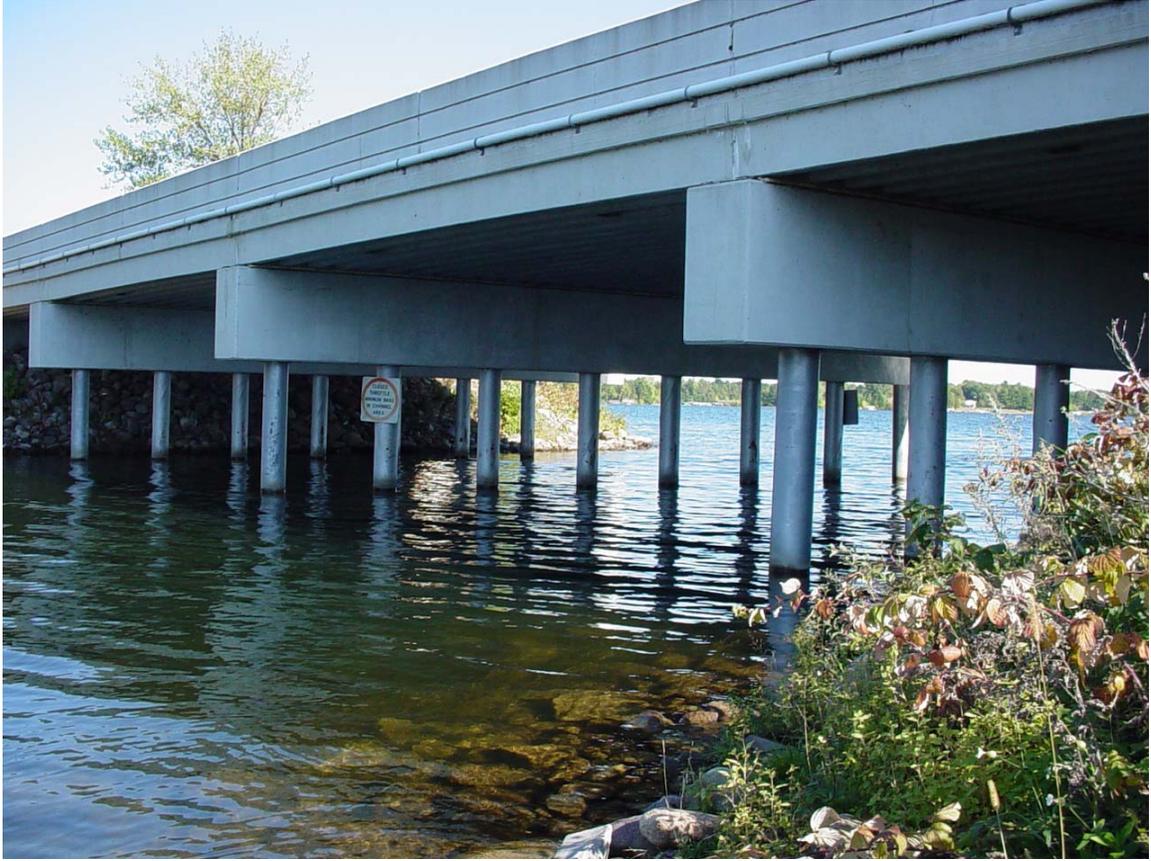
Photograph 3. View of Pier 2 (in center), Looking North.

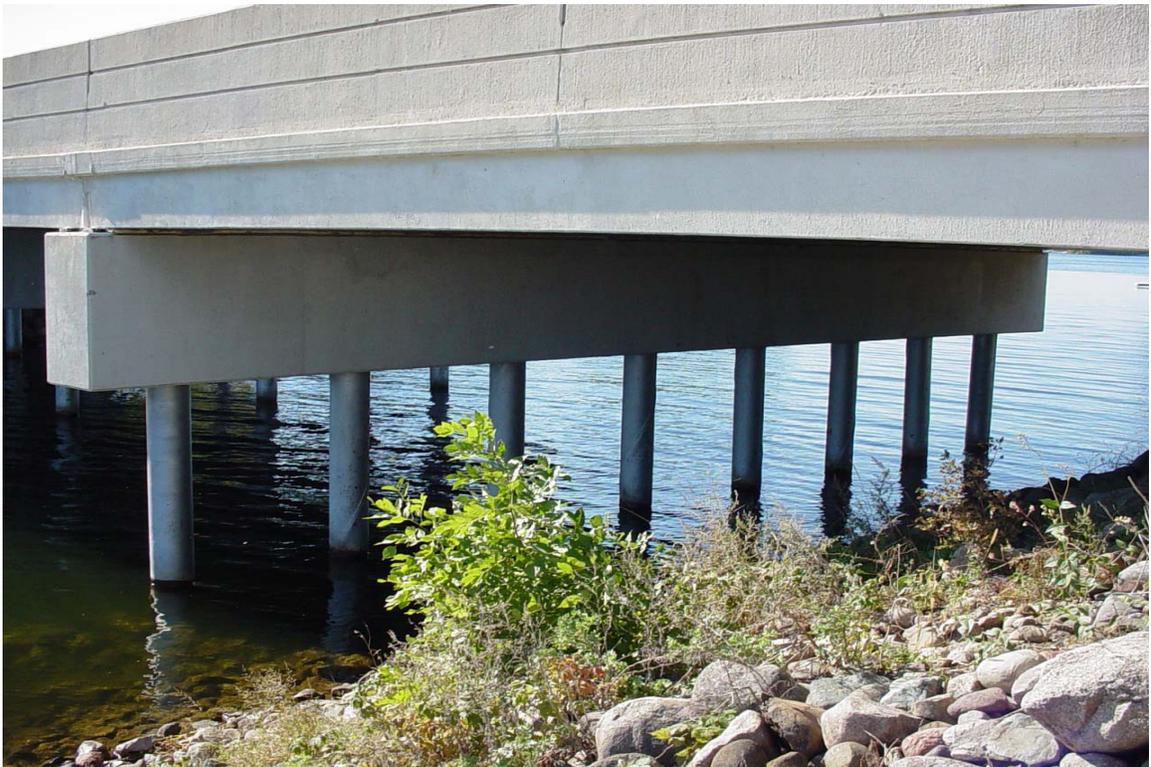
Photograph 4. View of Pier 3, Looking Southwest.
