UNDERWATER BRIDGE INSPECTION REPORT

STRUCTURE NO. 18510
CSAH NO. 6
OVER THE
DAGGETT CHANNEL
DISTRICT 3 – CROW WING COUNTY

PREPARED FOR THE
MINNESOTA DEPARTMENT OF TRANSPORTATION
BY
COLLINS ENGINEERS, INC.
JOB NO. 3512

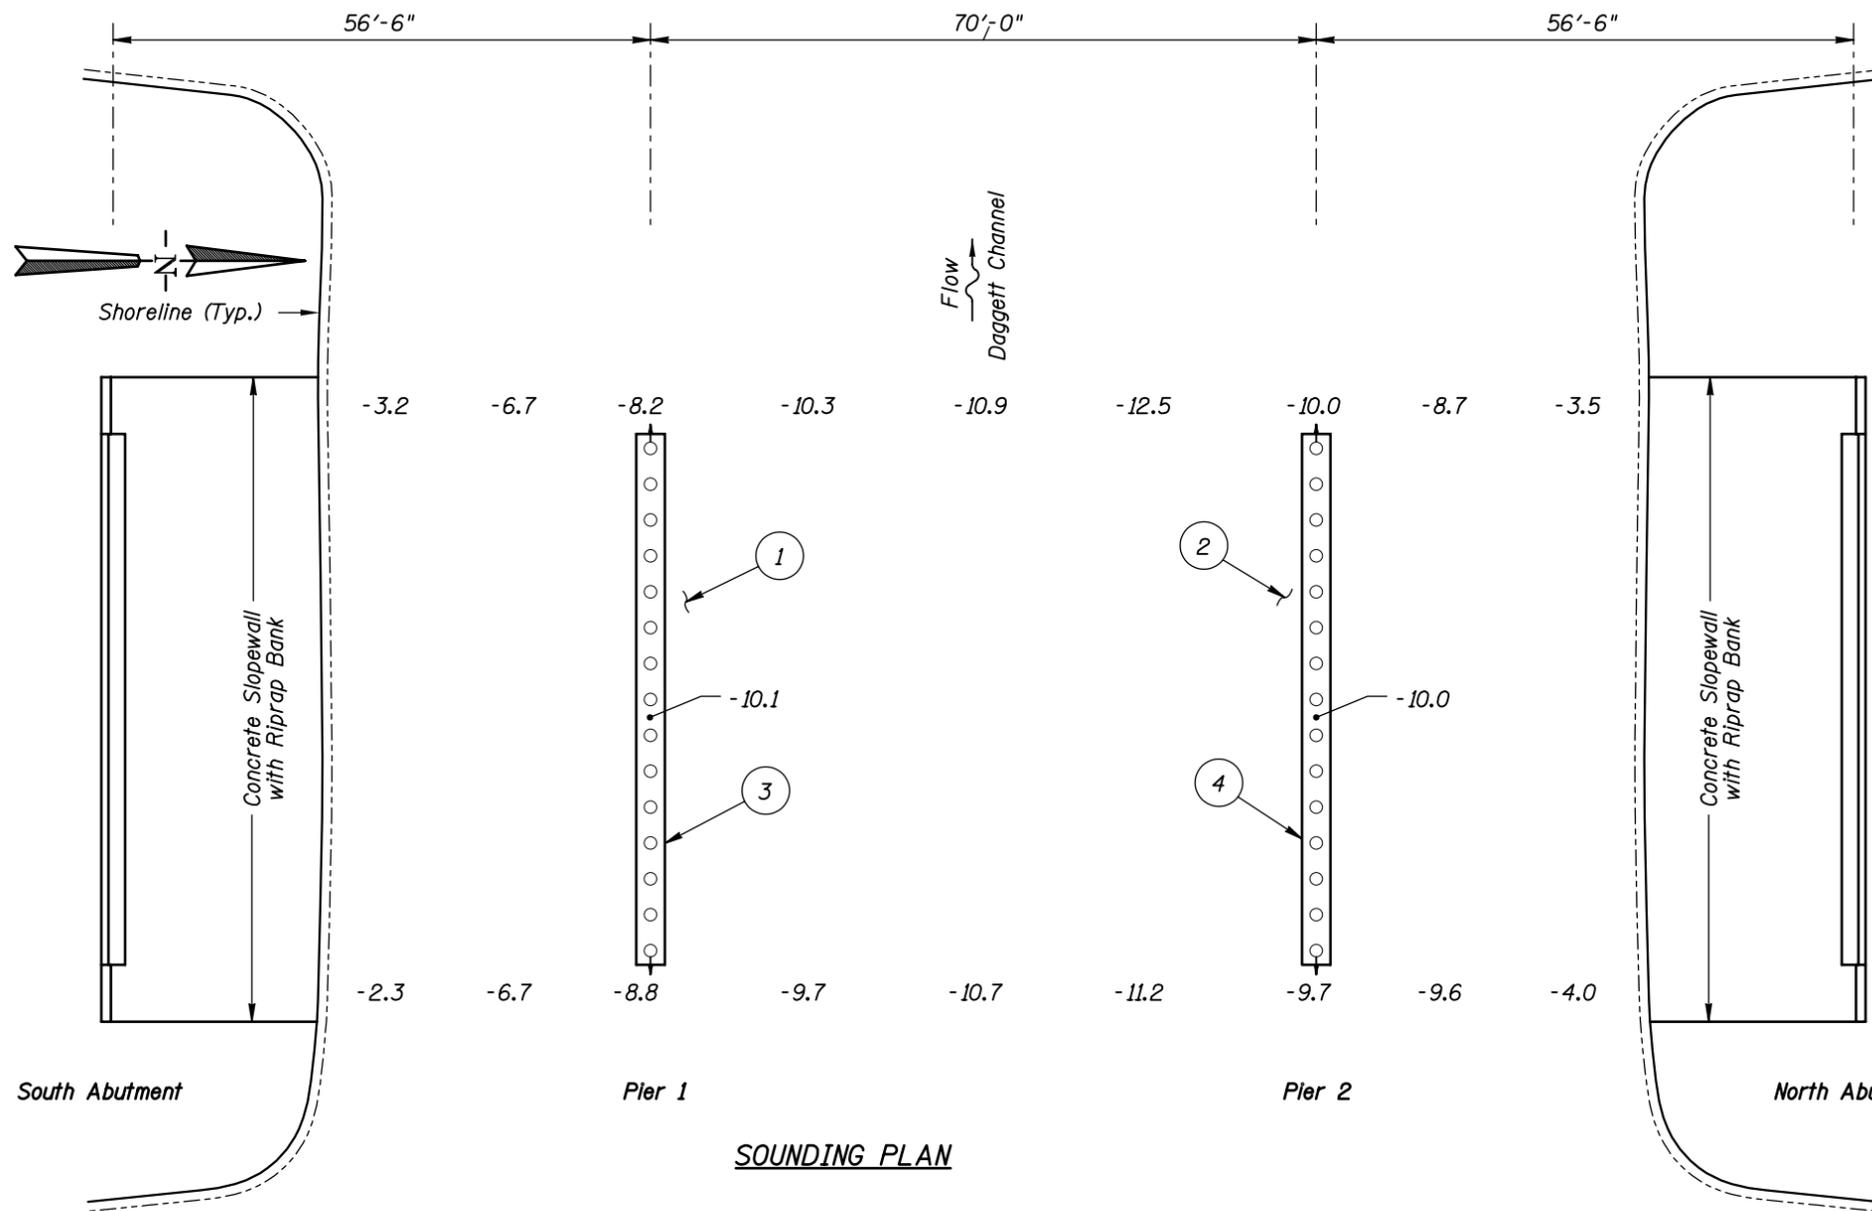
- ① The channel bottom around Pier 1 consisted of sand with with 6 to 8 inches of probe rod penetration.
- ② The channel bottom around Pier 2 consisted of sand and 6 to 8 inch diameter cobbles with 6 to 8 inches of probe rod penetration.
- ③ Pier 1 exhibited coating loss from the waterline to the mudline with 10% of the surface area covered with rust nodules that exhibited 1/2 inch maximum diameter. The piles exhibited only minor pitting and minimal section loss up to 1/32 inch deep.
- ④ Pier 2 exhibited coating loss from the waterline to the mudline with 30% of the surface area covered with rust nodules that exhibited 1/2 inch maximum diameter. The piles exhibited only minor pitting and minimal section loss up to 1/32 inch deep.

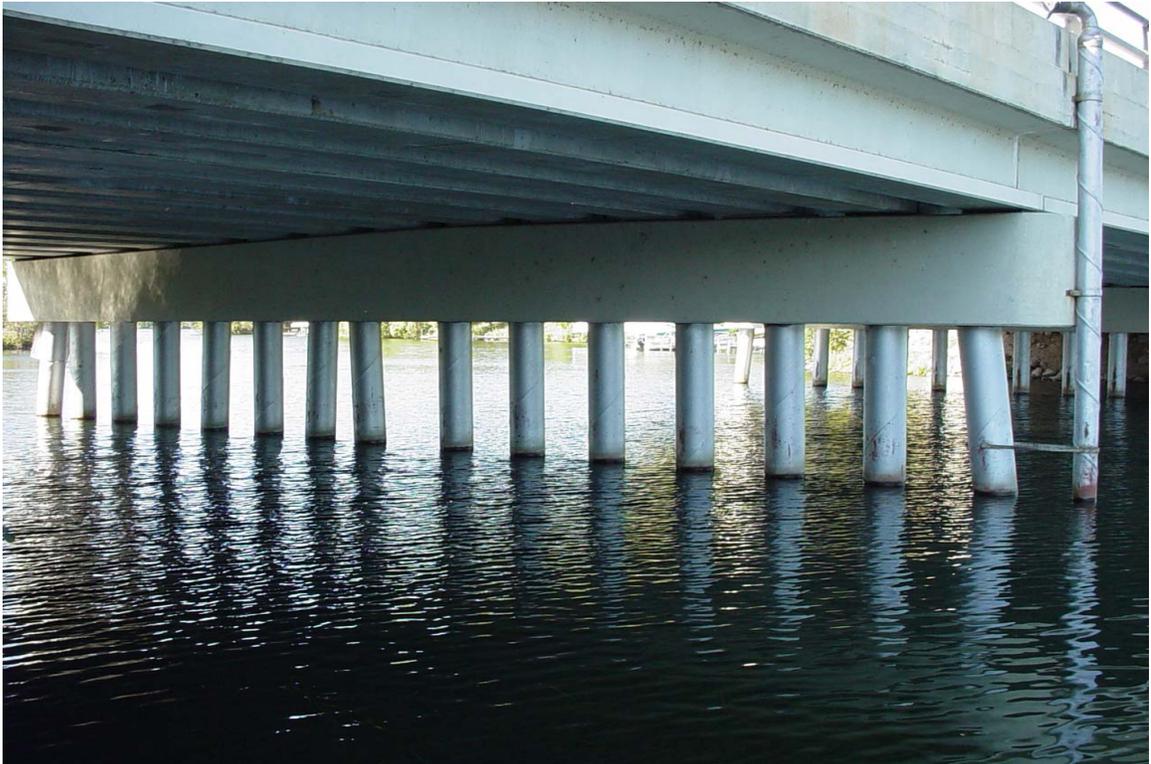
- (A) The piles of Pier 1 exhibited coating loss from the waterline to the mudline with 10% of the surface area covered with rust nodules that exhibited 1/2 inch maximum diameter. The piles exhibited only minor pitting and minimal section loss as a result of the present extent of corrosion.
- (B) The piles of Pier 2 exhibited coating loss from the waterline to the mudline with 30% of the surface area covered with rust nodules that exhibited 1/2 inch maximum diameter. The piles exhibited only minor pitting and minimal section loss as a result of the present extent of corrosion.

Photograph 2. View of Pier 1, Looking Northwest.

- (A) Reinspect the submerged substructure units at the normal maximum recommended (NBIS) interval of five (5) years.

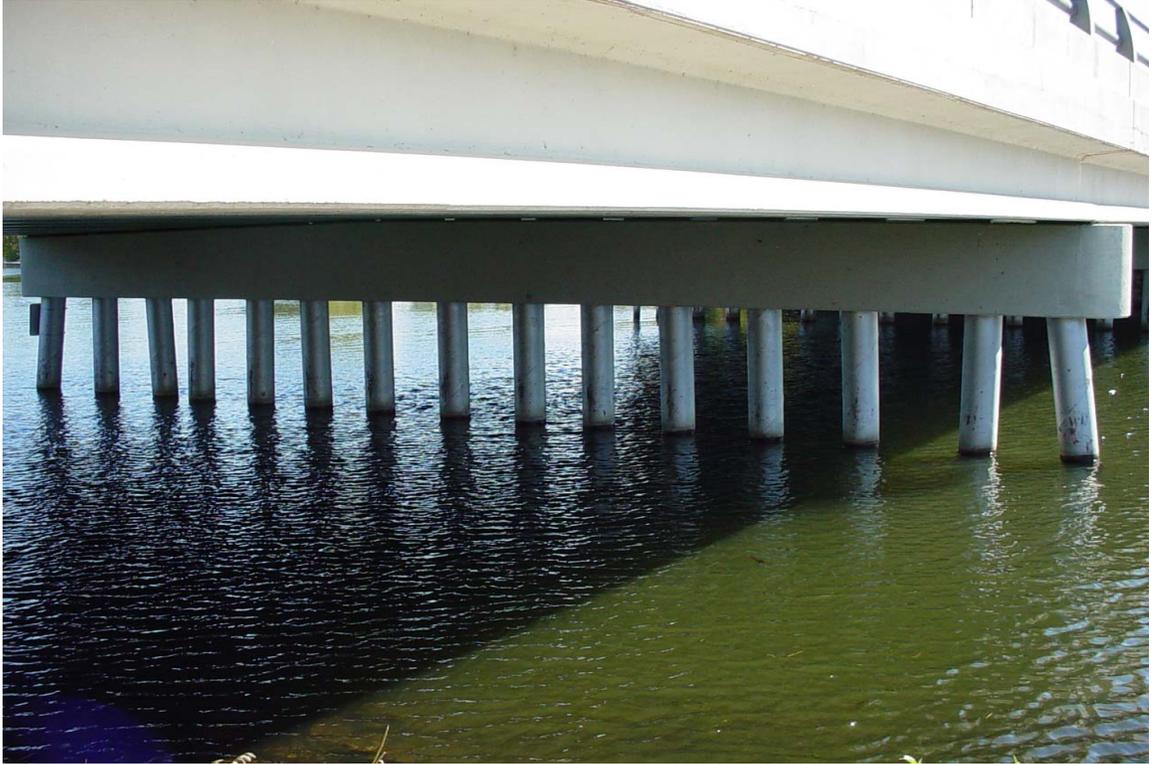
Photograph 3. View of Pier 2, Looking Southeast.
