UNDERWATER BRIDGE INSPECTION REPORT

STRUCTURE NO. 30505

CSAH NO. 14

RUM RIVER

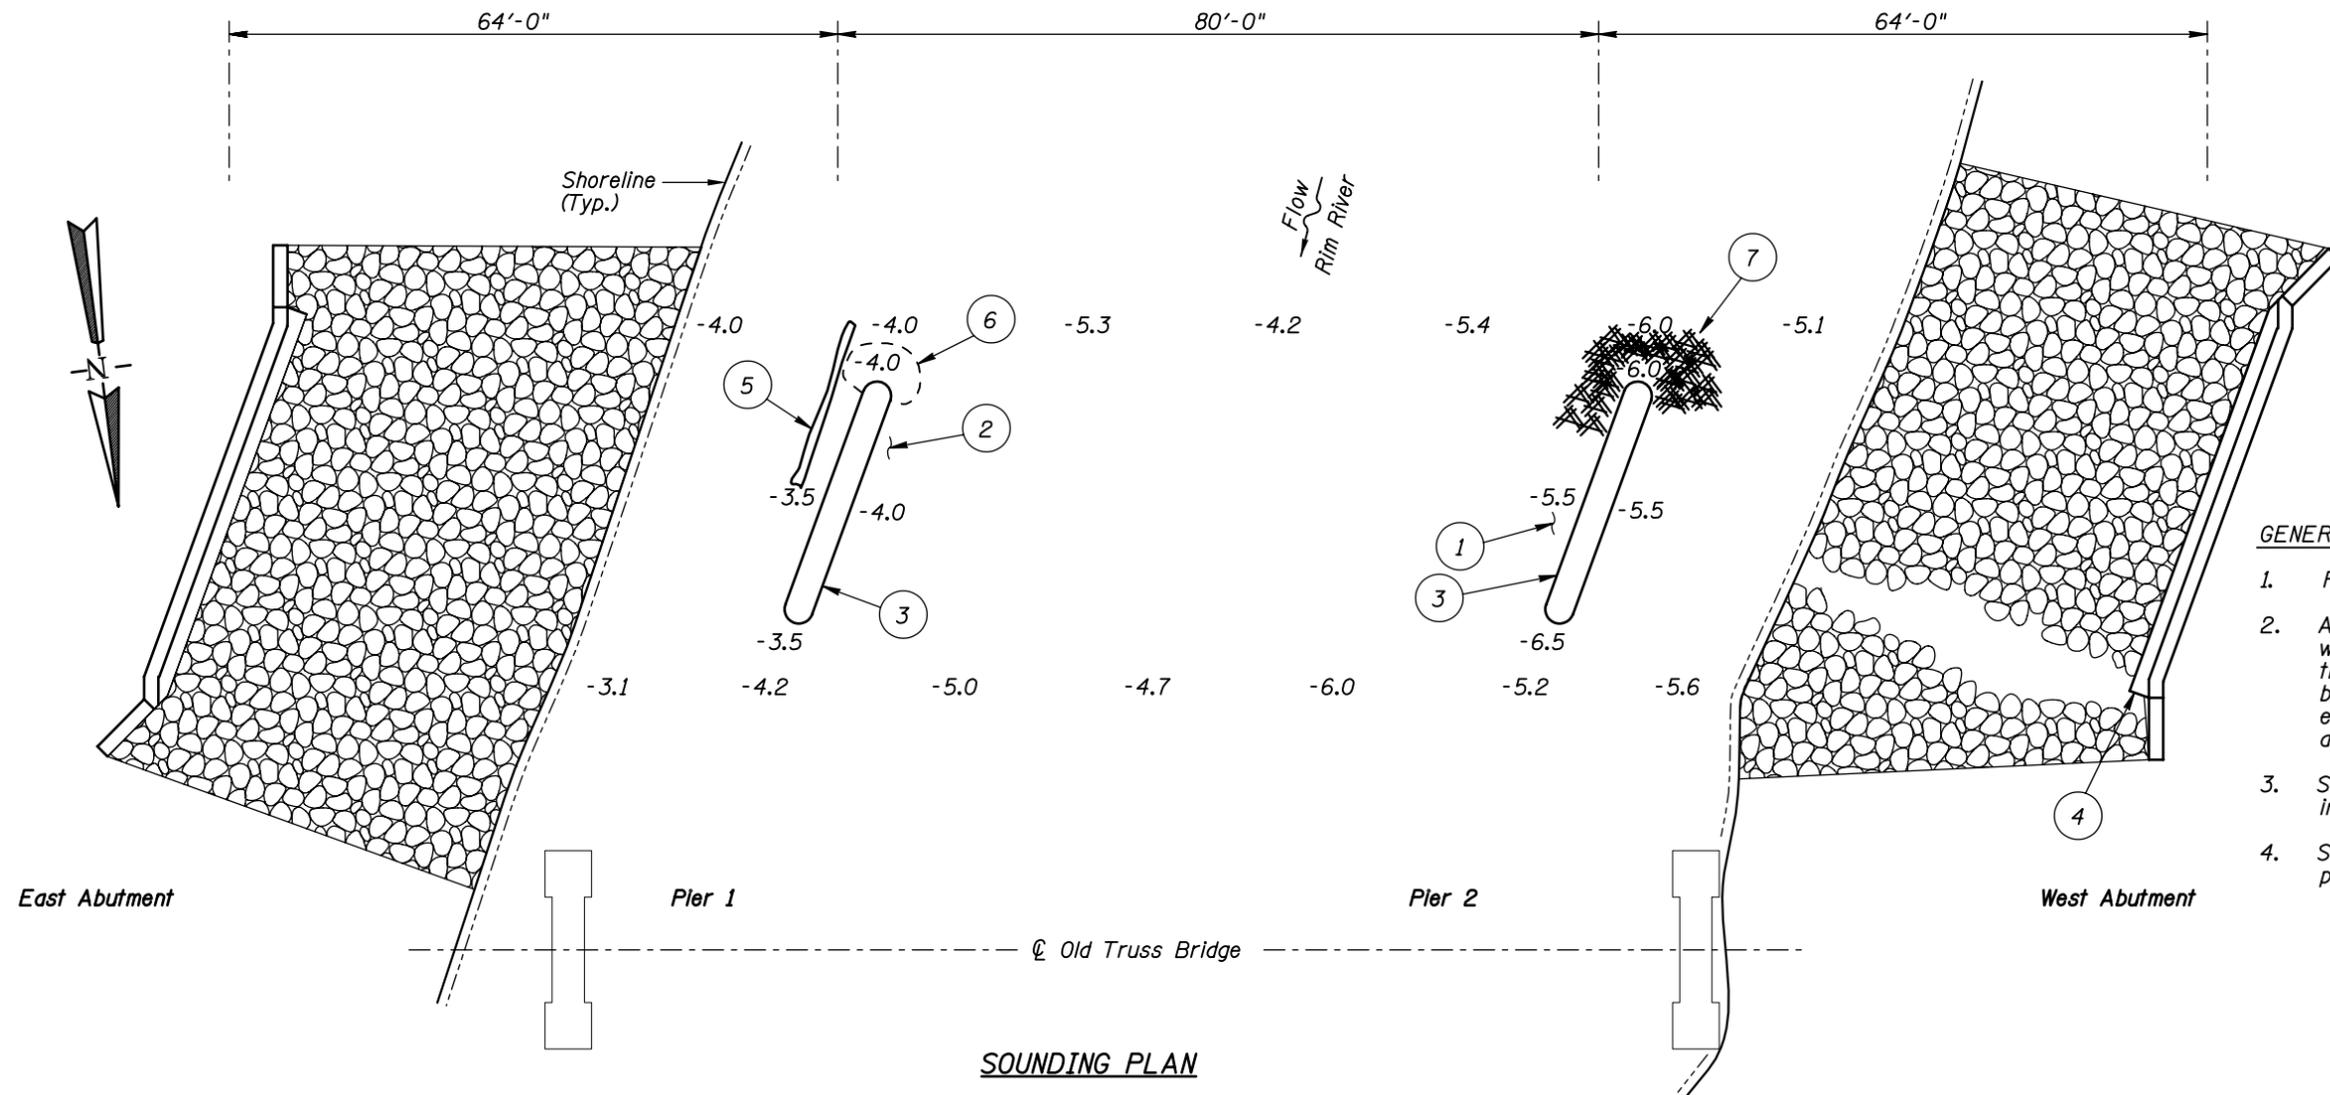
1. The channel bottom consisted of 4-inch-diameter cobbles with 1 inch of probe rod penetration.
2. The channel bottom consisted of sand with scattered 1-foot-diameter riprap with up to 6 inches of probe rod penetration.
3. The concrete of the substructure units was in good condition with no notable defects.
4. A portion of the west embankment exhibited minor erosion that has caused undermining at the north end of the West Abutment.
5. A 1-foot-diameter log was observed on the channel bottom along east face of Pier 1.
6. A scour pocket, 2 foot in radius and 1 foot deep, was observed at the upstream nose of Pier 1.
7. A moderate to heavy accumulation of 10-inch-diameter and smaller timber debris was observed at the upstream nose of Pier 2 extending from the channel bottom to 5 feet above the waterline.

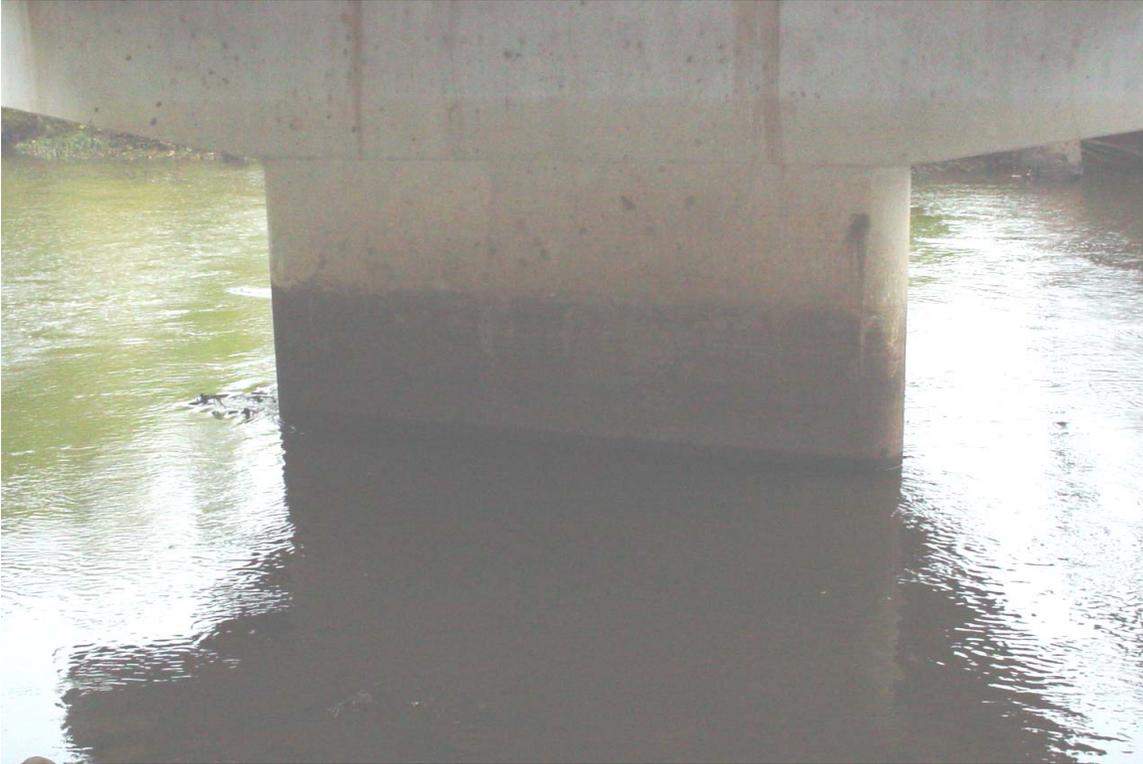
Photograph 2. View of Pier 1, Looking West.

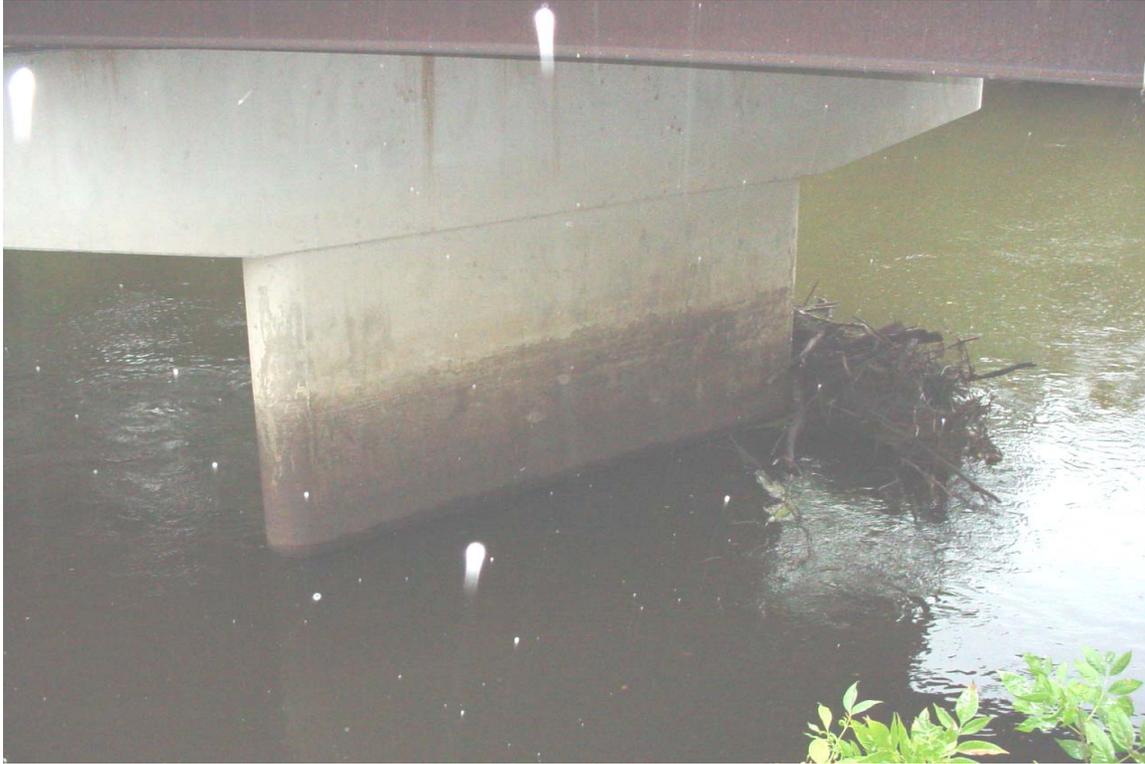
Photograph 3. View of Pier 2, Looking Southeast.

- (A) Monitor timber drift accumulation at Pier 2, and if found to be progressing (to an excessive extent), removal may be warranted at that time.

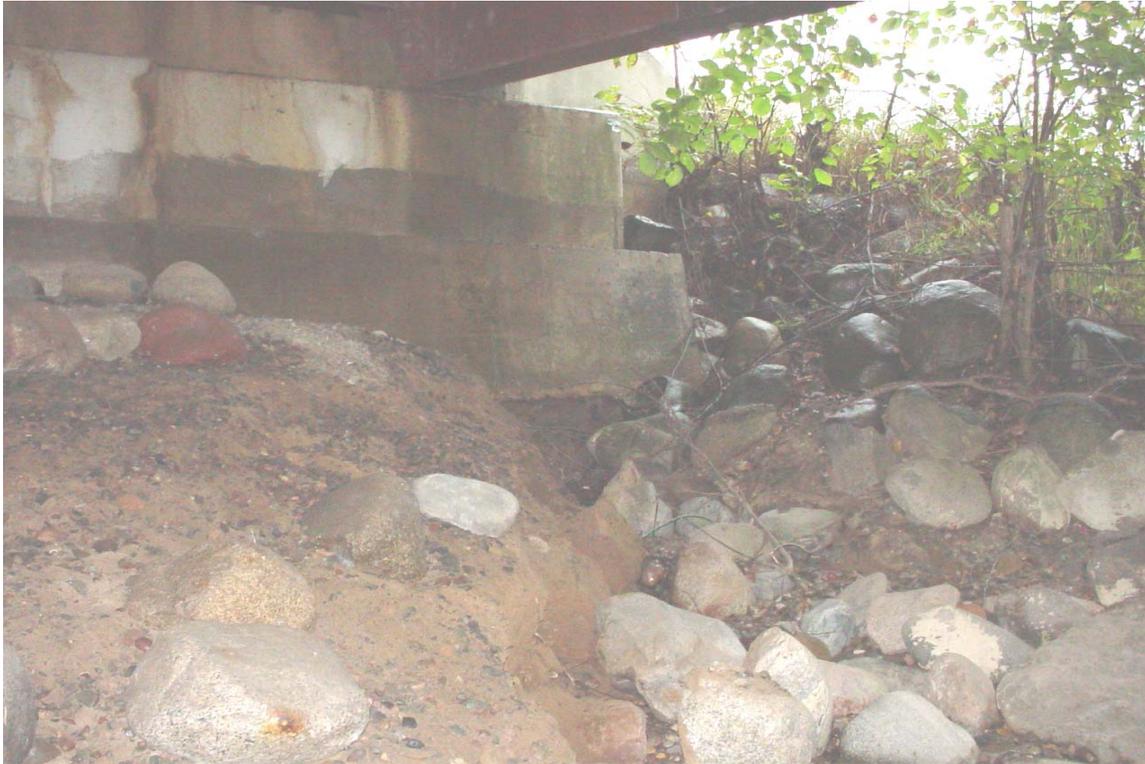
Photograph 4. View of Undermining at Northwest Corner of West Abutment, Looking North.
