UNDERWATER BRIDGE INSPECTION REPORT

STRUCTURE NO. 30506
CR NO. 63
OVER THE
STANCHFIELD CREEK
DISTRICT 3 - ISANTI COUNTY

PREPARED FOR THE
MINNESOTA DEPARTMENT OF TRANSPORTATION
BY
COLLINS ENGINEERS, INC.
JOB NO. 3512 (CEI 74)

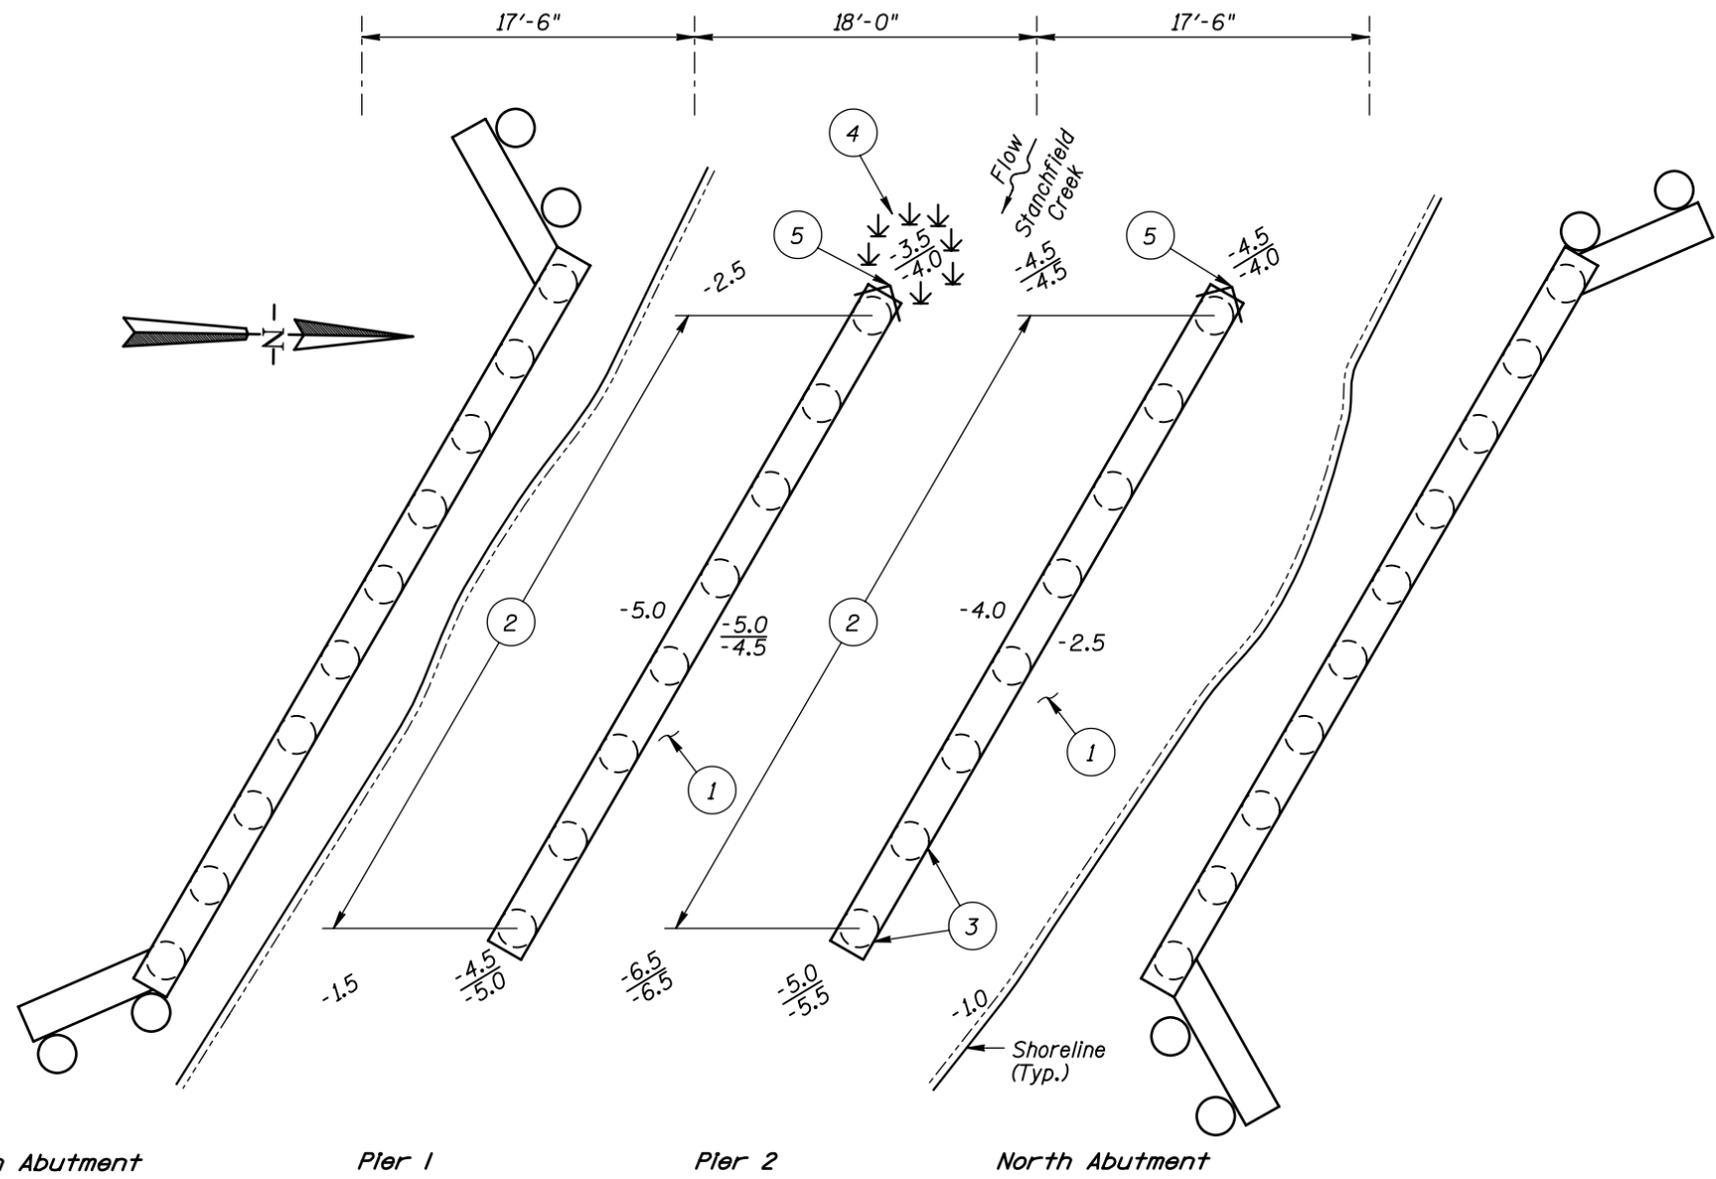
SOUNDING PLAN

- ① The channel bottom consisted of 6- to 8-inch-diameter cobbles with 1 inch of penetration.
- ② The timber piles exhibited minor checking up to 1/4 inch wide.
- ③ The timber bracing located between the easternmost piles exhibited minor cracking and wood shims have been placed between the piles and the bracing.
- ④ A large amount of grassy vegetation was observed at the upstream nose of Pier 1.
- ⑤ The upstream pile was protected with a steel ice breaker.

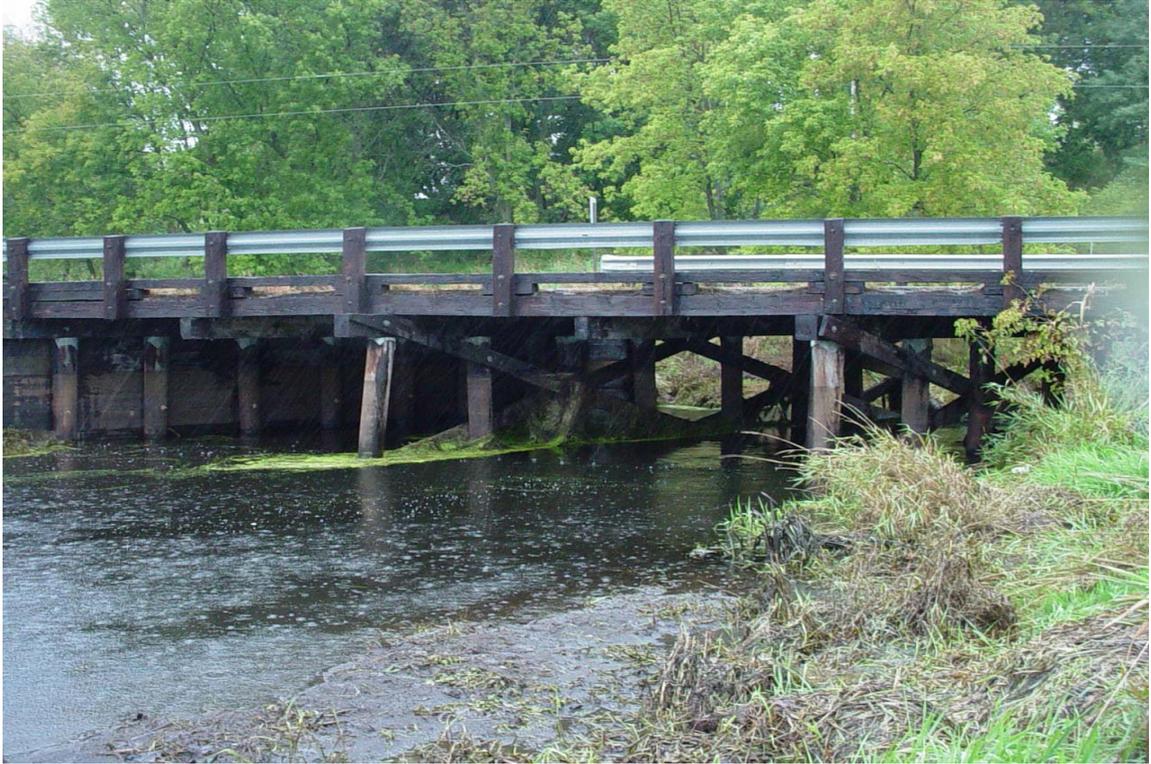
Photograph 1. Overall View of Structure, Looking Southwest.

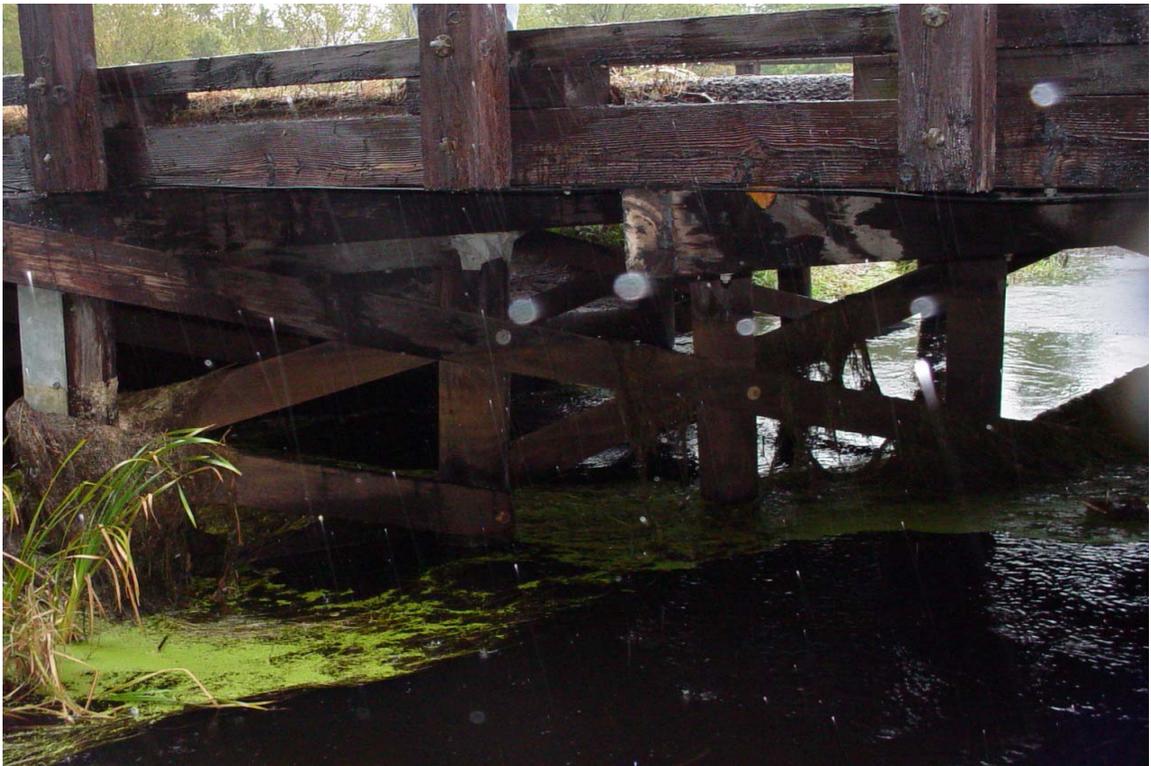
Photograph 2. View of Pier 1, Looking Northeast.

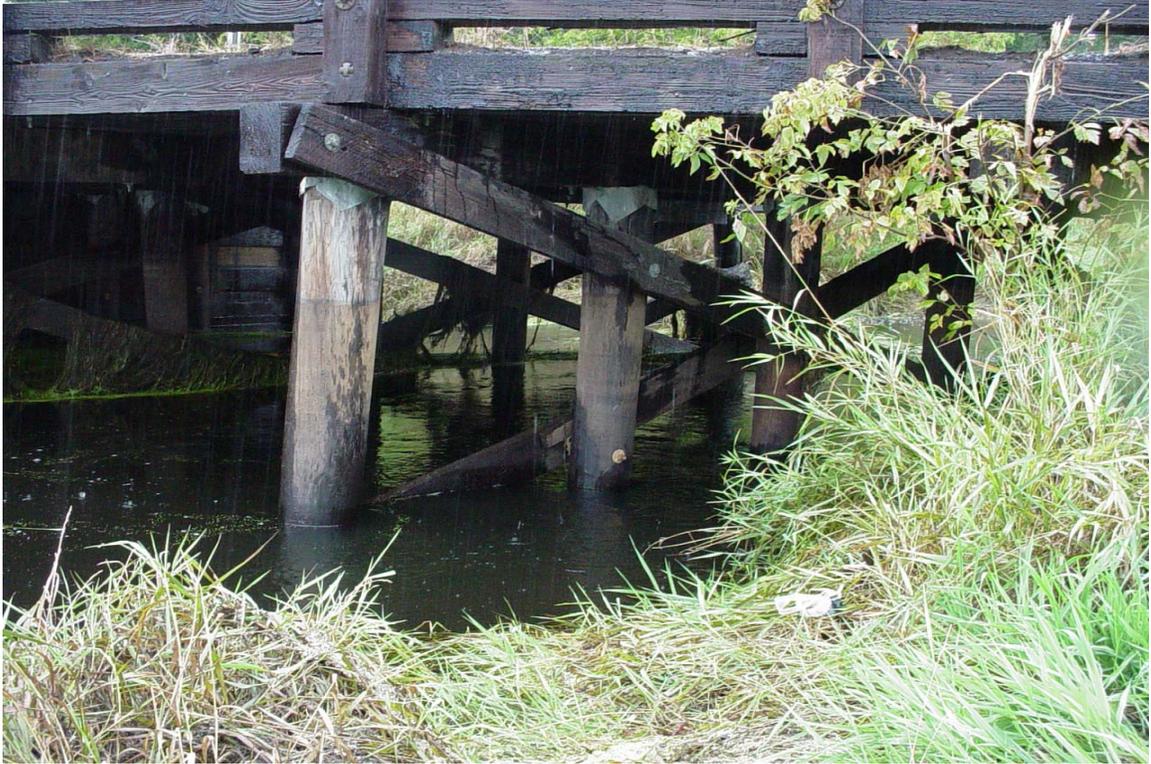
- (A) The timber piles at both piers were in good condition with minor checking up to 1/4 inch in width.
- (B) The timber bracing located between the easternmost piles of Pier 2 exhibited minor cracking and wood shims have been placed between the piles and the bracing, apparently in an effort to tighten the connections.
- (C) A large amount of grassy vegetation was observed at the upstream nose of Pier 1.

Photograph 3. View of Pier 2, Looking Southwest.

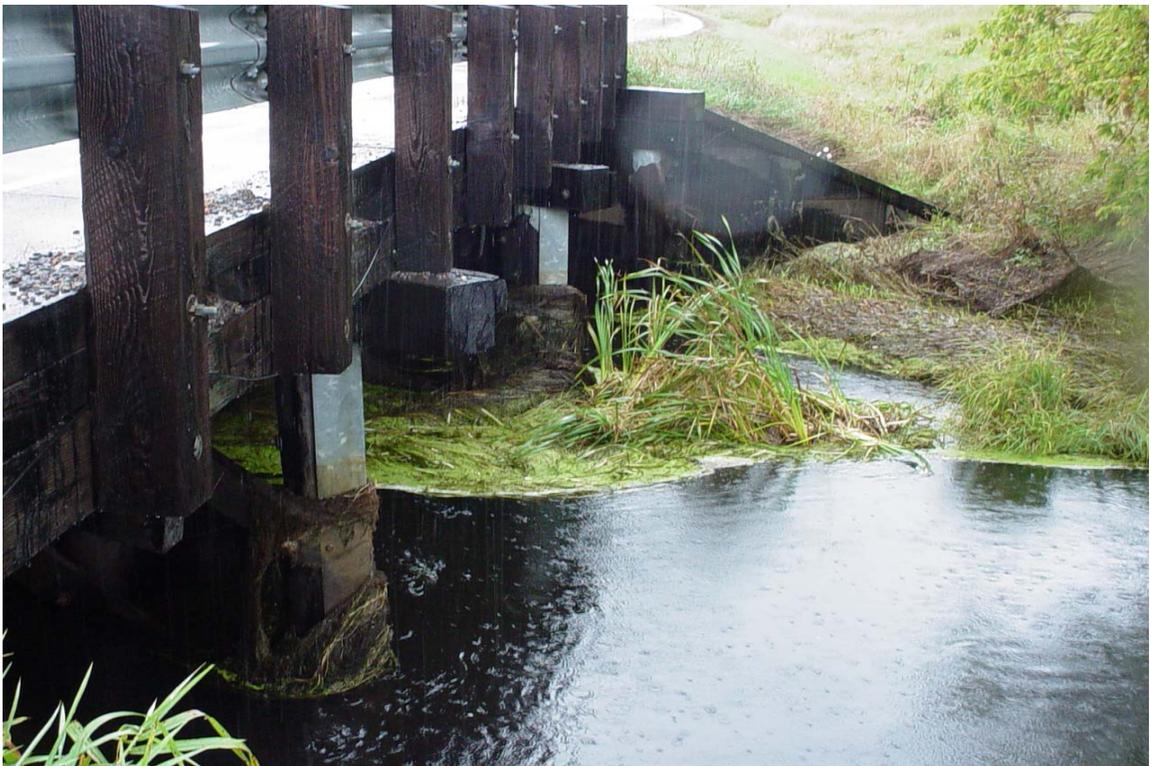
Photograph 4. View of the Vegetation at Pier 1, Looking South.
