UNDERWATER BRIDGE INSPECTION REPORT

STRUCTURE NO. 49528  
CSAH NO. 26  
OVER THE  
MISSISSIPPI RIVER  
DISTRICT 3 - MORRISON COUNTY

MINNESOTA DEPARTMENT OF TRANSPORTATION  
UNDERWATER BRIDGE INSPECTION

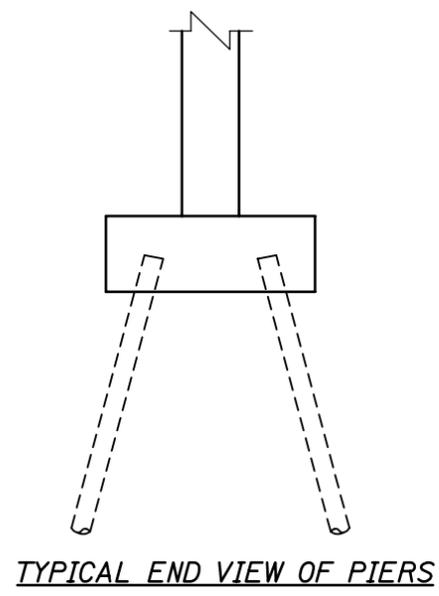
**SOUNDING PLAN**

- ① The channel bottom material consisted of gravel and up to 12 inch diameter riprap with typically 1 inch of probe rod penetration.
- ② A poorly formed construction joint was observed with the upper portion overlapping the lower portion of the pier by 1/2 to 1 inch at approximately 4 feet above the channel bottom.
- ③ A random area of poorly consolidated concrete was observed from 2 above the waterline to 1 foot below the waterline with a maximum penetration of 1/2 inch.
- ④ Light scaling was observed on all substructure units from 2 feet above the waterline to 1 foot below the waterline with 1/8 inch of maximum penetration.
- ⑤ A 1-foot-diameter log was on the channel bottom along the west face of Pier 1.

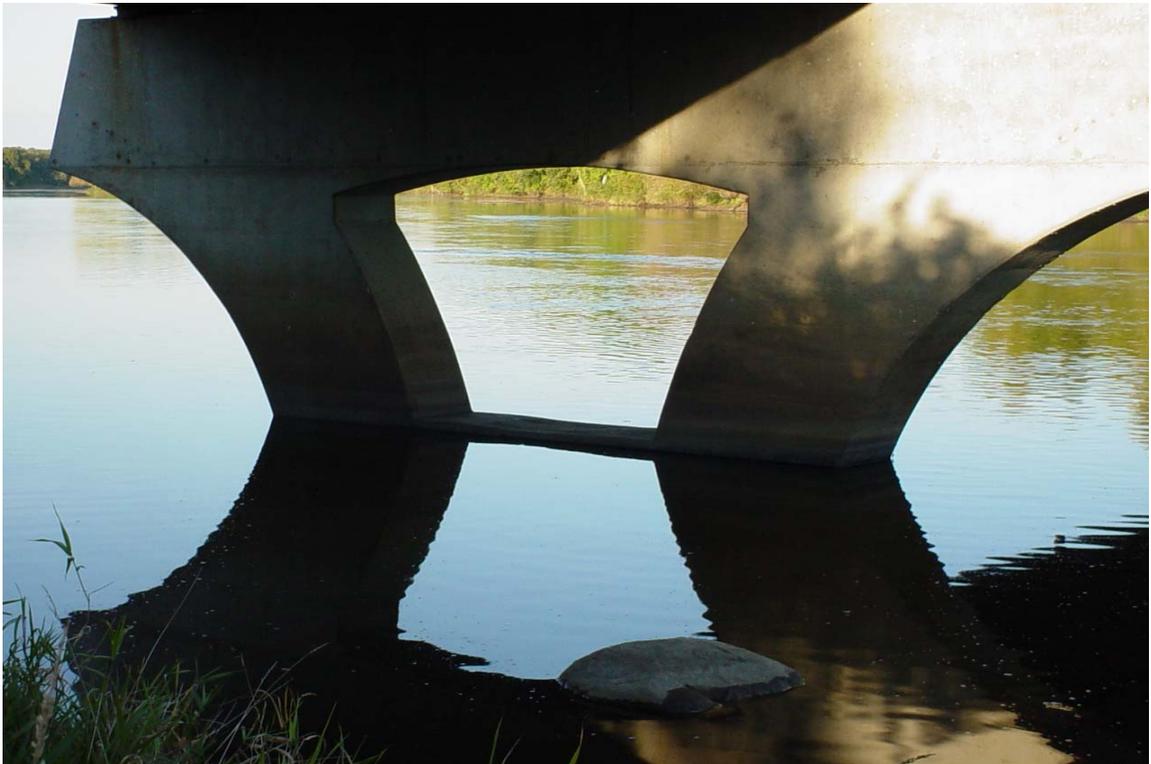
Photograph 2. View of Pier 1, Looking Northeast.

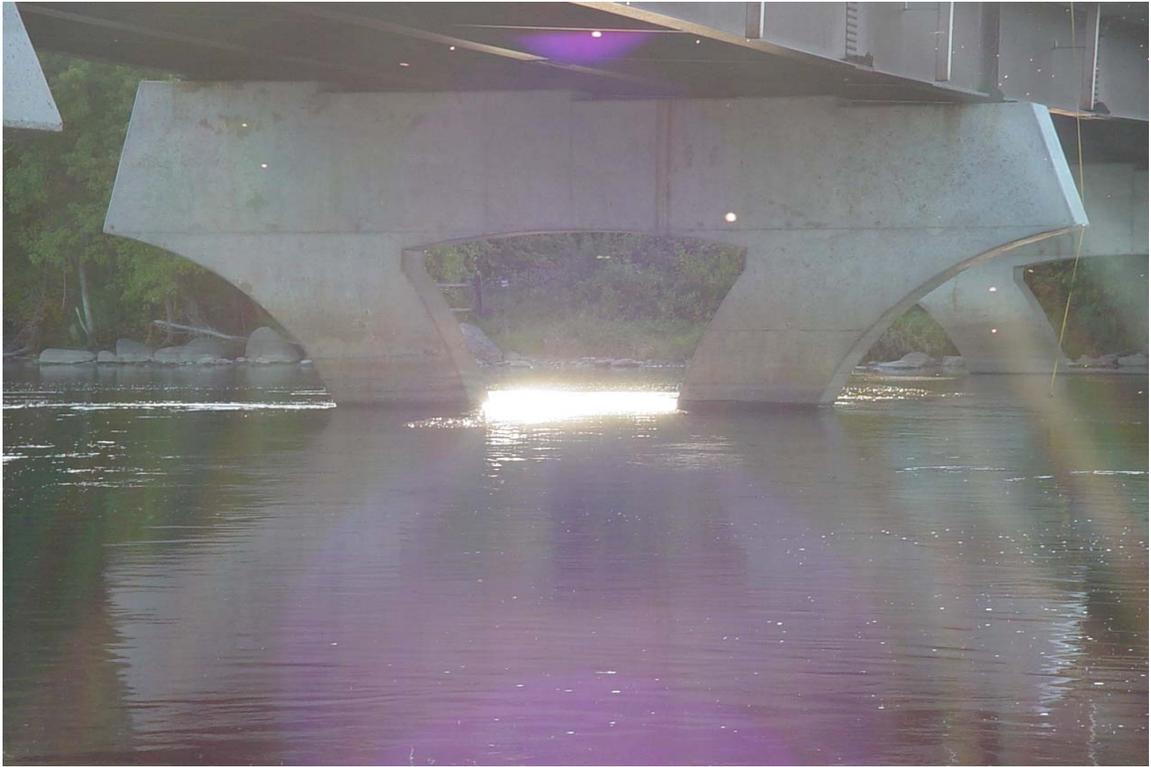
Photograph 3. View of Pier 2, Looking West.

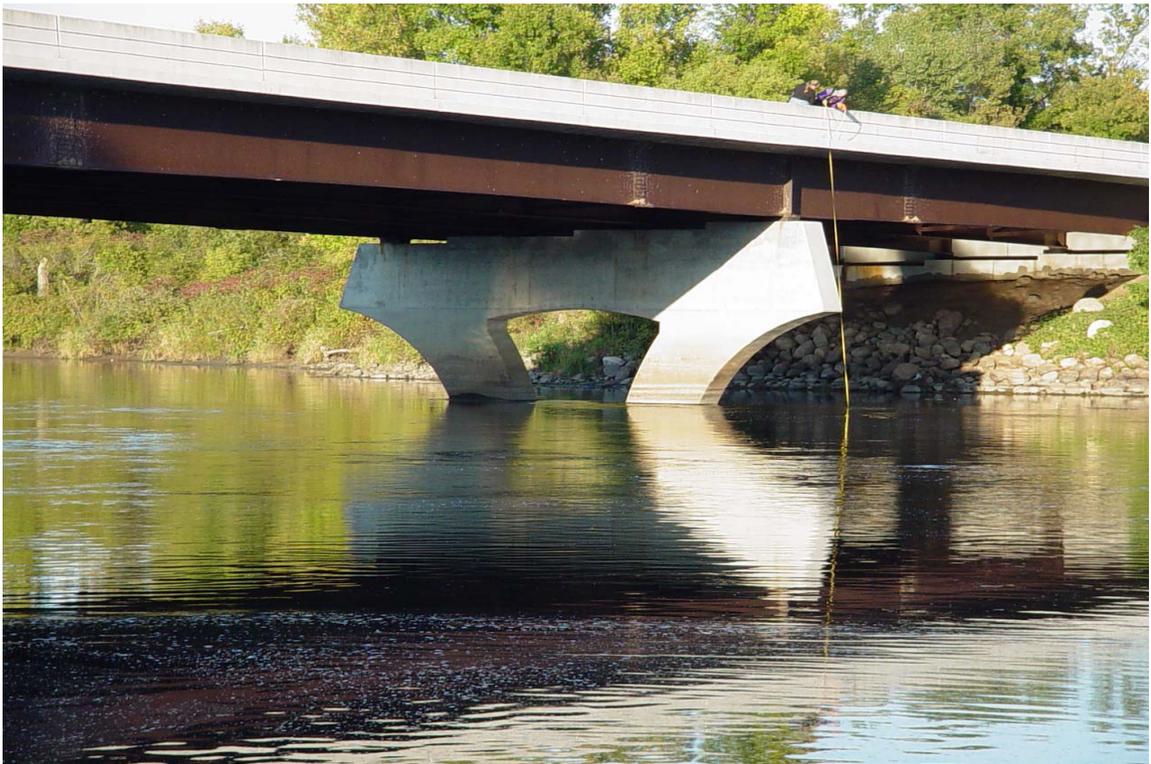
Photograph 4. View of Pier 3, Looking Northeast.
