UNDERWATER BRIDGE INSPECTION REPORT

STRUCTURE NO. 1506
CSAH NO. 1
OVER THE
MISSISSIPPI RIVER
DISTRICT 3 - AITKIN COUNTY

PREPARED FOR THE
MINNESOTA DEPARTMENT OF TRANSPORTATION
BY
COLLINS ENGINEERS, INC.
JOB NO. 5221 (CEI 68)

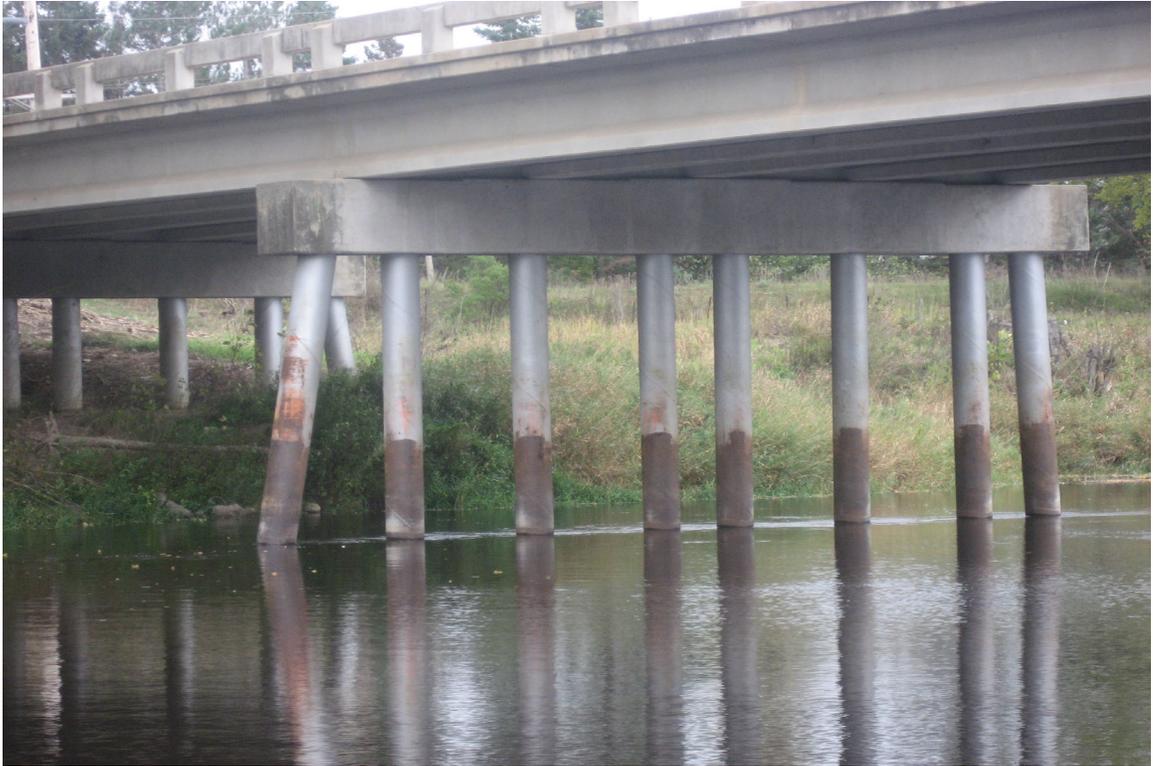
Photograph 1. View of Pier 2, Looking Southwest.

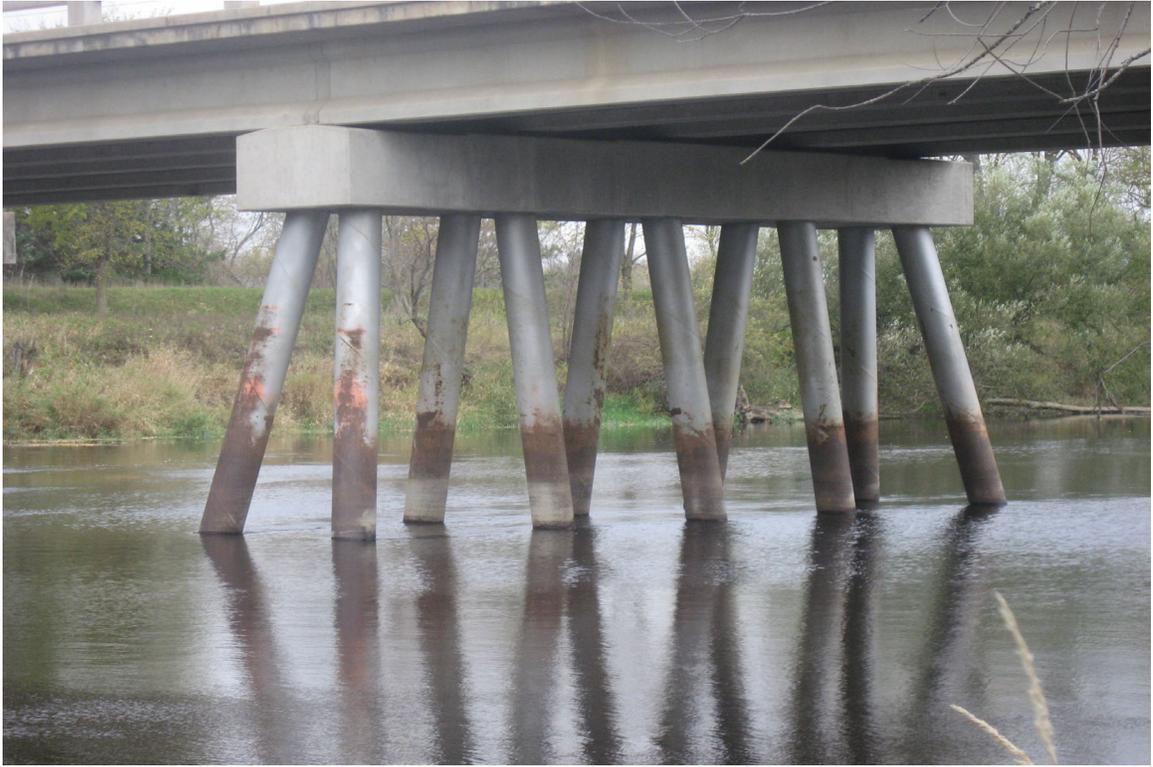
Photograph 2. View of Pier 3, Looking Southwest.

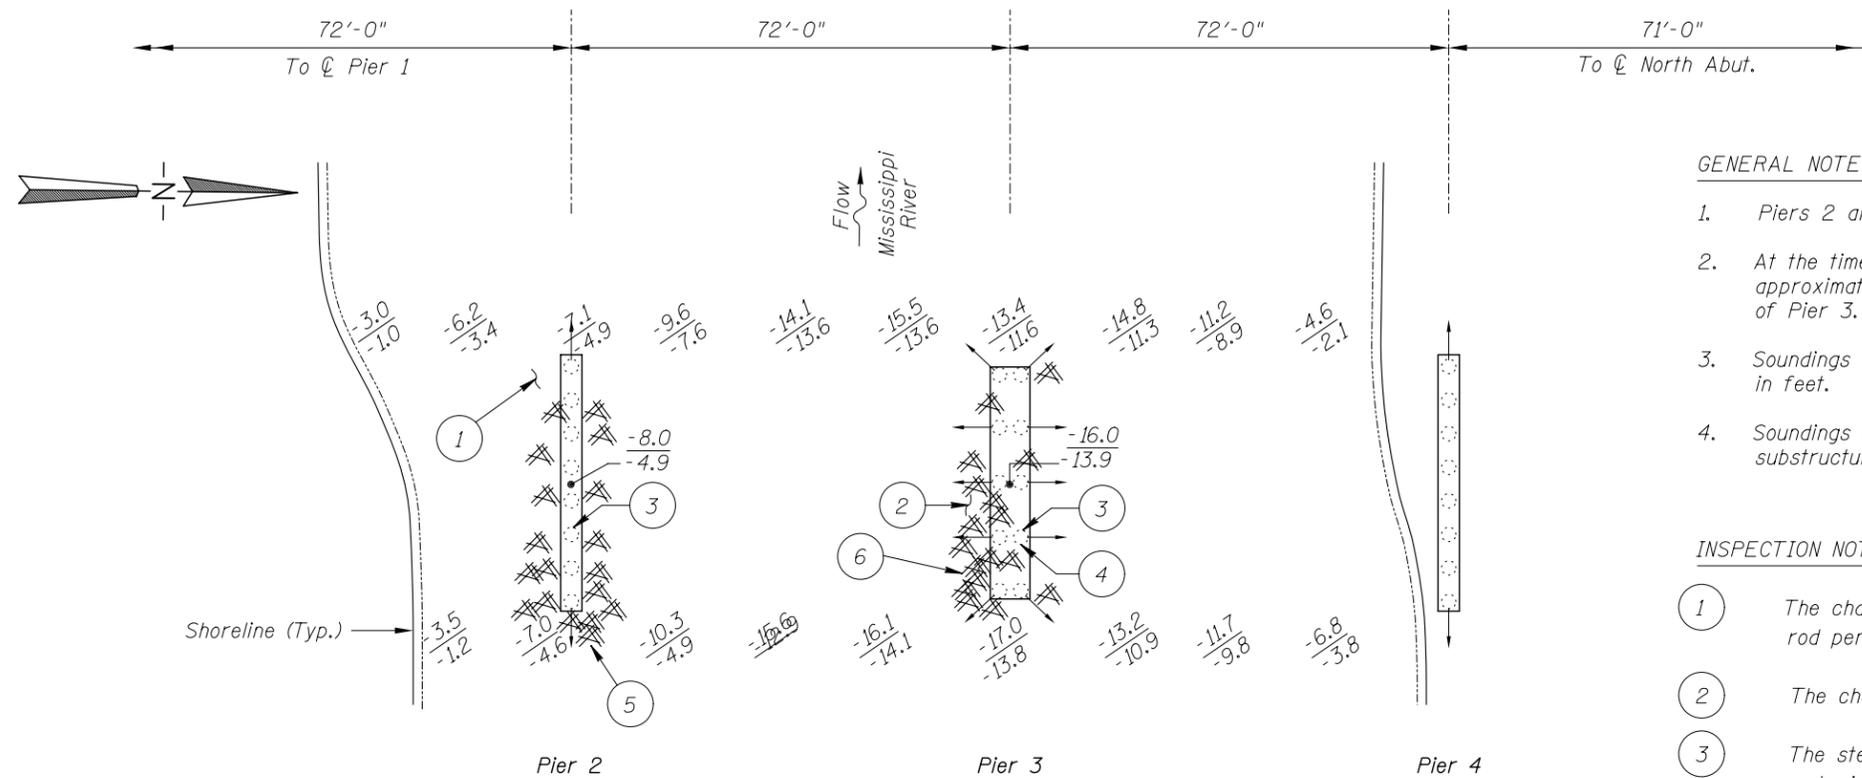
| Code: 52210068 | | Figure No.: 1 |

1. The channel bottom consisted of silty sand with 6 to 8 inches of probe rod penetration.
2. The channel bottom consisted of gravelly sand with up to 4 inches of probe rod penetration.

3. The steel pipe piles exhibited 100 percent coating failure with light to moderate corrosion and minor rust nodules with up to 1/8 inch deep pitting (1/16 inch typical) over 50 percent of the surface area from 6 feet above the waterline to the channel bottom, and on over 75% of the surface area below water.

4. The steel pipe piles at Pier 3 exhibited 1/16 inch thick rust delaminations due to corrosion from 3 below the waterline to the channel bottom.
5. A moderate accumulation of timber debris consisting of 1 foot diameter and smaller logs and branches was observed along the entire length of Pier 2 (heaviest at upstream nose) extending from channel bottom up 4 feet.

6. A moderate accumulation of timber debris consisting of 1 foot diameter and smaller logs and branches was observed on the three upstream piles on the south side of piles, extending from channel bottom up 10 feet. Scattered debris was observed along the entire length of Pier 3.
