UNDERWATER BRIDGE INSPECTION REPORT

STRUCTURE NO. 05525
CSAH NO. 29
OVER THE
MISSISSIPPI RIVER
DISTRICT 3 - BENTON COUNTY

PREPARED FOR THE
MINNESOTA DEPARTMENT OF TRANSPORTATION

BY
COLLINS ENGINEERS, INC.

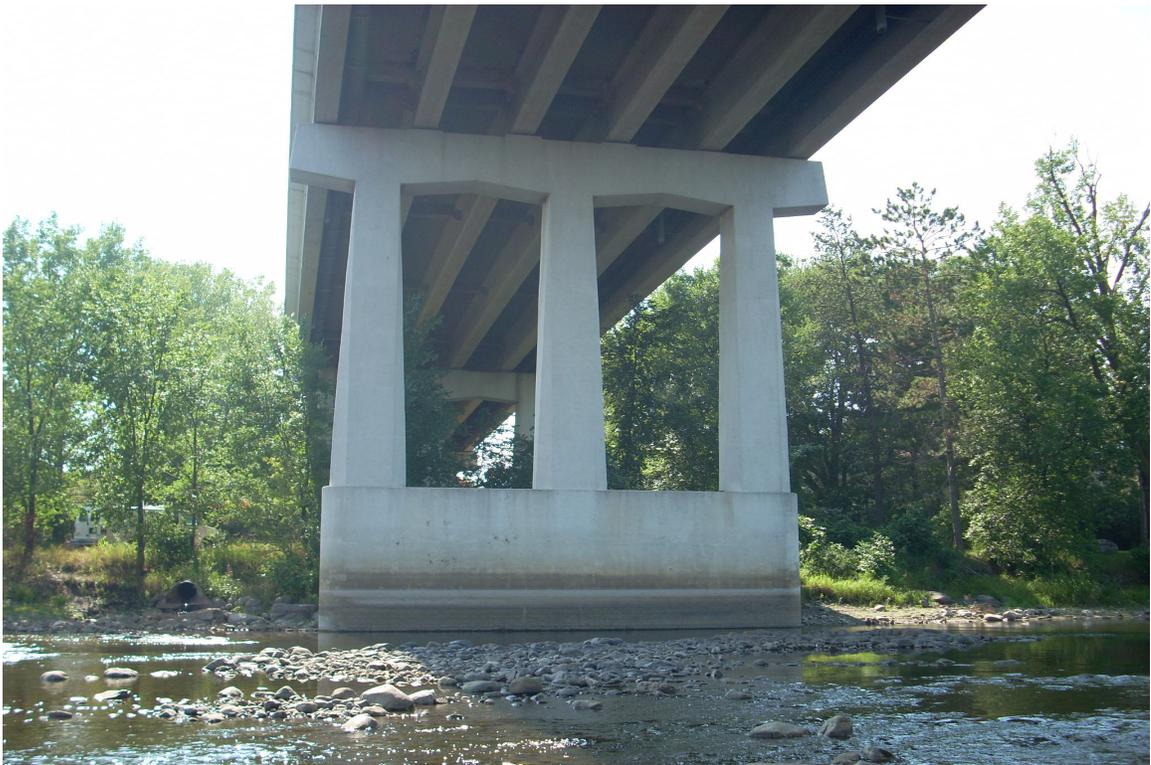
Photograph 2. View of Pier 3, Looking West.

- (B) Piers 3 through 7 exhibited random hairline cracks on each face extending from the top of the shaft to the channel bottom.
- (C) The footing at Pier 3 was exposed at the upstream nose and along the entire east face with up to 2.2 feet of vertical face exposed at the northeast corner.

- 3 The footing at Pier 3 was exposed at the upstream nose and along the entire east face with up to 2.2 feet of vertical face exposed at the northeast corner.

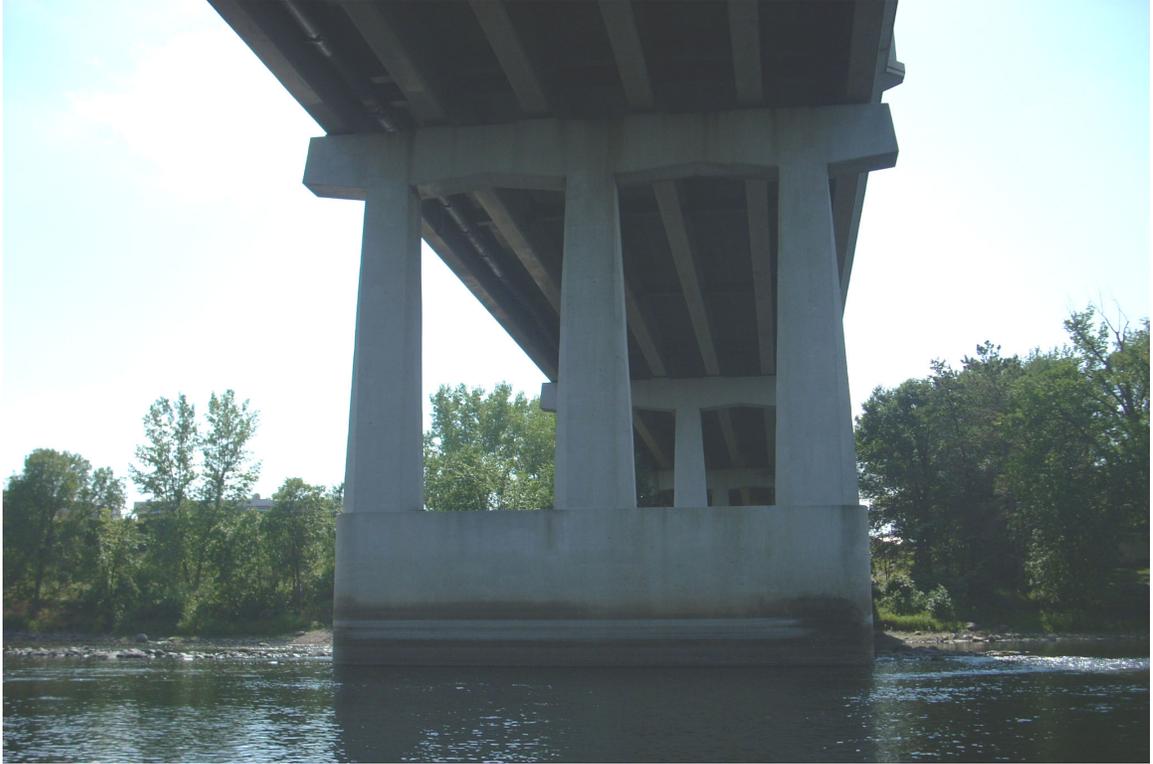
Photograph 3. View of Pier 4, Looking West.

- (D) The footing at Pier 4 was exposed along the entire east face, around the upstream nose, and up to the upstream quarter point along the west face with up to 2 inches of vertical face exposed.

- 4 The footing at Pier 4 was exposed along the entire east face, around the upstream nose, and up to the upstream quarter along the west face with up to 2 inches of vertical face exposed.

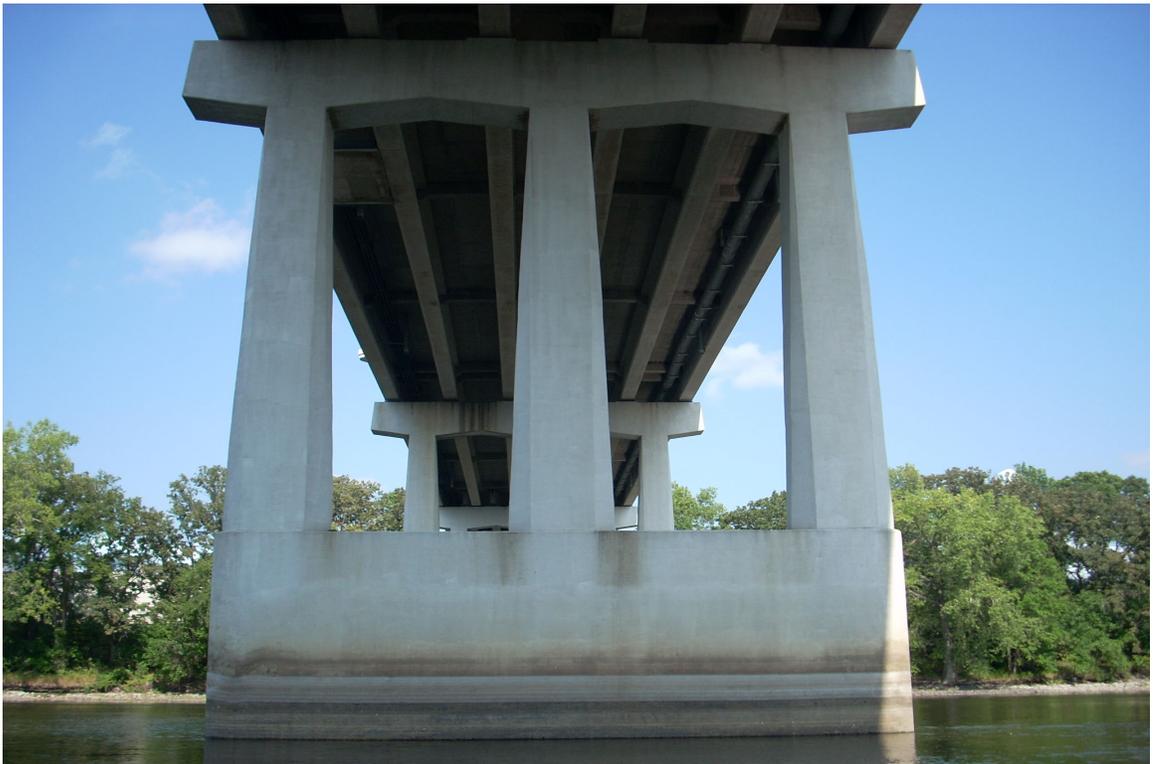
Photograph 4. View of Pier 5, Looking East.

- (E) The footing at Pier 5 was exposed along the entire east face and around the upstream nose with up to 10 inches of vertical face exposed at the southeast corner.

- 5 The footing at Pier 5 was exposed along the entire east face and around the upstream nose with up to 10 inches of vertical face exposed at the southeast corner.

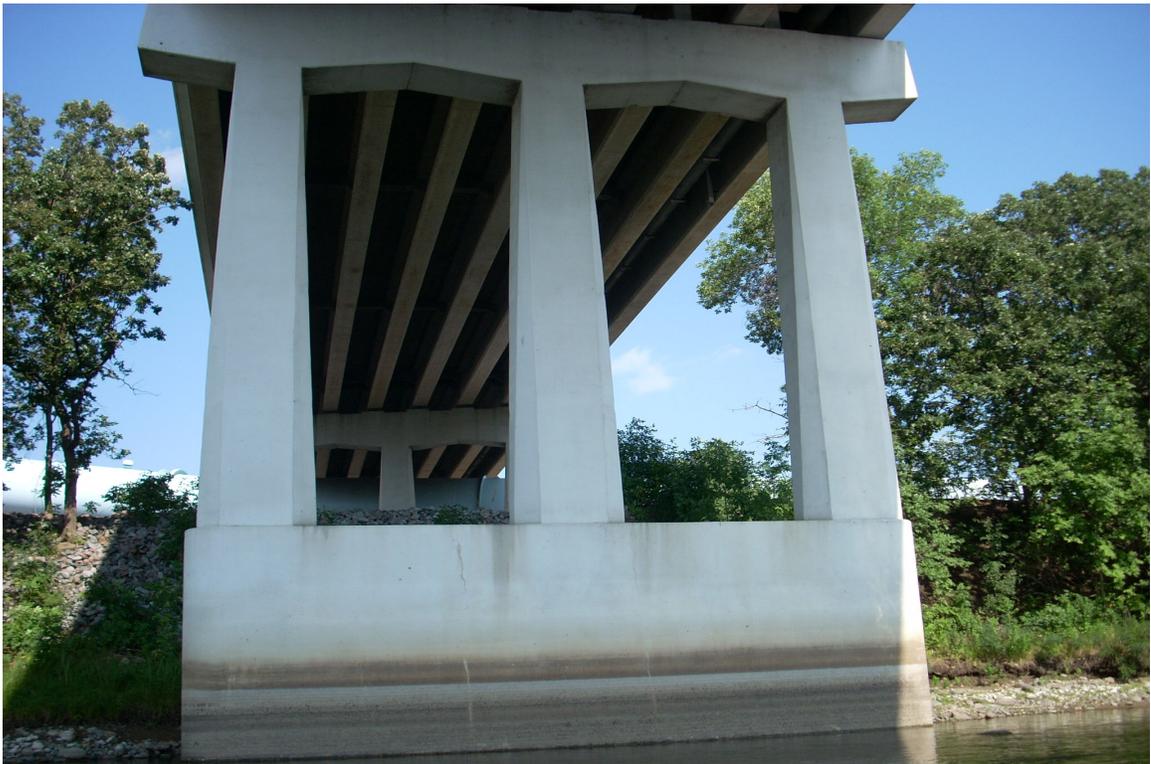
Photograph 6. View of Pier 7, Looking East.

- (F) The top of footing at Pier 7 was exposed at the northwest corners for approximately 5 feet with up to 10.5 inches of vertical face exposed.

- 6 The top of footing at Pier 7 was exposed at the northwest corner for approximately 5 feet with up to 10.5 inches of vertical face exposed.
- 7 A band of light scaling was observed around the entire perimeter of all the piers with a maximum penetration of 1/8 inch, extending 1.5 feet below to 1.5 feet above the waterline.

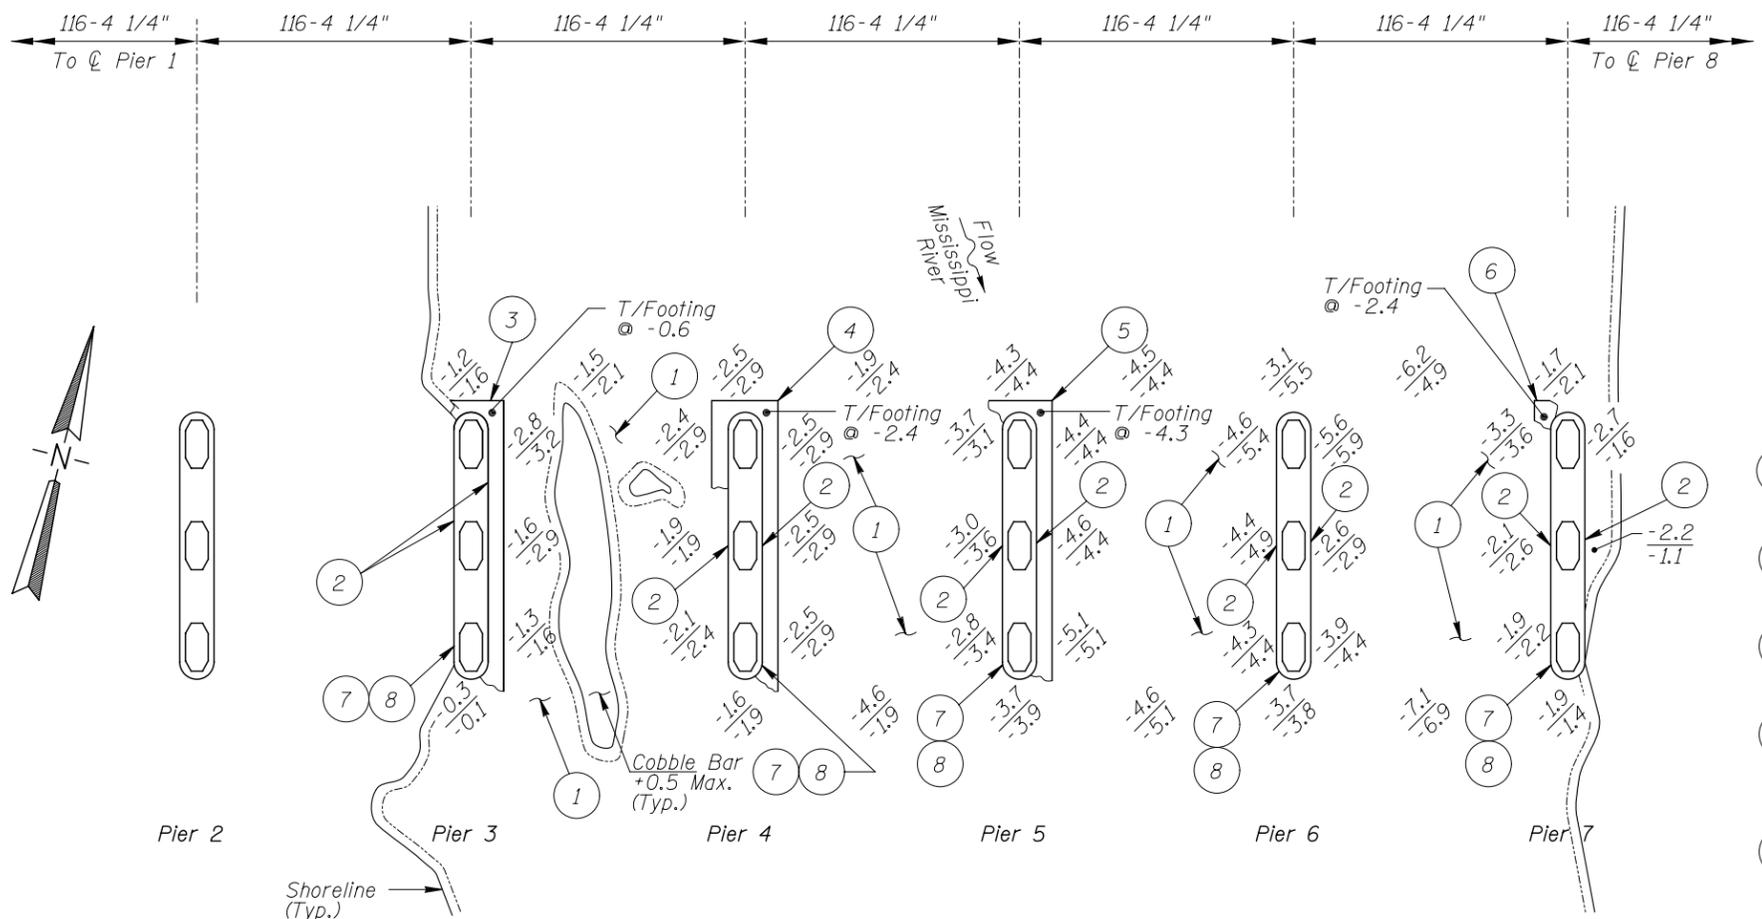
SOUNDING PLAN

- 1 The channel bottom consisted of 6-inch to 1-foot-diameter cobbles with sand and with up to 3 inches of probe rod penetration.
- 2 Piers 3 through 7 exhibited random hairline cracks on each face extending from the top of the shaft to the channel bottom.

- 8 The concrete surfaces of pier shafts and footings (where exposed) were typically smooth and sound with no deficiencies.
