UNDERWATER BRIDGE INSPECTION REPORT

STRUCTURE NO. 18501
CSAH NO. 16
OVER THE
PINE RIVER (CROSS LAKE / RUSH LAKE)
DISTRICT 3 – CROW WING COUNTY

PREPARED FOR THE
MINNESOTA DEPARTMENT OF TRANSPORTATION
BY
COLLINS ENGINEERS, INC.
JOB NO. 5221

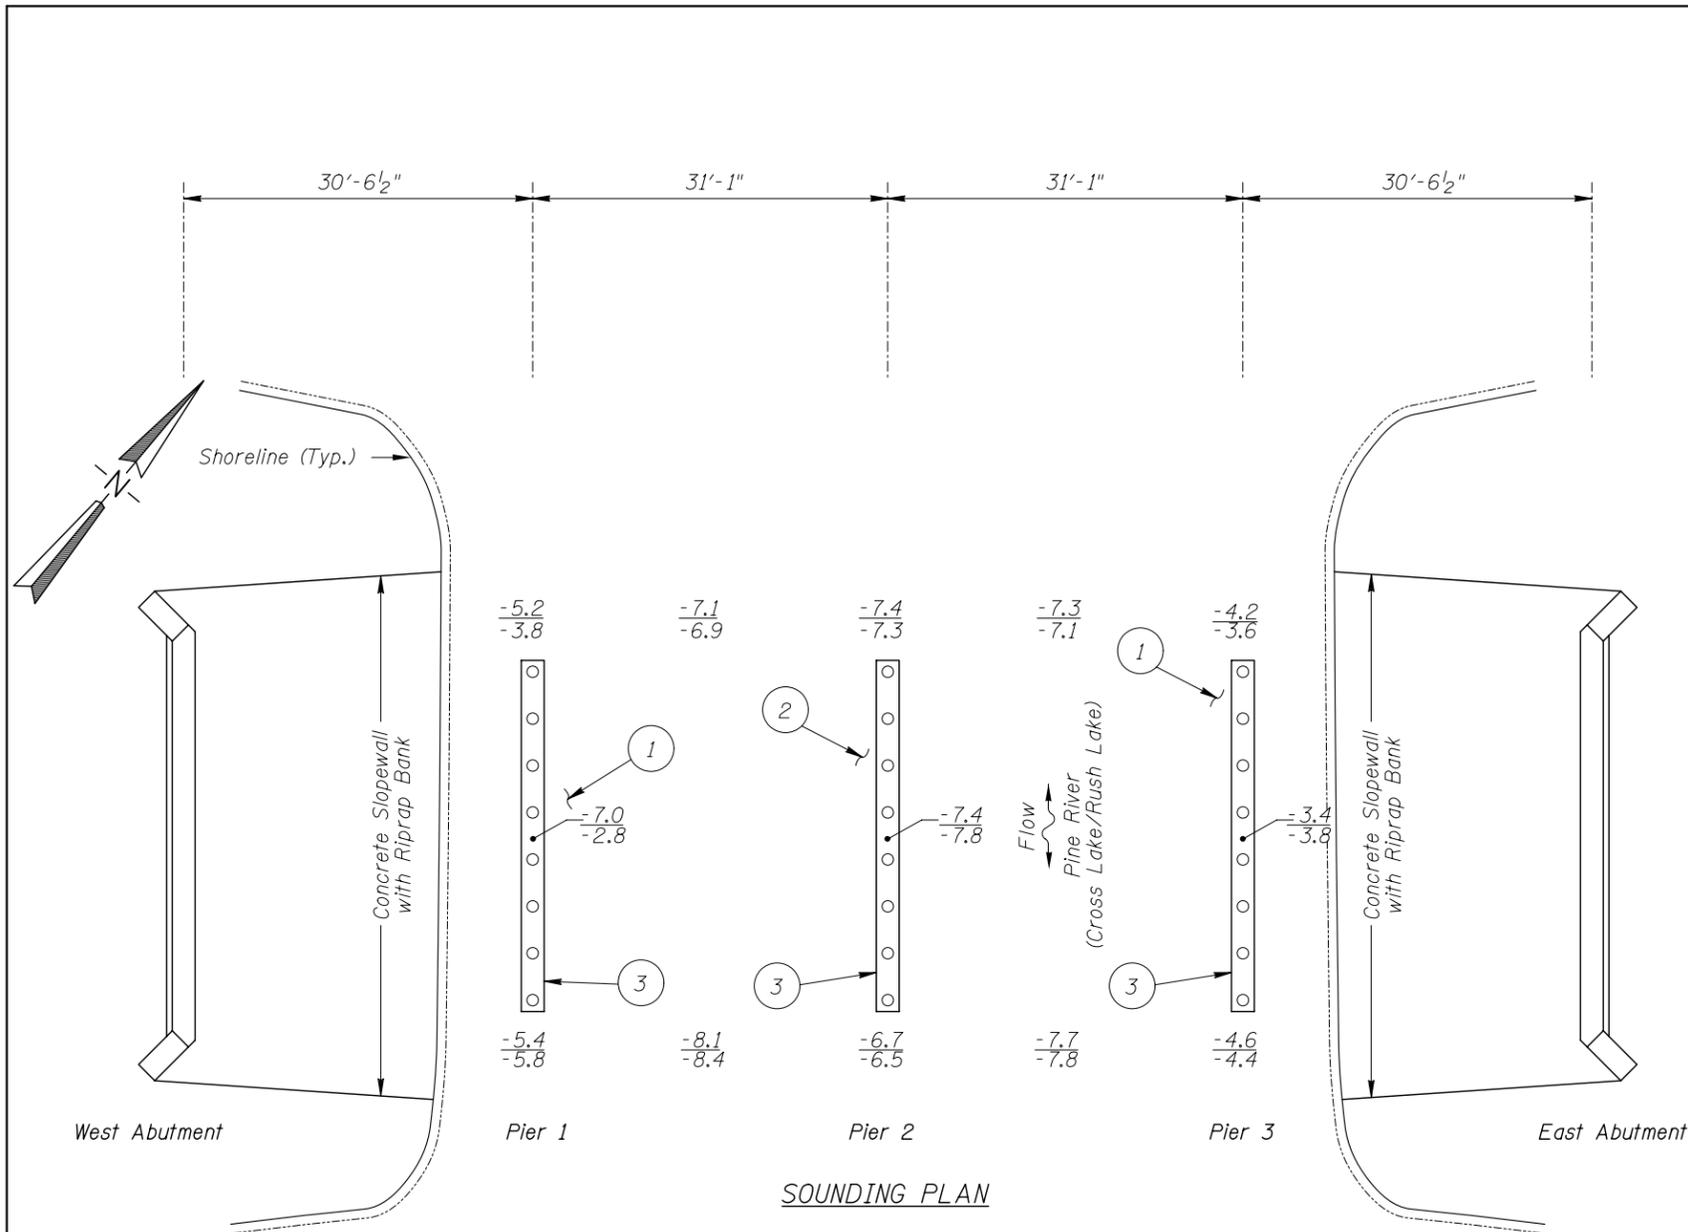
- 1 The channel bottom around Piers 1 and 3 consisted of 1- to 2-foot-diameter riprap.
- 2 The channel bottom around Pier 2 consisted of gravel and sand and 4- to 6-inch-diameter cobbles with up to 2 inches of probe rod penetration.
- 3 The piles exhibited coating failure and minimal surface corrosion on 15% to 20% of the surface area below the waterline. All piles exhibited a layer aquatic growth from the waterline to the mudline.
