UNDERWATER BRIDGE INSPECTION REPORT

STRUCTURE NO. 18505

MISSISSIPPI RIVER

DISTRICT 3 – CROW WING COUNTY, CITY OF BRAINERD

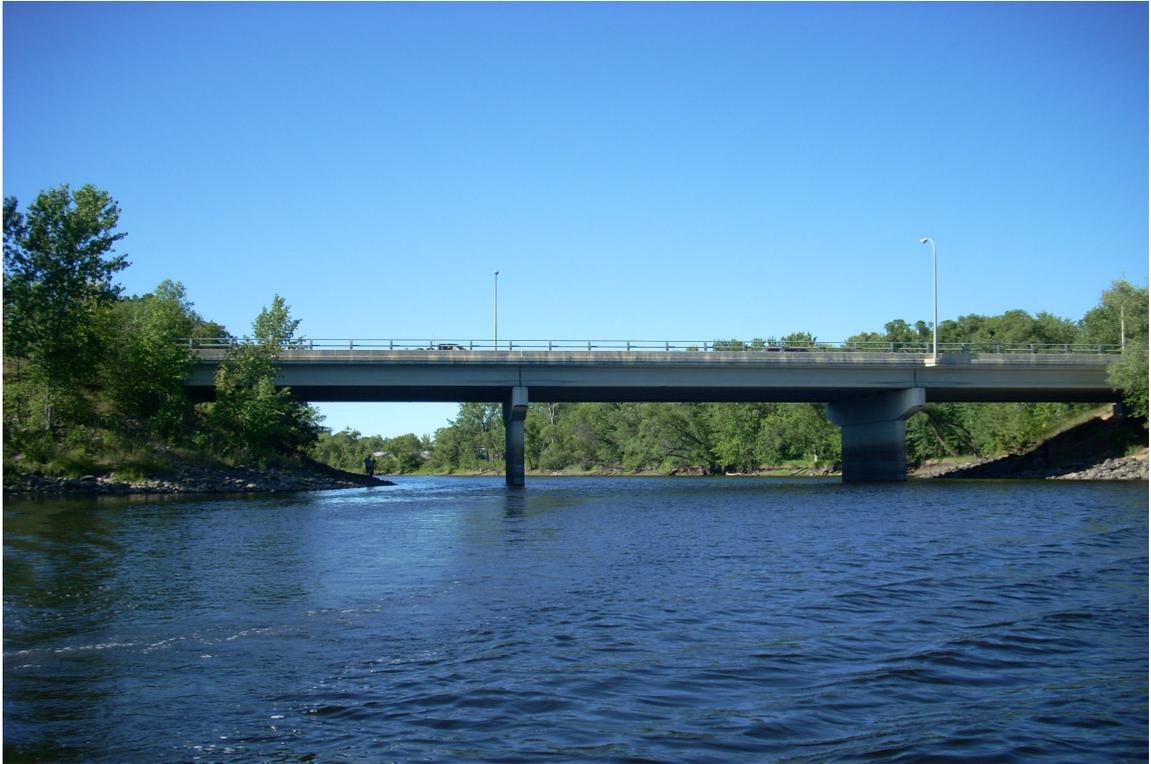
Photograph 1. Overall View of the Structure, Looking North.

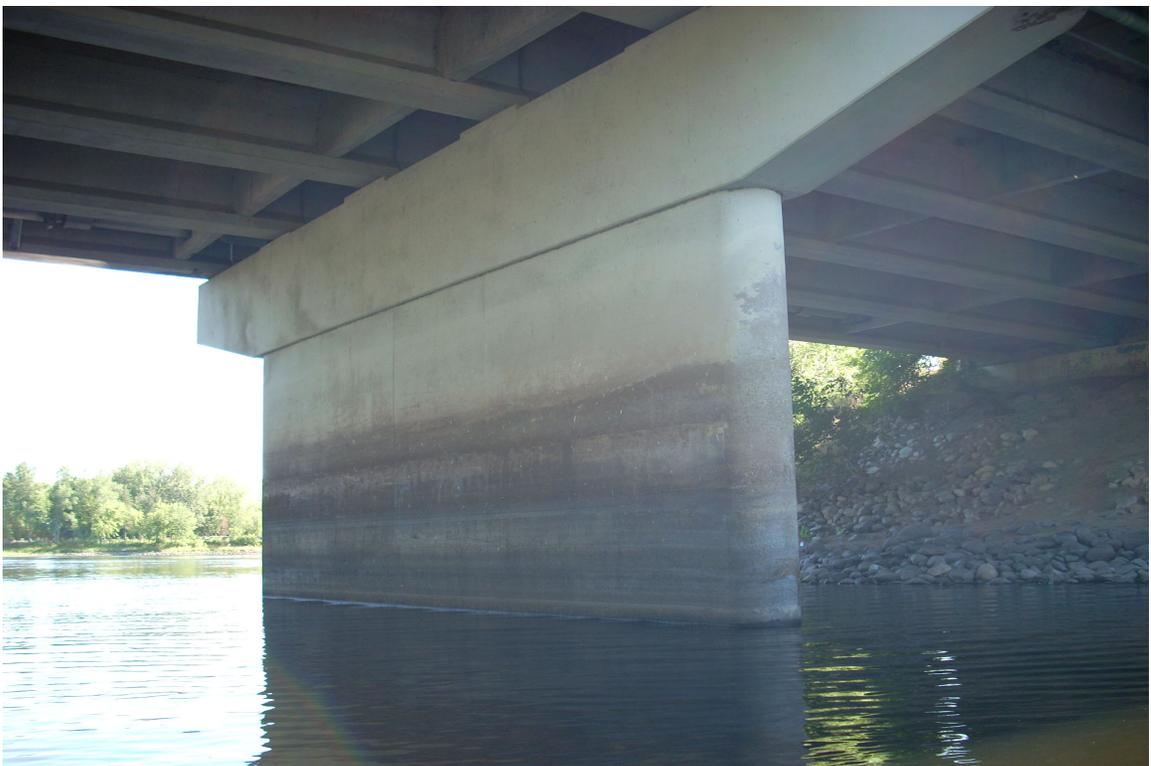
Photograph 2. View of Pier 1 and West Abutment, Looking Southwest.

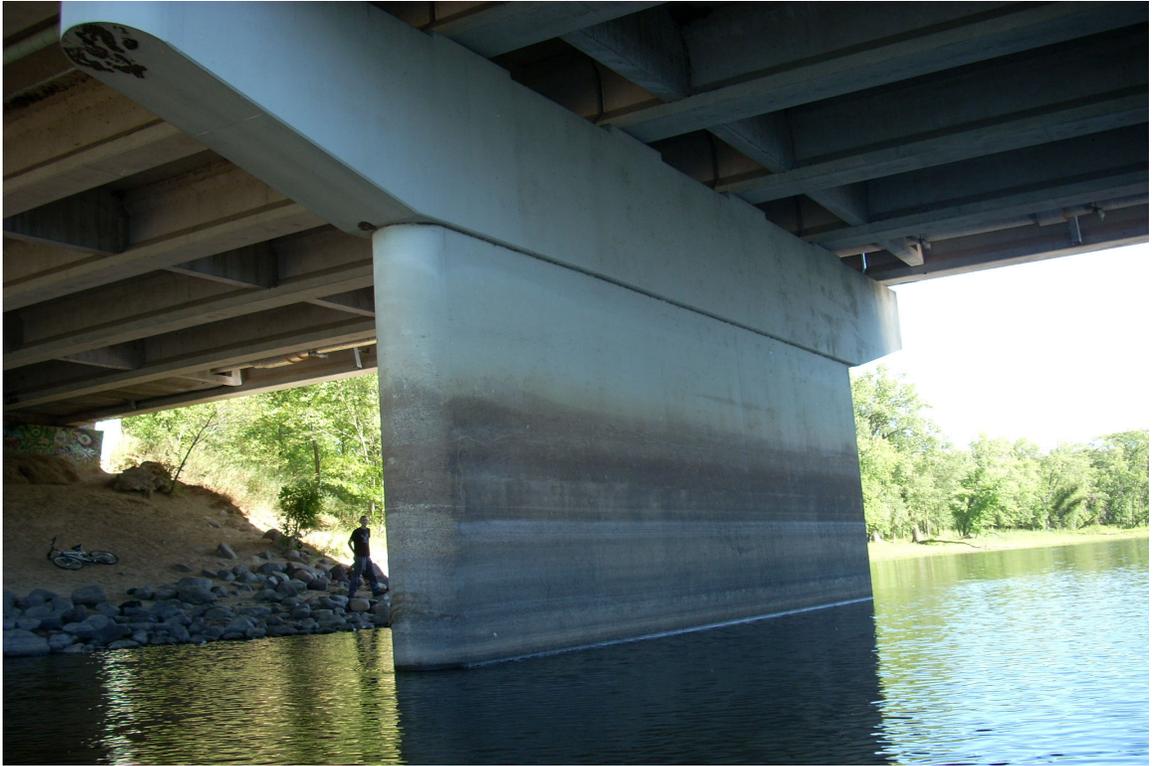
Photograph 3. View of Pier 2 and East Abutment, Looking Southeast.

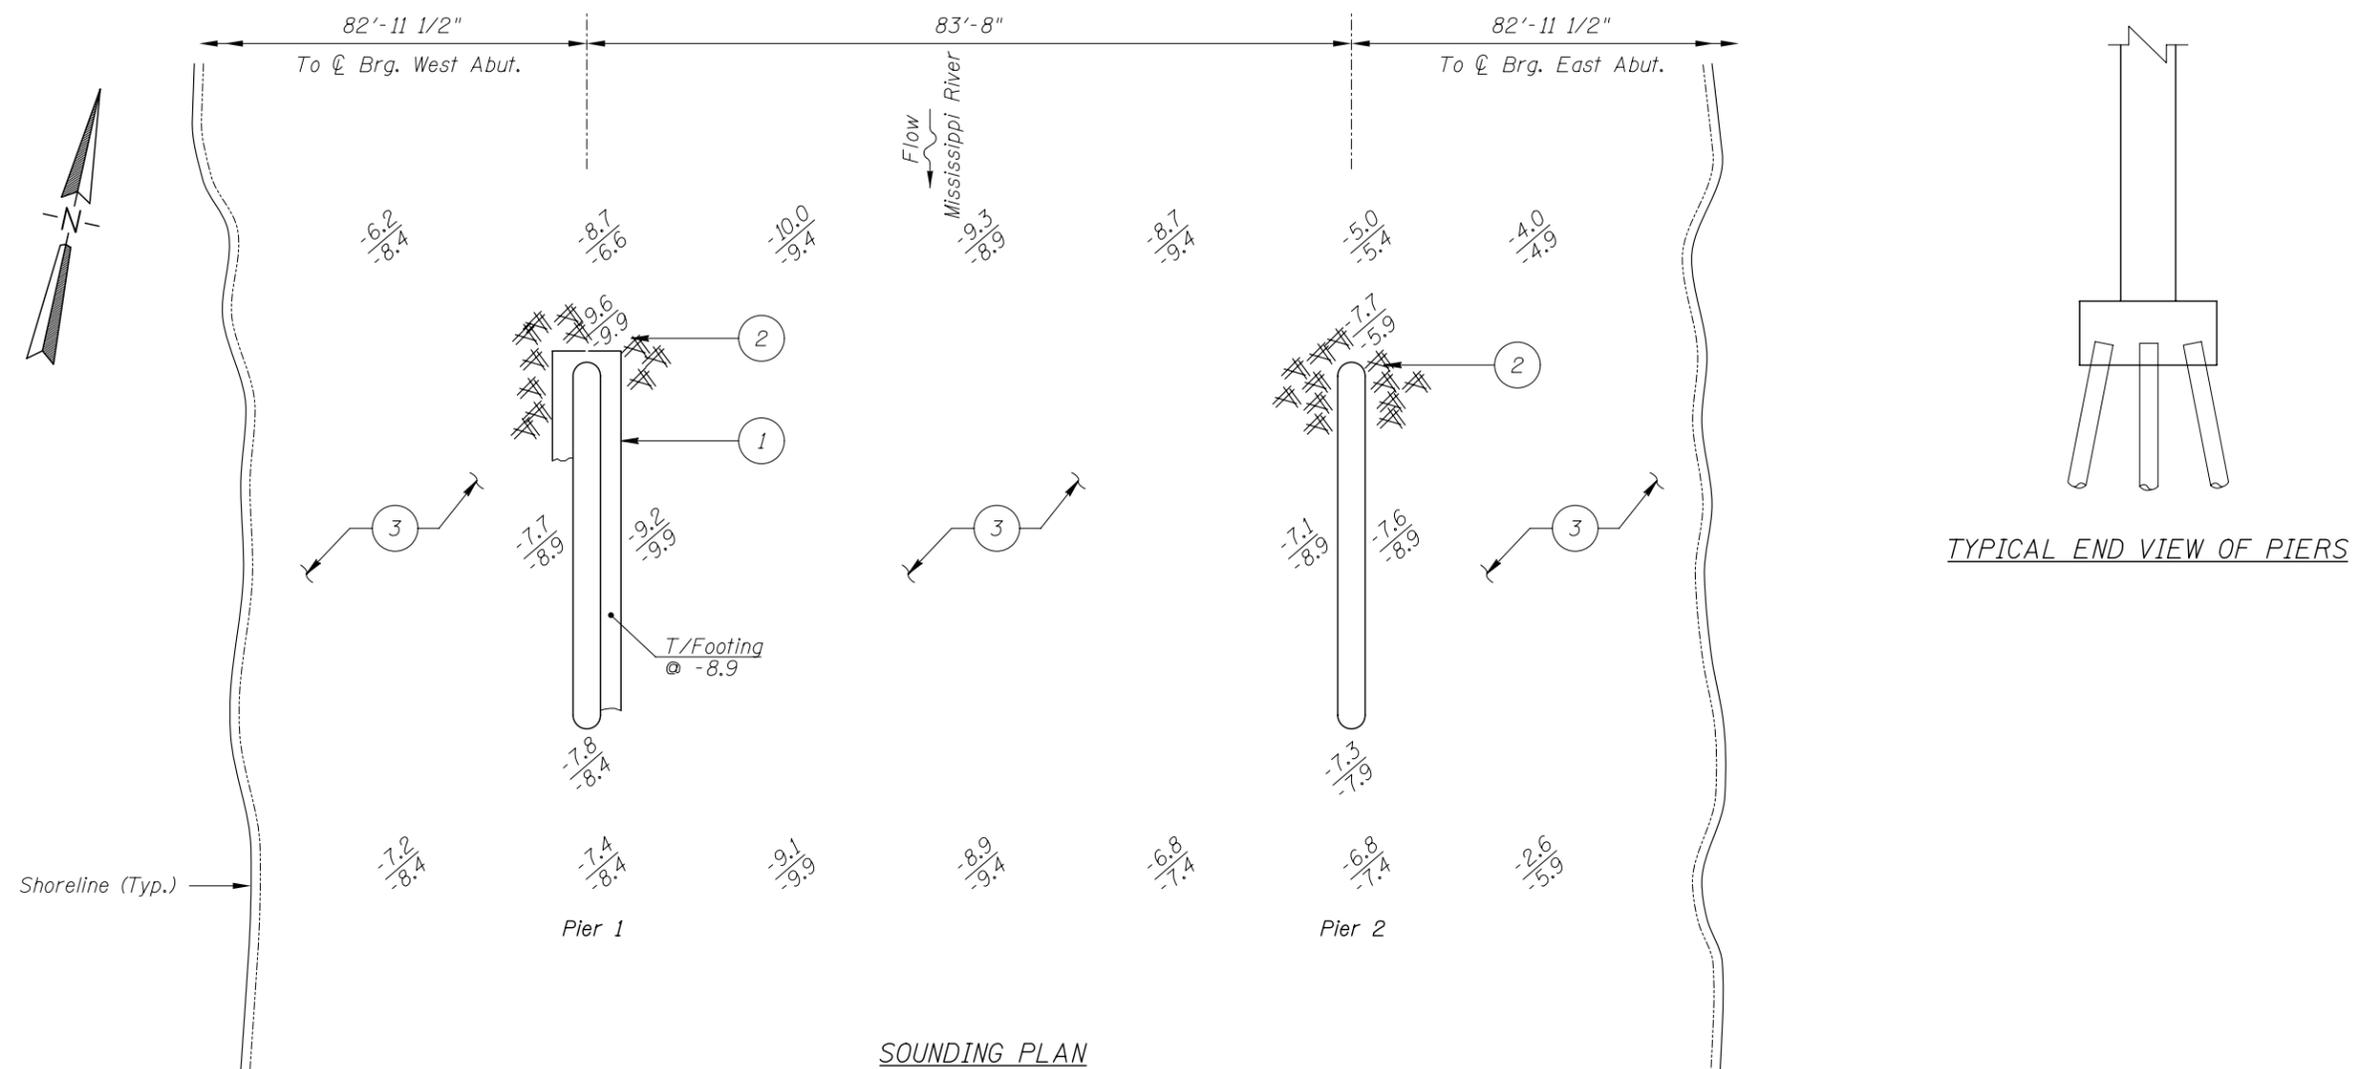
SOUNDING PLAN

- ① Footing exposure was observed at the upstream nose along to the upstream 1/4 on west side and along the entire east side of Pier 1 with up to 8 inches of vertical face exposure at the nose.

- ② A moderate accumulation of timber debris, with logs and branches up to 12 inches in diameter, was observed from the channel bottom up three feet around the upstream nose of both piers. The debris extends to the East by 10 feet, West by 5 feet, and North by 5 feet.

- ③ The channel bottom material consisted of sand and gravel with cobbles. Probe rod penetration was negligible.
- ④ Above and below the waterline the concrete at pier shafts and footings (were exposed) was typically smooth and sound with random minor areas of poor consolidation with penetration up to 1/4 inch.

- ⑤ Scaling was observed around the entire pier shafts at both piers typically from waterline up 4 feet with max penetration of 1/4 inch. The scaling was heaviest at the upstream nose where it extended up to 10 feet above the waterline.

- (A) Monitor the extent of the timber debris accumulation at both piers, and if shown to be increasing, remove during routine maintenance.
