UNDERWATER BRIDGE INSPECTION REPORT

STRUCTURE NO. 18509

MISSISSIPPI RIVER

COLLINS ENGINEERS, INC.

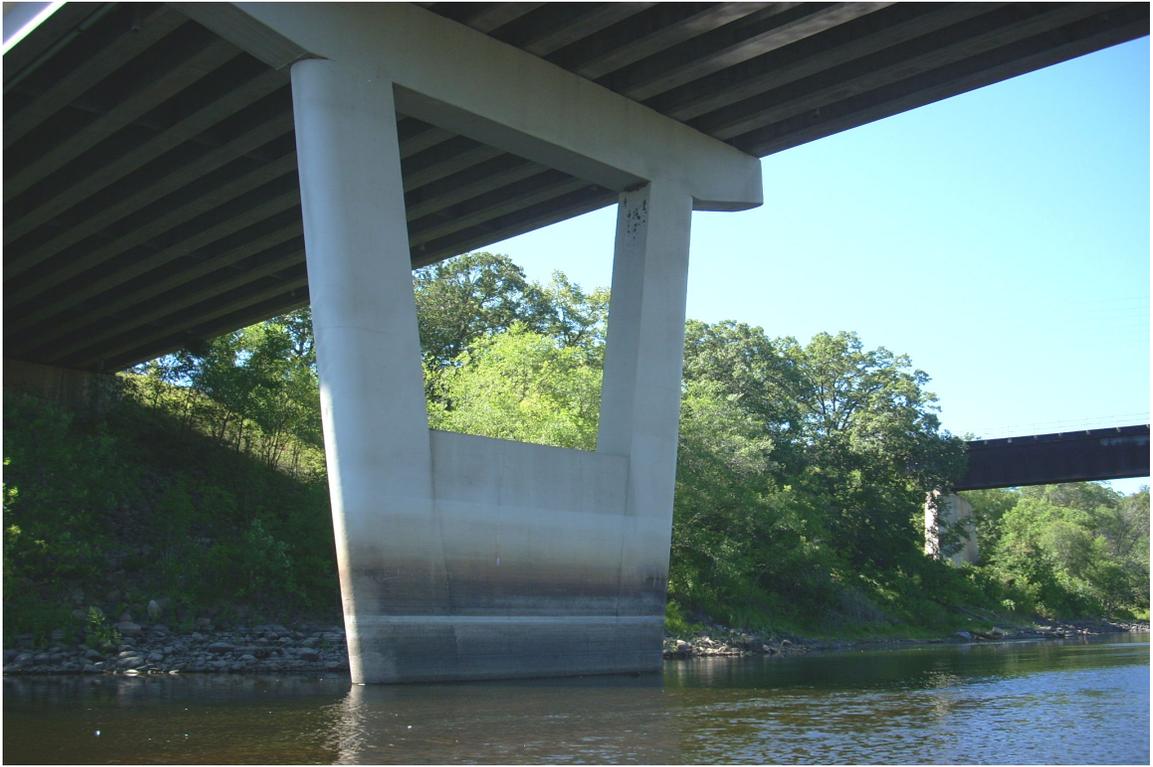
Photograph 1. View of Pier 1, Looking Northwest.

- 3 Riprap from 1 to 2 feet in diameter was located at the upstream nose of Piers 1 and 3.
- 4 A light accumulation of timber debris and a truck tire was observed along the upstream half of the east face of Pier 3 extending from the channel bottom up 3 feet and up to 6 feet off pier face.

- 5 A minor scour depression was observed at the upstream end of Pier 1 with a radius of 6 feet and a depth up to 2.5 feet.
- 6 A moderate scour depression was observed at the upstream end of Pier 2 with a radius of 6 feet and a depth up to 2 feet.

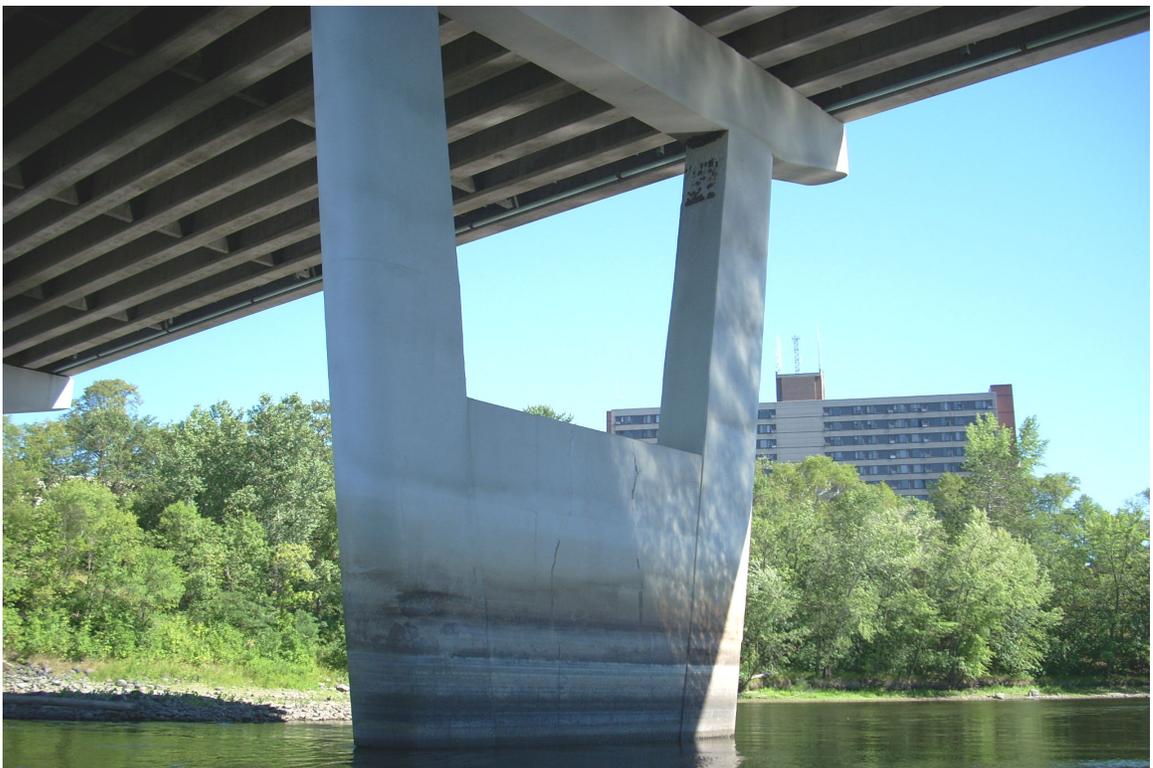
Photograph 2. View of Pier 2, Looking Southeast.

- 1 The channel bottom material consisted of firm sandy gravel with cobbles and a maximum of 2 inches of probe rod penetration.
- 2 Footing exposed with no vertical exposure at the upstream nose of Pier 2. Top of footing was rough with 1/4 inch irregularities.

- (A) Monitor the extent of the footing exposure at Pier 2 during future inspections, and if found to be significantly progressing, then countermeasures may be warranted.

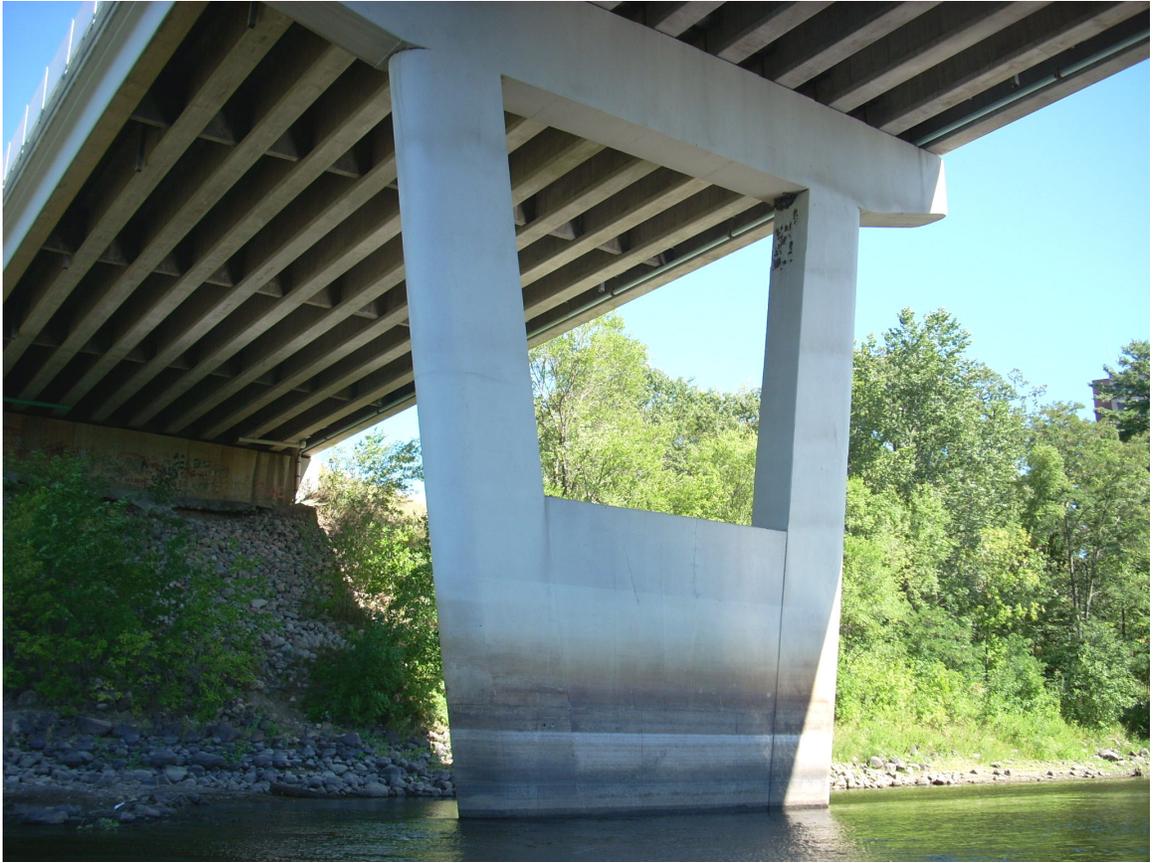
Photograph 3. View of Pier 3, Looking Southeast.

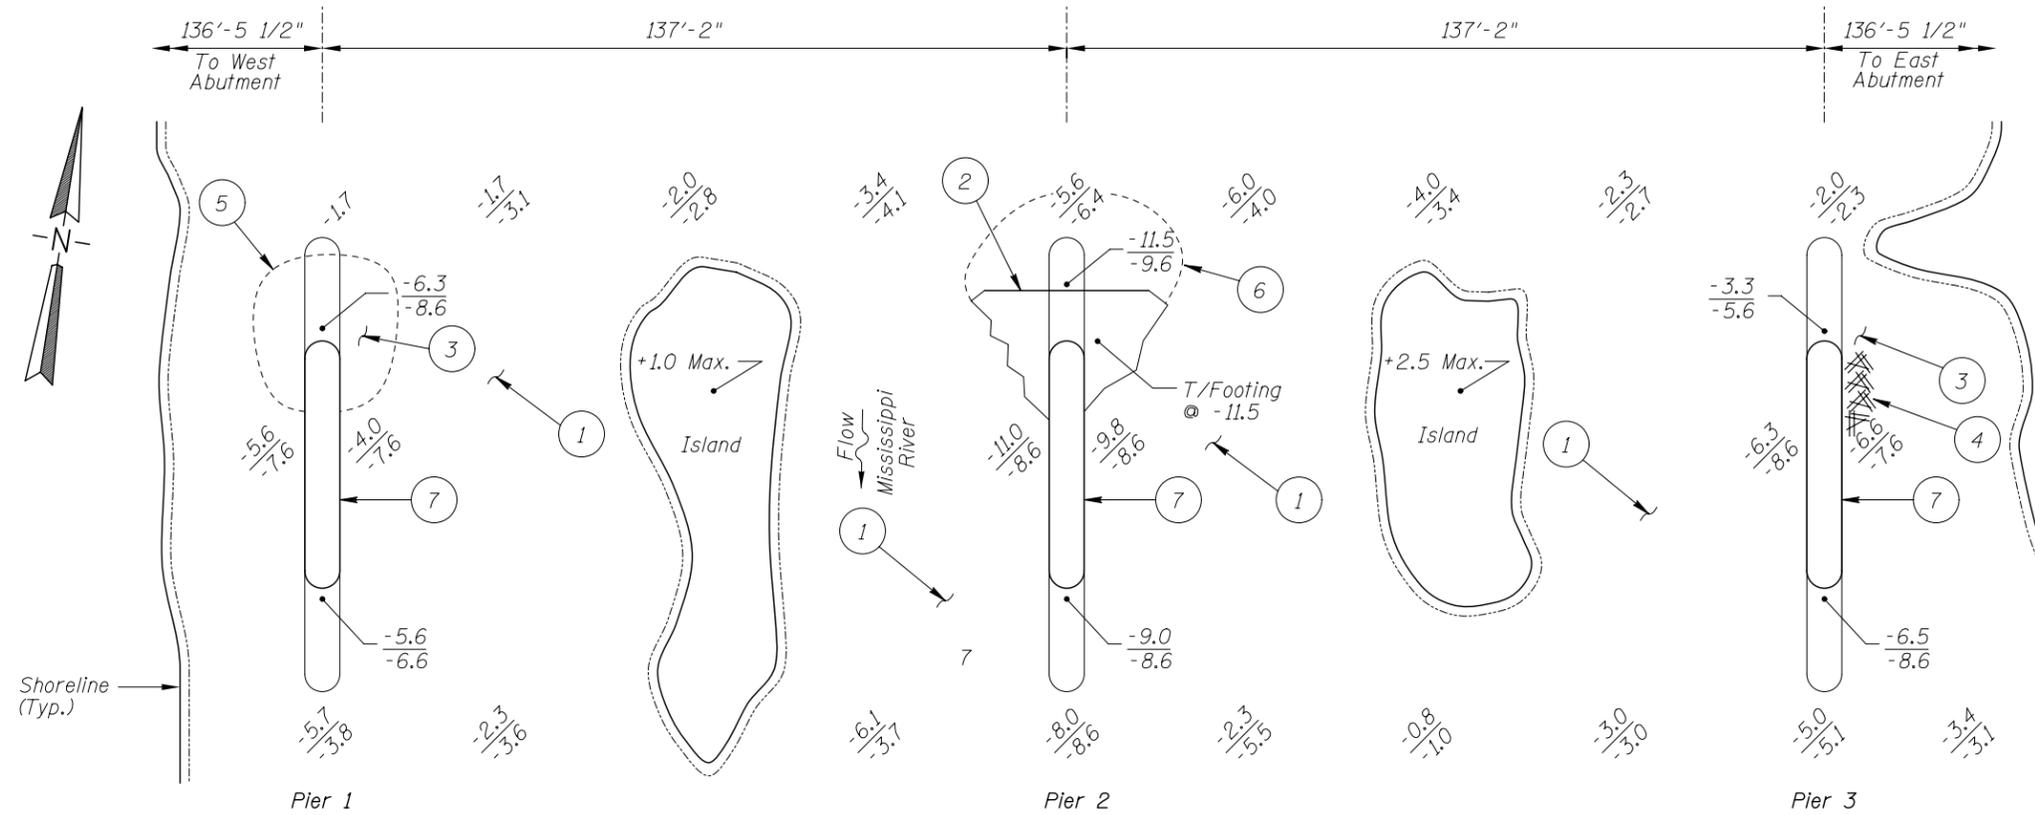
**SOUNDING PLAN**

- 7 Above and below the waterline, the concrete was typically smooth and sound with random areas of delaminating and loss of section of the finishing grout. Heaviest at downstream nose of Pier 2. In addition hairline vertical cracks were observed in the webwall in all piers from top of webwall to channel bottom.

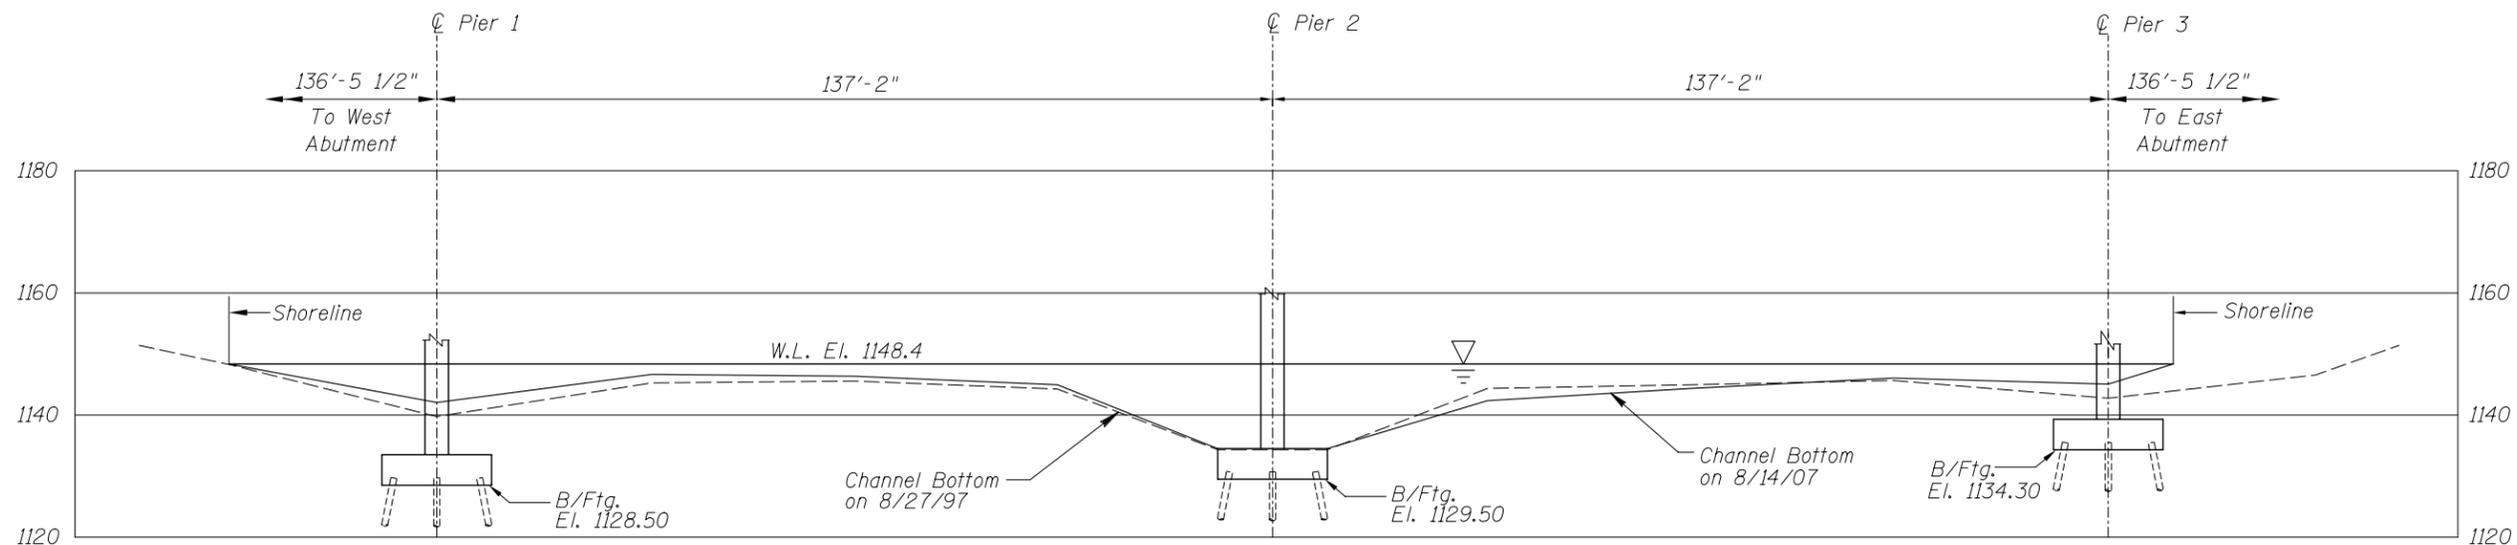
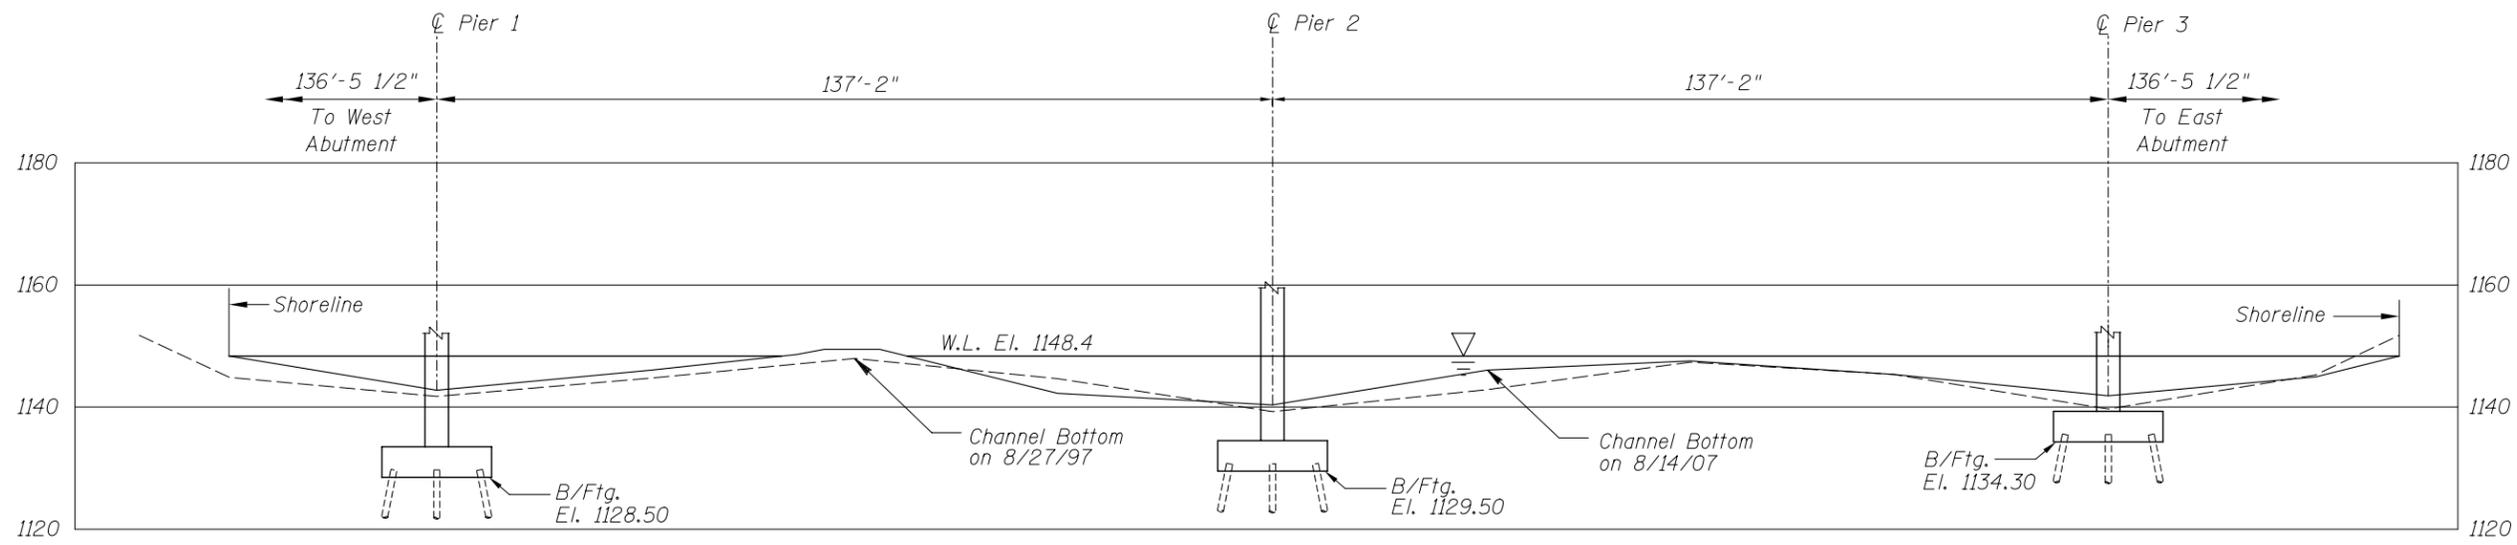
UPSTREAM FASCIA PROFILE

DOWNSTREAM FASCIA PROFILE
