UNDERWATER BRIDGE INSPECTION REPORT

STRUCTURE NO. 30505

RUM RIVER

DISTRICT 3 - ISANTI COUNTY

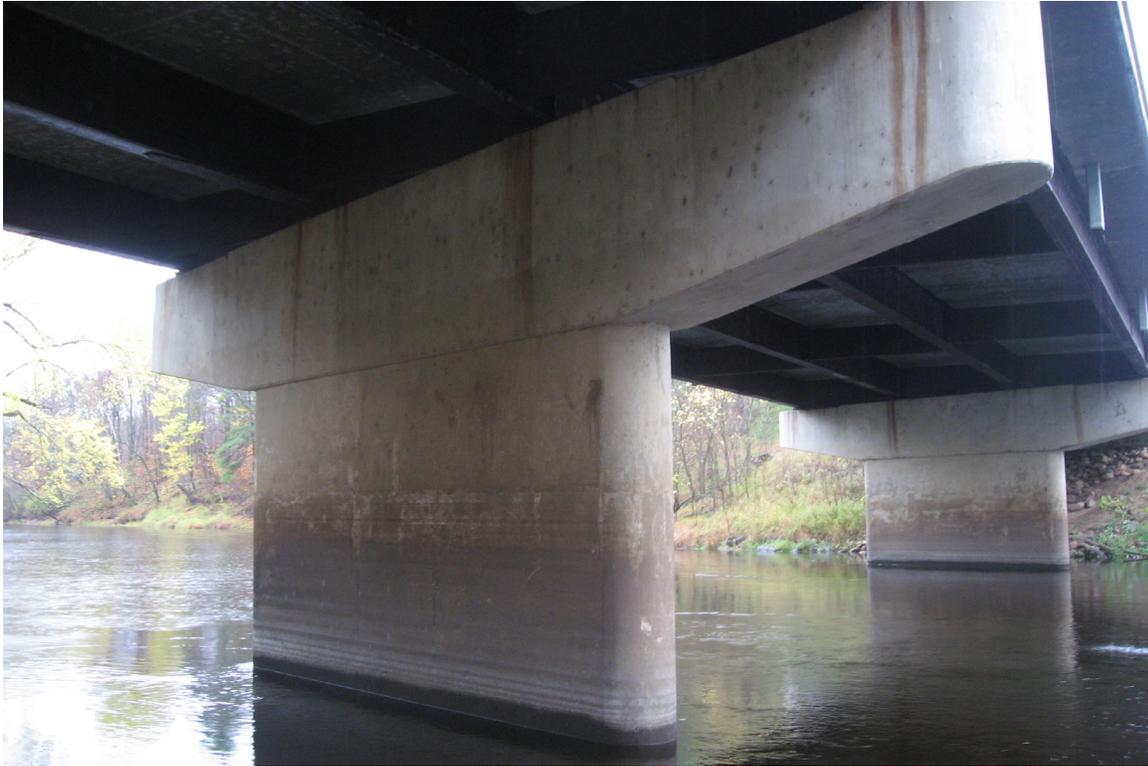
Photograph 1. View of Pier 1, Looking Southwest.

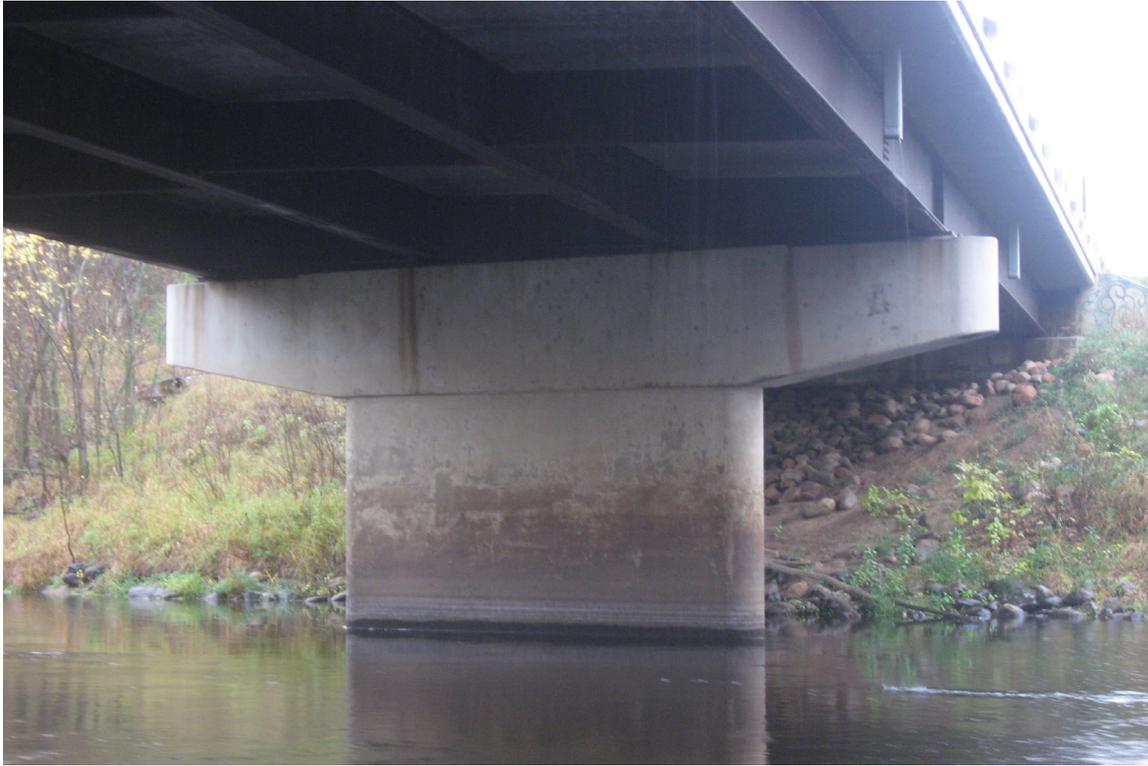
Photograph 2. View of Pier 2, Looking Southwest.

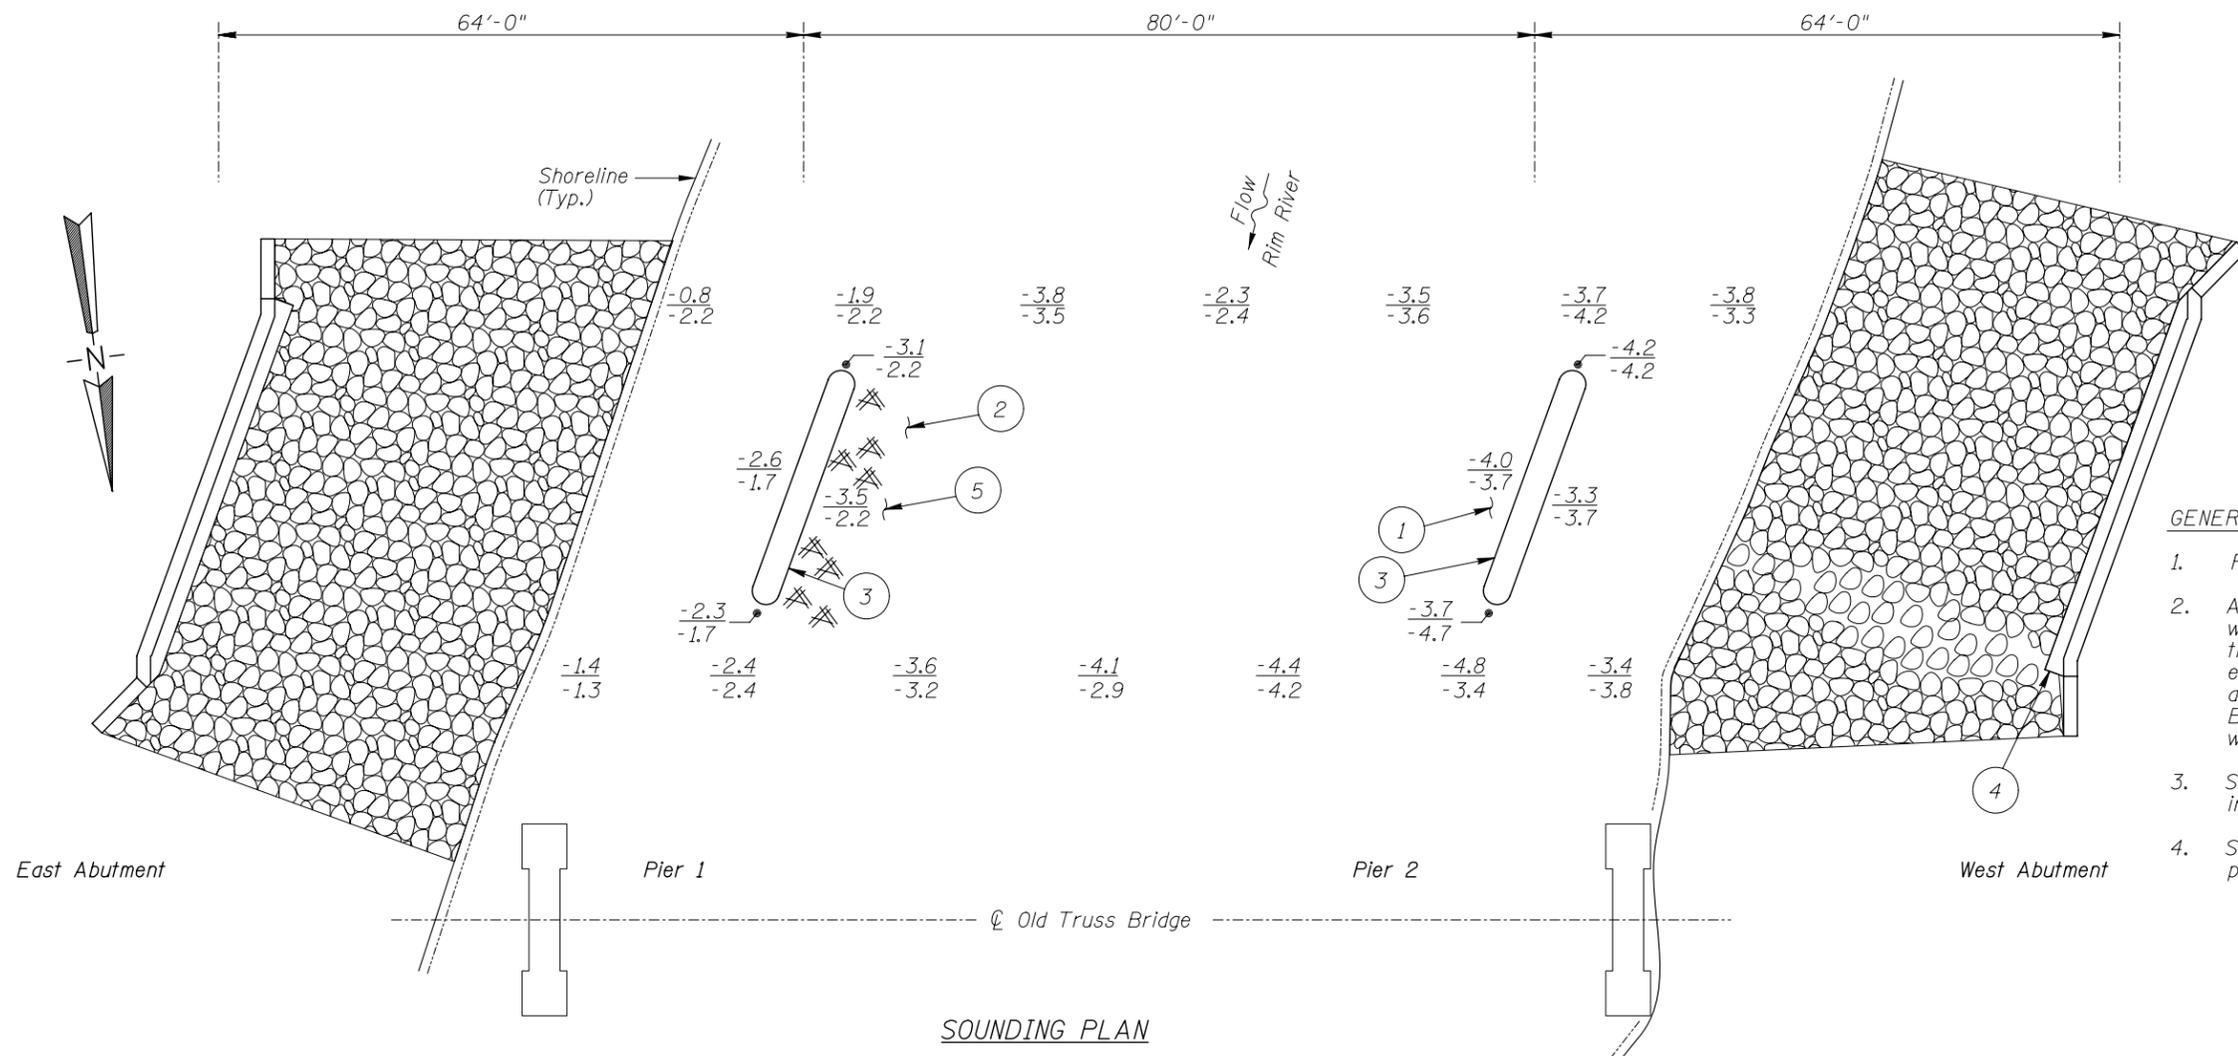
**INSPECTION AND SOUNDING PLAN**

- 1 The channel bottom consisted of sand, gravel, and 4-inch-diameter cobbles with up to 1 inch of probe rod penetration.
- 2 The channel bottom consisted of silty sand with up to 3 inches of probe rod penetration.
- 3 A band of light scaling was observed around the entire perimeter of Piers 1 and 2 from 2 feet above to 2 feet below the waterline with typical penetrations of 1/18 inch deep and maximum penetrations up to 1/4 inch deep at the upstream noses.
- 4 The previously noted undermining along the north end of the West Abutment has been repaired with the placement of 4-foot-diameter riprap.
- 5 A light accumulation of timber debris consisting of 6-inch-diameter and smaller logs and branches was observed along the west face of Pier 1 and extended from the channel bottom to the waterline and up to 3 feet off the face of the pier.
