UNDERWATER BRIDGE INSPECTION REPORT

STRUCTURE NO. 5947

MISSISSIPPI RIVER

COLLINS ENGINEERS, INC.

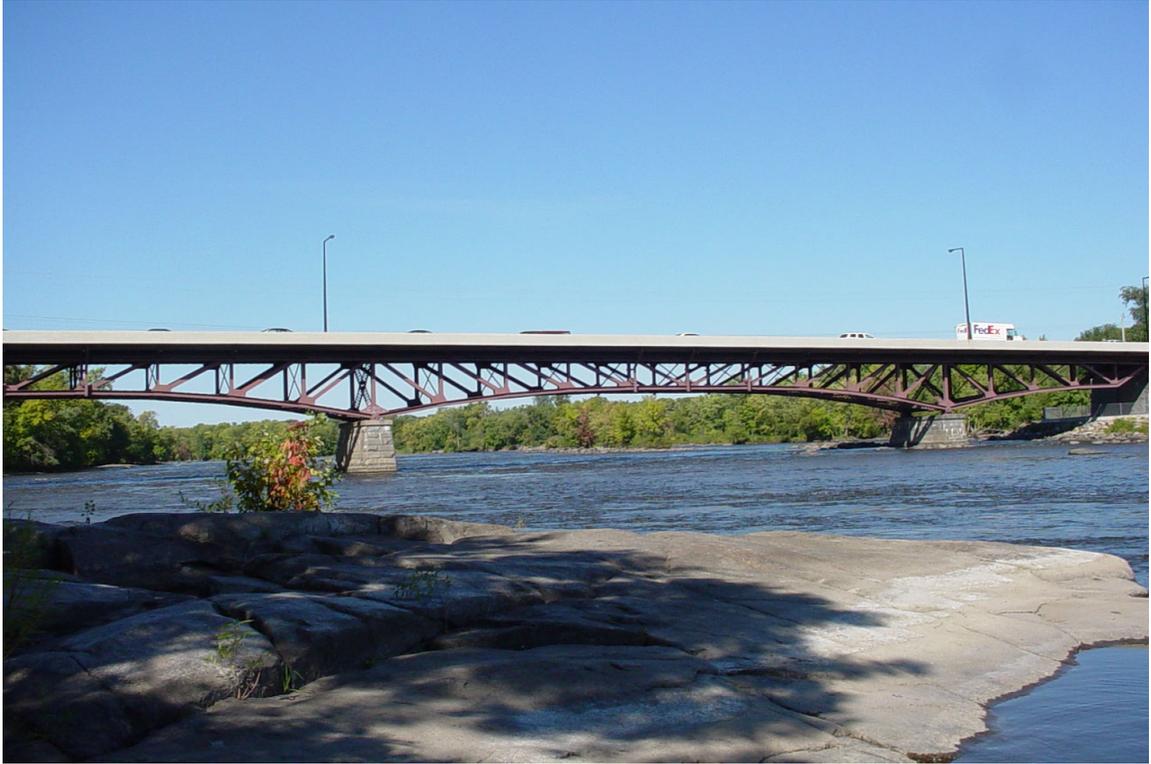
Photograph 1. Overall View of the Structure, Looking Northwest.

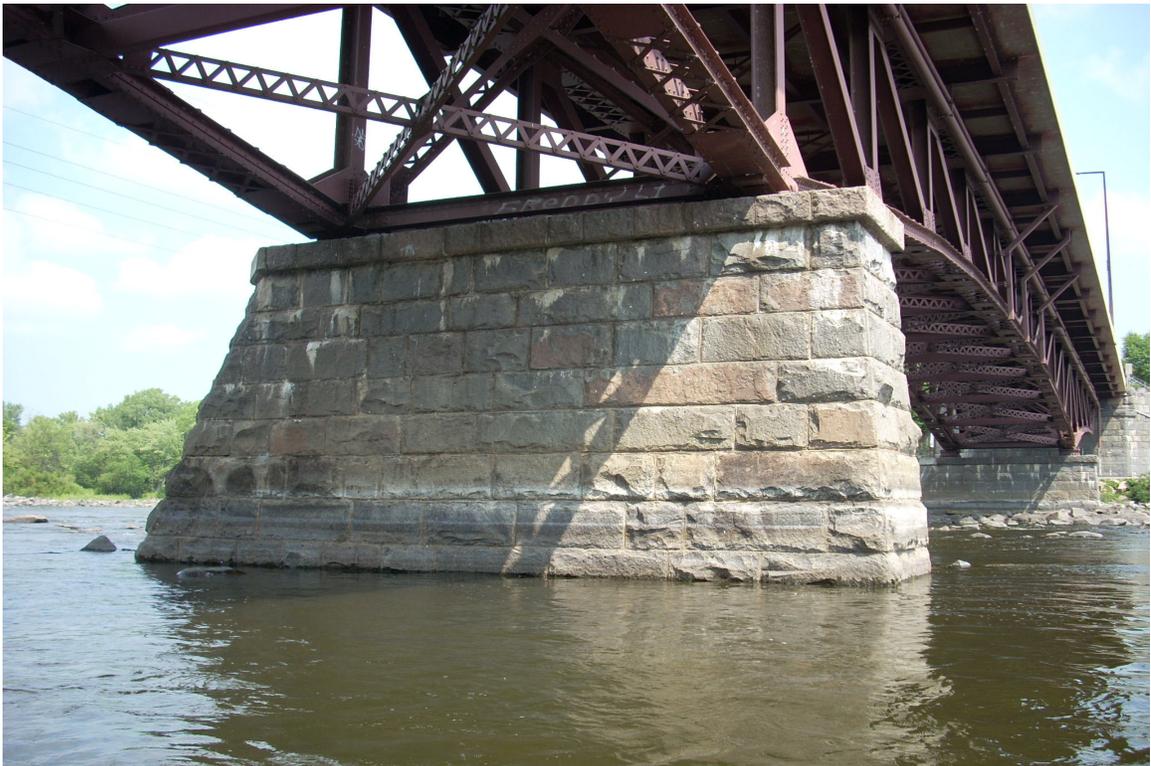
- (B) The masonry of Piers 2 and 3 was in good condition with no defects of structural significance observed. However, there were random areas of deteriorated joint mortar with penetrations of up to 2 inches deep (deepest losses concentrated around the upstream nose).

Photograph 2. View of Pier 2, Looking South.

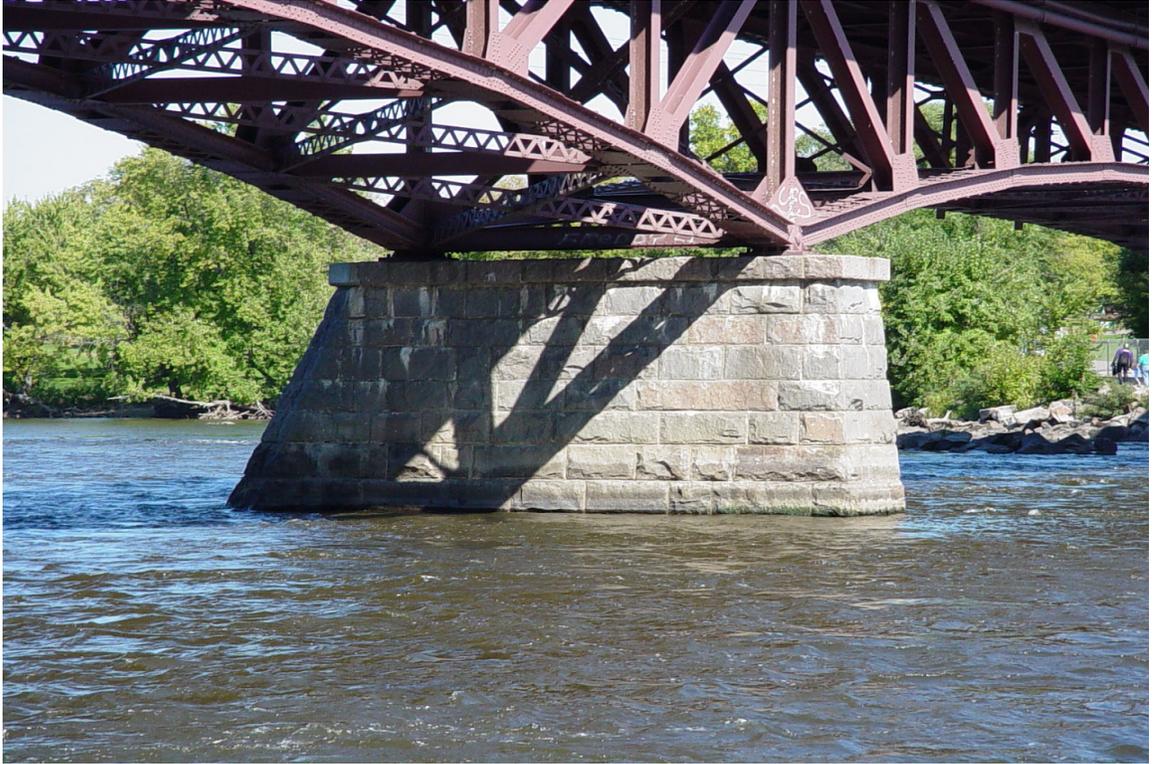
Photograph 3. View of Pier 2, Looking Northeast.

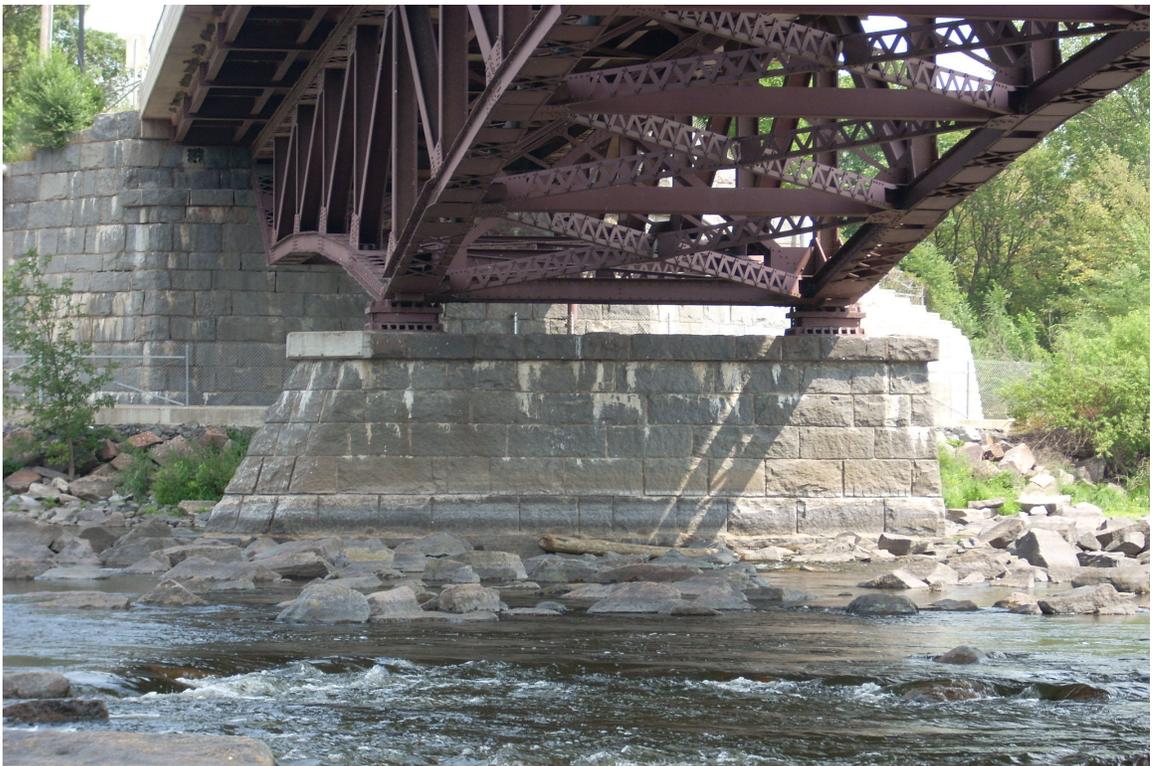
- (A) A 6-foot-long area of undermining was observed at the southeast corner of Pier 3 with a height of 1.3 feet and with 3 feet of maximum horizontal penetration. The undermining was due to the fractured bedrock channel bottom, which has shifted from under the footing.

Photograph 4. View of Pier 3, Looking South.

- (A) Repair the undermining at the southeast corner of Pier 3 by placing grout bags and/or pumped grout within the undermined area to restore the full bearing capacity of the pier.

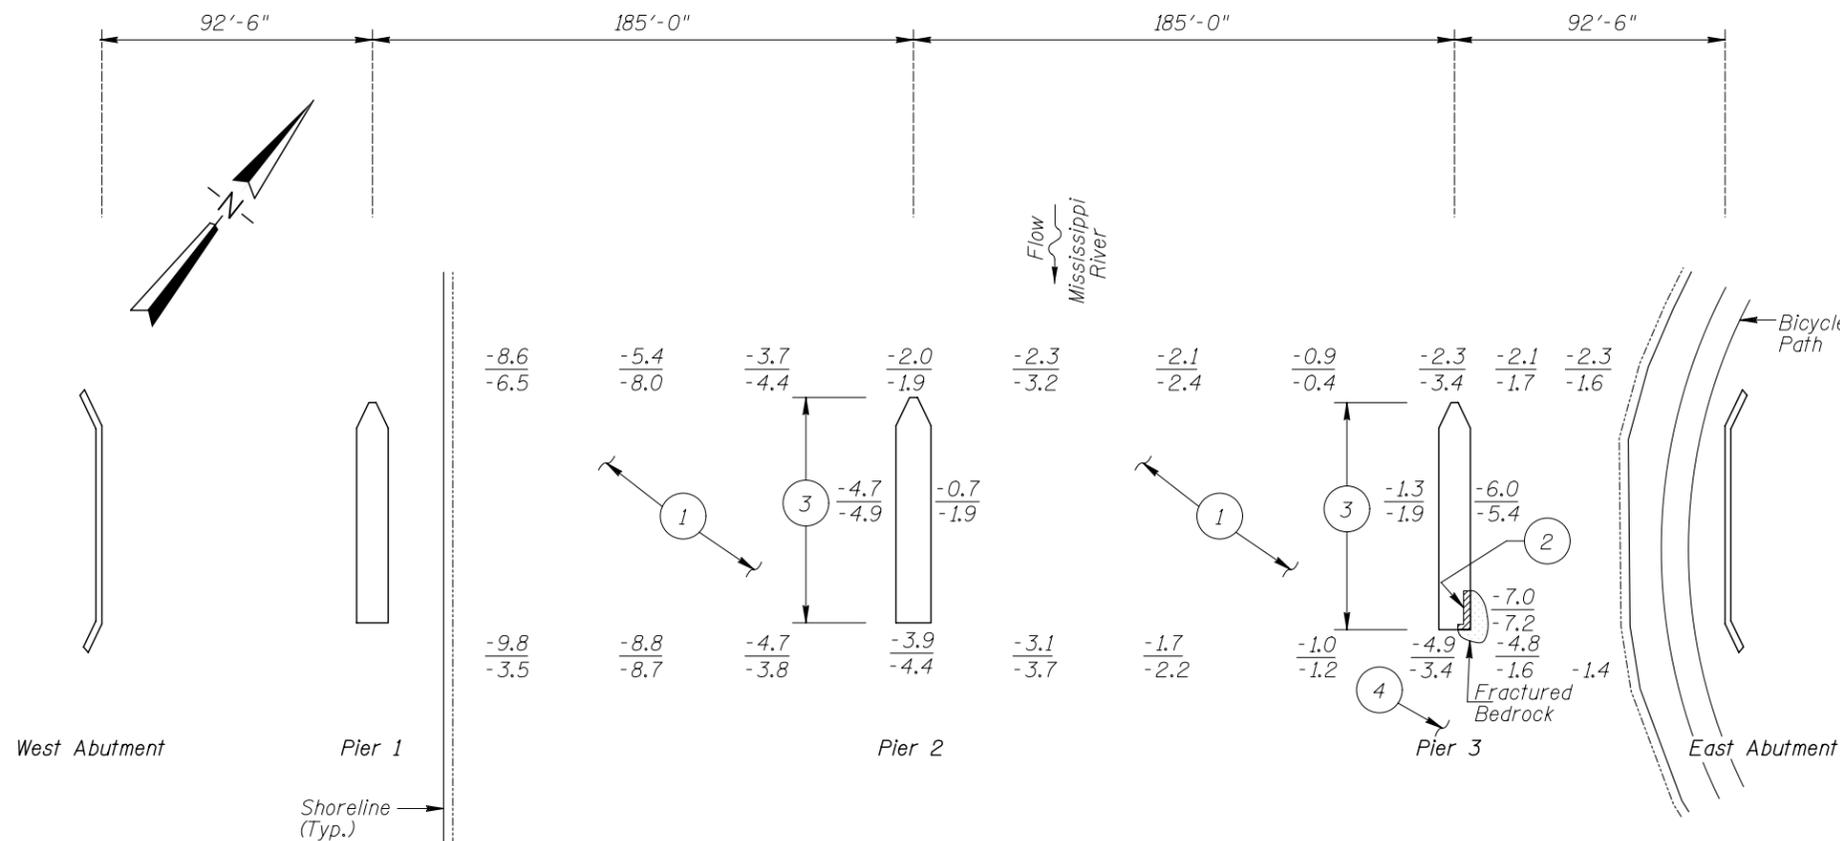
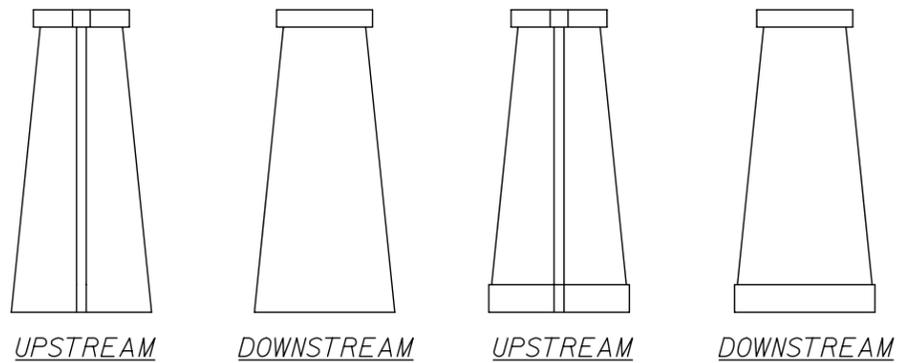
SOUNDING PLAN

- ① The channel bottom material around the entire perimeter of both piers consisted of large rocks and bedrock with no probe rod penetration.
- ② Undermining was observed at the southeast corner of Pier 3 due to an area of fractured bedrock. The undermining cavity was 1.3 feet high by 6 feet long with 3 feet of maximum horizontal penetration.
- ③ The masonry construction of both piers were observed to be in overall good condition, however, there were random areas of missing mortar up to 2 inches deep (heaviest at upstream nose).
- ④ 1- to 5-foot-diameter rocks scattered in the channel between Piers 2 and 3.
