UNDERWATER BRIDGE INSPECTION REPORT

STRUCTURE NO. 6518  
TRUNK HIGHWAY NO. 25  
OVER THE  
MISSISSIPPI RIVER  
DISTRICT 3 – CROW WING COUNTY

PREPARED FOR THE  
MINNESOTA DEPARTMENT OF TRANSPORTATION  
BY  
COLLINS ENGINEERS, INC.  
JOB NO. 5221

MINNESOTA DEPARTMENT OF TRANSPORTATION  
UNDERWATER BRIDGE INSPECTION

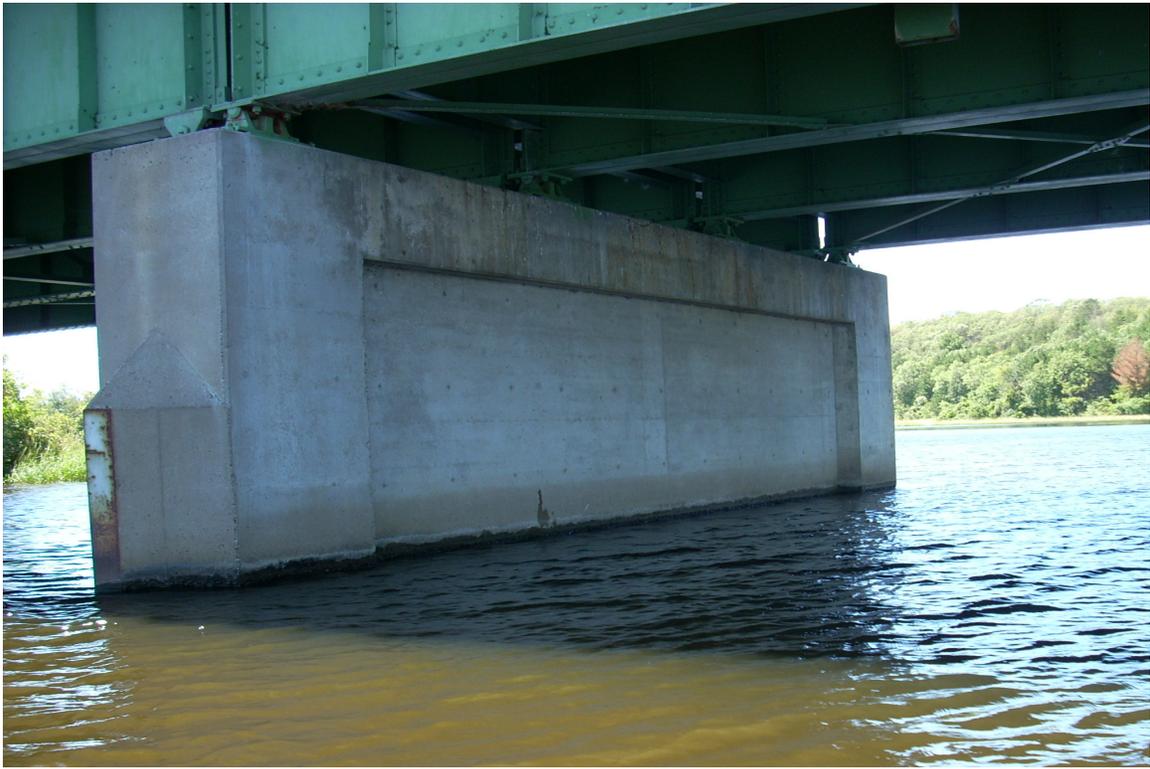
Photograph 1. View of Pier 1, Looking Southwest.

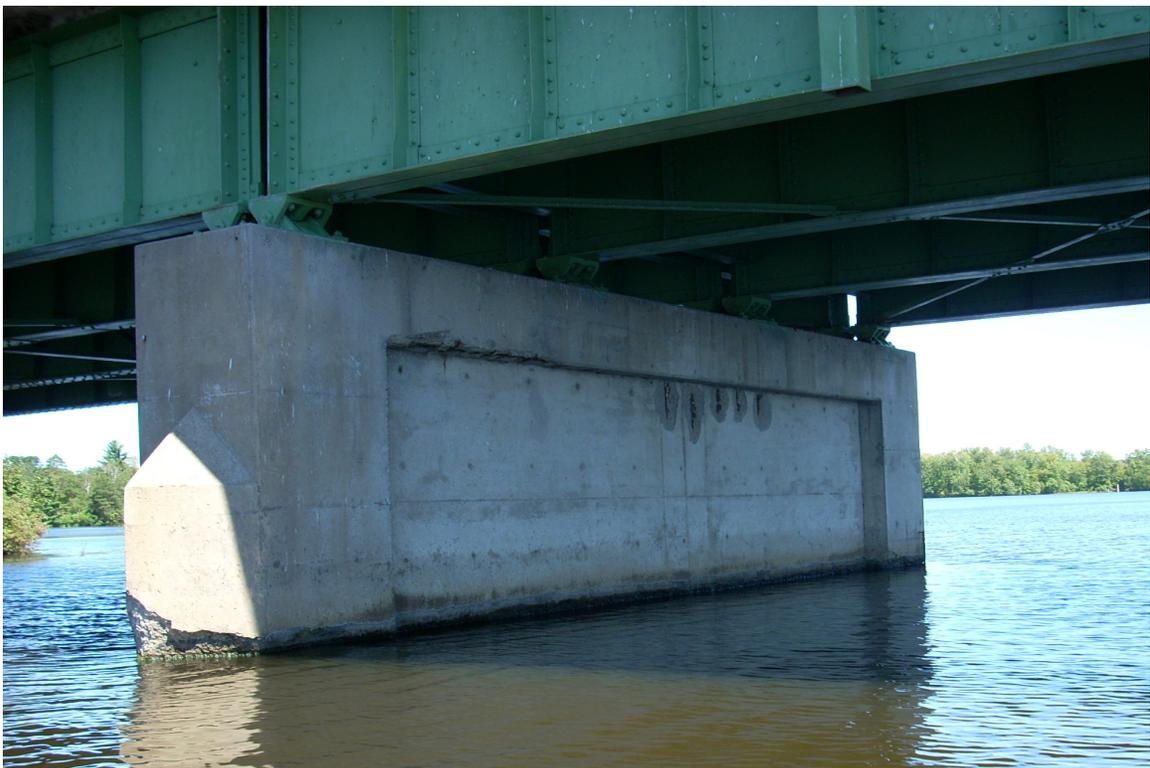
- (F) There was a moderate accumulation of timber debris at the downstream nose of Pier 2.

Photograph 2. View of Pier 2, Looking Northeast.

The accumulation of timber debris at Pier 2 should be monitored during future underwater inspections, and if found to be progressing, removal measures may be warranted at that time.

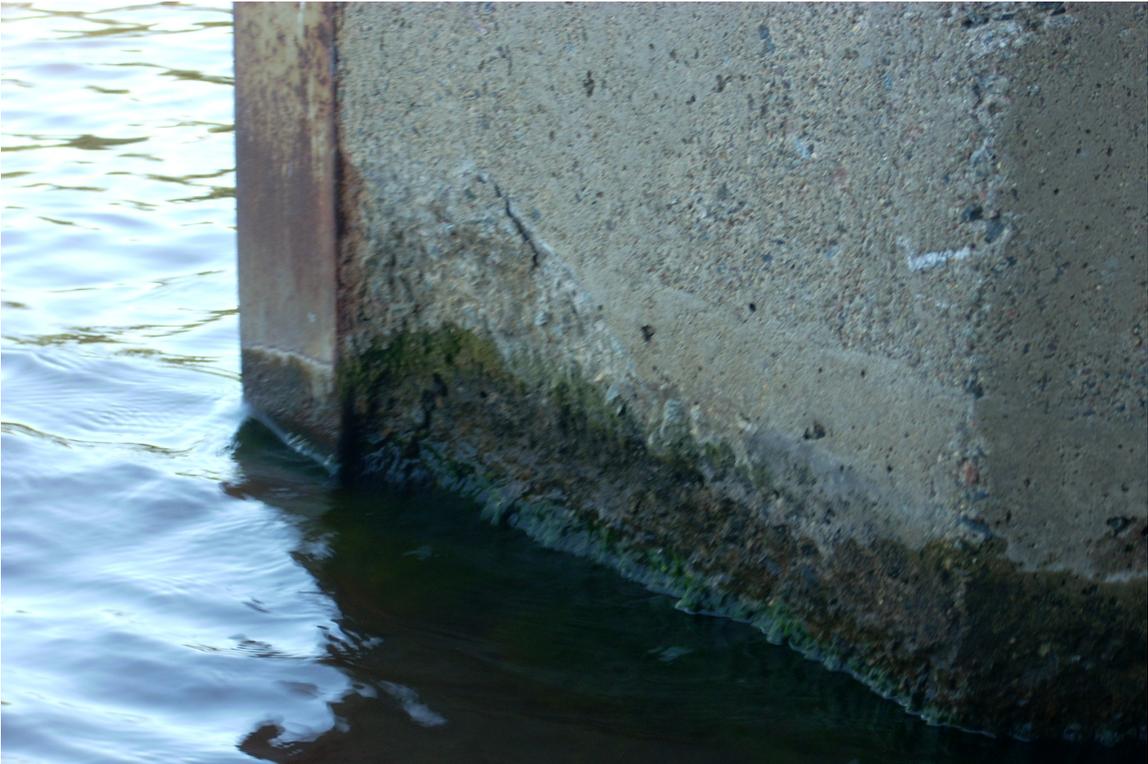
- (B) There was moderate to heavy concrete scaling on both piers, typically from 6 inches above to 2 feet below the waterline with a maximum penetration of 6 inches at the noses. Typical penetrations were up to 2 inches.

Photograph 3. Scaling at upstream nose of Pier 2, Looking Southeast.

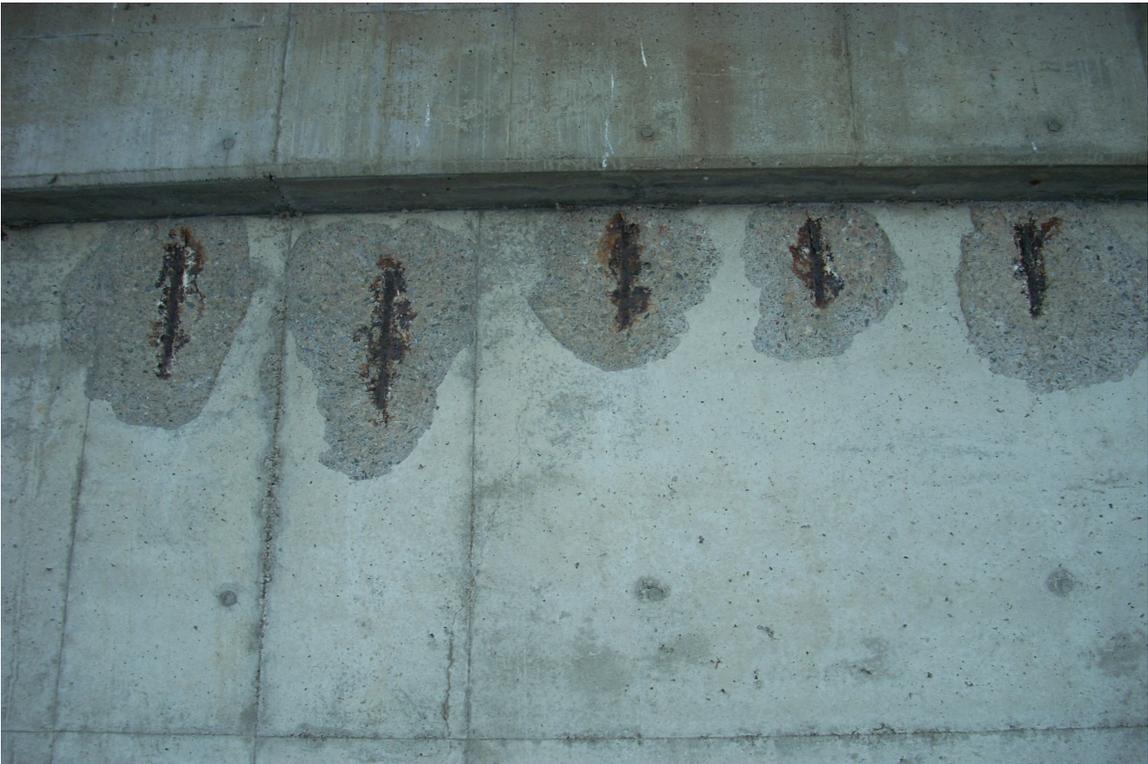
- (C) Spalls with 2 to 4 inches of penetration and exposed / corroded reinforcing steel were observed on the south face of Pier 2 from 6 feet to 8 feet above the waterline.

Photograph 4. Scaling / Spalls at the south face of Pier 2, Looking North.

Repair the spalls at Pier 2 by removing all unsound concrete, cleaning the reinforcing steel, and patching with a concrete mix designed to promote high durability and low permeability.

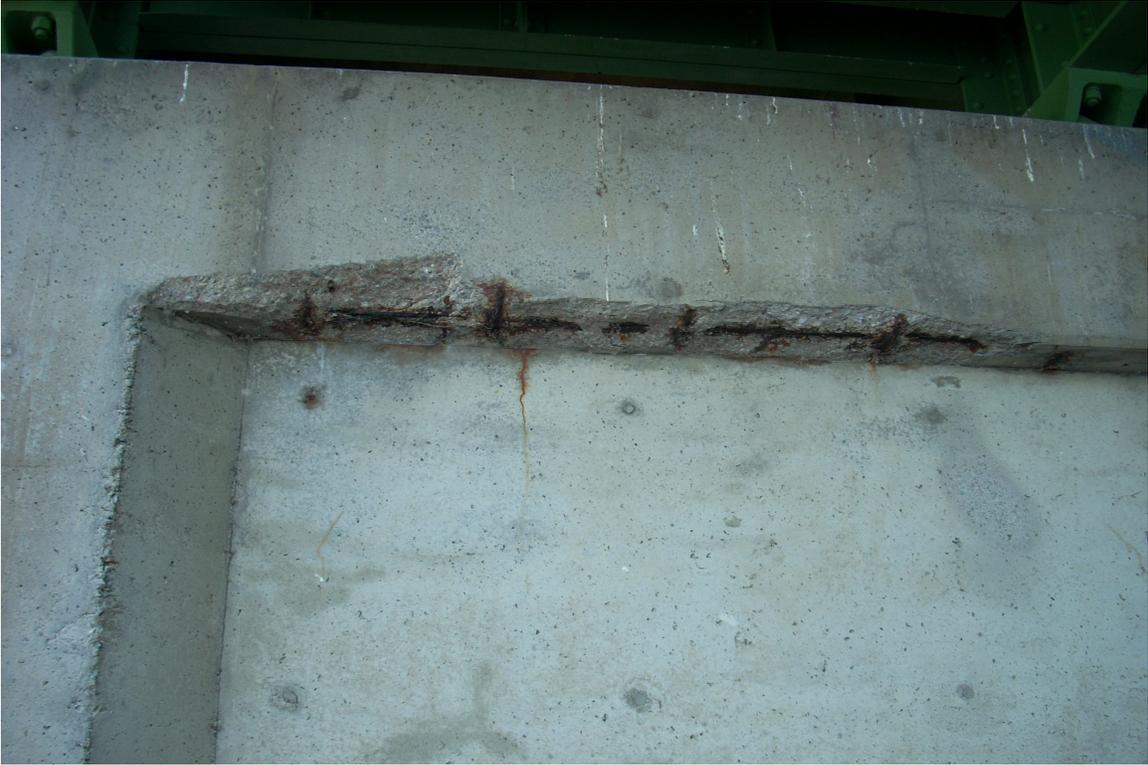
Photograph 5. Scaling/ Spalls at the south face of Pier 2 close to the upstream face, Looking North

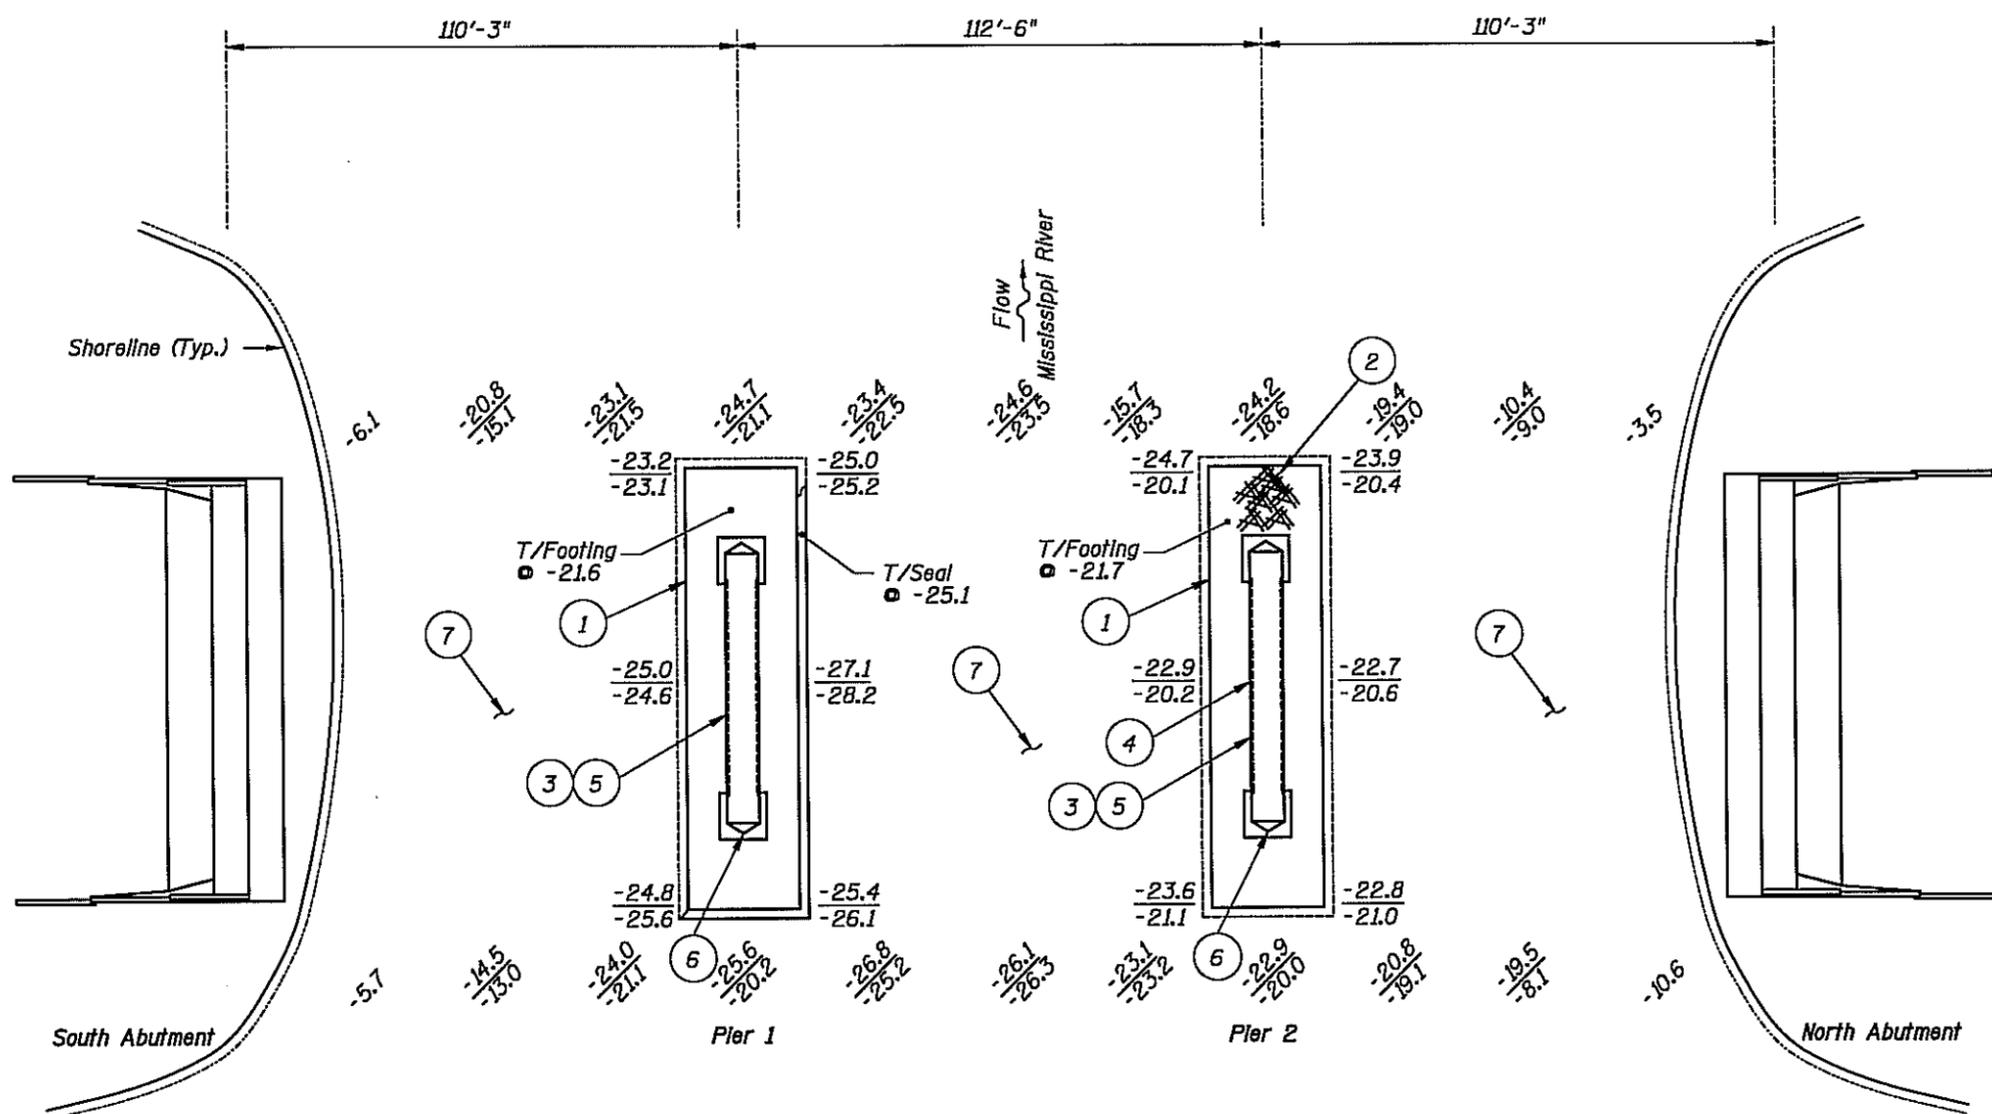
**SOUNDING PLAN**

1. There was footing exposure at both piers with a maximum vertical footing exposure of 3.5 feet and a maximum seal exposure of 2 feet (only) at Pier 1. At Pier 1, the 2 feet maximum seal exposure was at the middle of the north side. At Pier 2, the 3 feet maximum footing exposure was at the southwest corner.

2. There were logs up to 18-inch-diameter with associated branchy drift at the downstream nose of Pier 2 extending from the channel bottom up 4 feet, 10 feet long and 10 feet wide.

3. There was moderate to heavy concrete scaling on both piers, typically from 6 inches above to 3 feet below the waterline with maximum penetration of 6 inches at the noses. Typical penetrations were up to 2 inches.

4. Spalls with 2 to 4 inches of penetration and exposed reinforcing steel were observed on the south face of Pier 2 from 6 feet above to 8 feet above the waterline.

5. Above and below the scaling, the concrete of the pier faces and footings (where exposed) was typically smooth and sound with random minor areas of poor consolidation with up to 1/2 inch maximum penetration and random vertical hairline cracks from top of pier to channel bottom.

6. The steel ice breakers located at the upstream nose of both piers from 4 feet above the waterline to 6 inches below the waterline exhibited loss of coating and minor surface corrosion with no appreciable loss of section.

7. The channel bottom consisted of sand and cobbles up to 6 inches in diameter up with up to 4 inch probe rod penetration. The channel bottom was overlain by a 1 inch thick layer of fine silt.

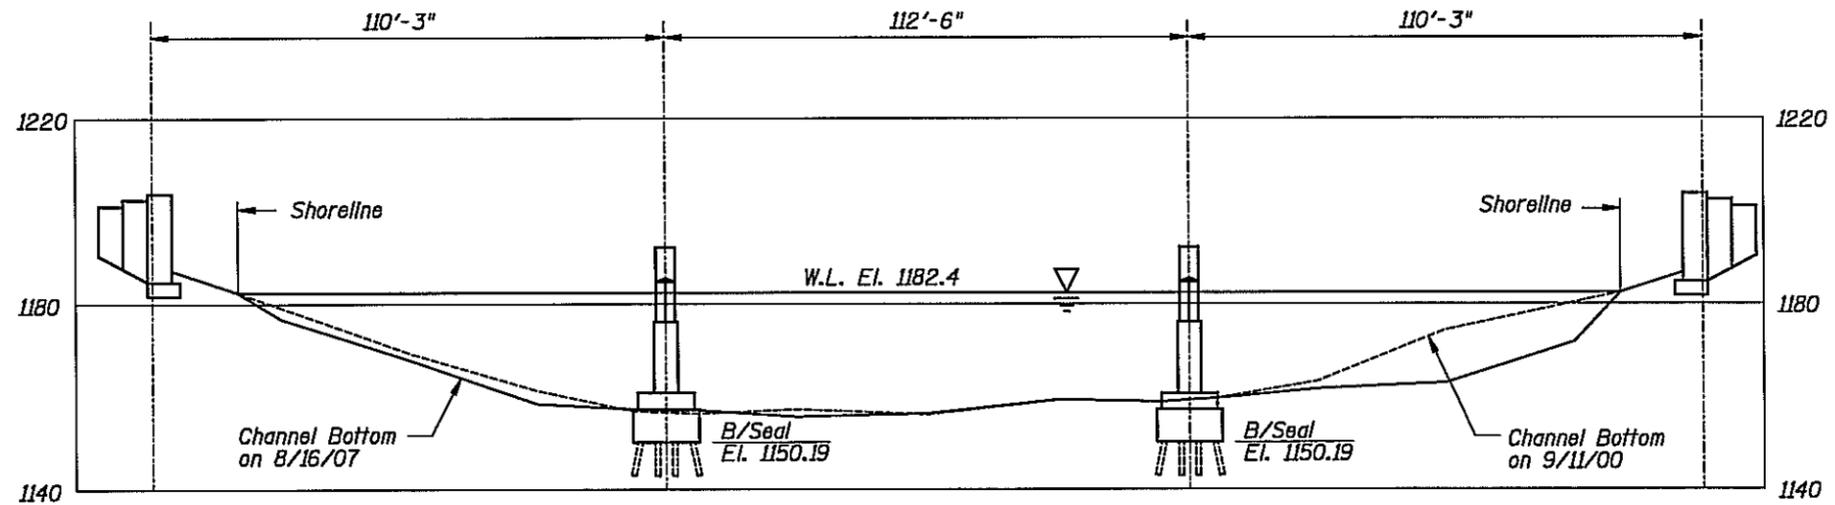
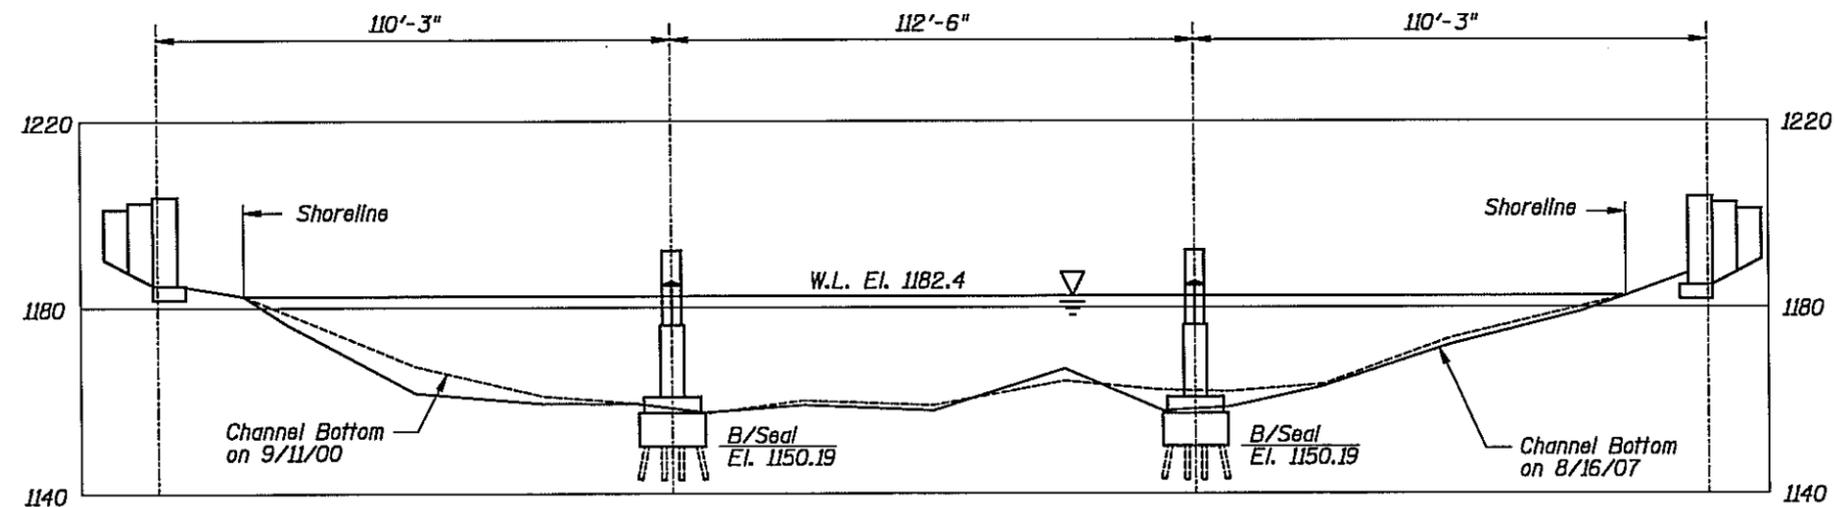
UPSTREAM FASCIA PROFILE

DOWNSTREAM FASCIA PROFILE
