UNDERWATER BRIDGE INSPECTION REPORT

STRUCTURE NO. 73510

CSAH NO. 64

SAUK RIVER

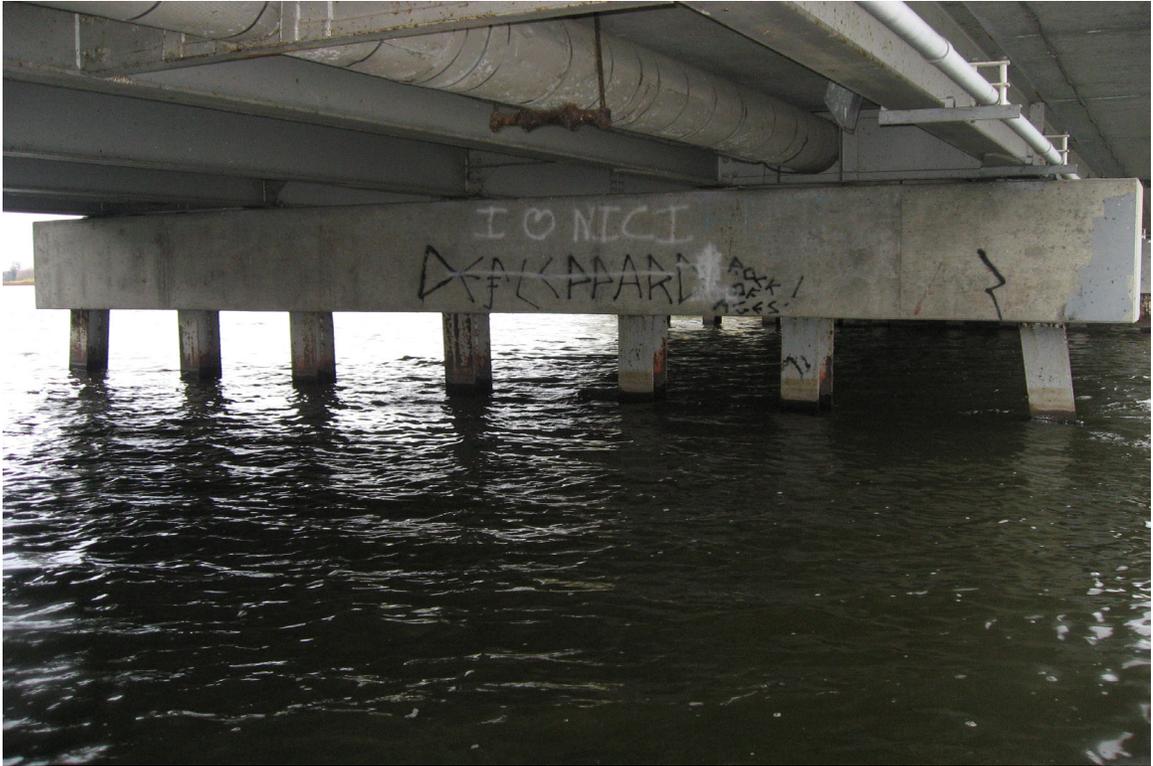
Photograph 1. View of Pier 2, Looking Southeast.

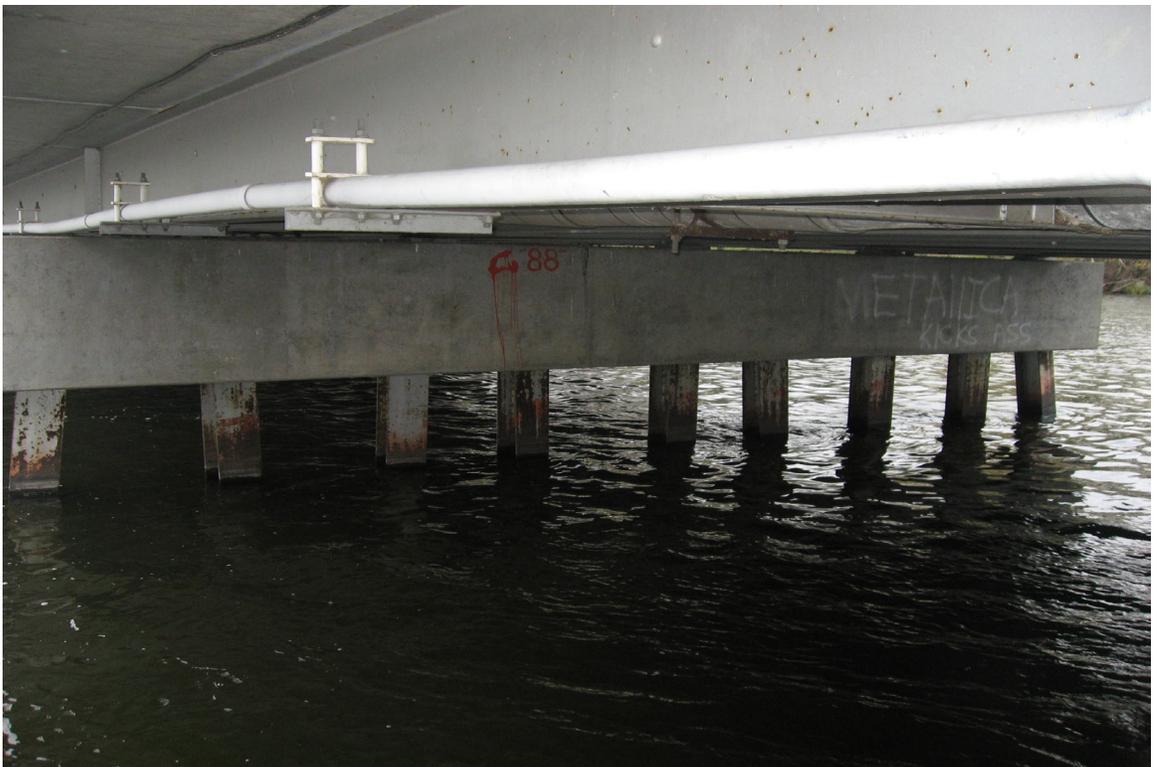
Photograph 2. View of Pier 1, Looking Northeast.

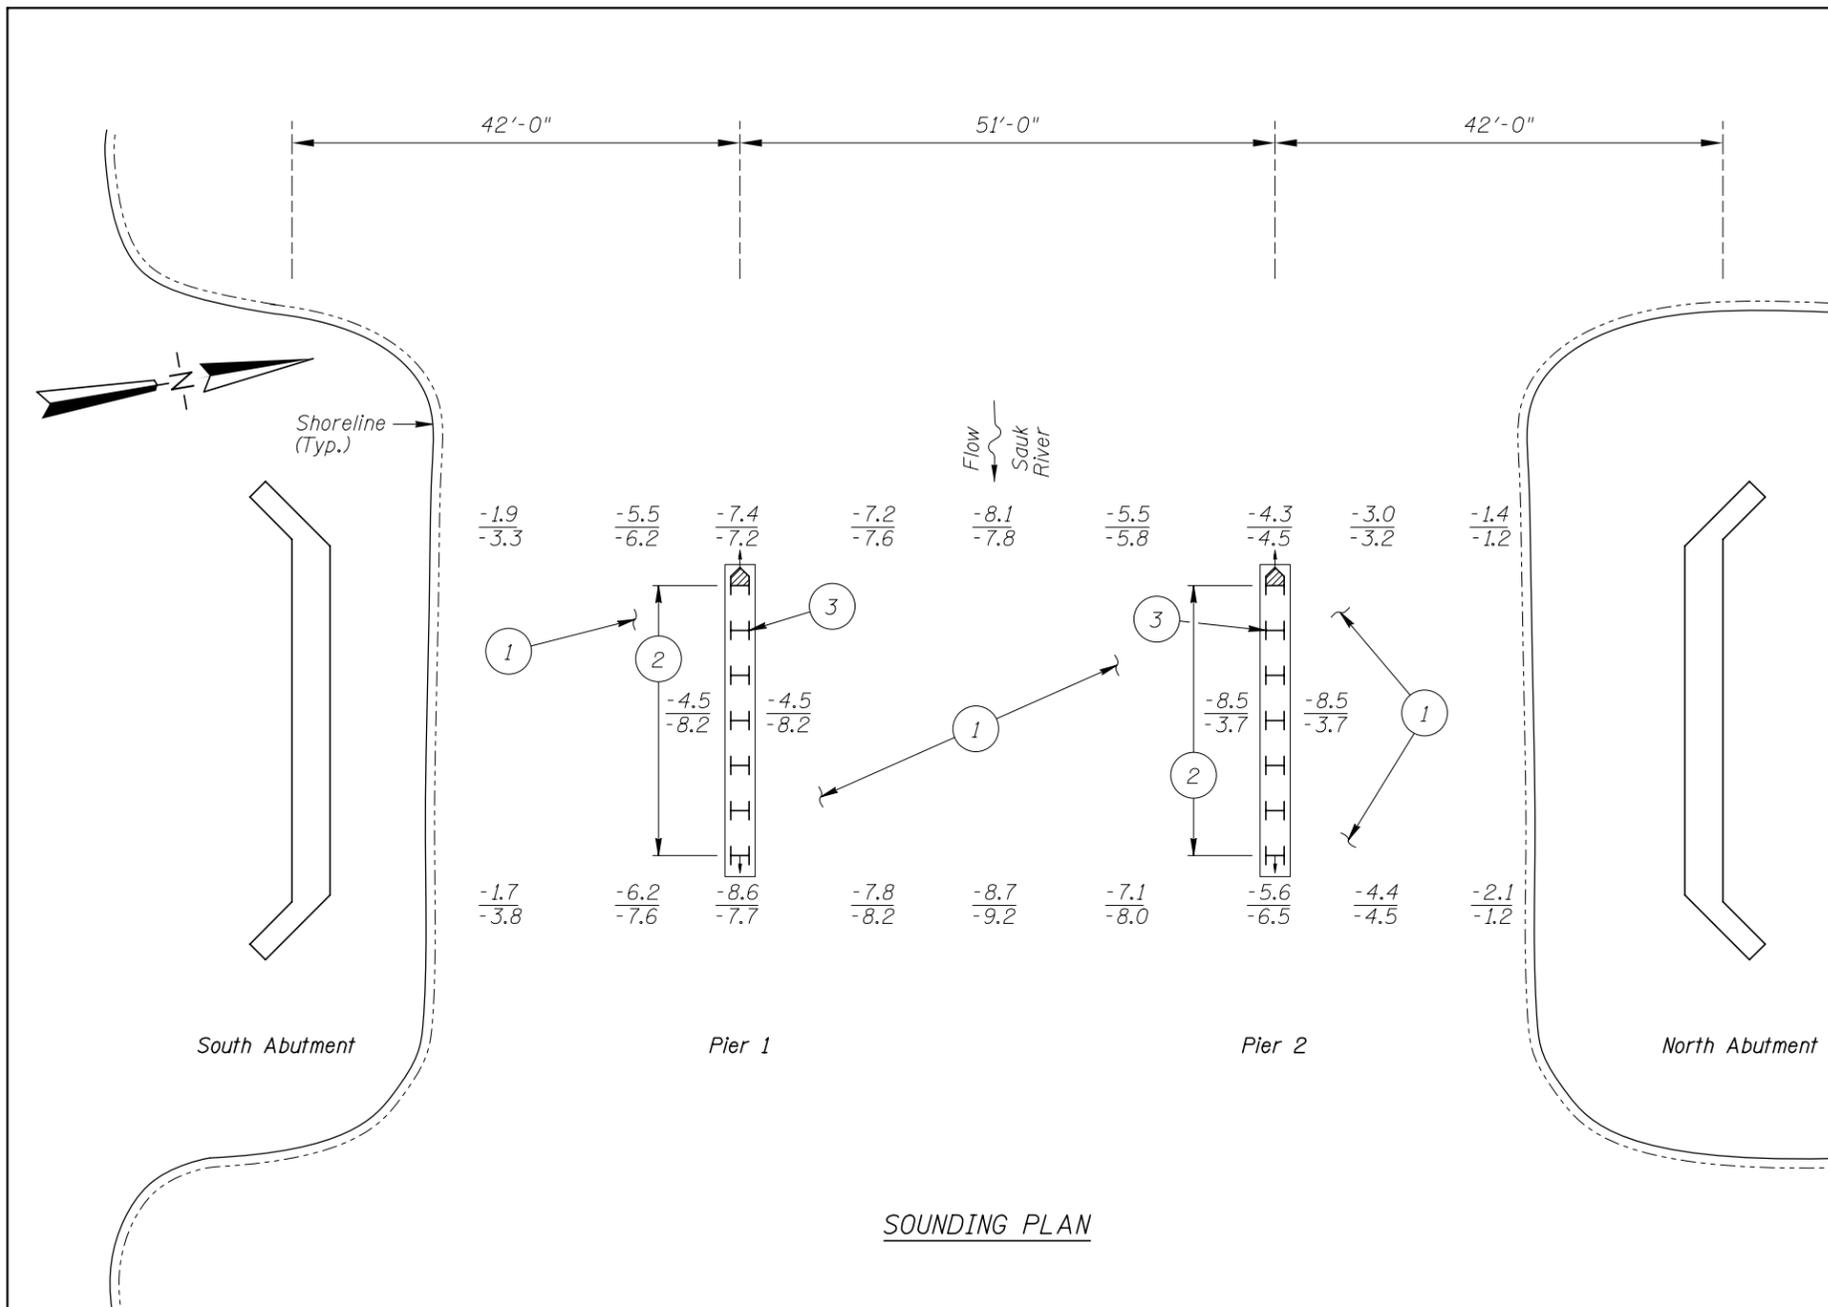
- ① The channel bottom material consisted of sand and 1 to 1.5 foot diameter rock with minimal probe rod penetration.
- ② Minor surface corrosion and light pitting in conjunction with coating failure/absence was observed on 100 percent of the surface area of the piles from 1.5 foot above to the channel bottom, with nodules 1/2 inch in diameter and 1/32 inch deep pitting on 25 to 50 percent of the surface area from the waterline to 1.5 feet above. No appreciable section loss was associated with the deterioration.
- ③ Light aquatic growth was observed on all piles below the waterline.
