UNDERWATER BRIDGE INSPECTION REPORT

STRUCTURE NO. 73536

SAUK RIVER

DISTRICT 3 - STEARNS COUNTY

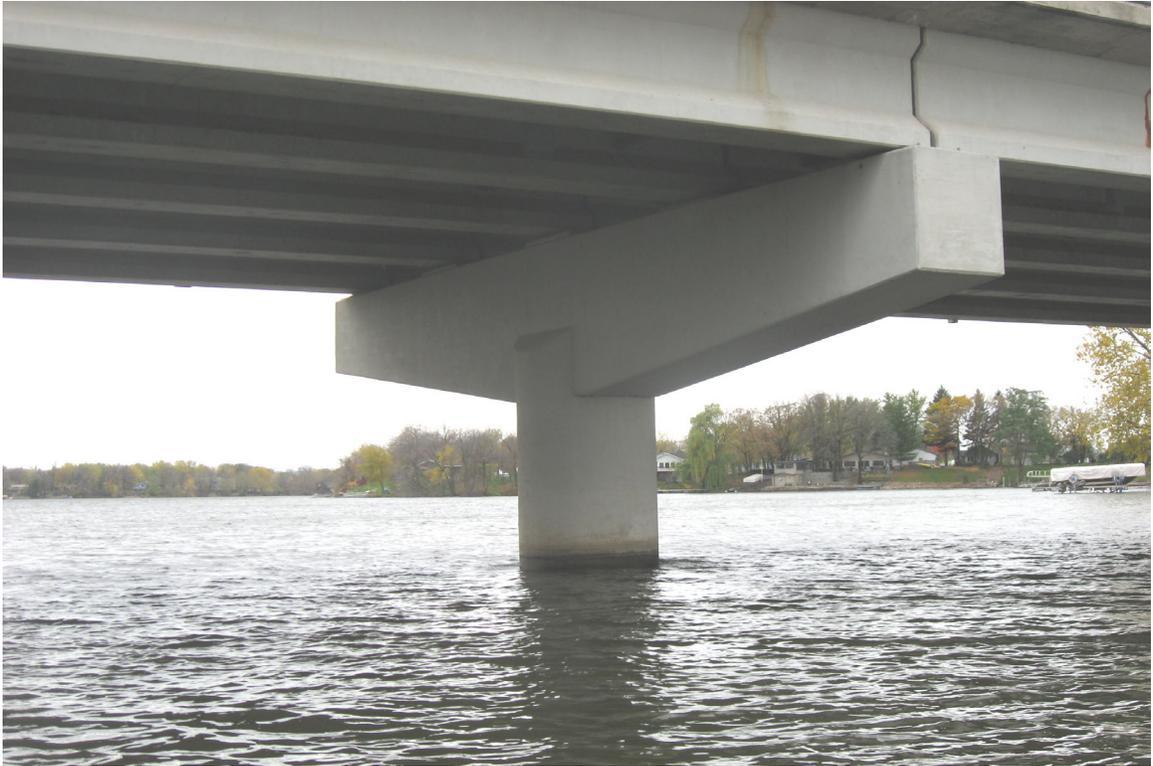
Photograph 1. View of Pier 1, Looking West.

- (A) There was minor footing exposure encountered at both piers due to localized scour depressions. The footing at Pier 1 was detected at the western corner with no vertical face exposure. The footing at Pier 2 was detected at the northern corner; again with no vertical exposure (edge could be detected). Both footings exposures were encountered through 3 inches of soft silt.

- (A) Reinspect the submerged substructure units at the normal maximum recommended (NBIS) interval of five (5) years.

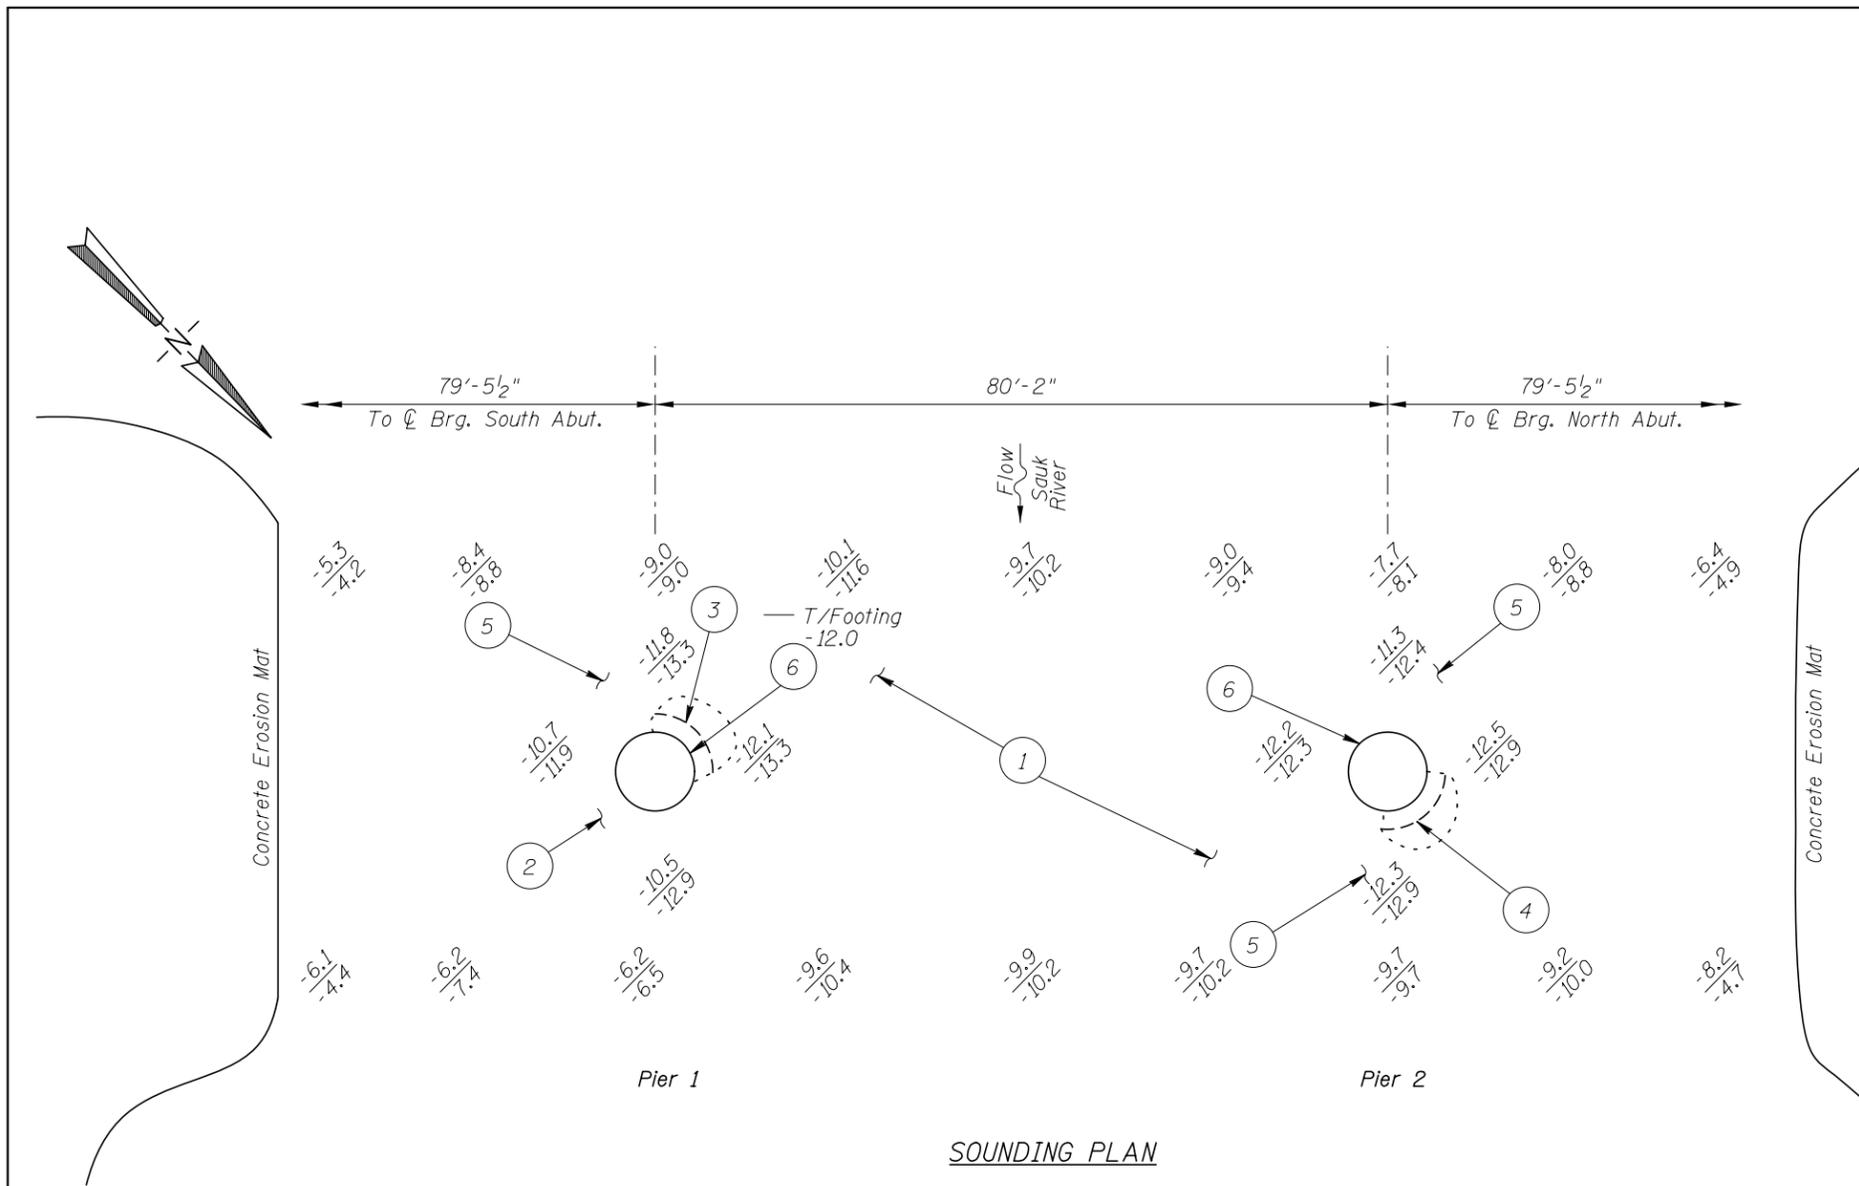
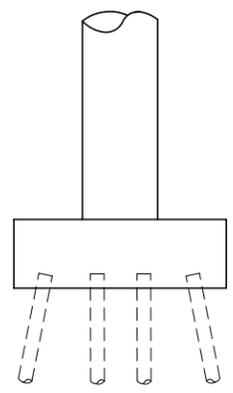
SOUNDING PLAN

- ① The channel bottom consisted of sandy gravel with up to 5 inches of probe rod penetration.
- ② The channel bottom consisted of sand with up to 8 inches of probe rod penetration.
- ③ The top of footing was detected at the western corner of Pier 1 (a 2 feet wide section) with no vertical face exposed under a 3 inch layer of silt.
- ④ The top of footing was detected around the column (a 2 feet wide section) and at the northern corner of Pier 2. The footing corner was located under a 3 inch layer of silt.
- ⑤ Localized scour pockets, 4 to 5 feet deep, were observed around the pier columns.
- ⑥ The submerged concrete was in good, sound condition with a light layer of aquatic growth observed.
