UNDERWATER BRIDGE INSPECTION REPORT

STRUCTURE NO. 73540

10TH STREET BRIDGE (MSAS NO. 101)

DISTRICT 3 - STEARNS COUNTY, CITY OF ST. CLOUD

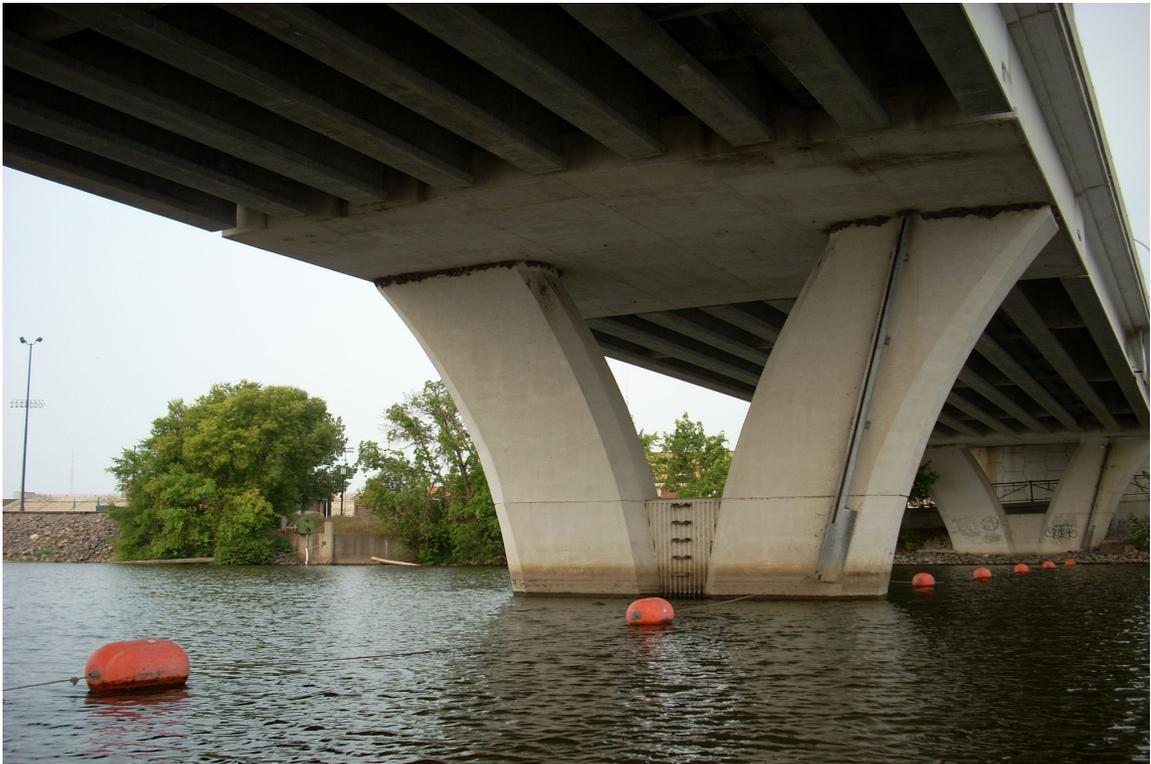
Photograph 2. View of Pier 2, Looking Southwest.

- 5 A light accumulation of 8-inch-diameter and smaller timber debris was observed around the entire perimeter of Piers 2 and 4 extending from the channel bottom to the waterline and up to 3 feet off of the noses and faces.

Remove the accumulation timber debris around the piers during routine bridge maintenance.

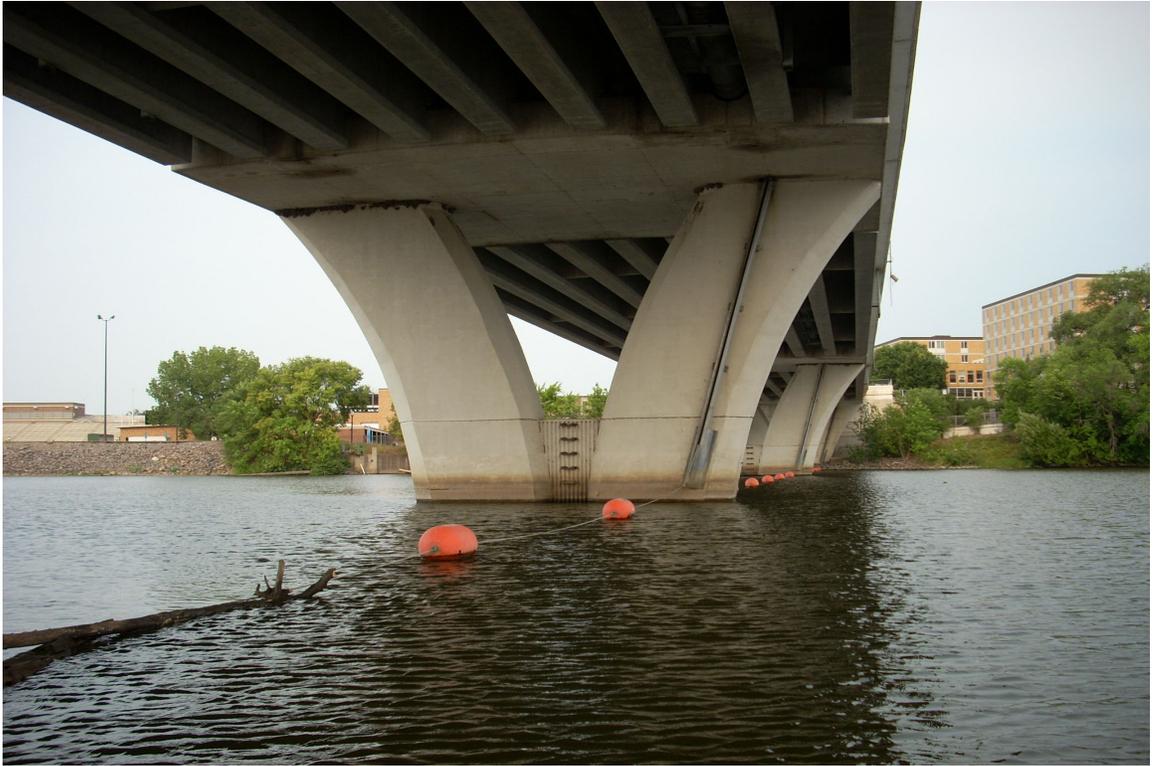
Photograph 3. View of Pier 3, Looking Southwest.

- 8 A light accumulation of timber debris, consisting of up to 8-inch-diameter branches, was observed at the upstream nose of Pier 3 from the channel bottom up 2 feet. The debris was approximately 8 feet long (E/W) by 3 feet wide (N/S).

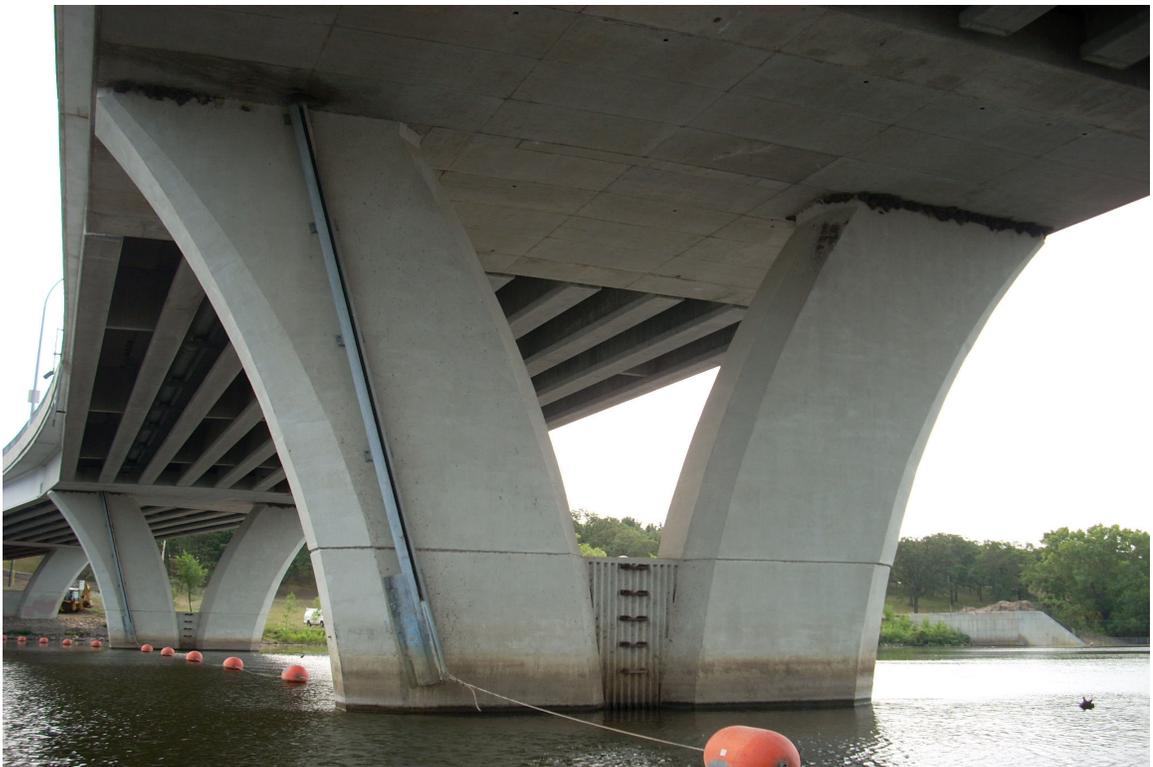
Photograph 4. View of Pier 4, Looking Southeast.

- 3 Footing exposure was observed at the upstream end of Pier 4, extending 8 feet downstream on the east and west sides of the pier with a maximum vertical face exposure of 2 feet at the upstream nose.

Scour screening assessment indicates stable rating, therefore, only monitor extent of scour and footing exposure during future inspections.

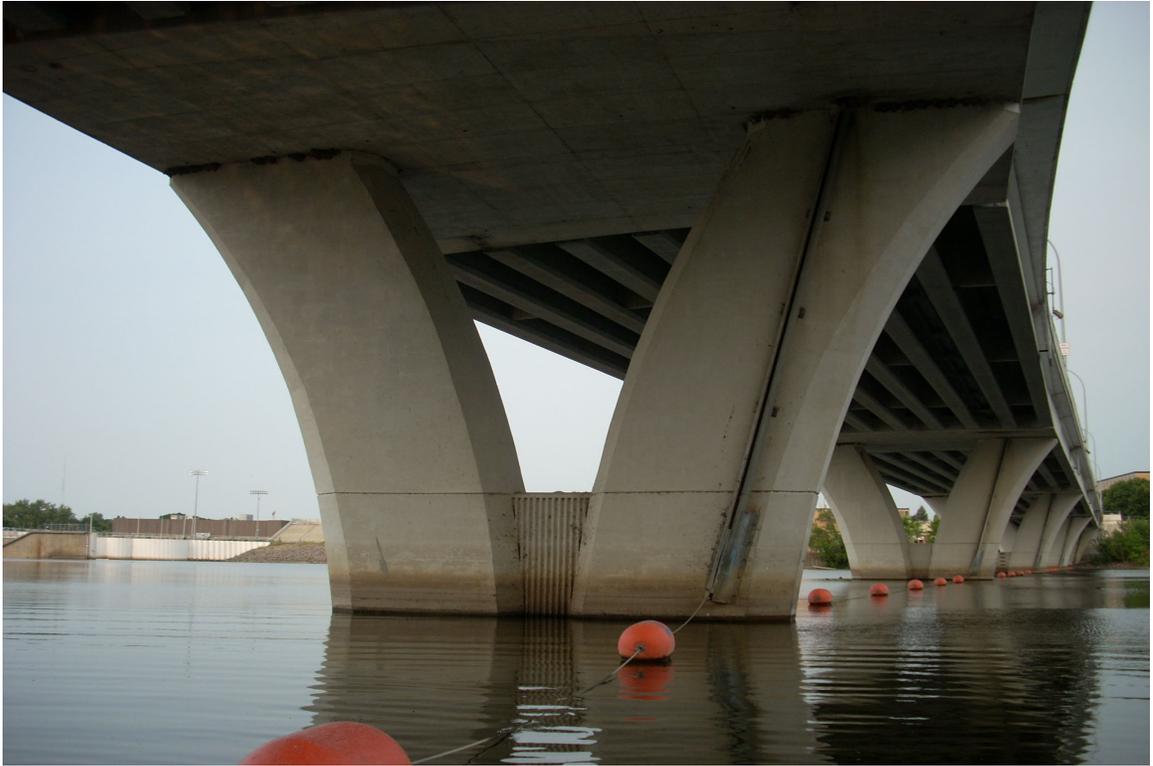
Photograph 5. View of Pier 5, Looking Southwest.

- 4 Footing exposure was observed at the upstream end of Pier 5, extending 5 feet downstream on both sides of the pier, with a maximum vertical face exposure of 3 feet at the upstream nose.

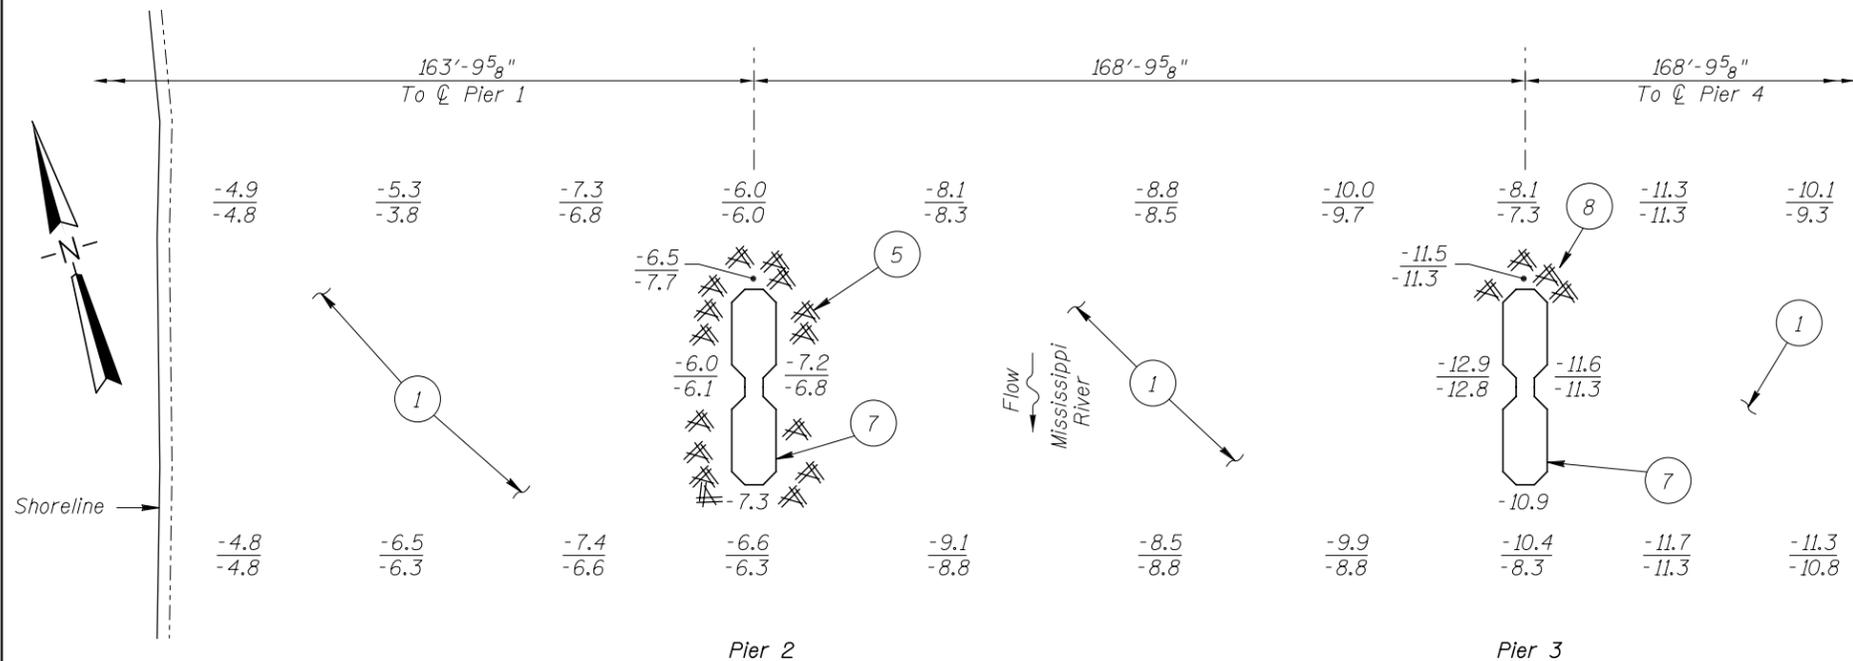
SOUNDING PLAN

- 1 The channel bottom material consisted of sandy gravel and random cobbles with a maximum probe rod penetration of 6 inches.
- 2 The channel bottom material consisted of silt with a maximum probe rod penetration of 2 feet at the upstream end of Pier 5.

- 6 Minor scour depressions, typically 5 foot in radius and 2 to 3 feet deep, were observed around the upstream ends of all the piers, resulting in footing exposure at Piers 4 and 5.

- 7 The submerged concrete of the piers and exposed footings was in smooth and sound condition with minor random areas of poor consolidation with 1/4 inch maximum penetration.
