UNDERWATER BRIDGE INSPECTION REPORT

STRUCTURE NO. 86515
CSAH NO. 42
OVER THE
MISSISSIPPI RIVER
DISTRICT 3 - WRIGHT COUNTY

PREPARED FOR THE
MINNESOTA DEPARTMENT OF TRANSPORTATION
BY
COLLINS ENGINEERS, INC.
JOB NO. 5221 (CEI 102)

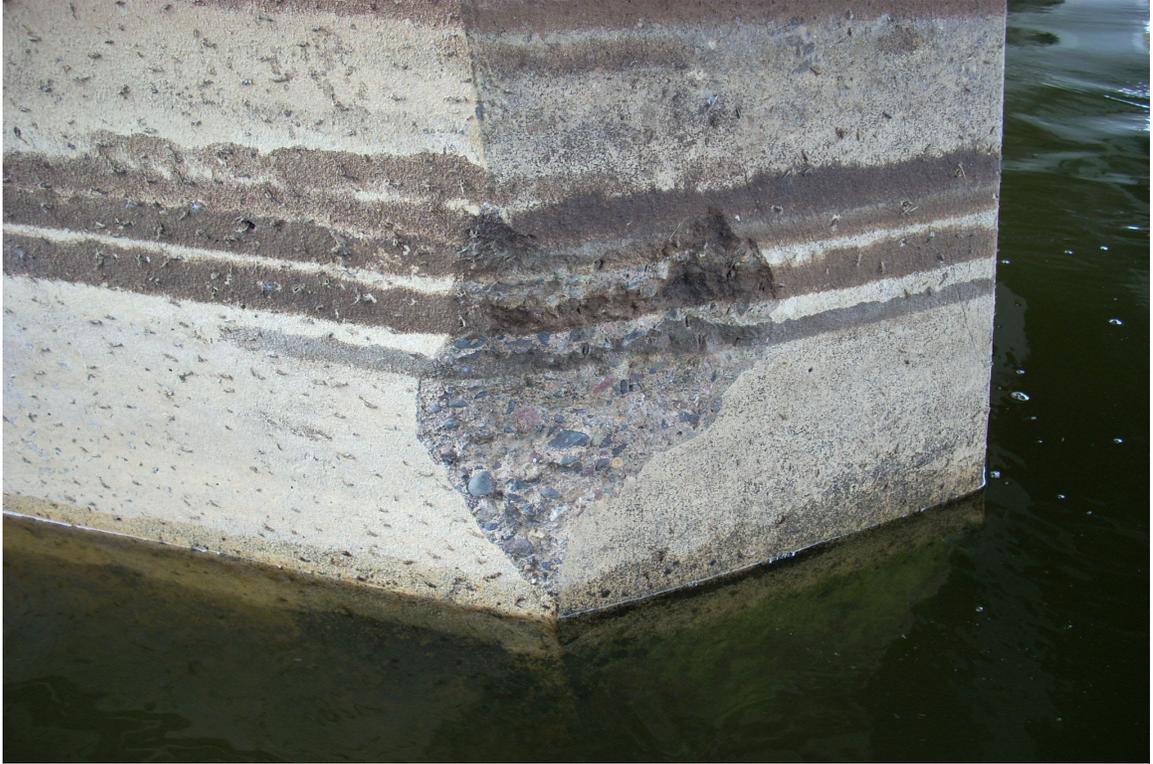
Photograph 5. View of area of impact damage at the Southeast Corner of the Upstream Column of Pier 2, Looking Northwest.

- ⑨ The concrete of the columns and webwalls (Piers 1 through 3) and footing (Pier 3) was typically smooth and sound with random, minor areas of poor consolidation with penetration up to 1/2 inch.
- ⑩ Area of impact damage observed in the South-East corner of the upstream column of Pier 2. The impact damage extended from waterline to 1 foot above. It was 8 inches wide and exhibited a maximum penetration of 1 inch with no exposed rebar.

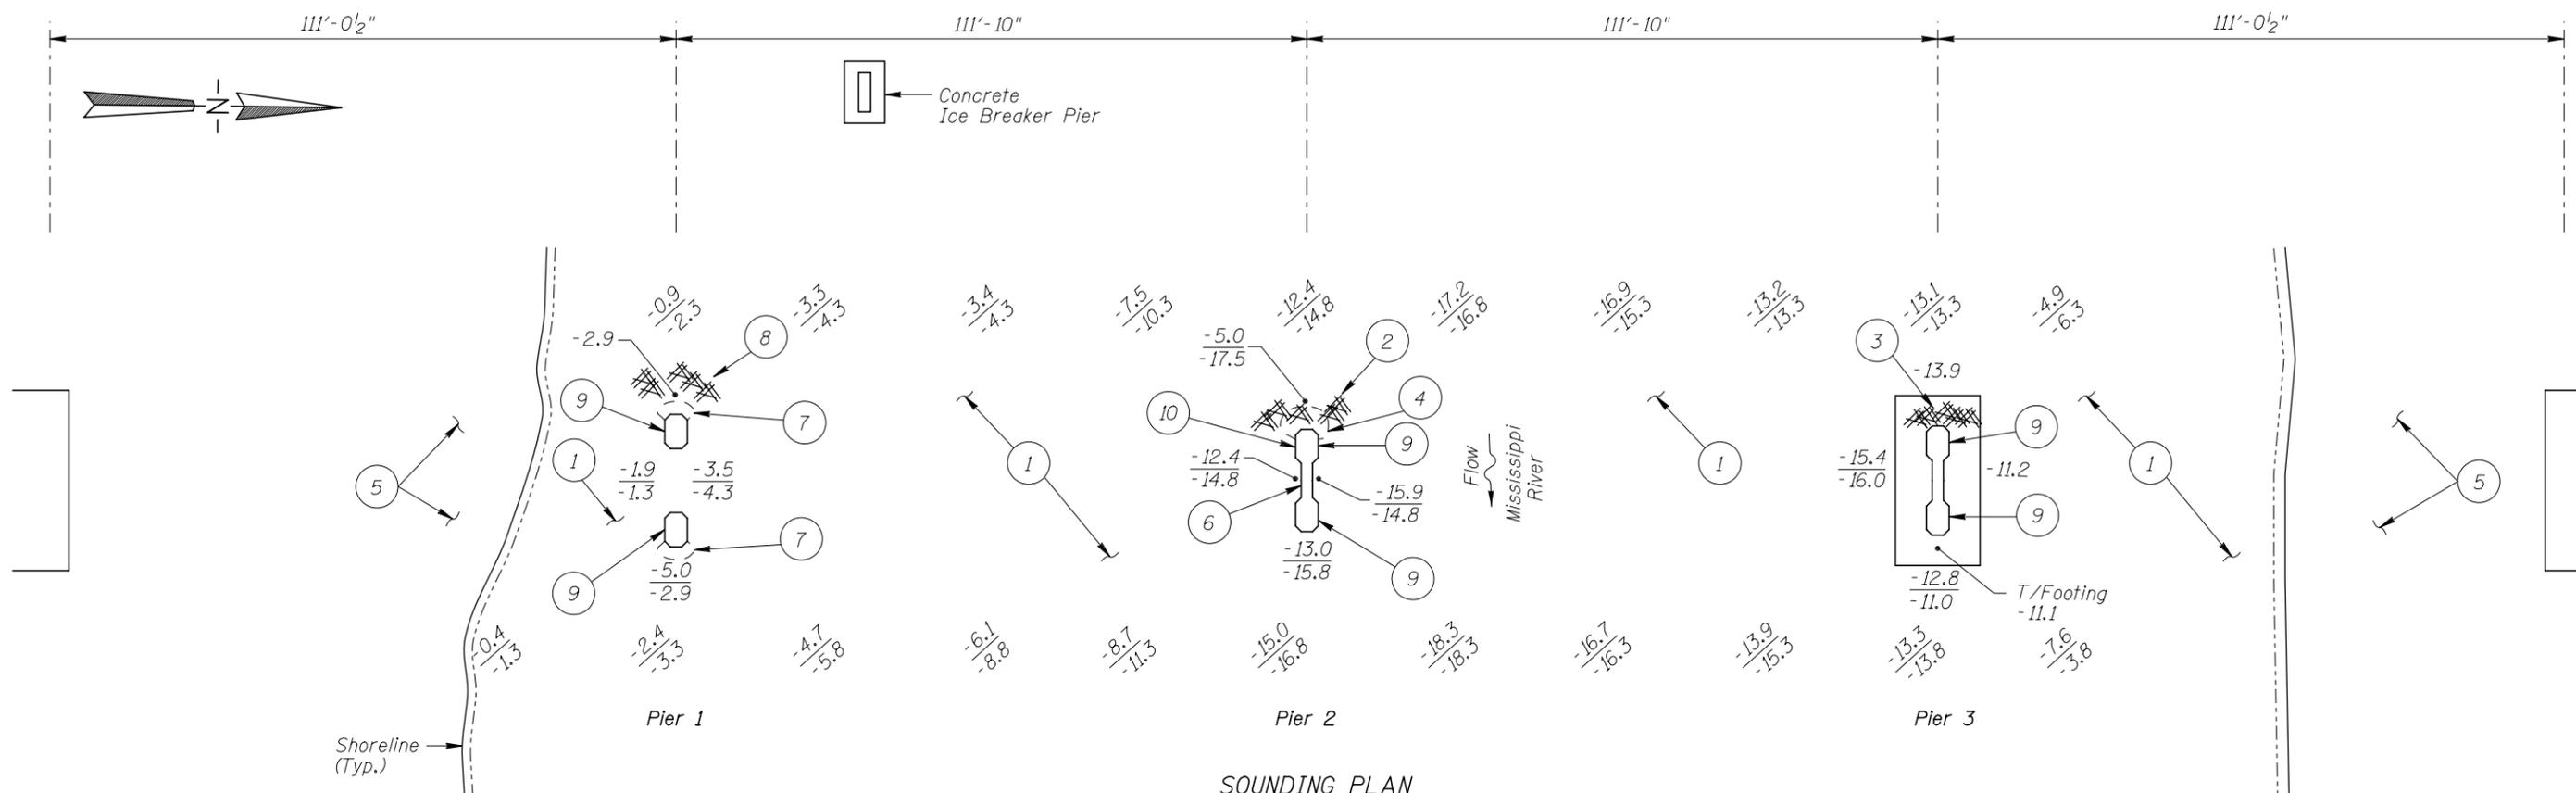
SOUNDING PLAN

- ① The channel bottom material consisted of sand, gravel and scattered cobbles, 1-foot-diameter and smaller, with up to 1 foot of probe rod penetration.

- ② A light accumulation of timber debris consisting of logs 1-foot-diameter or smaller was observed at the upstream nose of Pier 2. Accumulation extended from channel bottom up 2 feet, 5 feet long in the North-South direction by 3 feet wide in the East-West direction.

- ③ A moderate accumulation of 2-foot-diameter and smaller timber debris was observed at the upstream nose of the pier extending from the channel bottom up 4 feet, 10 feet long in the North-South direction and 4 feet wide in the East-West direction.

- ④ A 4-foot-radius, 1.5-foot-deep scour pocket was observed at the upstream nose of the Pier 2.
- ⑤ The embankments consisted of 1- to 2-foot-diameter cobbles.

- ⑥ A horizontal steel H-pile strut was observed 3 feet below the top of web wall and protruded 4 inches from each side of the web wall. There was no associated spalling present.

- ⑦ 1-foot-deep scour pocket was observed around the entire perimeter of both the upstream and downstream columns of Pier 1. The pockets typically extended up to 4 feet off the column faces.

- ⑧ A light accumulation of 10-inch-diameter and smaller timber debris was observed at the upstream end of the Pier 1. The debris extended from channel bottom to 2 feet above waterline and was approximately 5 feet wide in the East-West direction by 15 feet long in the North-South direction.

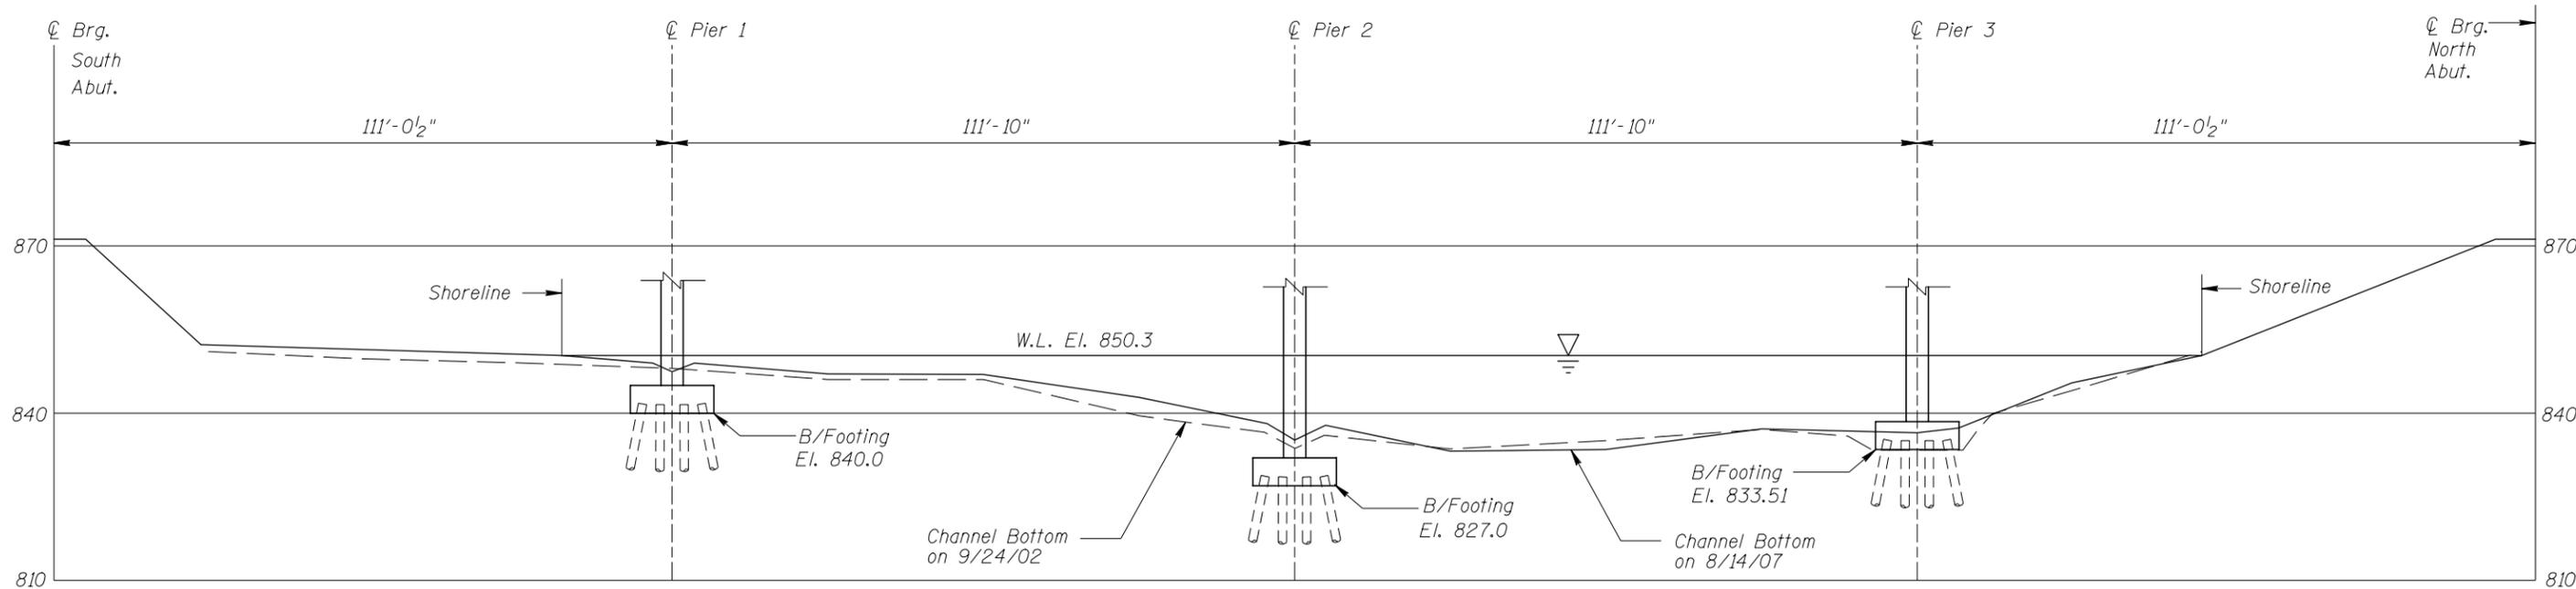
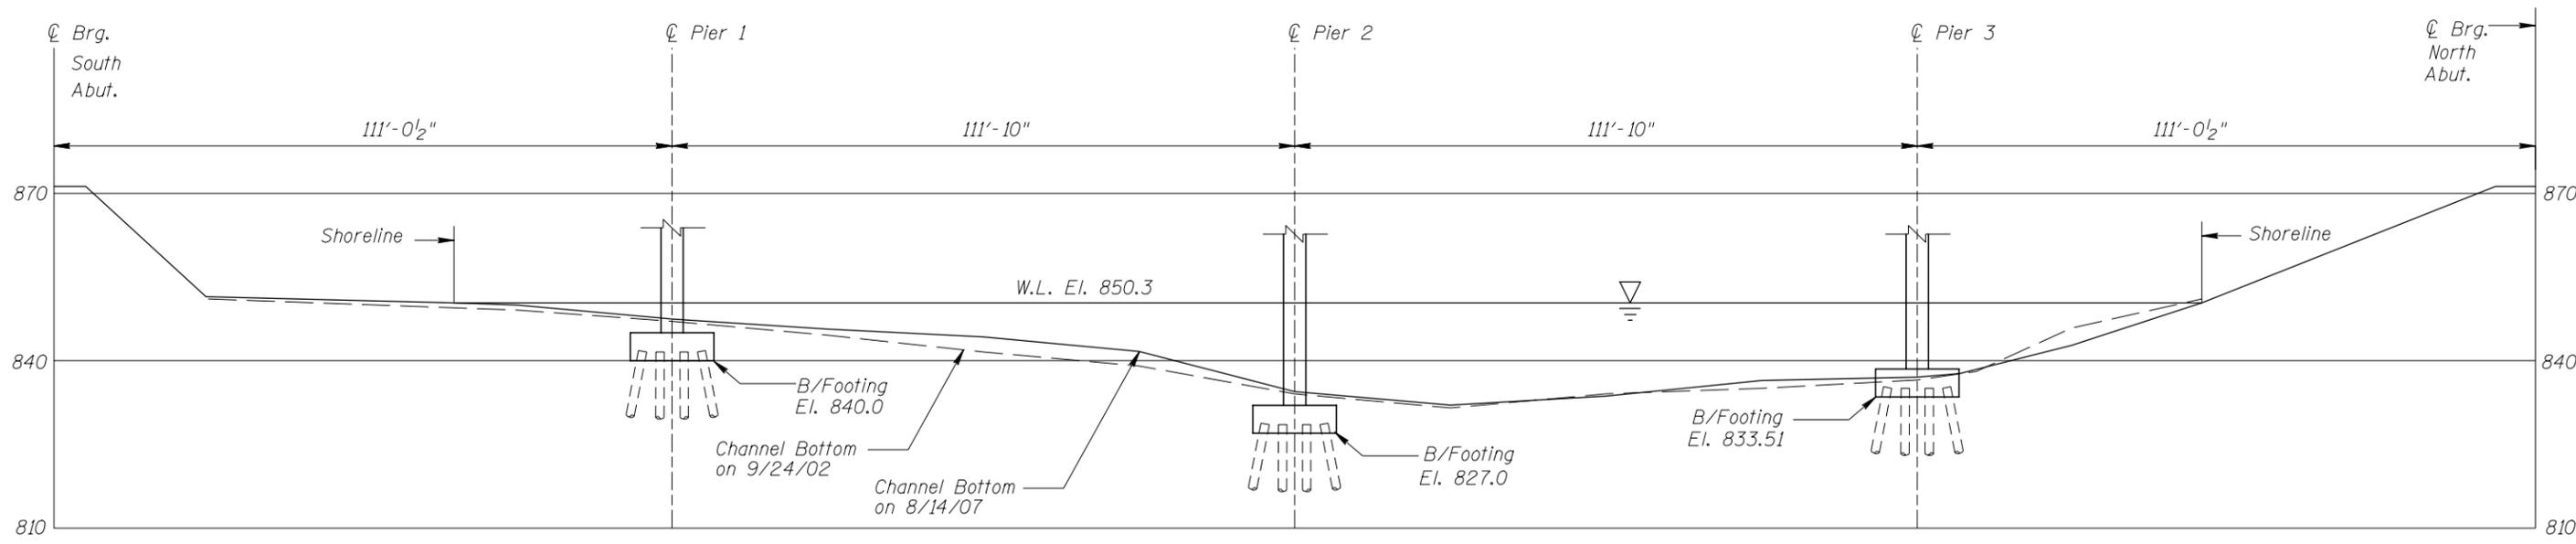
- (A) The concrete of Piers 1 through 3 was typically smooth and sound with random minor areas of poor consolidation with up to 1/2 inch penetration.
- (B) Light to moderate accumulations of timber debris were observed around the upstream noses of Piers 1, 2 and 3.
- (C) Since the previous inspection, a 4-foot-radius by 1.5-foot-deep scour depression has developed at the upstream end of Pier 2. There was also a 1-foot-deep scour depression around the entire perimeter of both the upstream and downstream columns of Pier 1.
- (D) The top of the footing was exposed at 11.1 feet below water line around the entire perimeter of Pier 3. The maximum vertical exposure was 4.3 feet at the midpoint of the south face. No undermining was observed.
