UNDERWATER BRIDGE INSPECTION REPORT

STRUCTURE NO. 01506
CSAH NO. 1, (410th AVE)
OVER THE
MISSISSIPPI RIVER
DISTRICT 3 – AITKIN COUNTY

OCTOBER 23, 2012

BY
COLLINS ENGINEERS, INC.

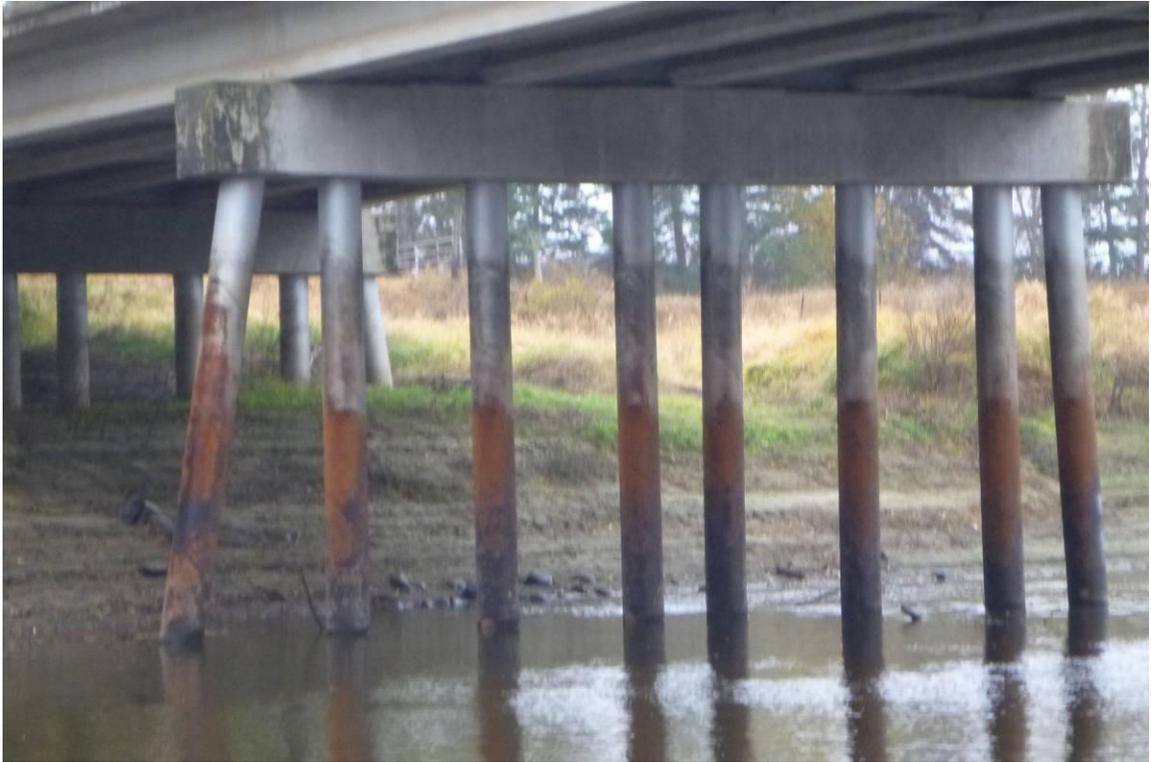
Photograph 1. View of Pier 2, Looking Southwest.

- (A) The channel bottom material around Pier 2 consisted of silty sand allowing 6 to 8 inches of probe rod penetration.
- (B) The channel bottom material around Pier 3 consisted of soft silt allowing up to 8 inches of probe rod penetration.

- (C) The steel pipe piles exhibited 100 percent coating failure with light to moderate corrosion and minor rust nodules with up to 1/8 inch deep pitting (1/16 inch typical) over 50 percent of the surface area from 8 feet to 2 feet above the waterline, and on 100% of the surface area below water.

- (D) The steel pipe piles at Pier 3 exhibited 1/16 inch thick rust delaminations due to corrosion from the waterline to the channel bottom.
- (E) A moderate accumulation of timber debris consisting of 1 foot diameter and smaller logs and branches was observed along the entire length of Pier 2 (heaviest at upstream nose) extending from channel bottom to the waterline.

- (A) Monitor timber debris accumulations around the piles at Piers 2 and 3 during future inspections, and if found to be progressing, removal may become warranted, to eliminate excessive lateral loads on piers and the potential for scour.

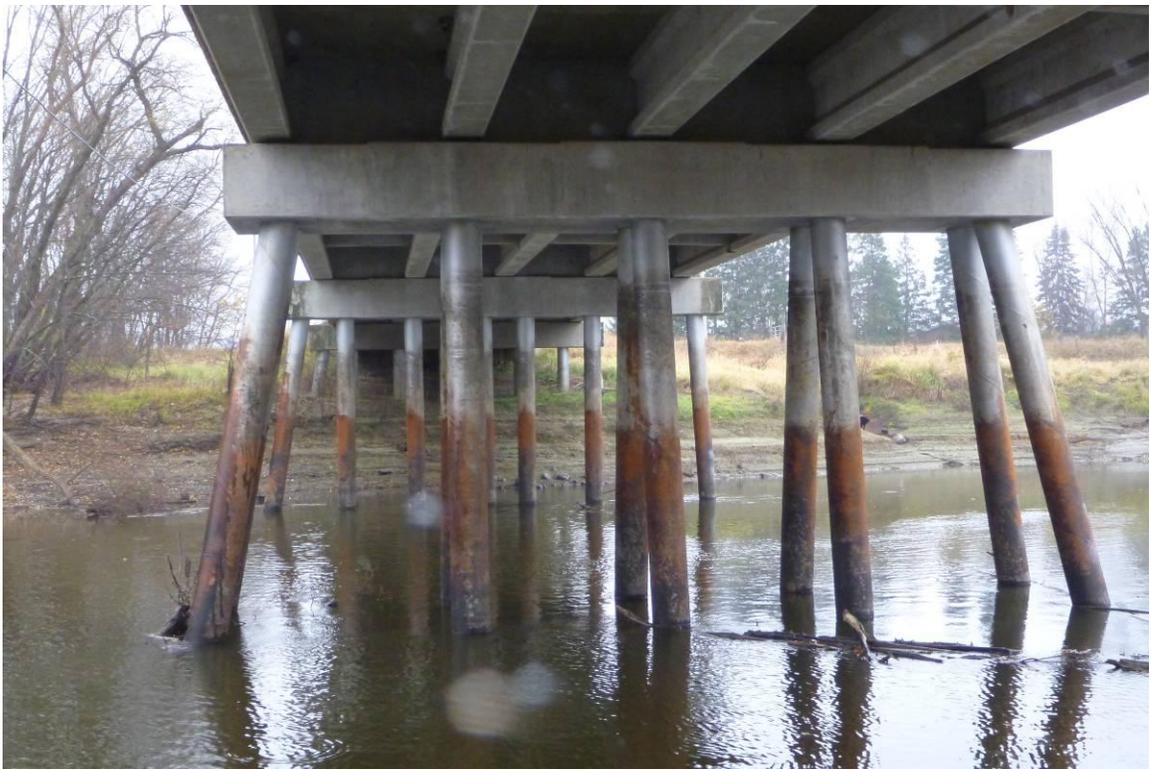
Photograph 2. View of Pier 3, Looking South.

- (F) A moderate accumulation of timber debris consisting of 1 foot diameter and smaller logs and branches was observed scattered throughout Pier 3, extending from channel

bottom up 10 feet.

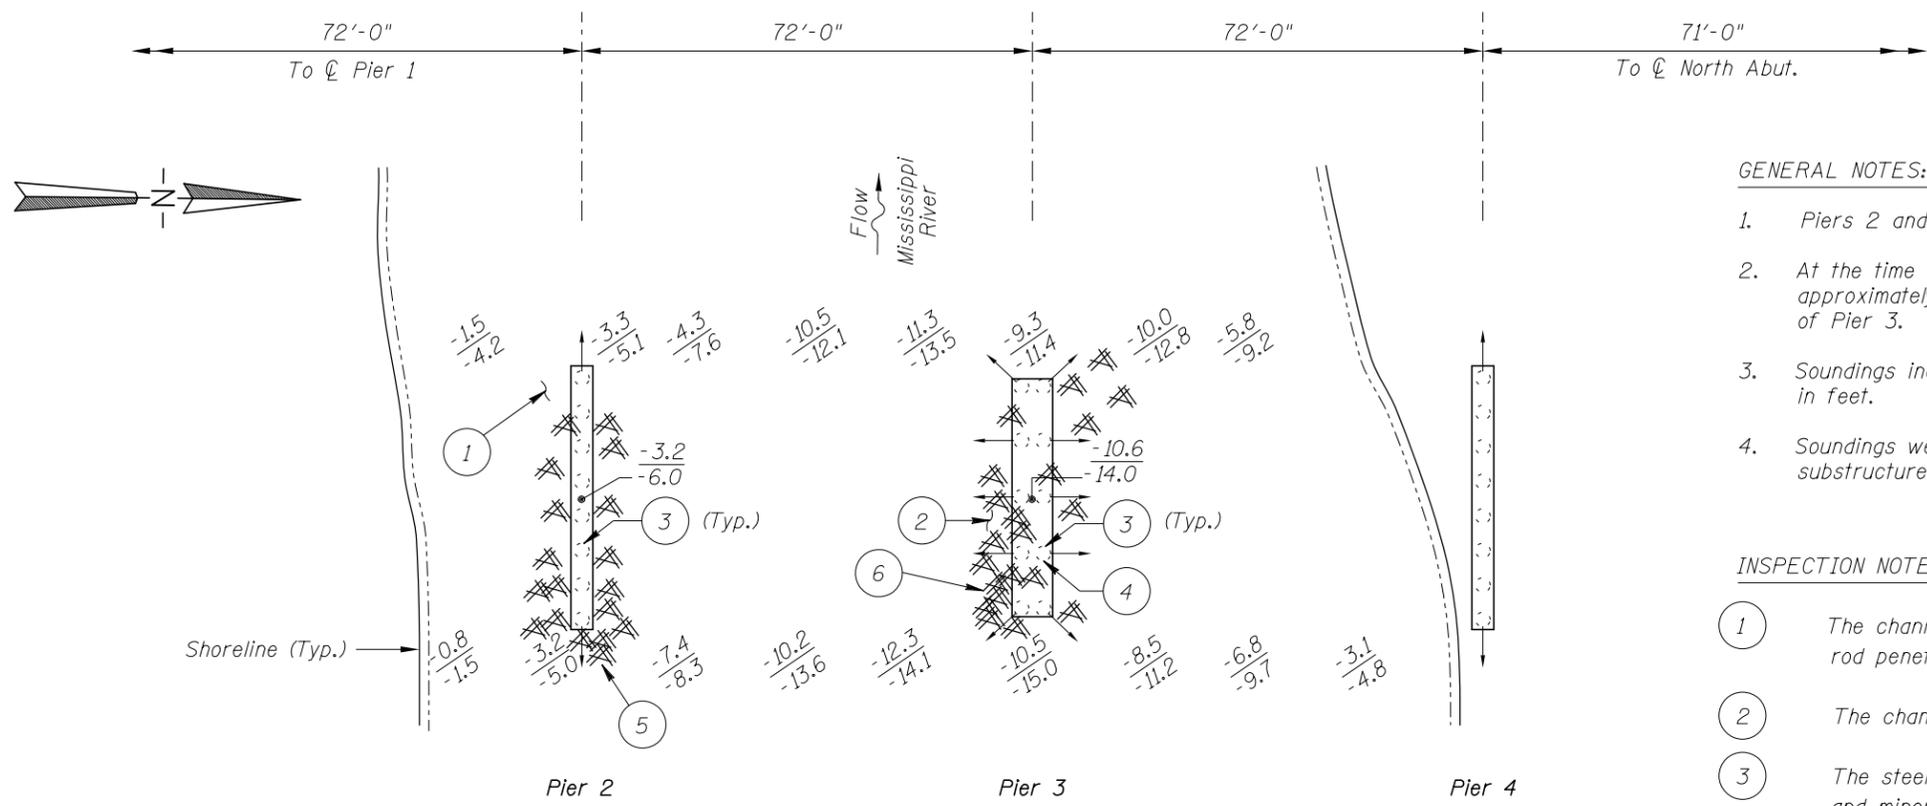
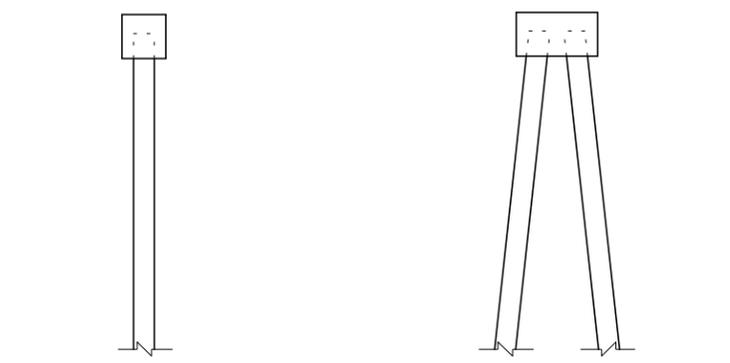
SOUNDING PLAN

- 1 The channel bottom material consisted of silty sand with 6 to 8 inches of probe rod penetration.
- 2 The channel bottom material consisted of soft silt with up to 8 inches of probe rod penetration.

- 3 The steel pipe piles exhibited 100 percent coating failure with light to moderate corrosion and minor rust nodules with up to 1/8 inch deep pitting (1/16 inch typical) over 50 percent of the surface area from 8 feet to 2 feet above the waterline, and on 100% of the surface area below water.

- 4 The steel pipe piles at Pier 3 exhibited 1/16 inch thick rust delaminations due to corrosion from the waterline to the channel bottom.
- 5 A moderate accumulation of timber debris consisting of 1 foot diameter and smaller logs and branches was observed along the entire length of Pier 2 (heaviest at upstream nose) extending from channel bottom to the waterline.

- 6 A moderate accumulation of timber debris consisting of 1 foot diameter and smaller logs and branches was observed scattered throughout Pier 3, extending from channel bottom up 10 feet.
