UNDERWATER BRIDGE INSPECTION REPORT

STRUCTURE NO. 05521
CSAH NO. 2
OVER THE
MISSISSIPPI RIVER
DISTRICT 3 - BENTON COUNTY

OCTOBER 25, 2012
PREPARED FOR THE
MINNESOTA DEPARTMENT OF TRANSPORTATION
BY
COLLINS ENGINEERS, INC.
JOB NO. 7423

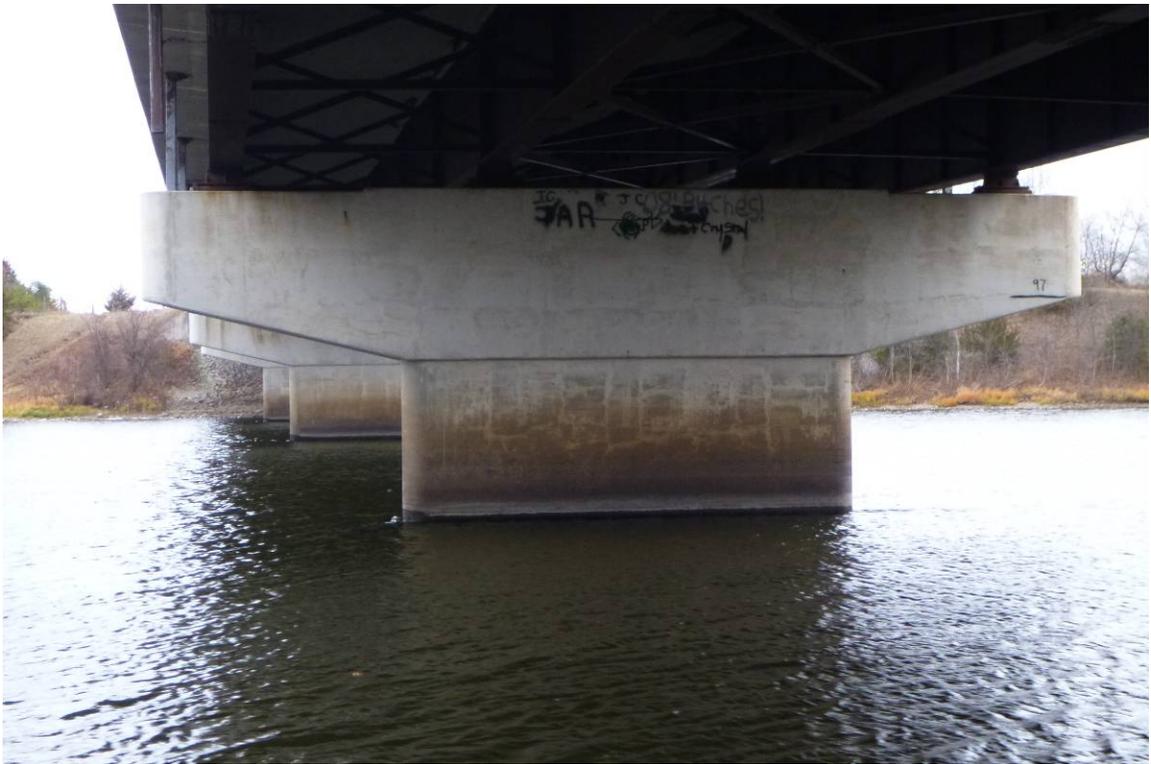
Photograph 2. View of Pier 1, Looking East.

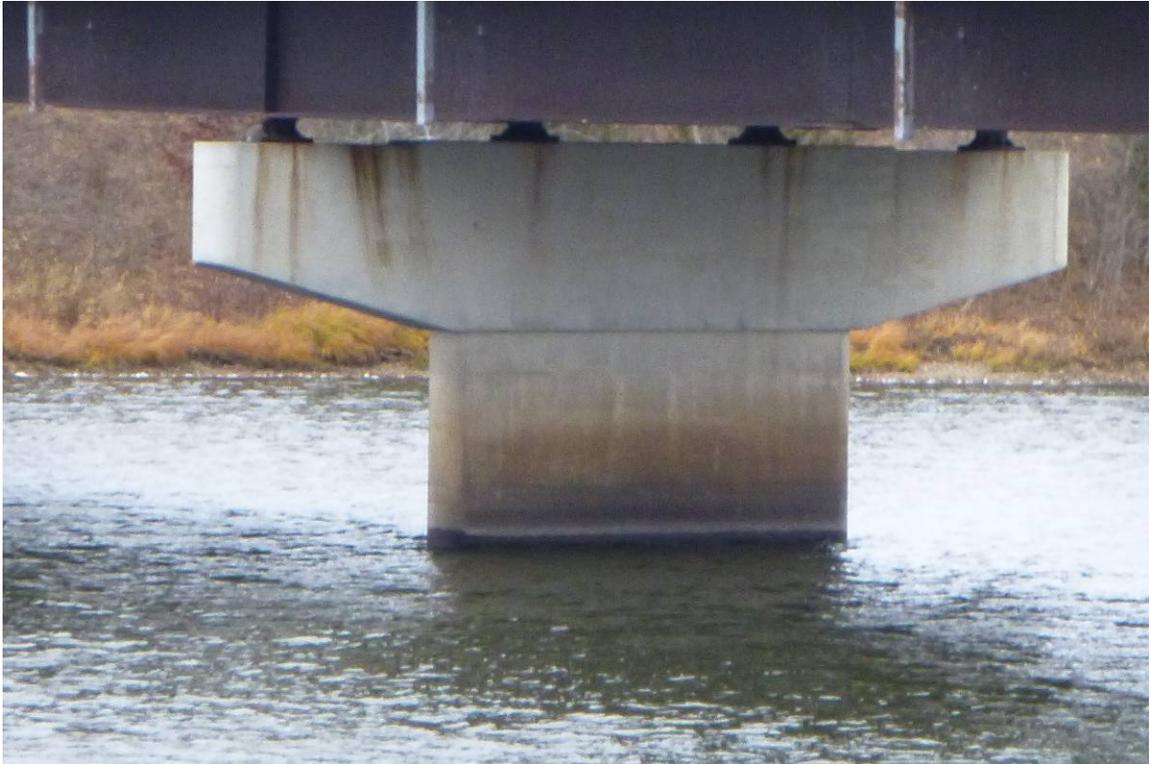
Photograph 3. View of Pier 2, Looking East.

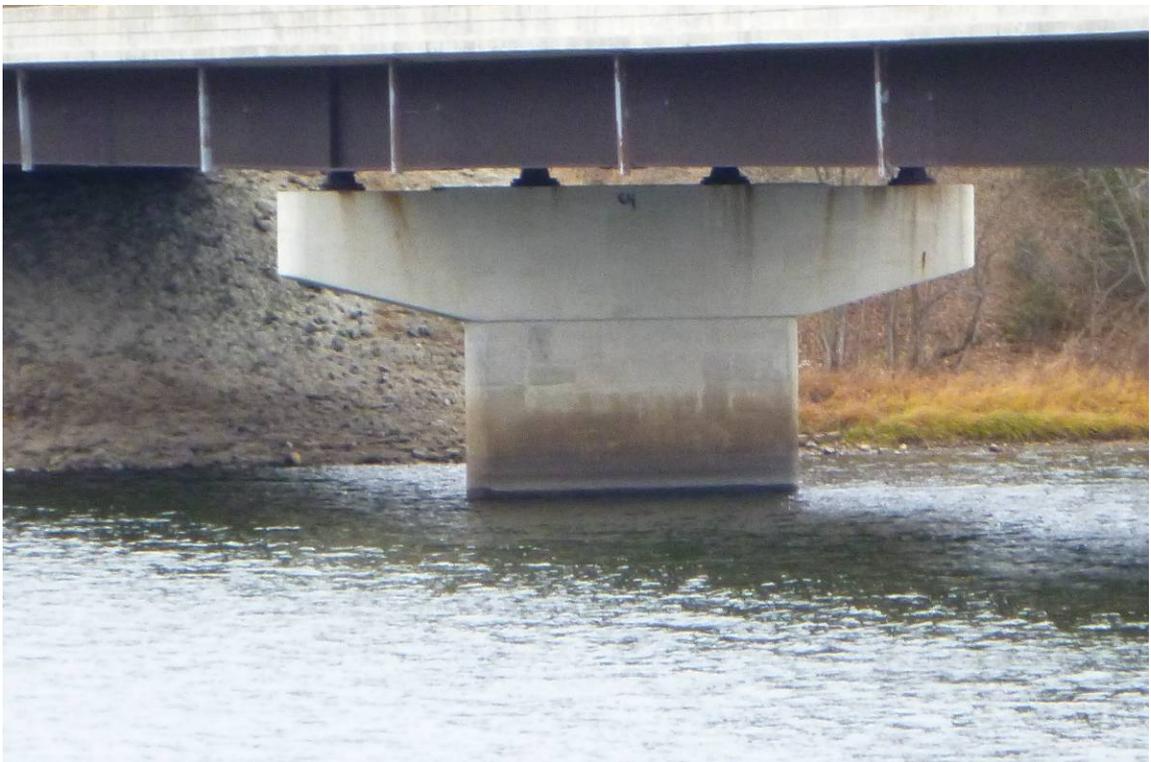
Photograph 4. View of Pier 3, Looking East.

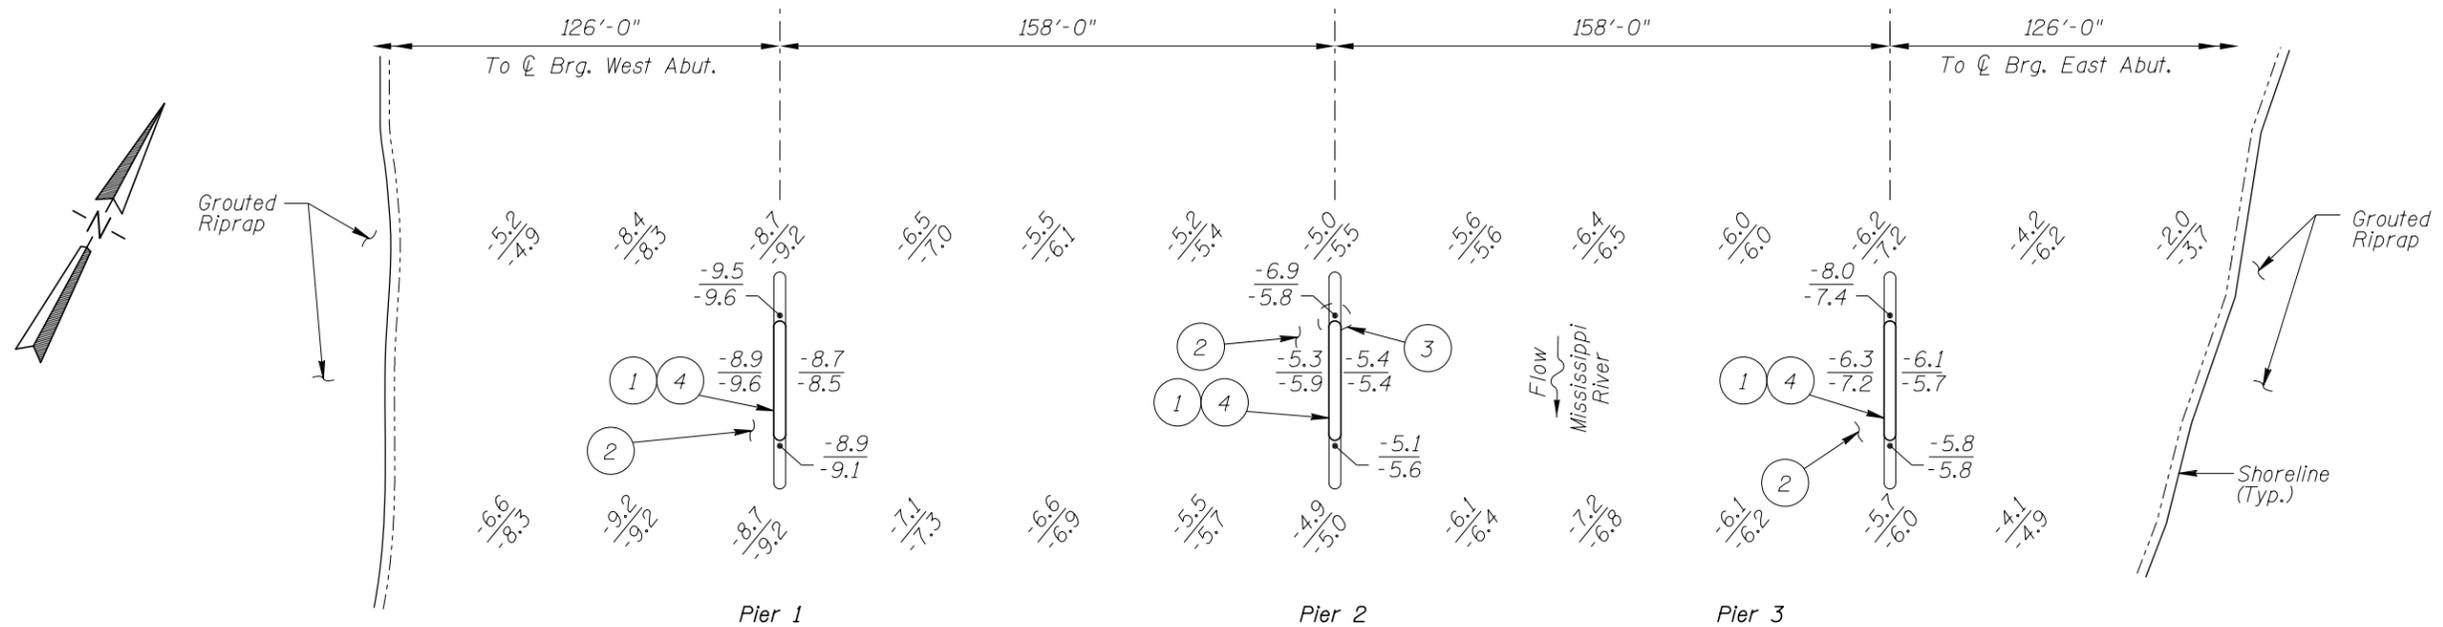
SOUNDING PLAN

- 1 A band of minor scaling was observed at all piers from 3 feet above to 3 feet below the waterline, with typical penetrations of 1/8 inch and a maximum penetration of 1/4 inch, with heaviest deterioration at the upstream nose.
- 2 The channel bottom material consisted of sandy gravel and up to 5-inch-diameter cobbles allowing a maximum probe rod penetration of 4 inches.
- 3 A 3-foot-radius, 2.5-foot-deep scour pocket was observed at the upstream end of Pier 2.
- 4 Above and below the band of scaling the concrete surfaces were smooth and sound.
