UNDERWATER BRIDGE INSPECTION REPORT

STRUCTURE NO. 05525
CSAH NO. 29
OVER THE
MISSISSIPPI RIVER
DISTRICT 3 - BENTON COUNTY

OCTOBER 26, 2012

BY
COLLINS ENGINEERS, INC.

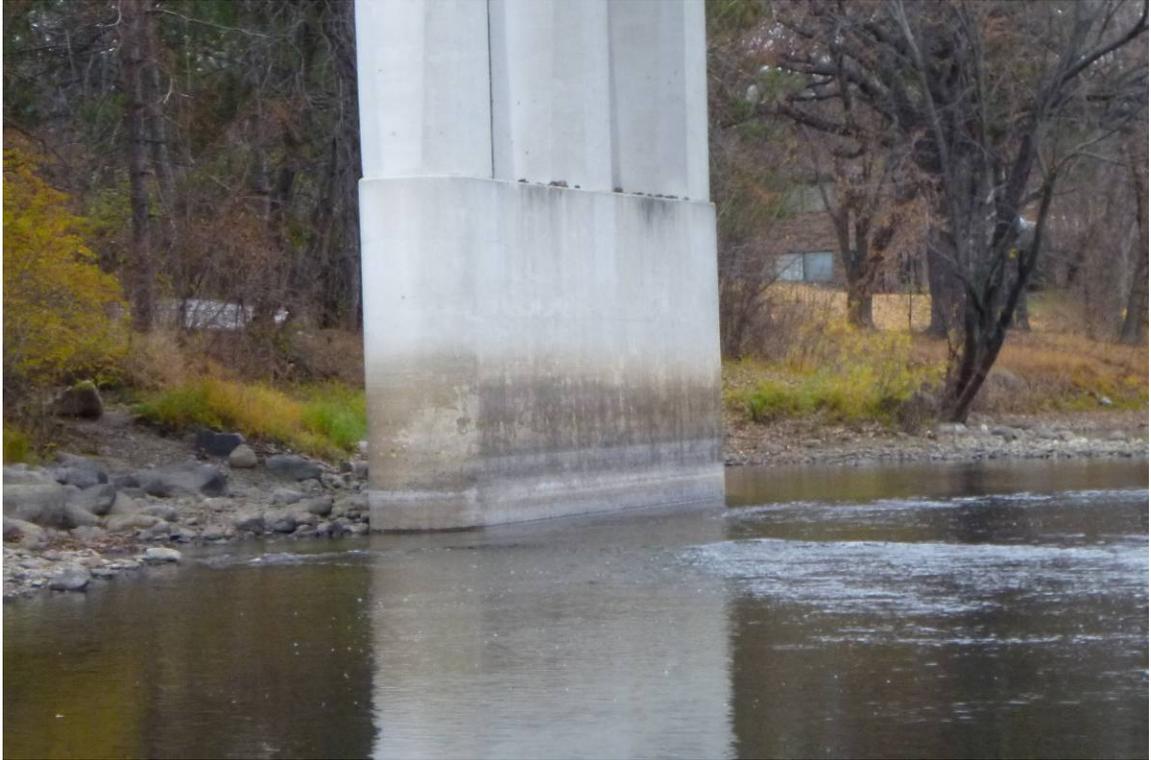
Photograph 1. View of Pier 3, Looking Northwest.

- Piers 3 through 7 exhibited random hairline cracks on each face extending from the top of the shaft to the channel bottom.
 - The footing at Pier 3 was exposed at the upstream nose and along the entire east face with up to 2.2 feet of vertical face exposed at the northeast corner.

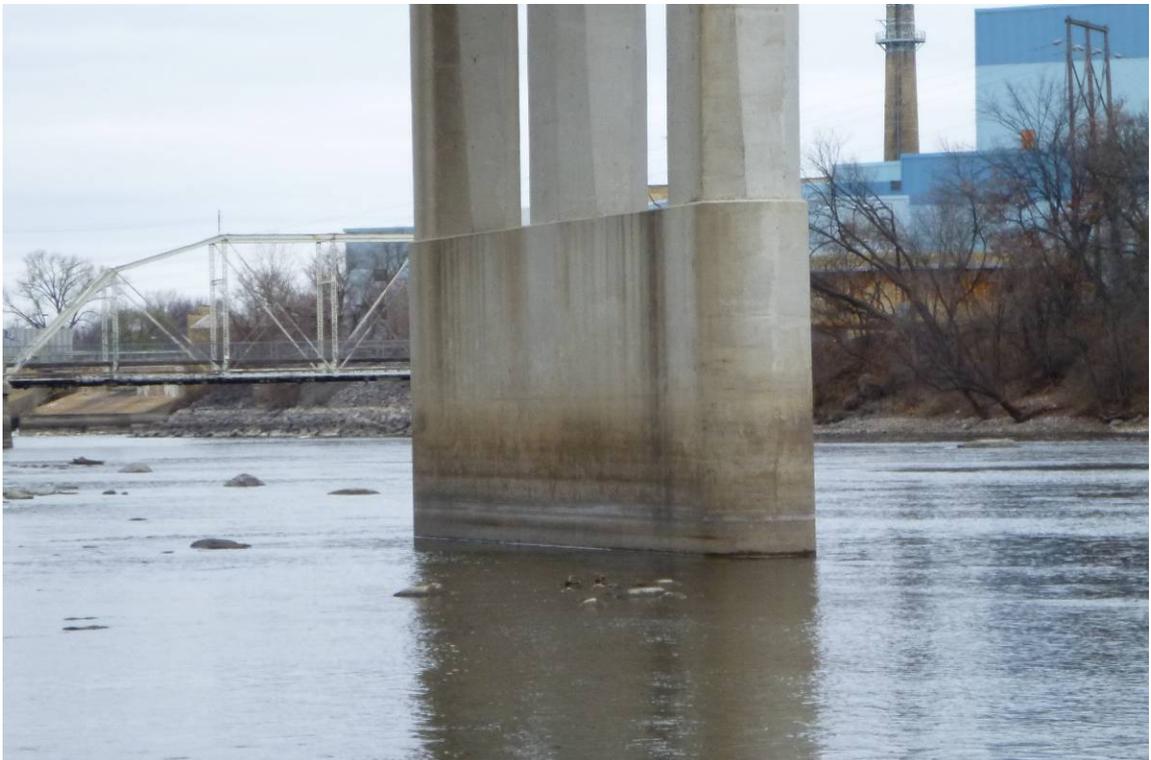
Photograph 2. View of Pier 4, Looking Northeast.

- The footing at Pier 4 was exposed along the entire east face, around the upstream nose, and up to the upstream quarter as well as an 8 foot section along the downstream quarter on the west face with up to 4 inches of vertical face exposed.

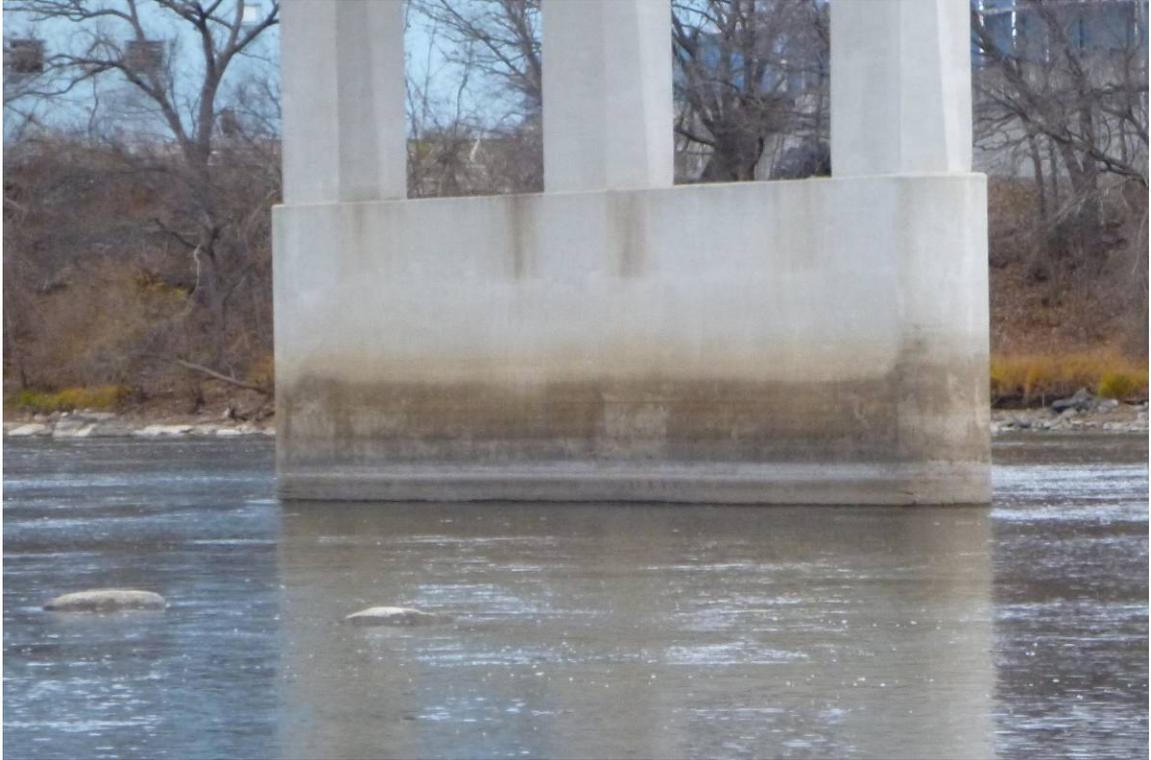
Photograph 3. View of Pier 5, Looking Northeast.

- The footing at Pier 5 was exposed along the entire east face and around the upstream nose with up to 7 inches of vertical face exposed at the southeast corner.

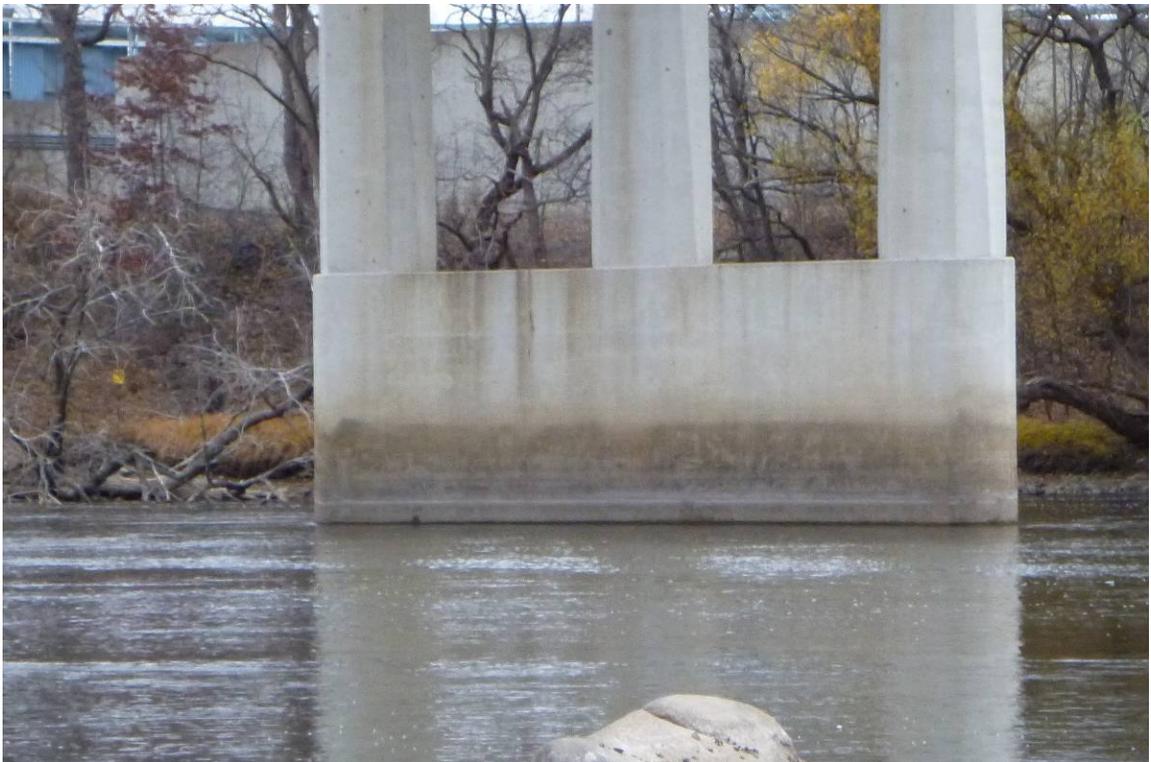
Photograph 4. View of Pier 6, Looking Northeast.

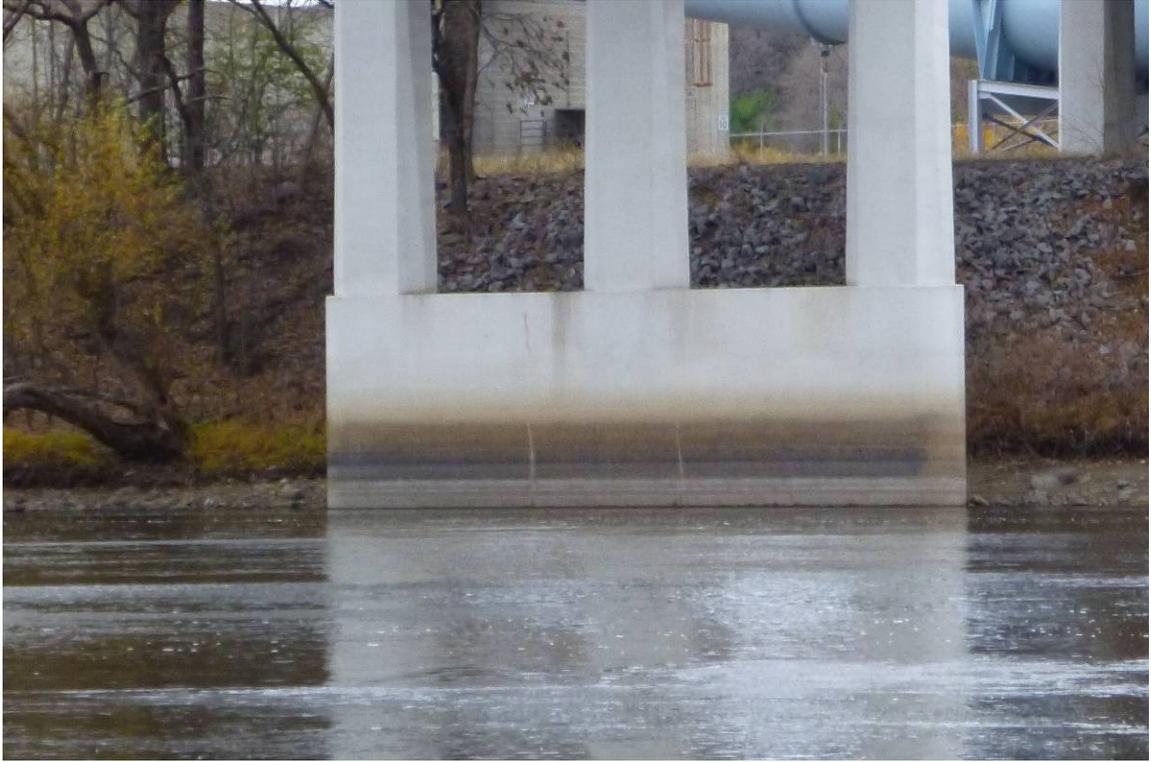
Photograph 5. View of Pier 7, Looking Northeast.

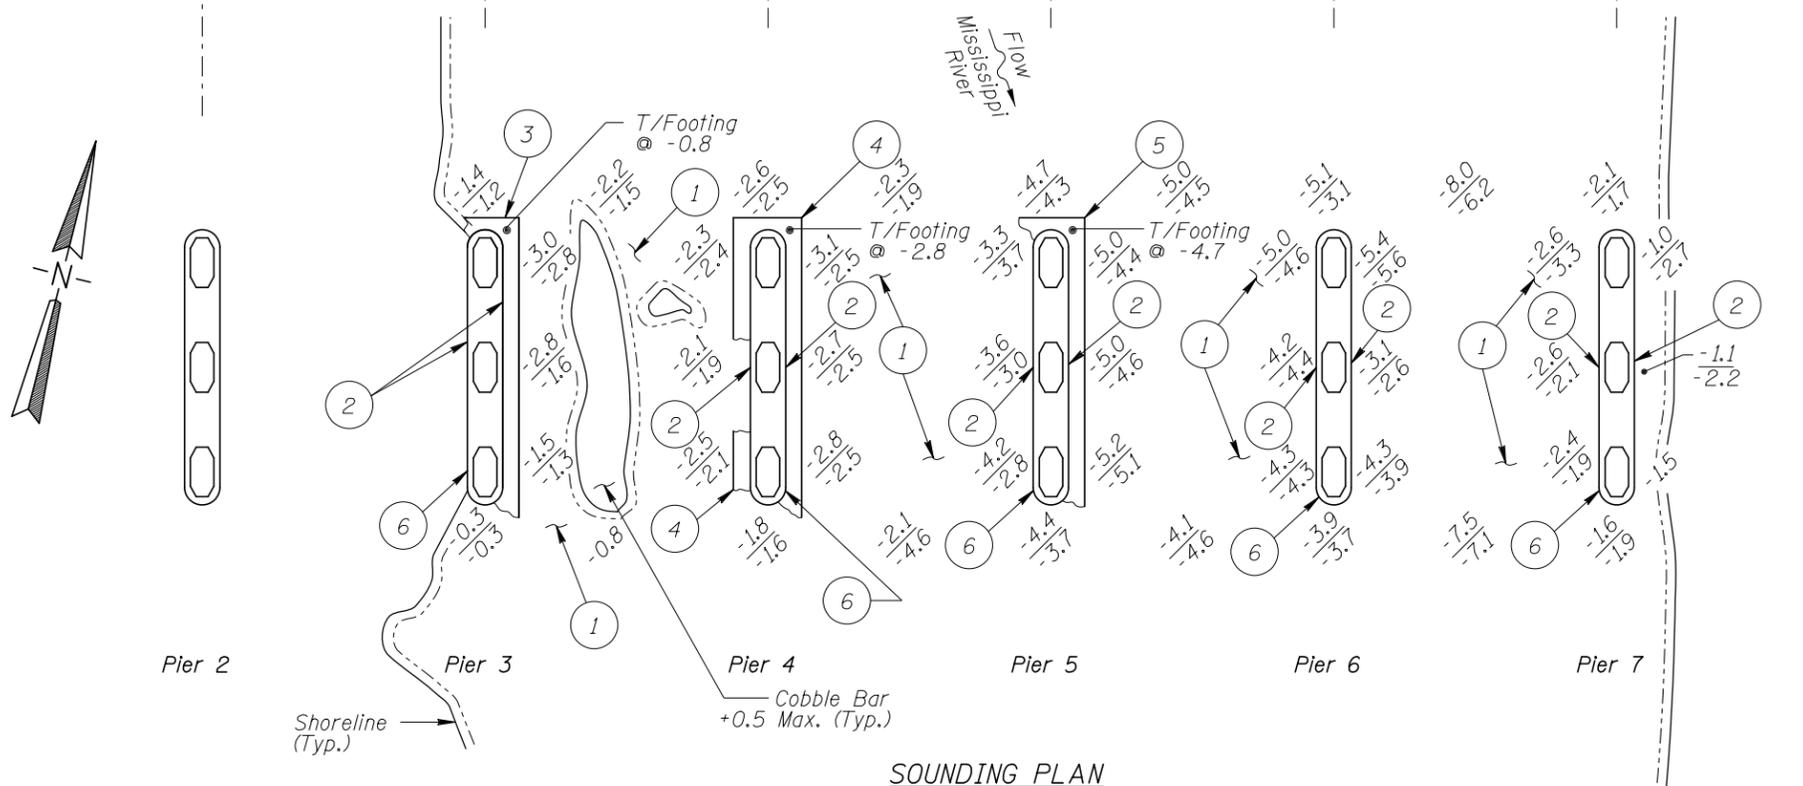
SOUNDING PLAN

- INSPECTION NOTES:**
- The channel bottom material consisted of 6-inch to 1-foot-diameter cobbles with sand allowing up to 3 inches of probe rod penetration.

- A band of light scaling was observed around the entire perimeter of all the piers with a maximum penetration of 1/8 inch, extending 1.5 feet below to 1.5 feet above the waterline.

Monitor the extent of footing exposure during future underwater inspections.
