UNDERWATER BRIDGE INSPECTION REPORT

STRUCTURE NO. 18501  
CSAH NO. 16  
OVER THE  
PINE RIVER (CROSS LAKE / RUSH LAKE)  
DISTRICT 3 – CROW WING COUNTY

SEPTEMBER 9, 2012  
PREPARED FOR THE  
MINNESOTA DEPARTMENT OF TRANSPORTATION  
BY  
COLLINS ENGINEERS, INC.  
AND  
WSB & ASSOCIATES, INC.  
JOB NO. 2107

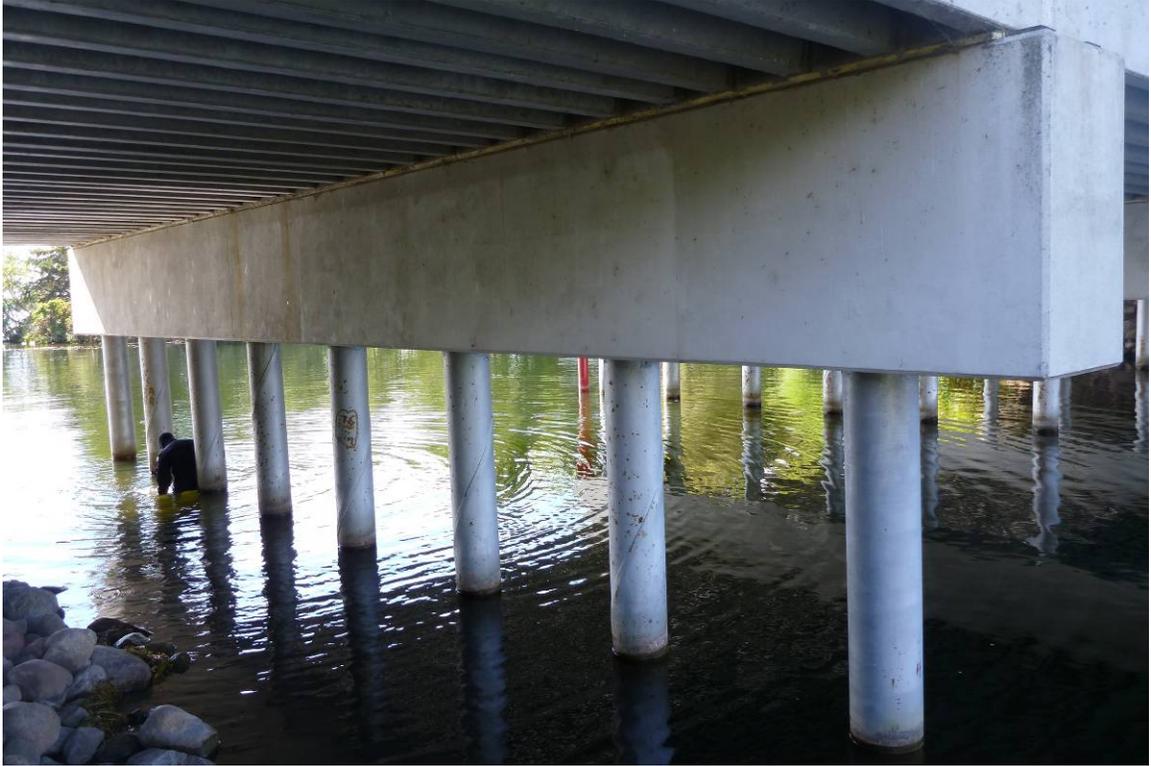
Photograph 1. View of Pier 1, Looking South.

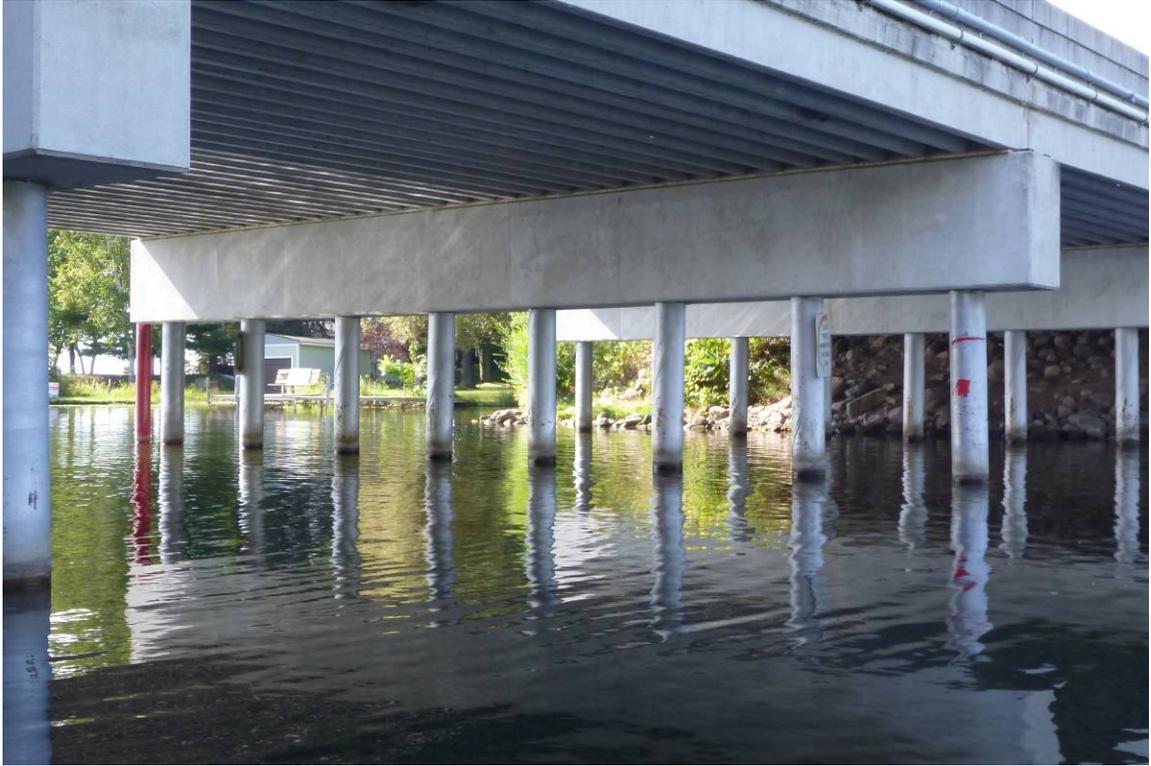
Photograph 2. View of Pier 2, Looking South.

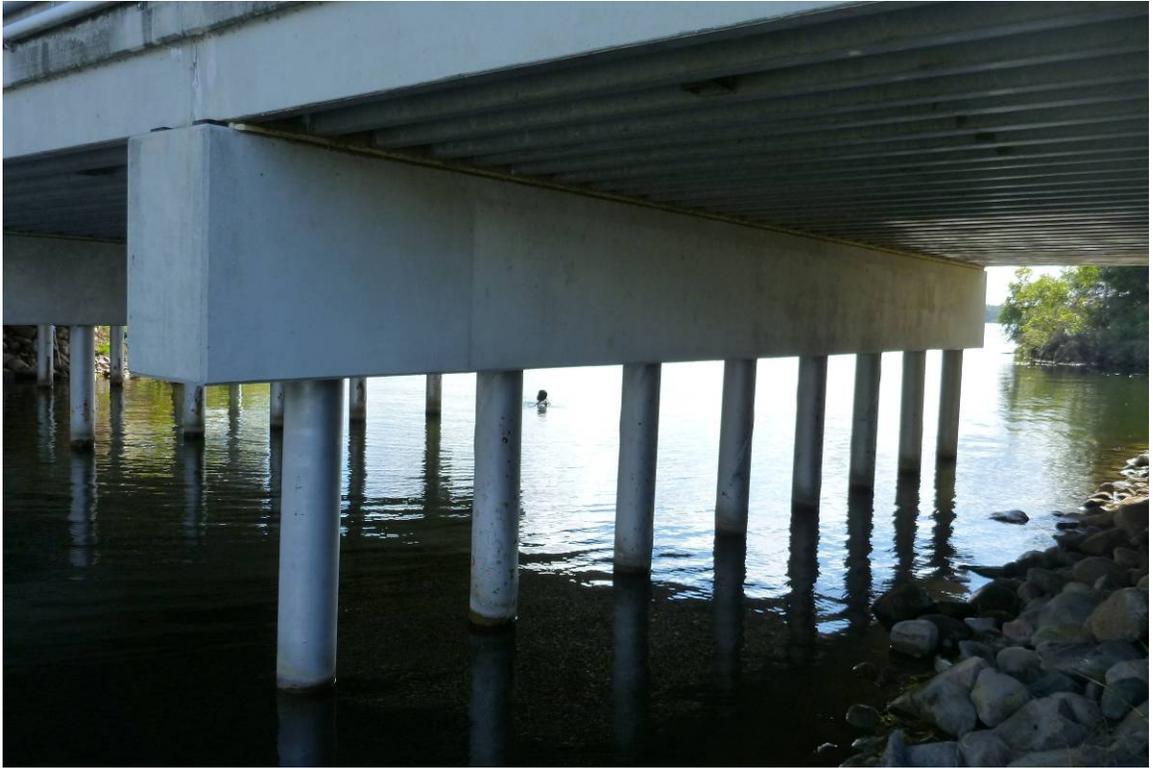
Photograph 3. View of Pier 3, Looking North.

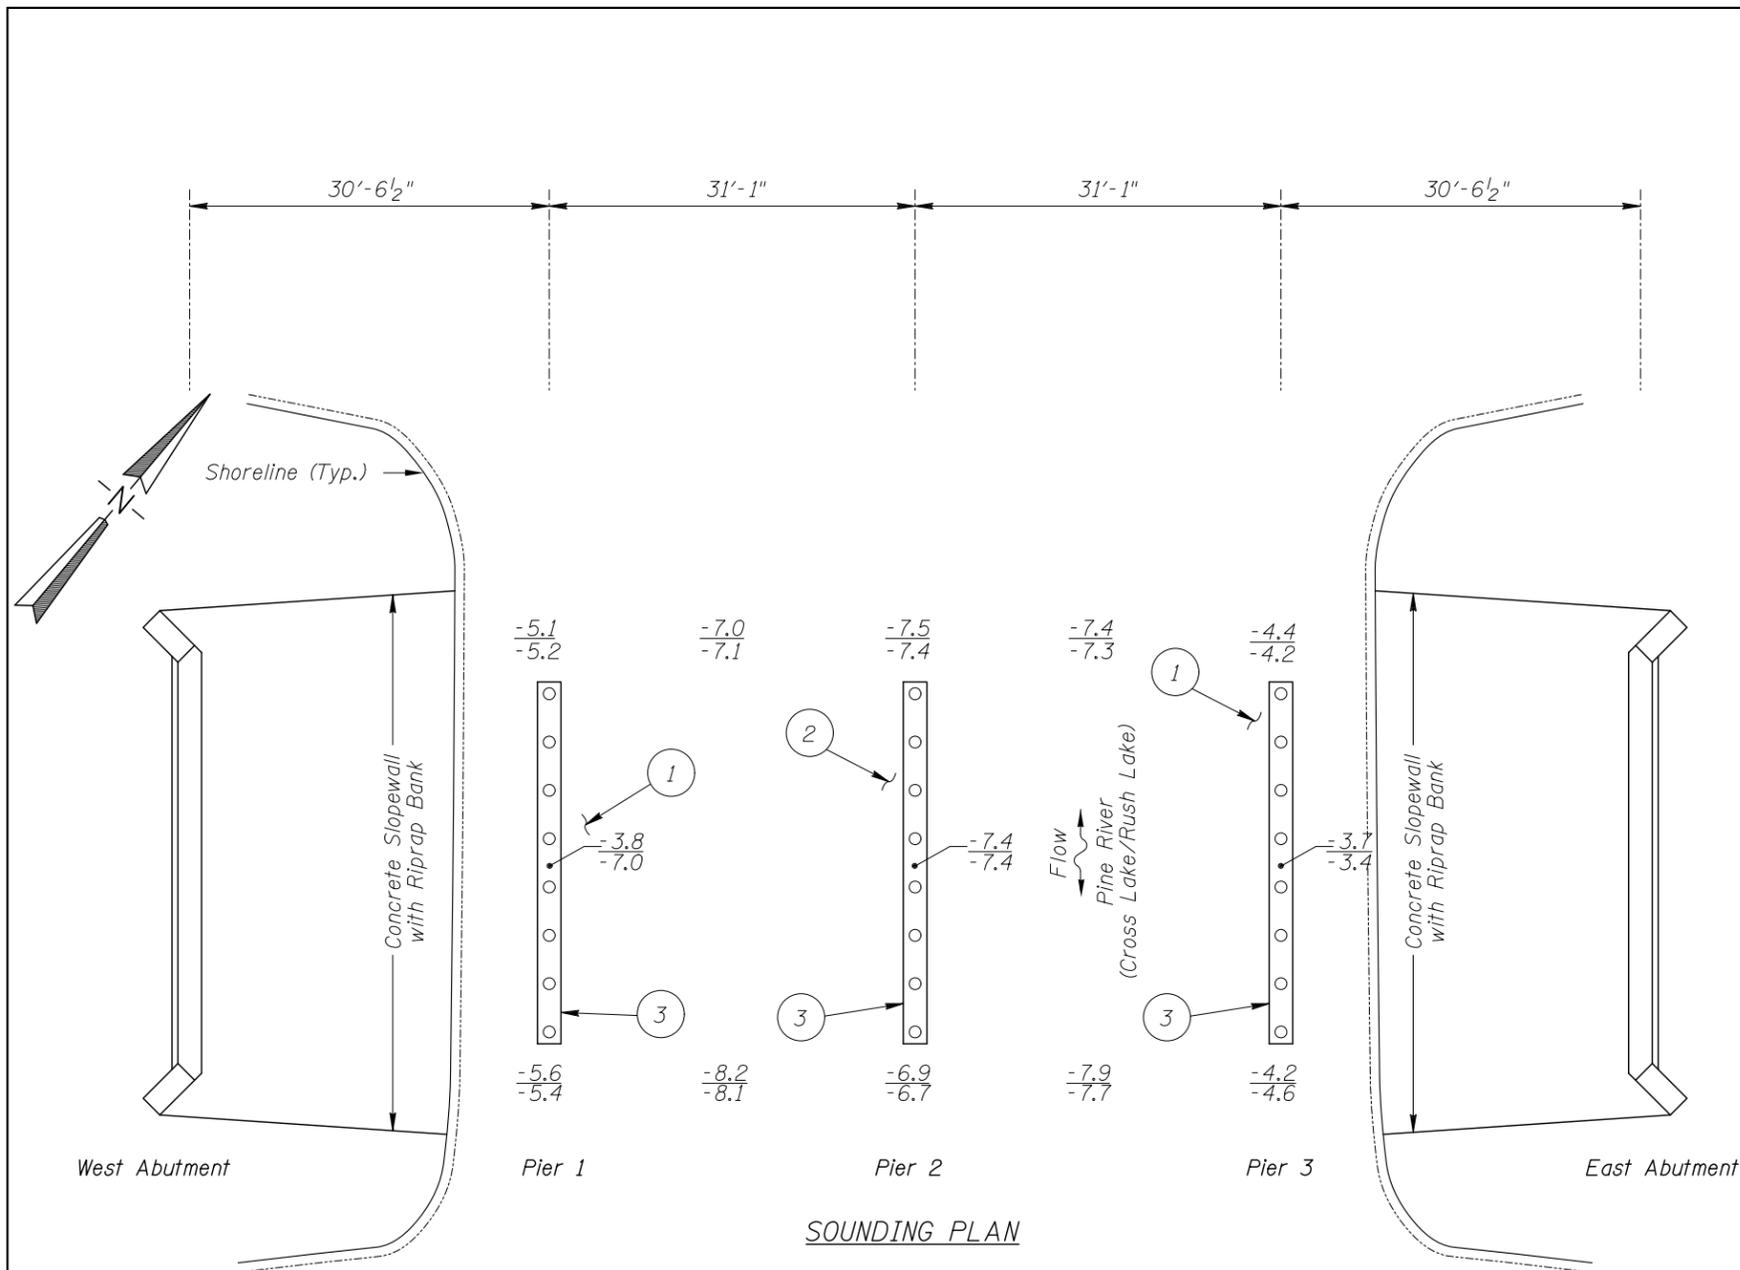
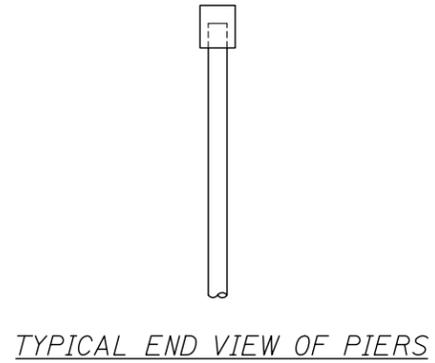
**INSPECTION AND SOUNDING PLAN**

- The channel bottom around Piers 1 and 3 consisted of 1 to 2 foot diameter riprap.
- The channel bottom around Pier 2 consisted of gravel and sand and 4 to 6 inch diameter cobbles with up to 2 inches of probe rod penetration.
- The piles exhibited coating failure and minimal surface corrosion on 15% to 20% of the surface area below the waterline. All piles exhibited a layer aquatic growth from the waterline to the mudline.
