UNDERWATER BRIDGE INSPECTION REPORT

STRUCTURE NO. 18505

MSAS NO. 126 (COLLEGE DR)

OCTOBER 24, 2012

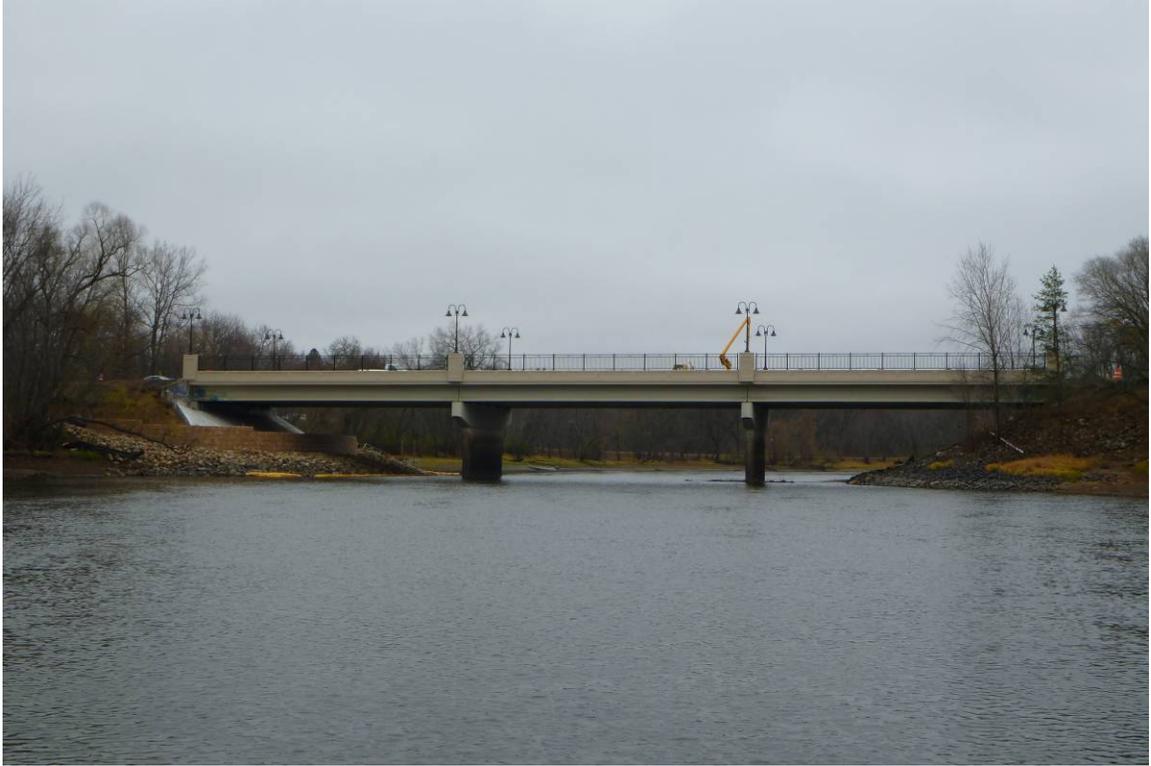
Photograph 1. Overall View of the Structure, Looking South.

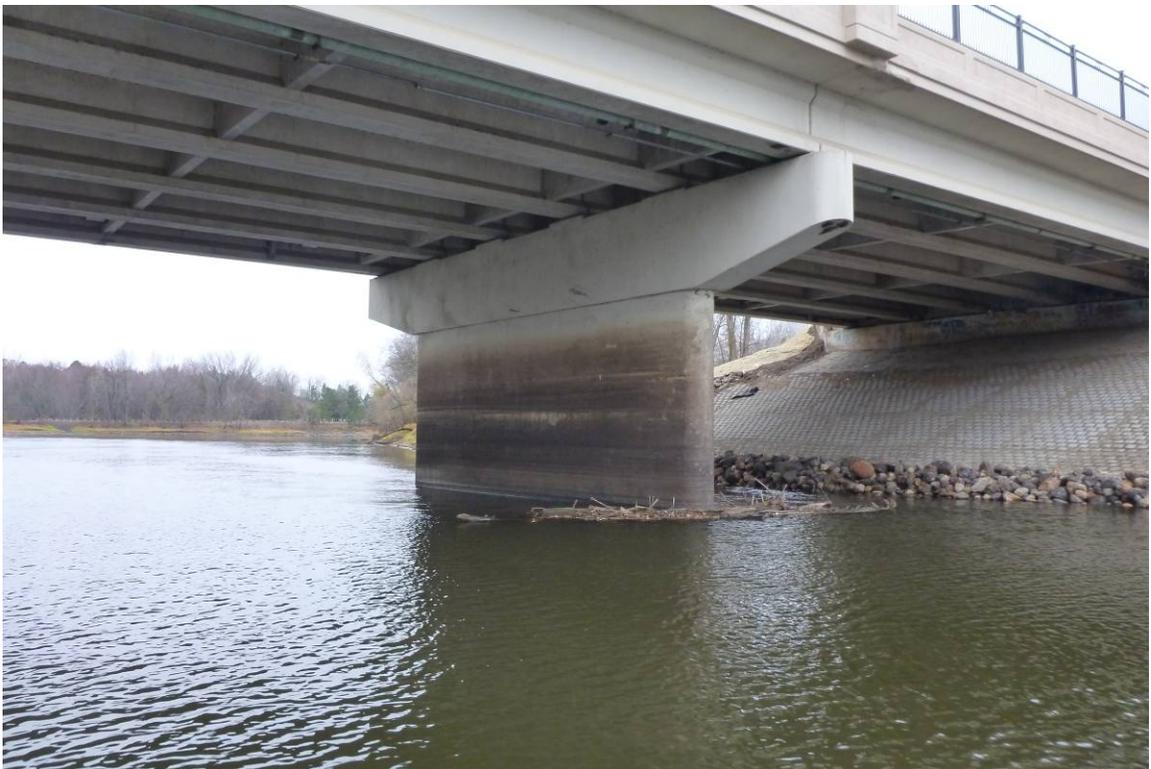
Photograph 2. View of Pier 1 and West Abutment, Looking Southwest.

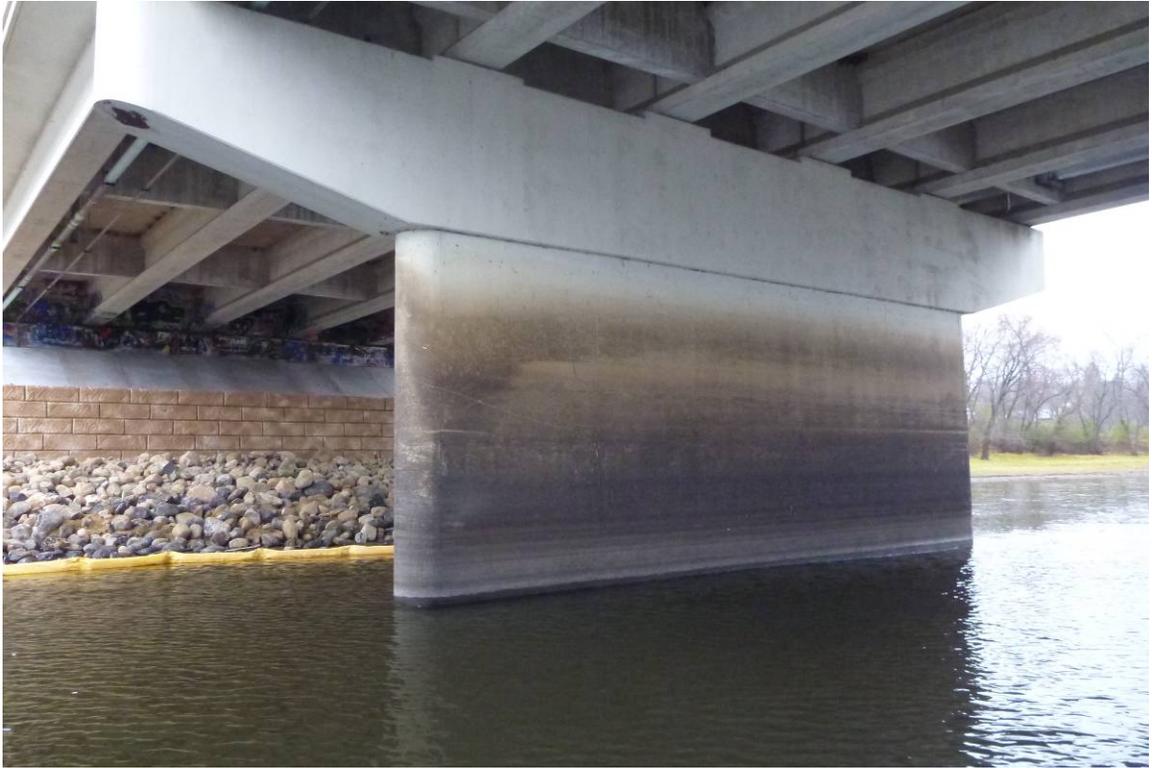
Photograph 3. View of Pier 2 and East Abutment, Looking Southeast.

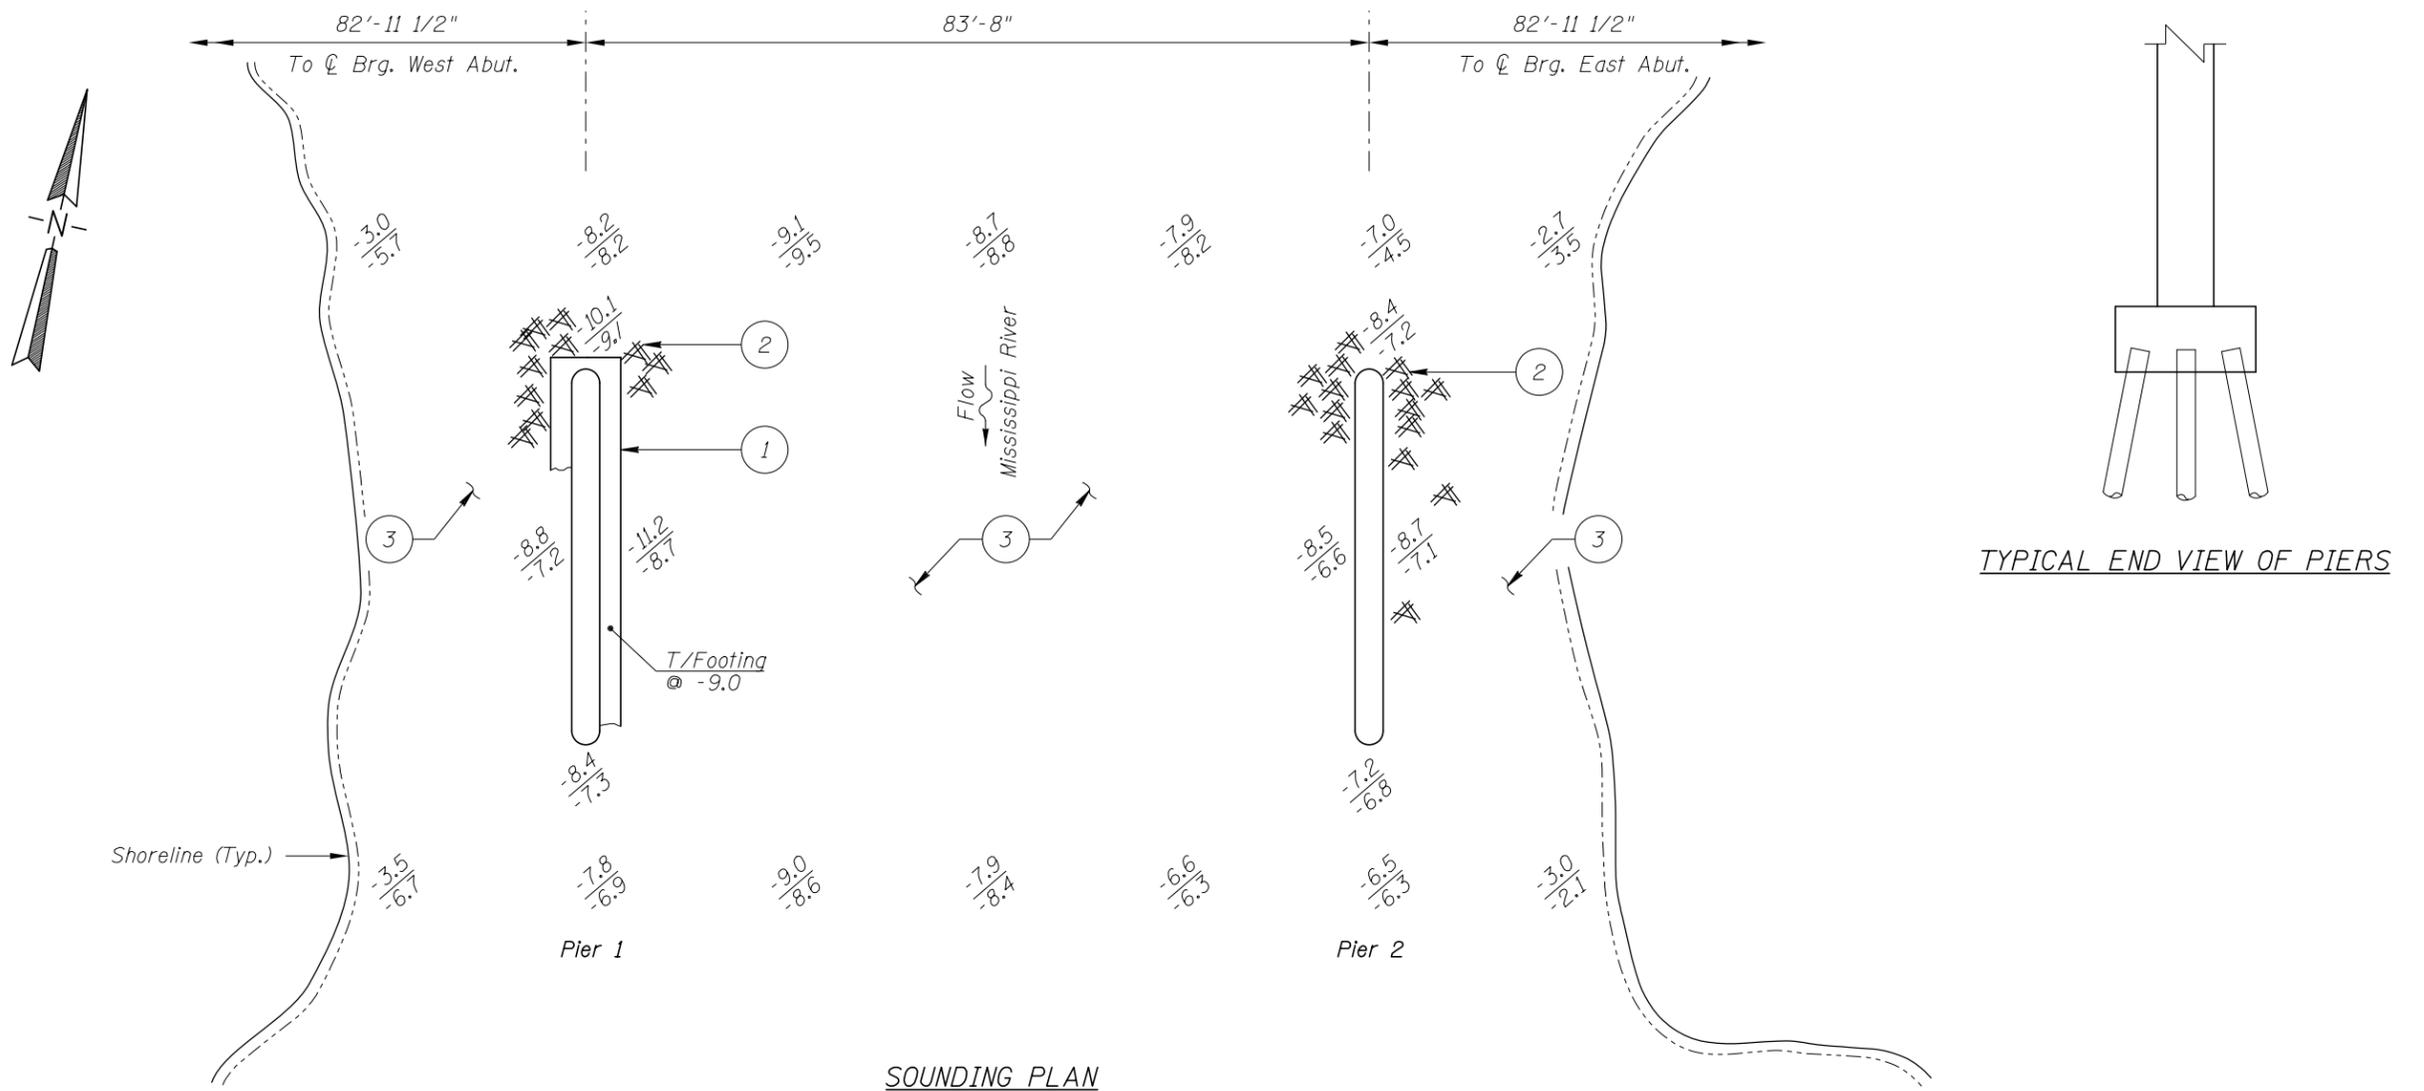
| <p>① Footing exposure was observed at the upstream nose, along the upstream quarter on west side, and along the entire east side of Pier 1 with up to 2 feet of vertical face exposure.</p> <p>② A moderate accumulation of timber debris, with logs and branches up to 12 inches in diameter, was observed from the channel bottom up three feet around the upstream nose of both piers. The debris extended approximately 5 to 10 feet off the pier faces.</p> <p>③ The channel bottom material consisted of sand and gravel with cobbles. Probe rod penetration was negligible.</p> | <p>④ Above and below the waterline the concrete at pier shafts and footing (where exposed) was typically smooth and sound with random minor areas of poor consolidation with penetration up to 1/4 inch.</p> <p>⑤ Scaling was observed around the entire pier shaft of both piers typically extending from the waterline up 4 feet with maximum penetration of 1/4 inch. The scaling was heaviest at the upstream nose where it extended up to 10 feet above the waterline.</p> |
