UNDERWATER BRIDGE INSPECTION REPORT

STRUCTURE NO. 18506

RABBIT LAKE

SEPTEMBER 9, 2012

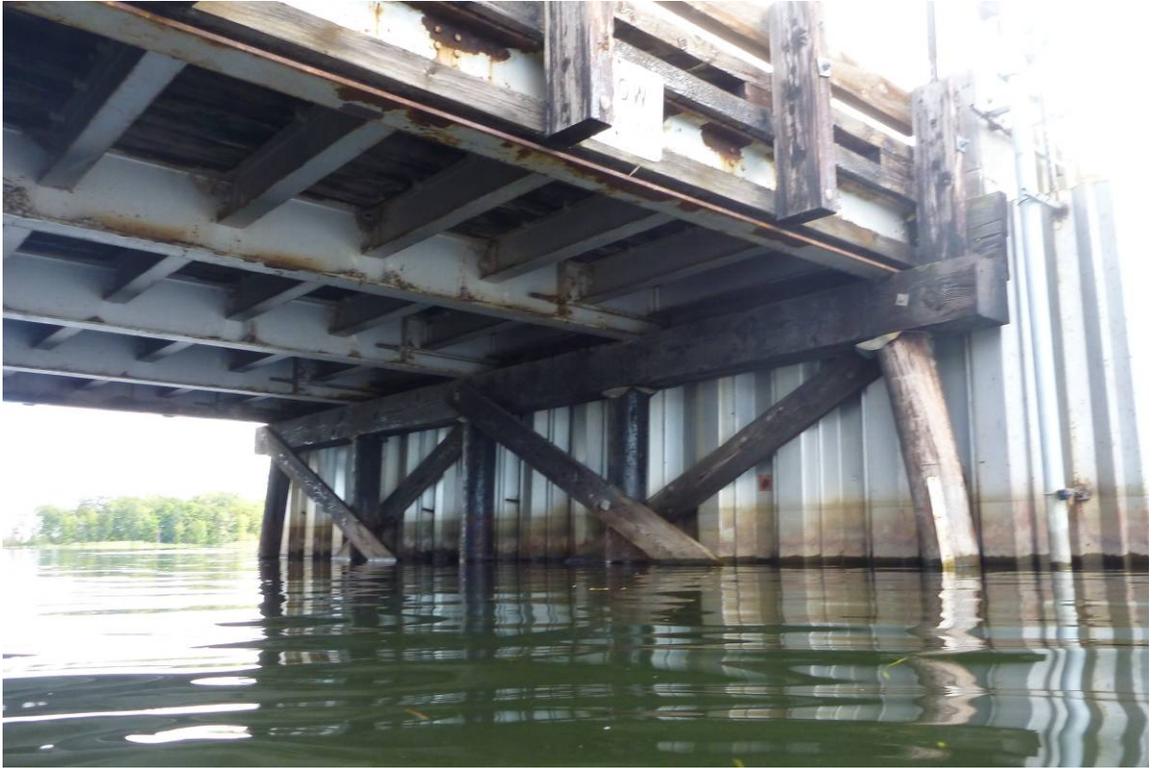
Photograph 1. View of South Abutment, Looking South.

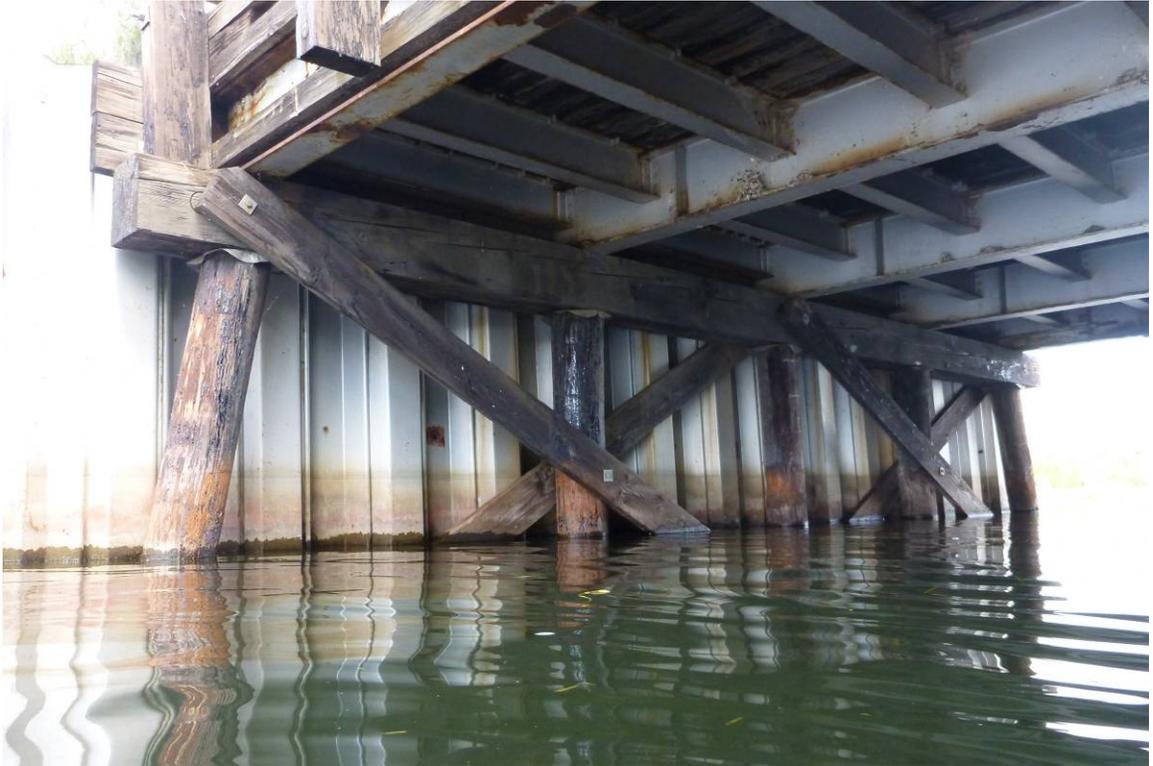
Photograph 2. View of North Abutment, Looking North.

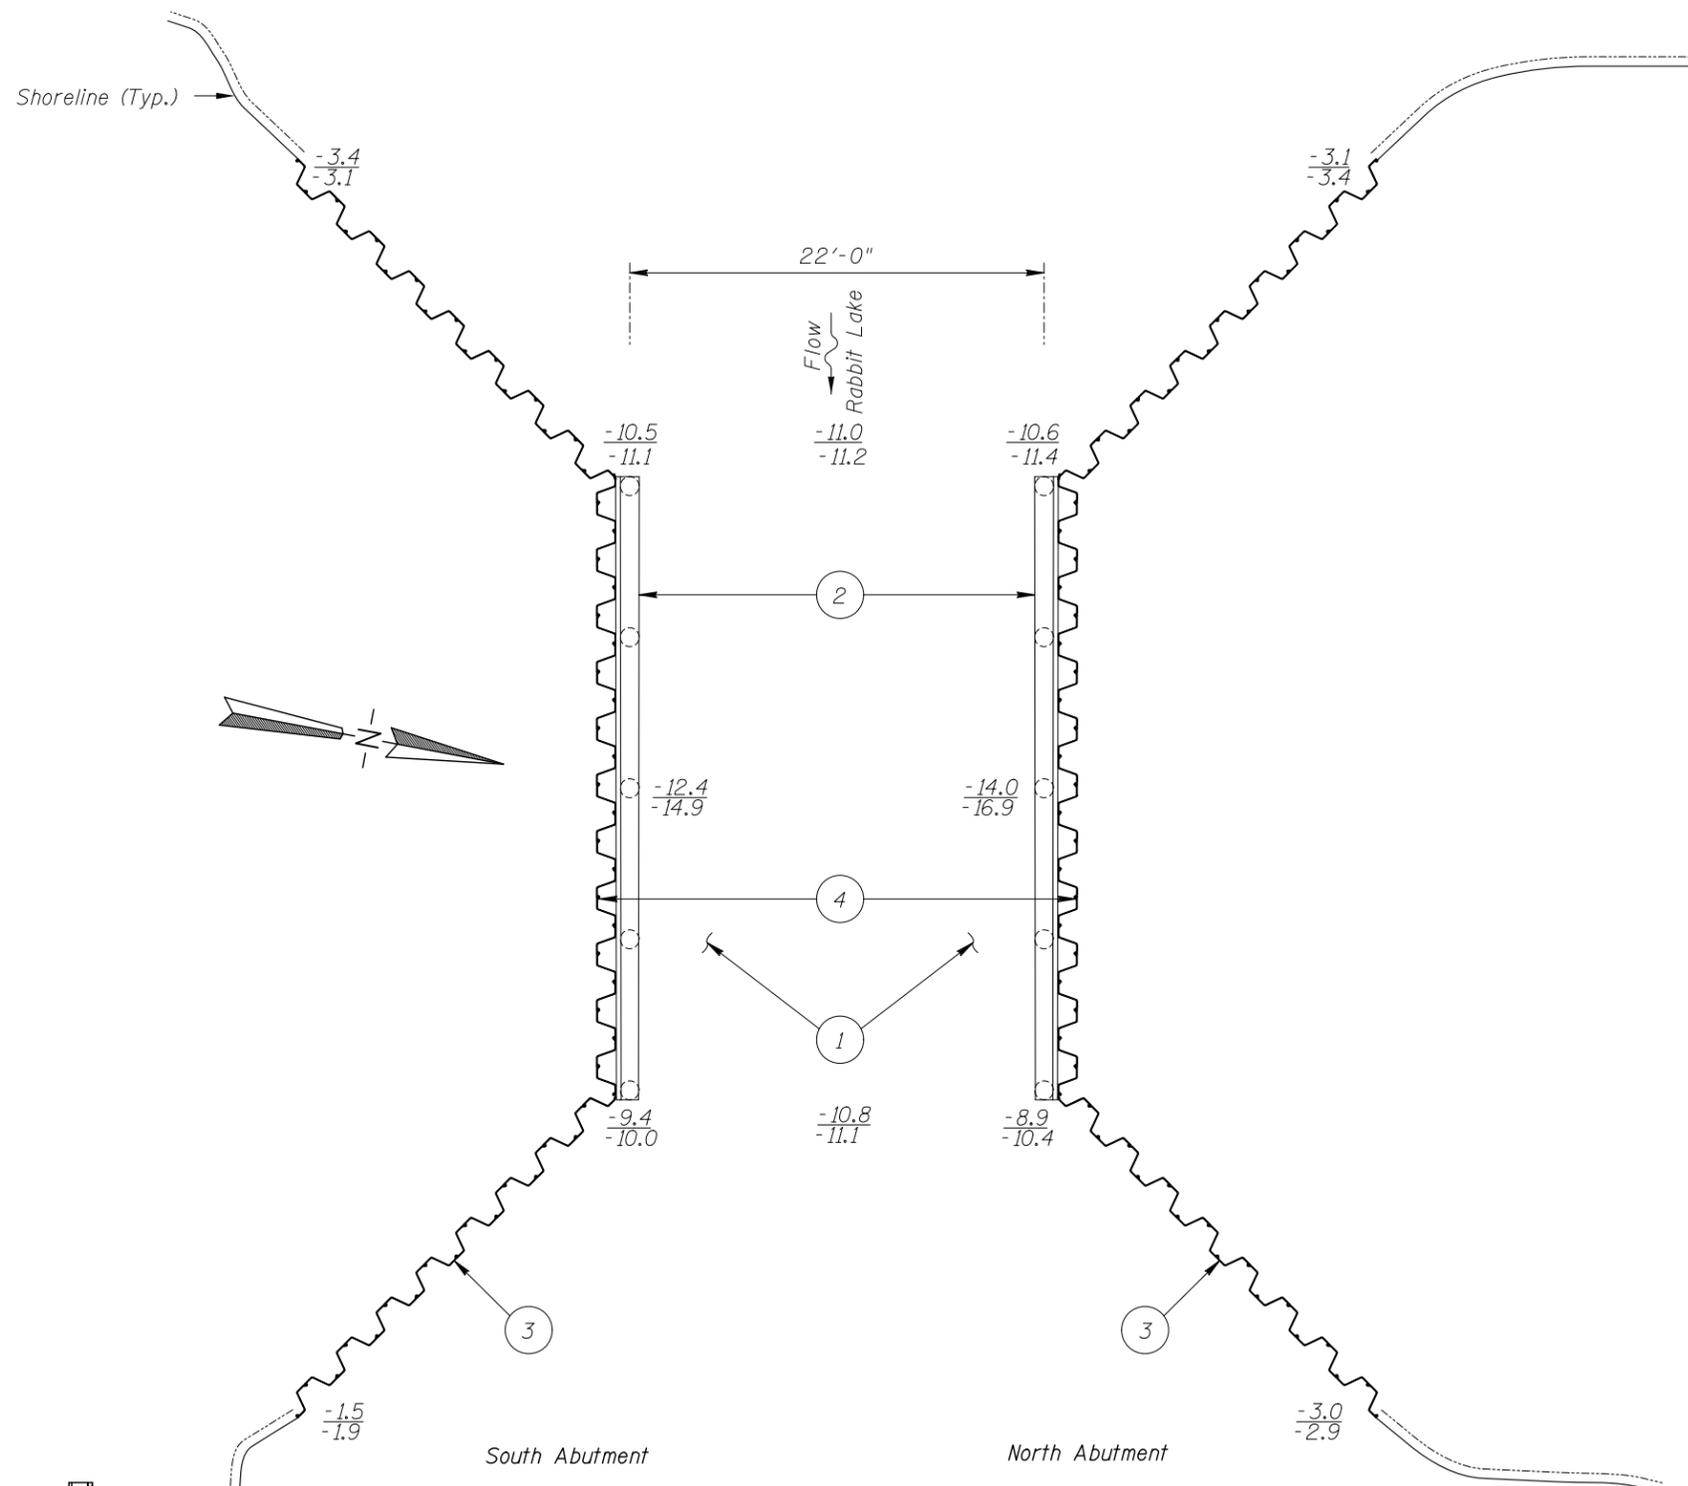
<b>MINNESOTA DEPARTMENT OF TRANSPORTATION UNDERWATER BRIDGE INSPECTION</b>		
STRUCTURE NO. 18506 OVER RABBIT LAKE DISTRICT 3, CROW WING COUNTY		
<b>INSPECTION AND SOUNDING PLAN</b>		
Drawn By: BJR	<b>COLLINS ENGINEERS</b>	Date: SEP. 2012
Checked By: BRL		Scale: NTS
Code: 522118506		Figure No.: 1

- 1 The channel bottom consisted of silty sand with 2 to 4 inches of probe rod penetration.
- 2 The timber members exhibited minor checking up to 1/4 inch wide.
- 3 Light aquatic growth was observed on the steel sheeting below the waterline.
- 4 The steel sheeting exhibited coating failure and surface corrosion on 50 to 100 percent of the surface area from 1 foot above to 1.5 feet below the waterline with minor delaminations and section loss of up to 1/32 inch in depth. From 1.5 feet below the waterline to the channel bottom, the steel sheeting exhibited rust nodules with up to 1/16-inch-deep pitting on less than 5 percent of the surface area.

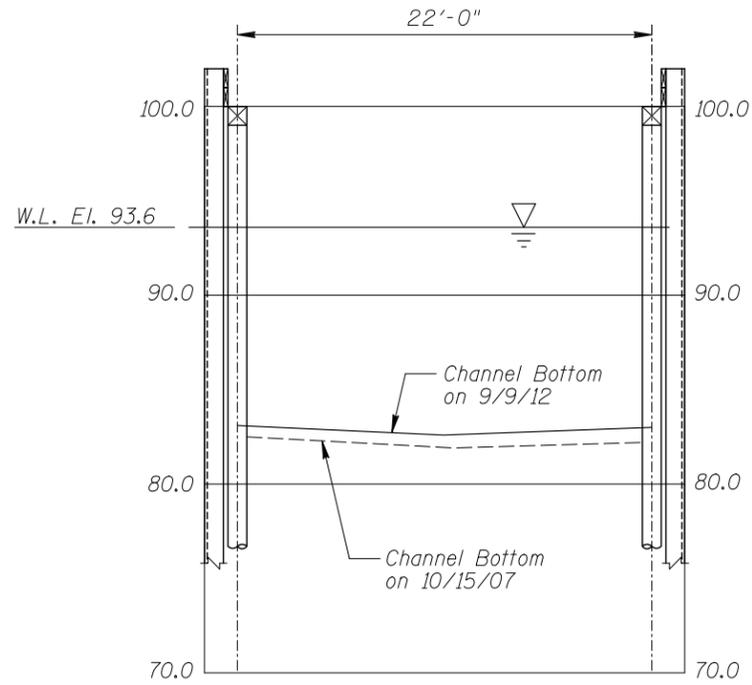
UPSTREAM FASCIA PROFILE

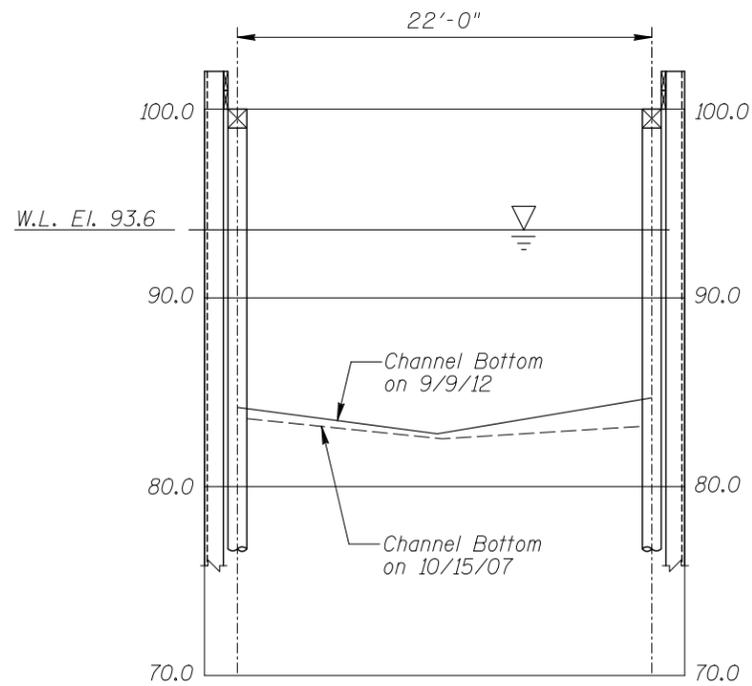
DOWNSTREAM FASCIA PROFILE
