UNDERWATER BRIDGE INSPECTION REPORT

STRUCTURE NO. 18509

MISSISSIPPI RIVER

COLLINS ENGINEERS, INC.

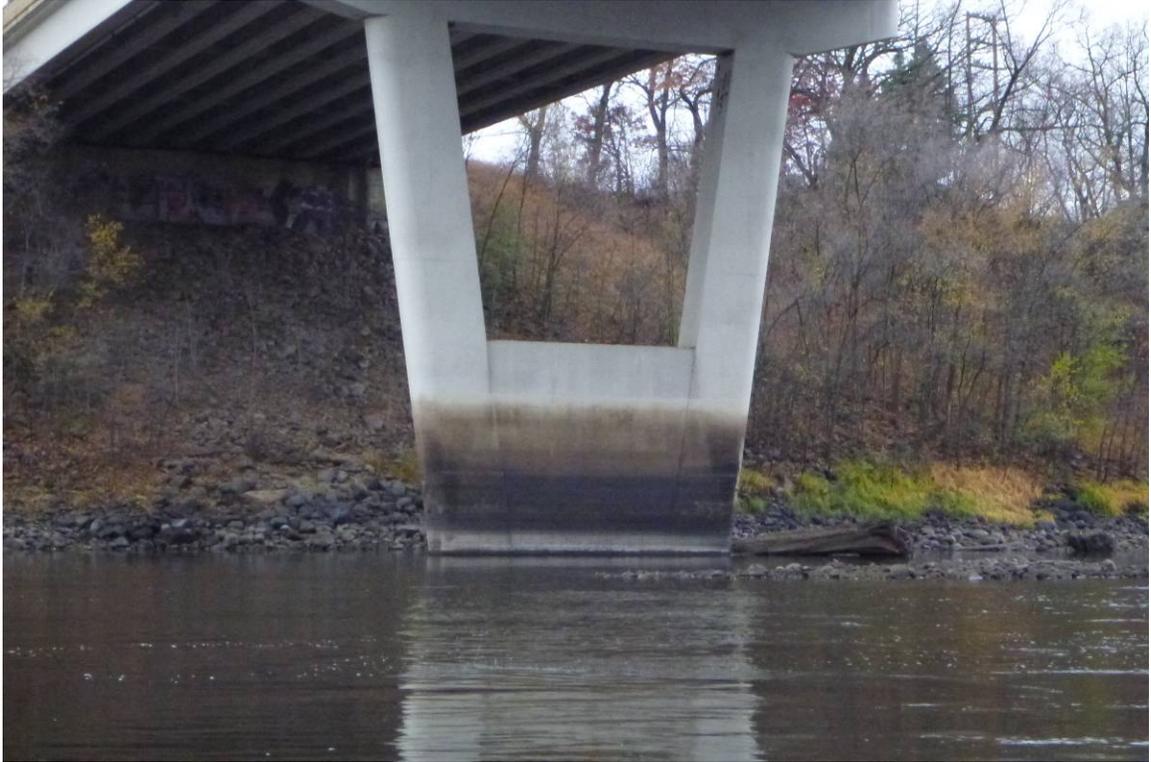
Photograph 1. View of Pier 1, Looking Northwest.

- (E) A scour depression was observed at the upstream end of Pier 1 with a radius of 6 feet and a depth up to 2.5 feet.
- (F) Above and below the waterline, the concrete was typically smooth and sound with random areas of minor delaminating, heaviest at downstream nose of Pier 2. In

- (G) A moderate accumulation of timber debris consisting of 2 foot diameter and smaller trees and branches was observed around the upstream half of Pier 1, extending from the channel bottom to 3 feet above the waterline.

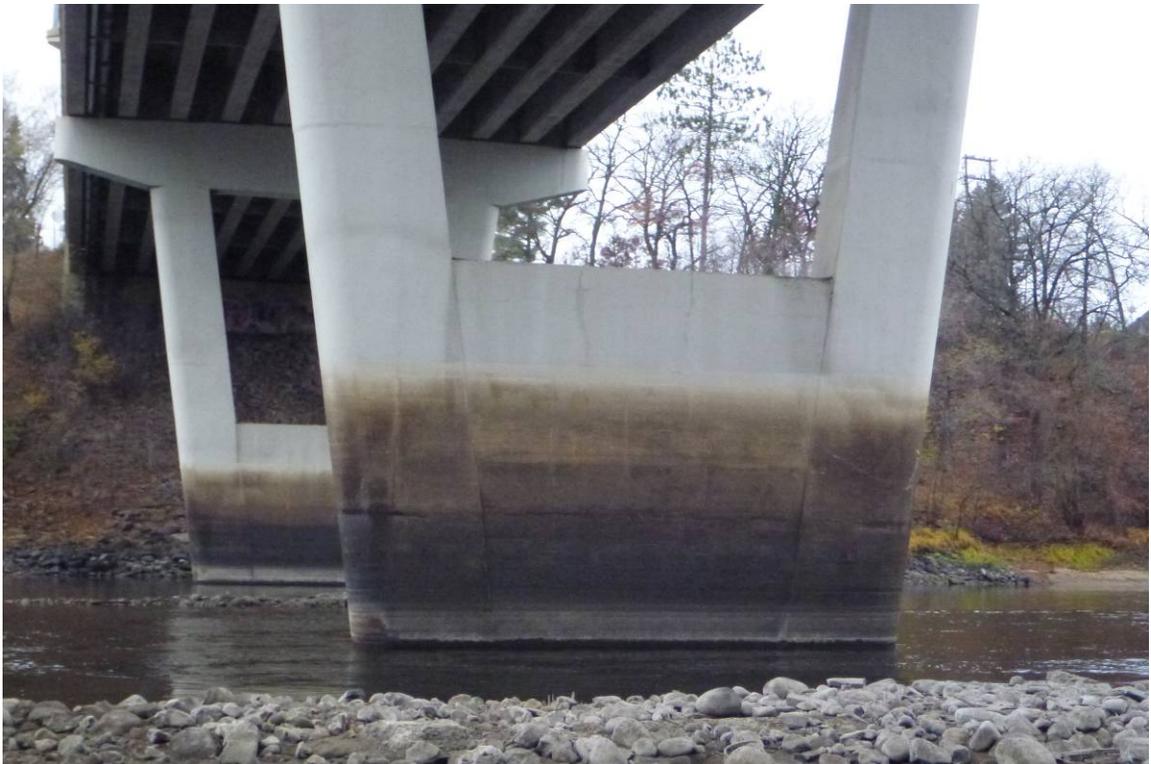
Photograph 2. View of Pier 2, Looking Northwest.

- (A) The channel bottom material consisted of firm sandy gravel with cobbles and rocks allowing a maximum 2 inches of probe rod penetration.
- (B) A scour depression was observed around the upstream half of Pier 2 with a radius of 8 feet and a depth of up to 2.5 feet. Top of footing was exposed around the upstream half of Pier 2 within the scour depression with maximum vertical exposure of 2 inches along the east face of the pier. Top of footing was rough with 1/4 inch irregularities.

- (A) Monitor the extent of the footing exposure at Pier 2 during future inspections, and if found to be significantly progressing, then countermeasures may be warranted.
- (B) Reinspect the submerged substructure units at the normal maximum recommended (NBIS) interval of sixty (60) months.

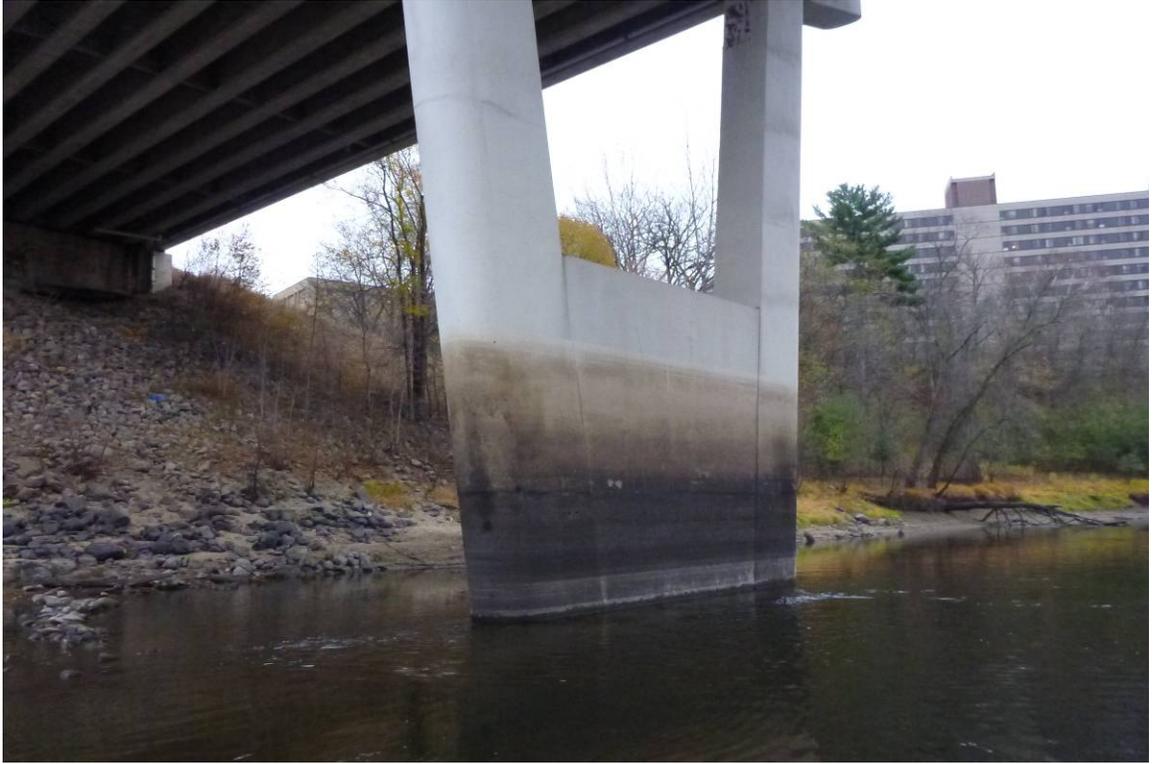
Photograph 3. View of Pier 3, Looking Southeast.

- (C) Riprap 1 to 2 feet in diameter was located at the upstream nose of Piers 1 and 3.
- (D) A light accumulation of timber debris and a truck tire was observed along the upstream half of the east face of Pier 3 extending from the channel bottom up 3 feet and up to 6 feet off the pier face.
