UNDERWATER BRIDGE INSPECTION REPORT

STRUCTURE NO. 18510  
CSAH NO. 66  
OVER THE  
DAGGETT CHANNEL  
DISTRICT 3 – CROW WING COUNTY

SEPTEMBER 9, 2012  
PREPARED FOR THE  
MINNESOTA DEPARTMENT OF TRANSPORTATION  
BY  
COLLINS ENGINEERS, INC.  
AND  
WSB & ASSOCIATES, INC.  
JOB NO. 2107

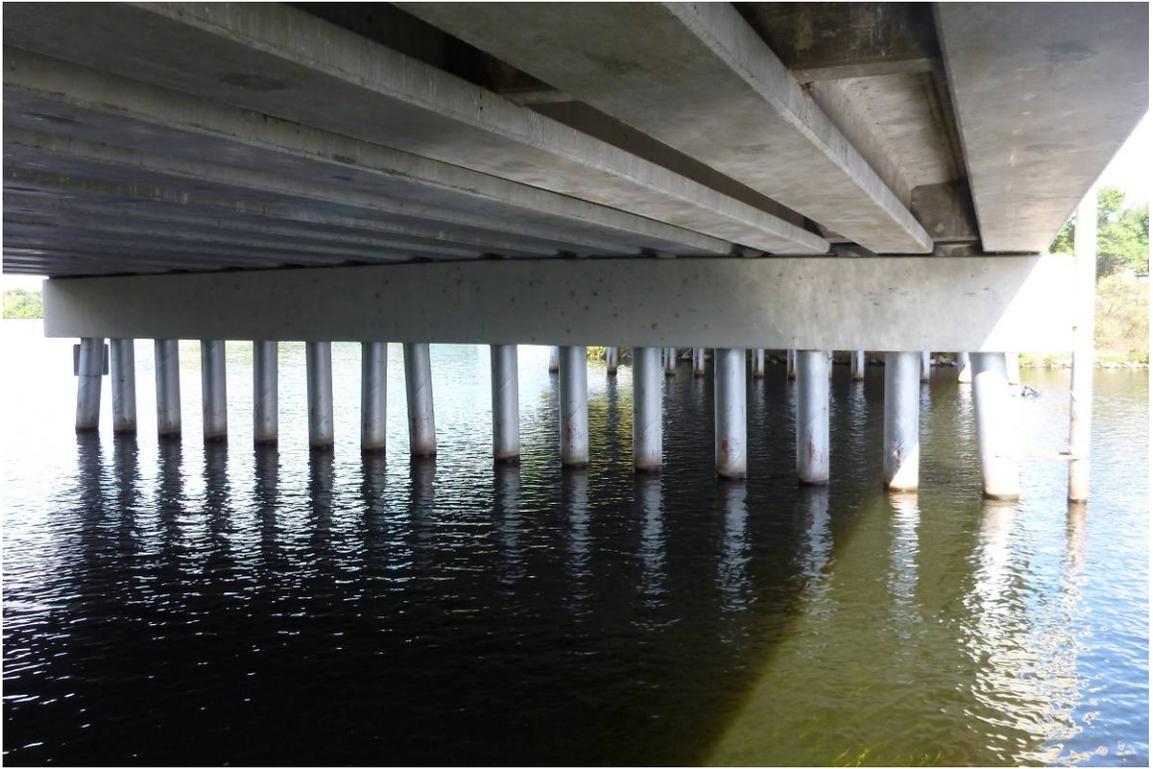
Photograph 1 View of Pier 1, Looking North.

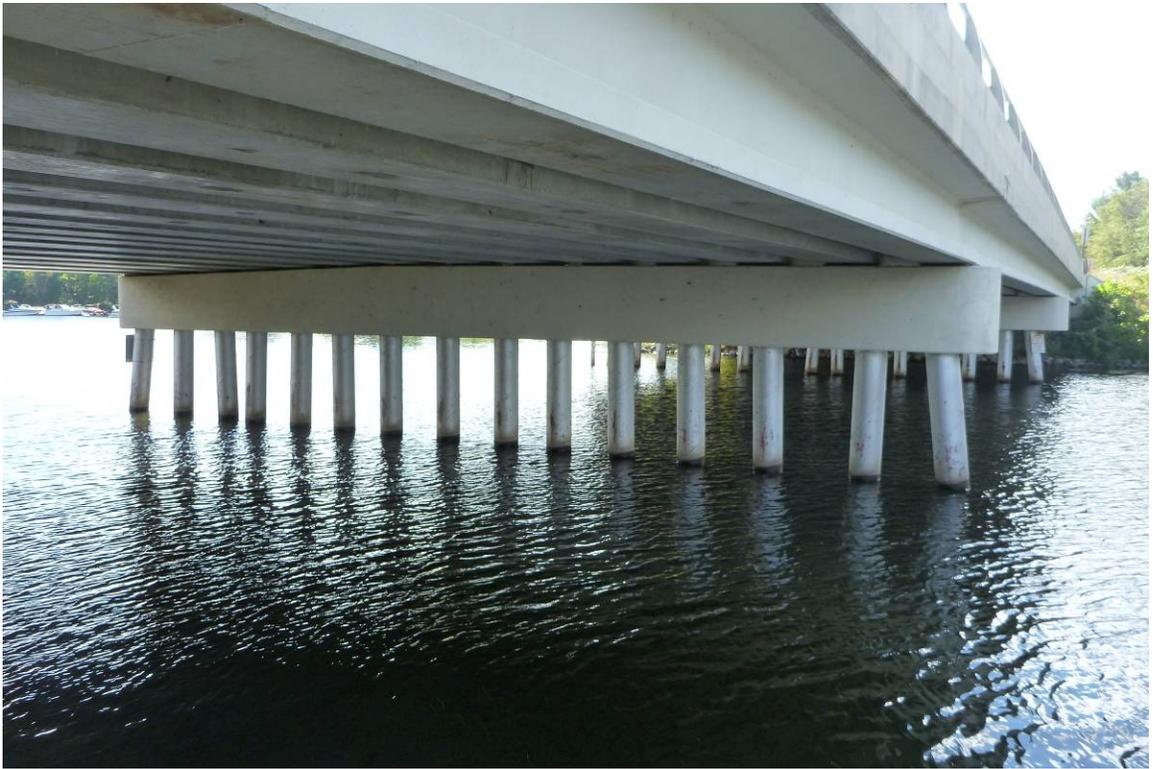
Photograph 2 View of Pier 2, Looking Southeast.

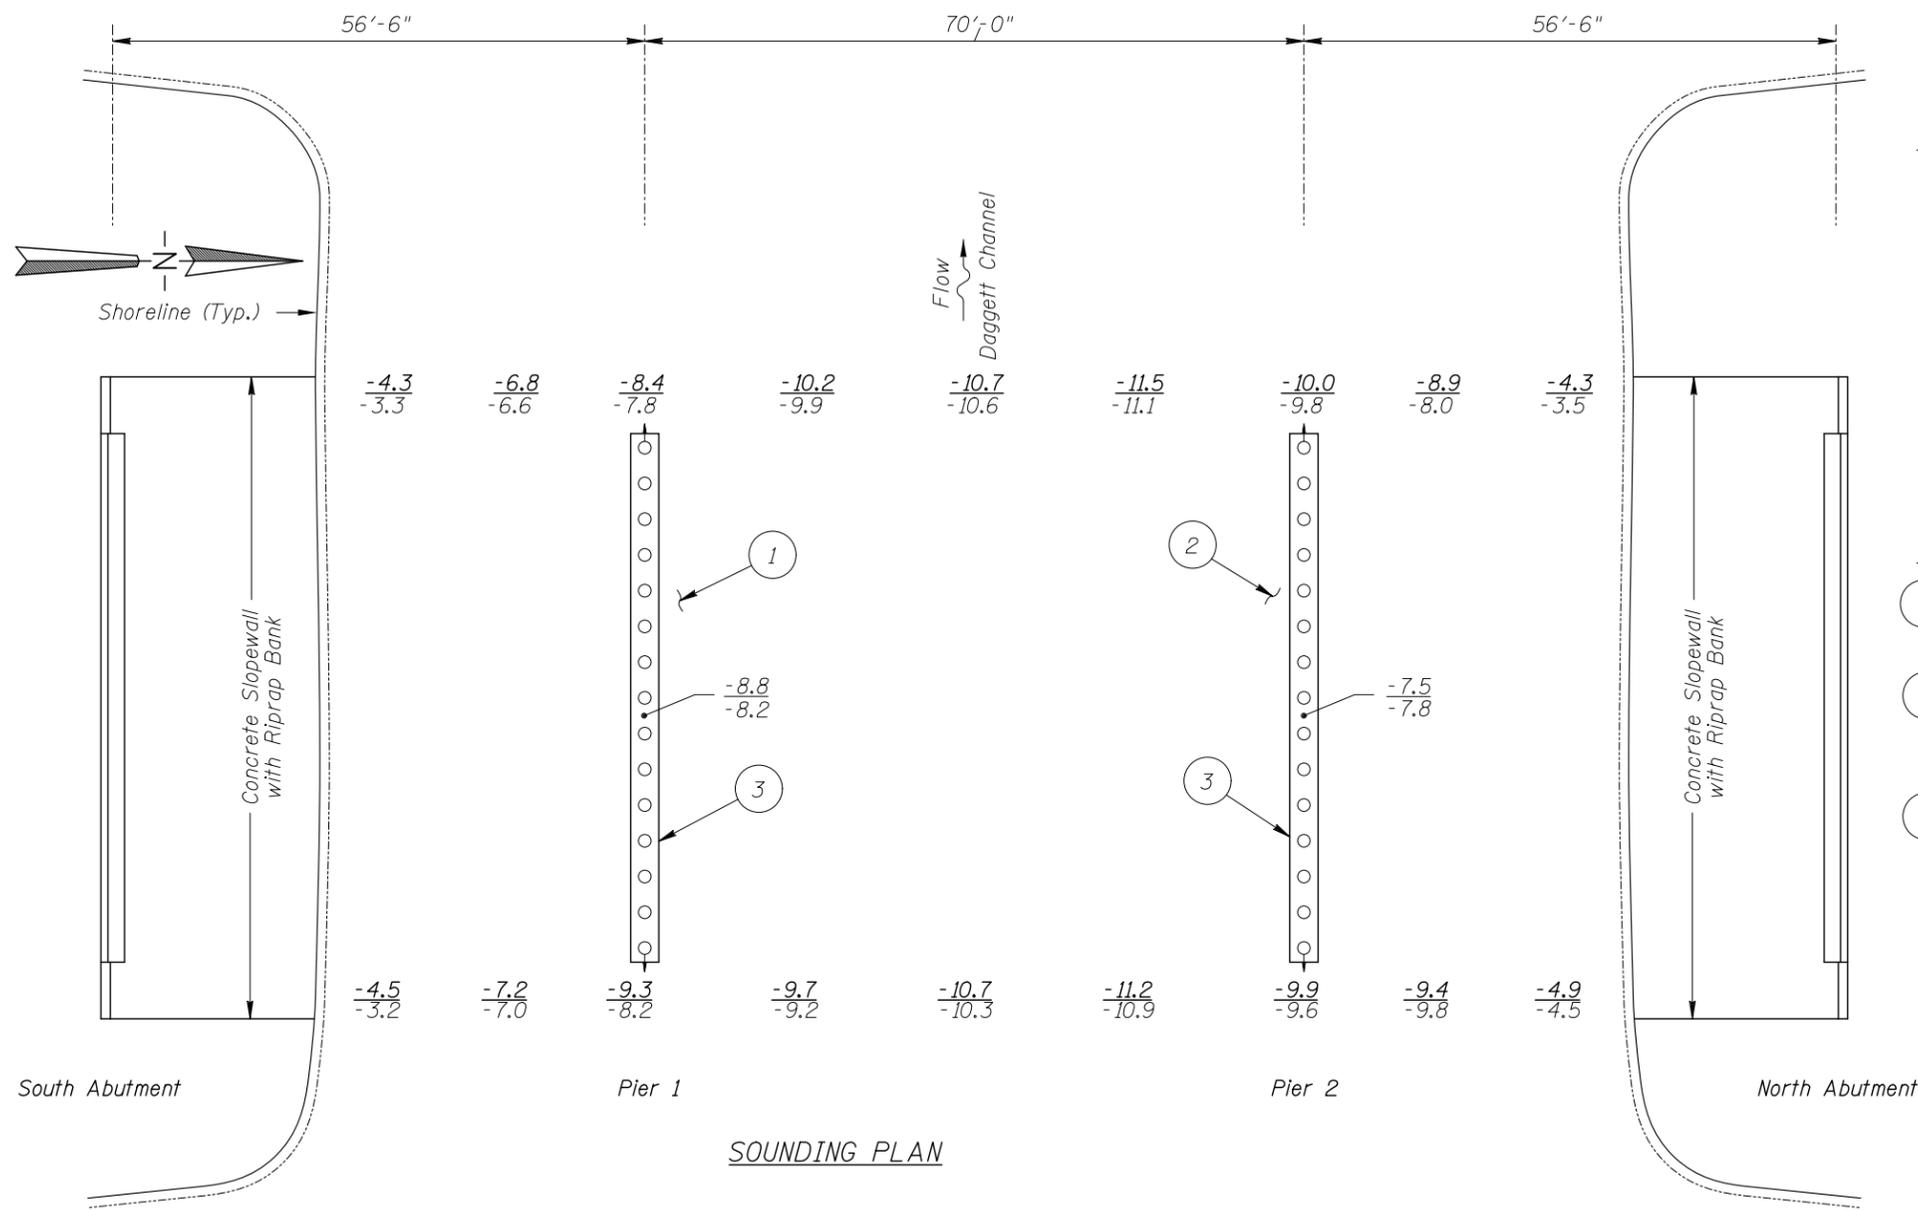
TYPICAL END VIEW OF PIERS

- 1 The channel bottom around Pier 1 consisted of sand with 6 to 8 inches of probe rod penetration.
- 2 The channel bottom around Pier 2 consisted of sand and 6- to 8-inch-diameter cobbles with 6 to 8 inches of probe rod penetration.
- 3 Piers 1 and 2 exhibited coating failure and surface corrosion from approximately 9 inches above the waterline to the channel bottom on approximately 30 percent of the surface area with 1/2-inch to 1.5-inch-diameter rust nodules and minimal section loss with pitting up to 1/32 inches deep.
