UNDERWATER BRIDGE INSPECTION REPORT

STRUCTURE NO. 30501

RUM RIVER

DISTRICT 3 - ISANTI COUNTY

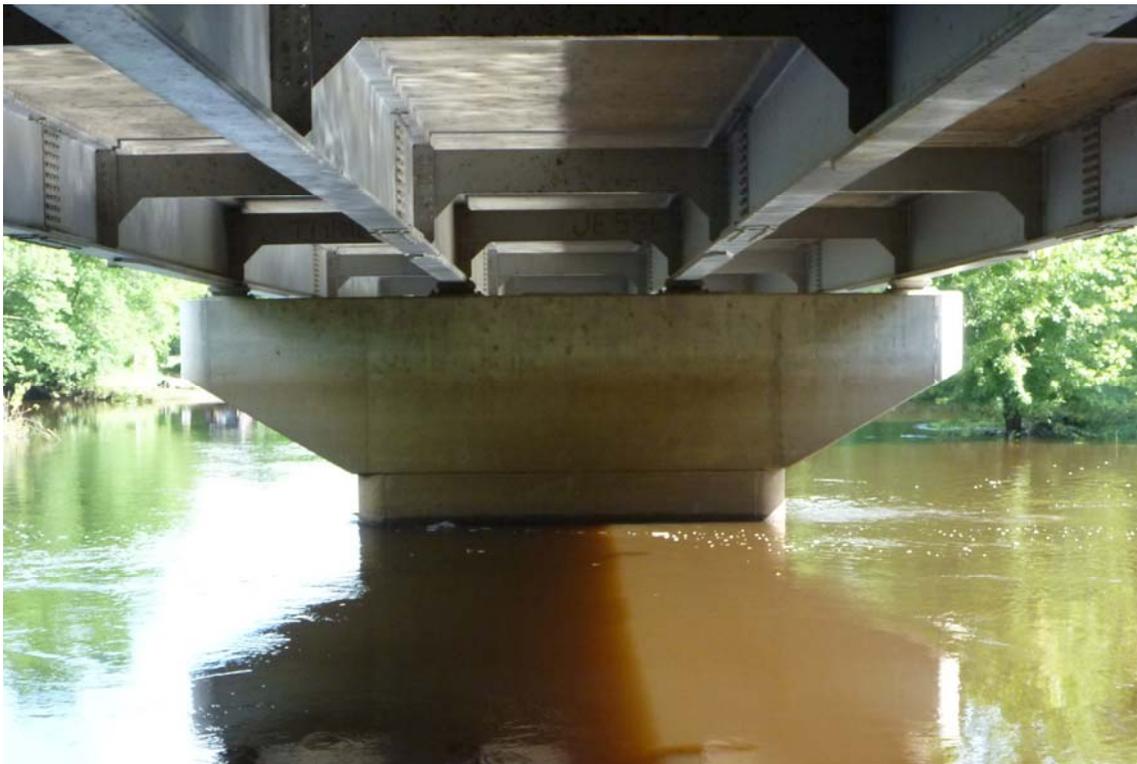
Photograph 2. View of Pier 1, Looking North.

- (A) A band of light scaling was observed around the entire perimeter of Piers 1 and 2 from the channel bottom to 2 feet below the waterline with up to 1/4 inch of penetration.
- (B) The entire pier shaft at Pier 1 and Pier 2 was located in a 2-foot-deep scour depression which extended approximately 3 feet off the pier faces and noses.

- (A) Monitor scour around the stem of each pier during future underwater inspections. If scour is found to be increasing and/or foundation undermining develops, scour counter measures may become warranted.

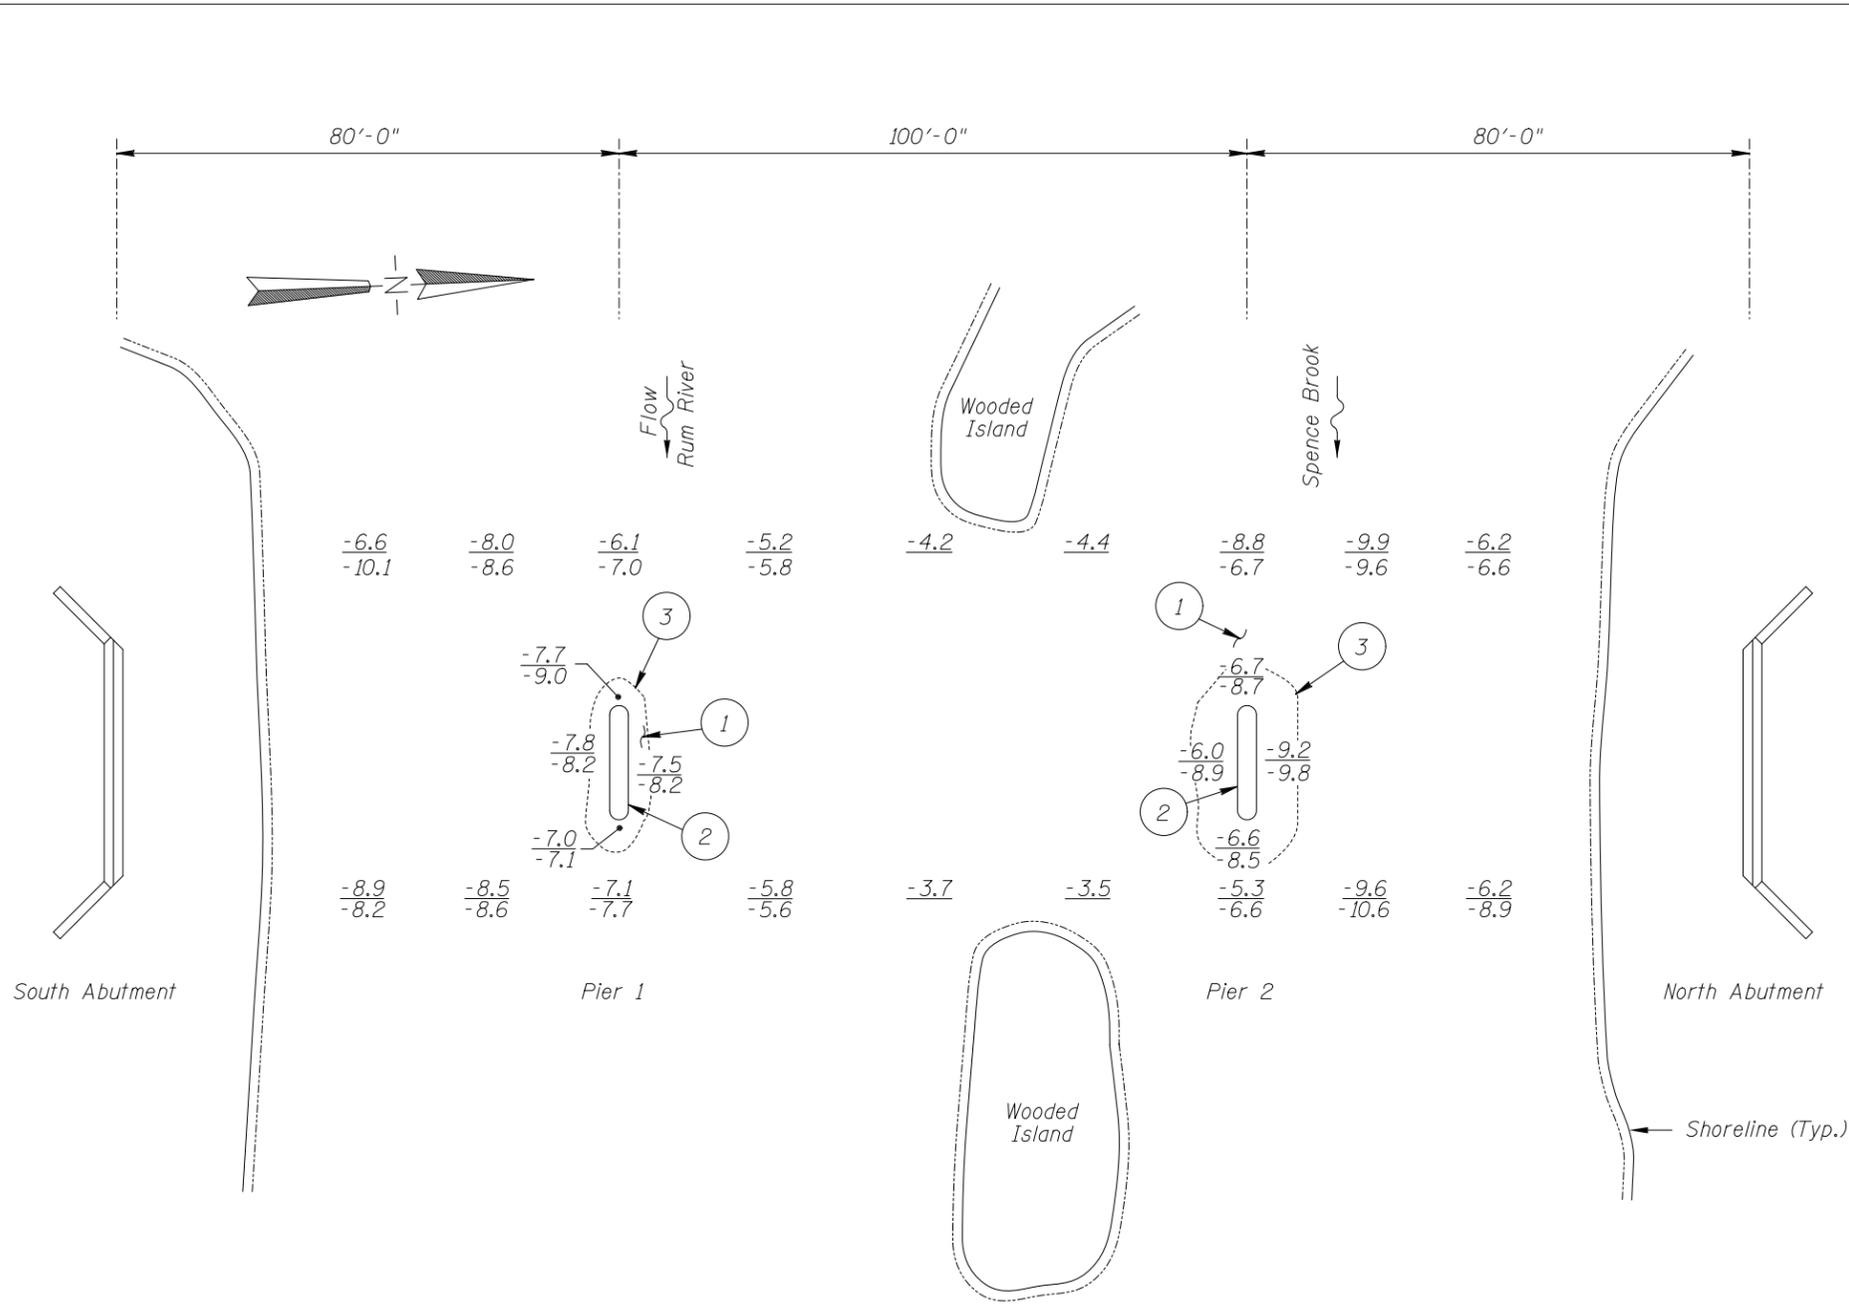
INSPECTION AND SOUNDING PLAN

- 1 The channel bottom consisted of silty sand with up to 1 foot of probe rod penetration.
- 2 A band of light scaling was observed around the entire perimeter of both piers and extended from the channel bottom to 2 feet below the waterline with up to 1/4 inch of penetration.
- 3 A scour pocket, 3 feet in radius by 2 feet deep, extended around the entire pier shaft at Pier 1 and 2.
