UNDERWATER BRIDGE INSPECTION REPORT

STRUCTURE NO. 30505

RUM RIVER

DISTRICT 3 - ISANTI COUNTY

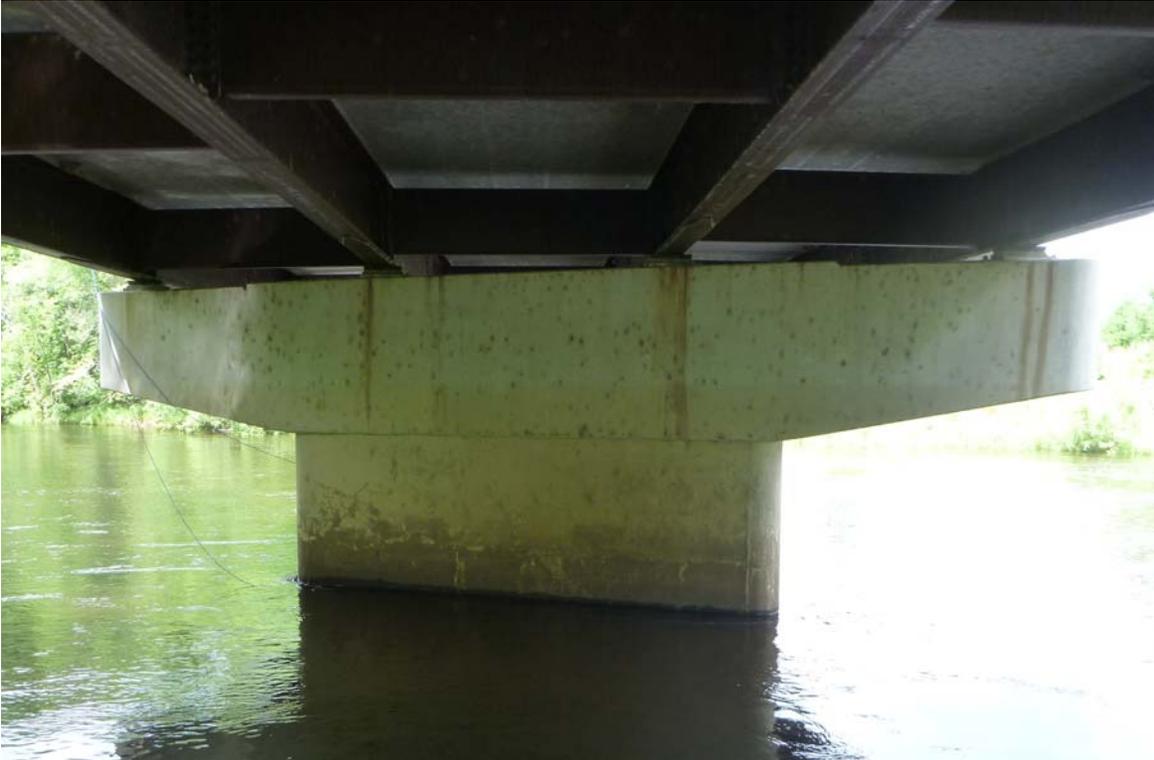
Photograph 2. View of Pier 1, Looking West.

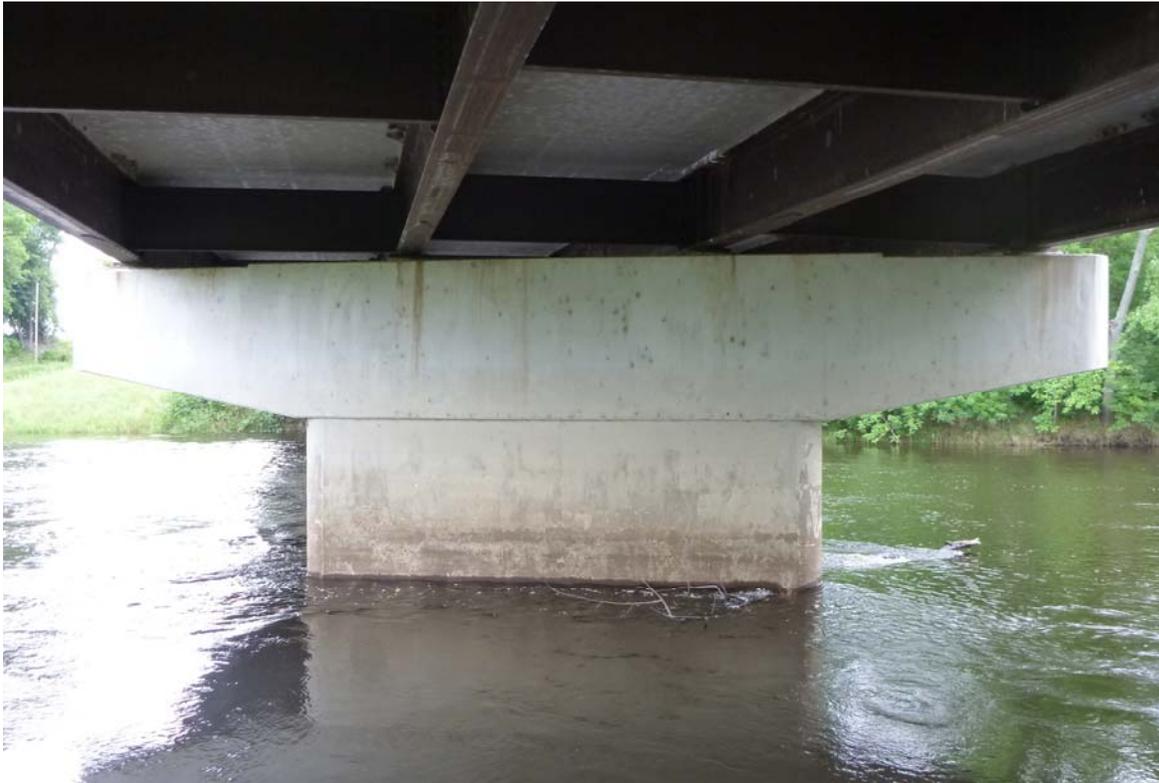
- (A) A band of light scaling was observed around the entire perimeters of Piers 1 and 2 from 7 feet below the waterline to 3 feet above the waterline with typical penetrations of 1/8 inch and a maximum penetration of 1/4 inch at the upstream nose.
- (B) Moderate accumulation of timber debris consisting of logs and branches up to 8 inches in diameter was observed along the upstream nose and the entire west face of Pier 2 extending from the channel bottom to the waterline and up to 3 feet off the pier face.

Photograph 3. View of Pier 2, Looking East.

- (A) Monitor the timber debris accumulation at Pier 2, during future inspections, and if found to be increasing to a more detrimental extent, removal operations may become warranted at that time.

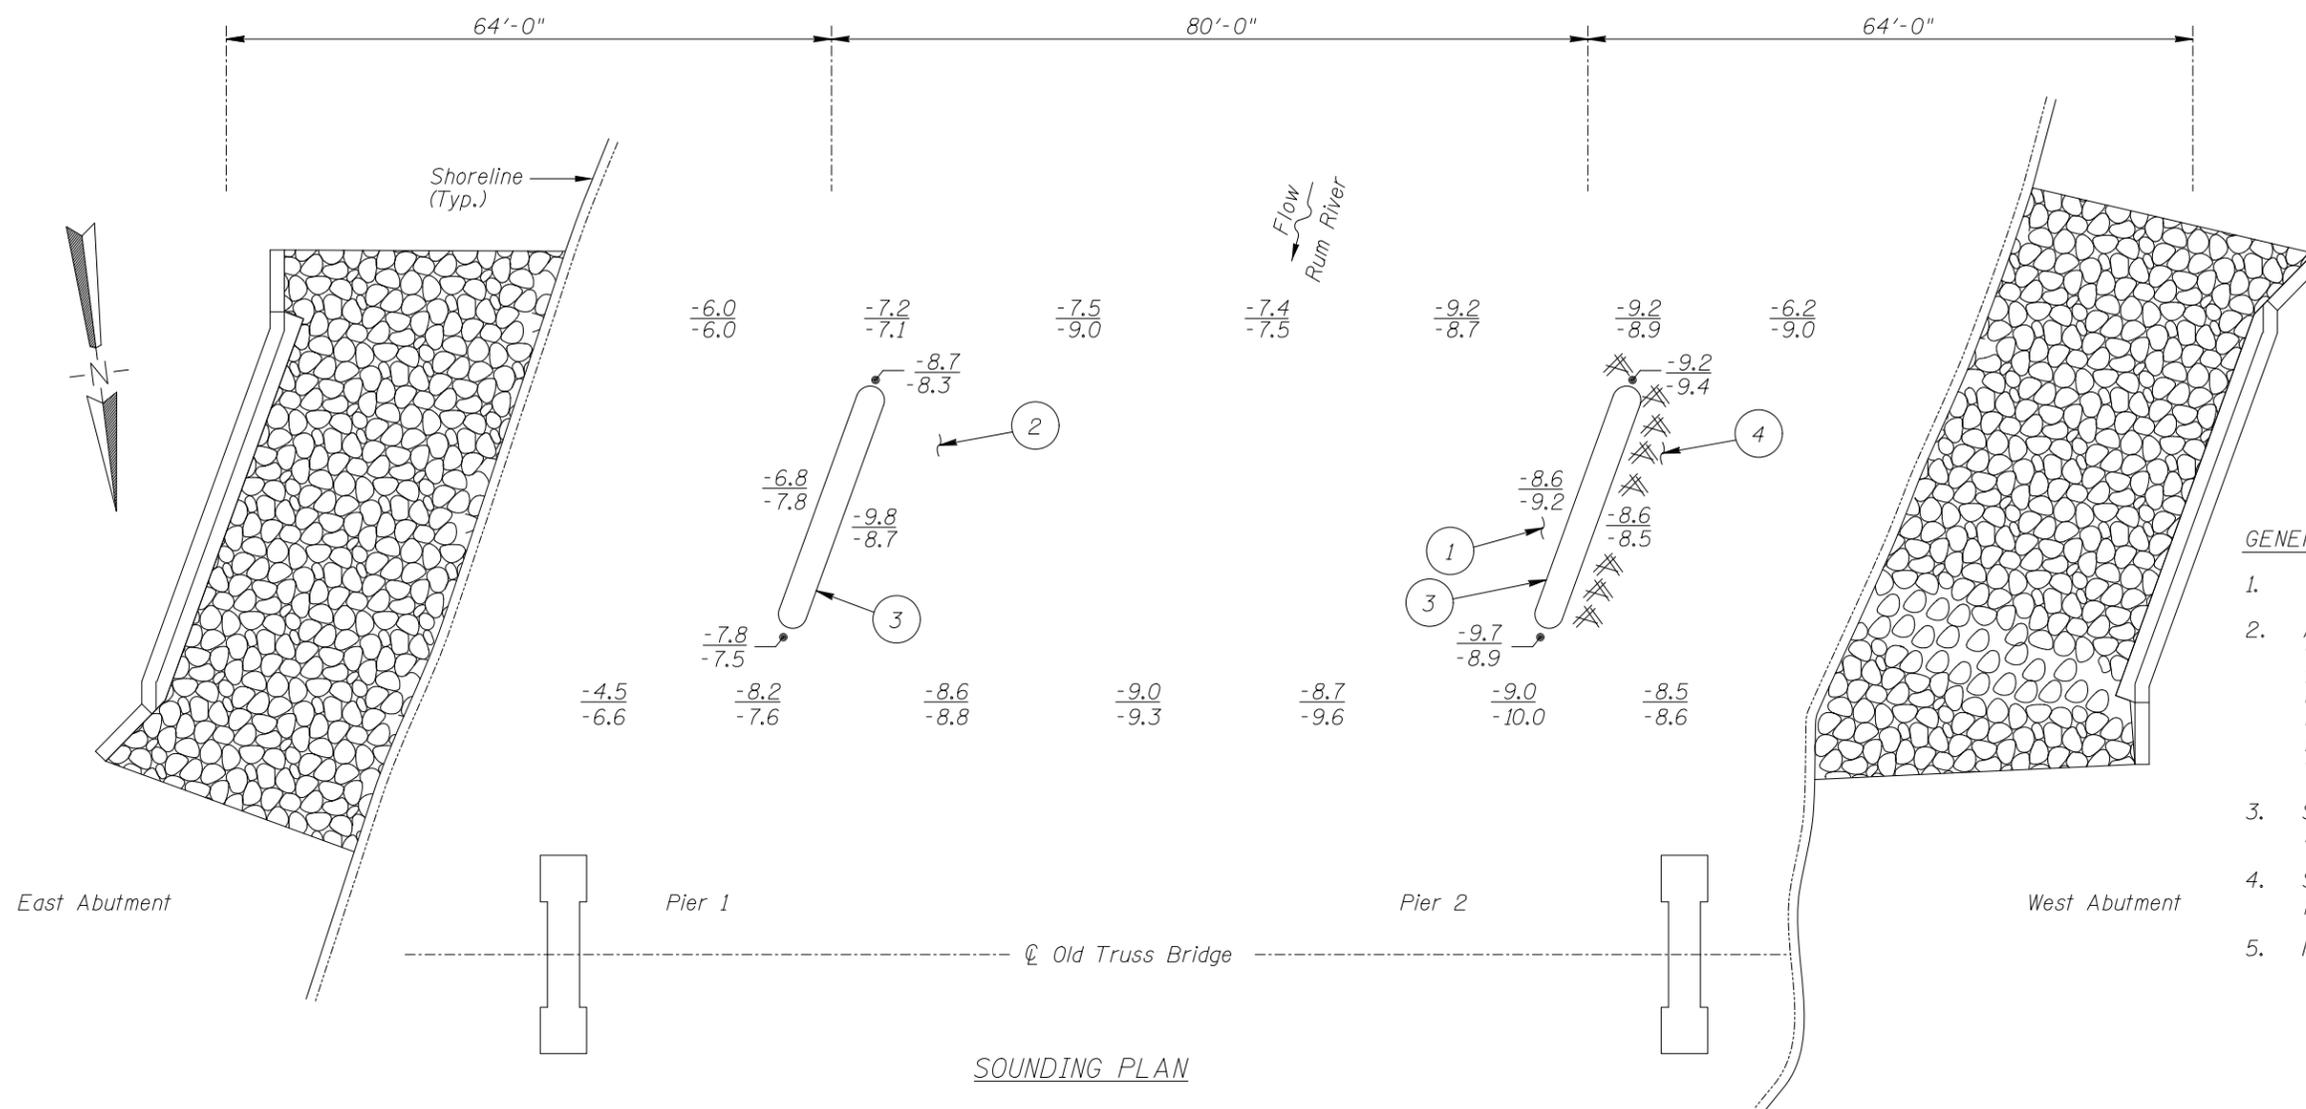
INSPECTION AND SOUNDING PLAN

- ① The channel bottom consisted of sand, gravel, and 4-inch-diameter cobbles with up to 1 inch of probe rod penetration.
- ② The channel bottom consisted of silty sand with up to 3 inches of probe rod penetration.
- ③ A band of light scaling was observed around the entire perimeter of Piers 1 and 2 from 3 feet below the waterline with typical penetrations of 1/8 inch deep and maximum penetrations of up to 1/4 inch deep at the upstream noses.
- ④ A moderate accumulation of timber debris, consisting of 8-inch-diameter and smaller logs and branches, was observed along the upstream nose and west face of Pier 2 and extended from the channel bottom to the waterline and up to 3 feet off the face of the pier.
