UNDERWATER BRIDGE INSPECTION REPORT

STRUCTURE NO. 30506
CR NO. 63
OVER THE
STANCHFIELD CREEK
DISTRICT 3 - ISANTI COUNTY

JULY 27, 2012

BY
COLLINS ENGINEERS, INC.

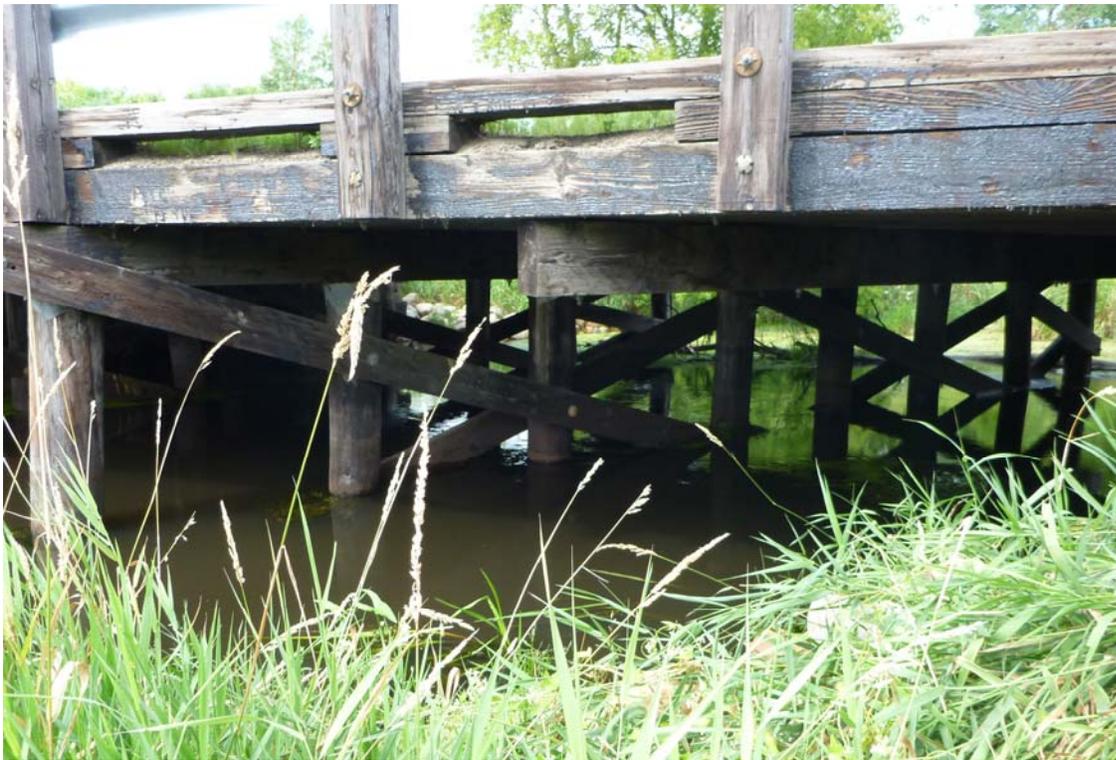
- (A) The timber piles at both piers were in good condition with minor checking up to 1/4 inch in width.
- (B) The upper and lower bracing connection to the easternmost pile of Pier 2 exhibited minor splits which did not affect the connection.
- (C) The upstream piles of each pier were protected with a steel ice breaker which exhibited moderate corrosion with rust delamination up to 1/4 inch thick and nodules up to 1/4 inch in diameter with 1/16 inch deep pitting extending from the channel bottom to the waterline.
- (D) Moderate accumulation of timber debris consisting of logs and branches up to 12 inches in diameter along with some vegetation was observed at the upstream fascia from Pier 1 to the North Shore, extending 5 feet upstream of the fascia and extending from the channel bottom to 1 foot above the waterline. The accumulation was 25 feet long by 3 feet wide.

Photograph 2. View of Pier 2, Looking Southwest.

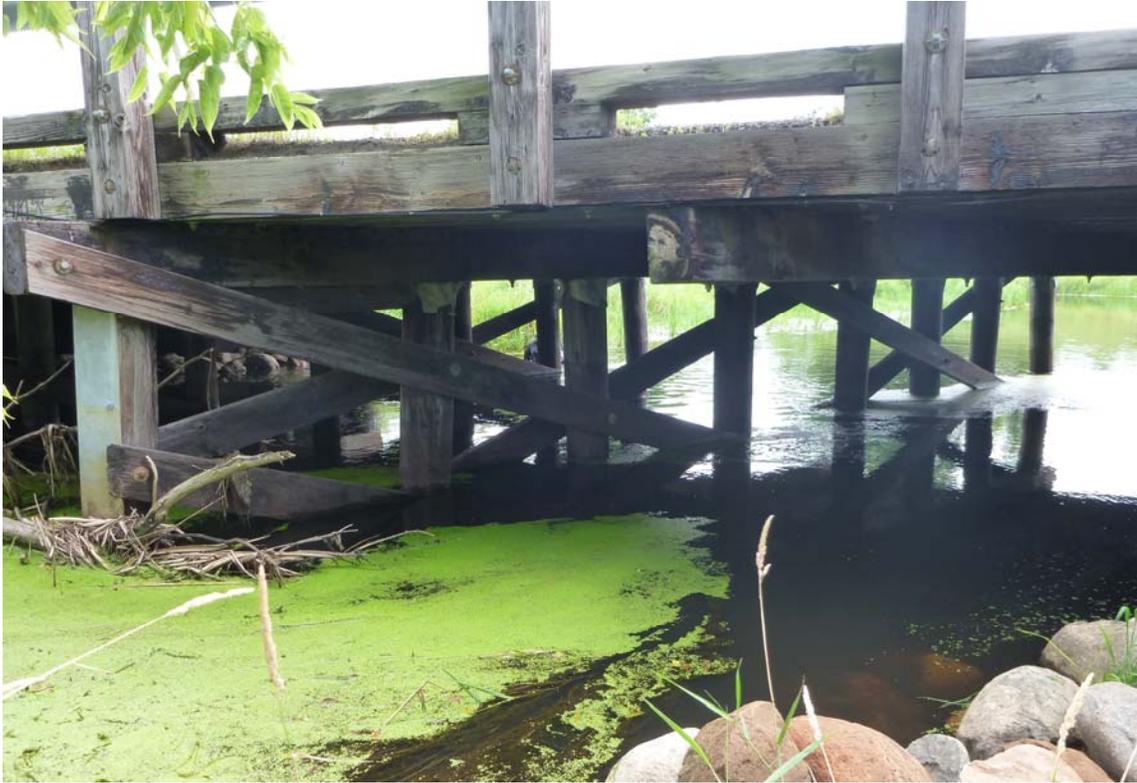
Photograph 3. View of Pier 1 and Timber Debris, Looking Northeast.

- (A) Monitor the timber debris accumulation at the piers, during future inspections, and if found to be increasing to a more detrimental extent, removal operations may become warranted at that time.

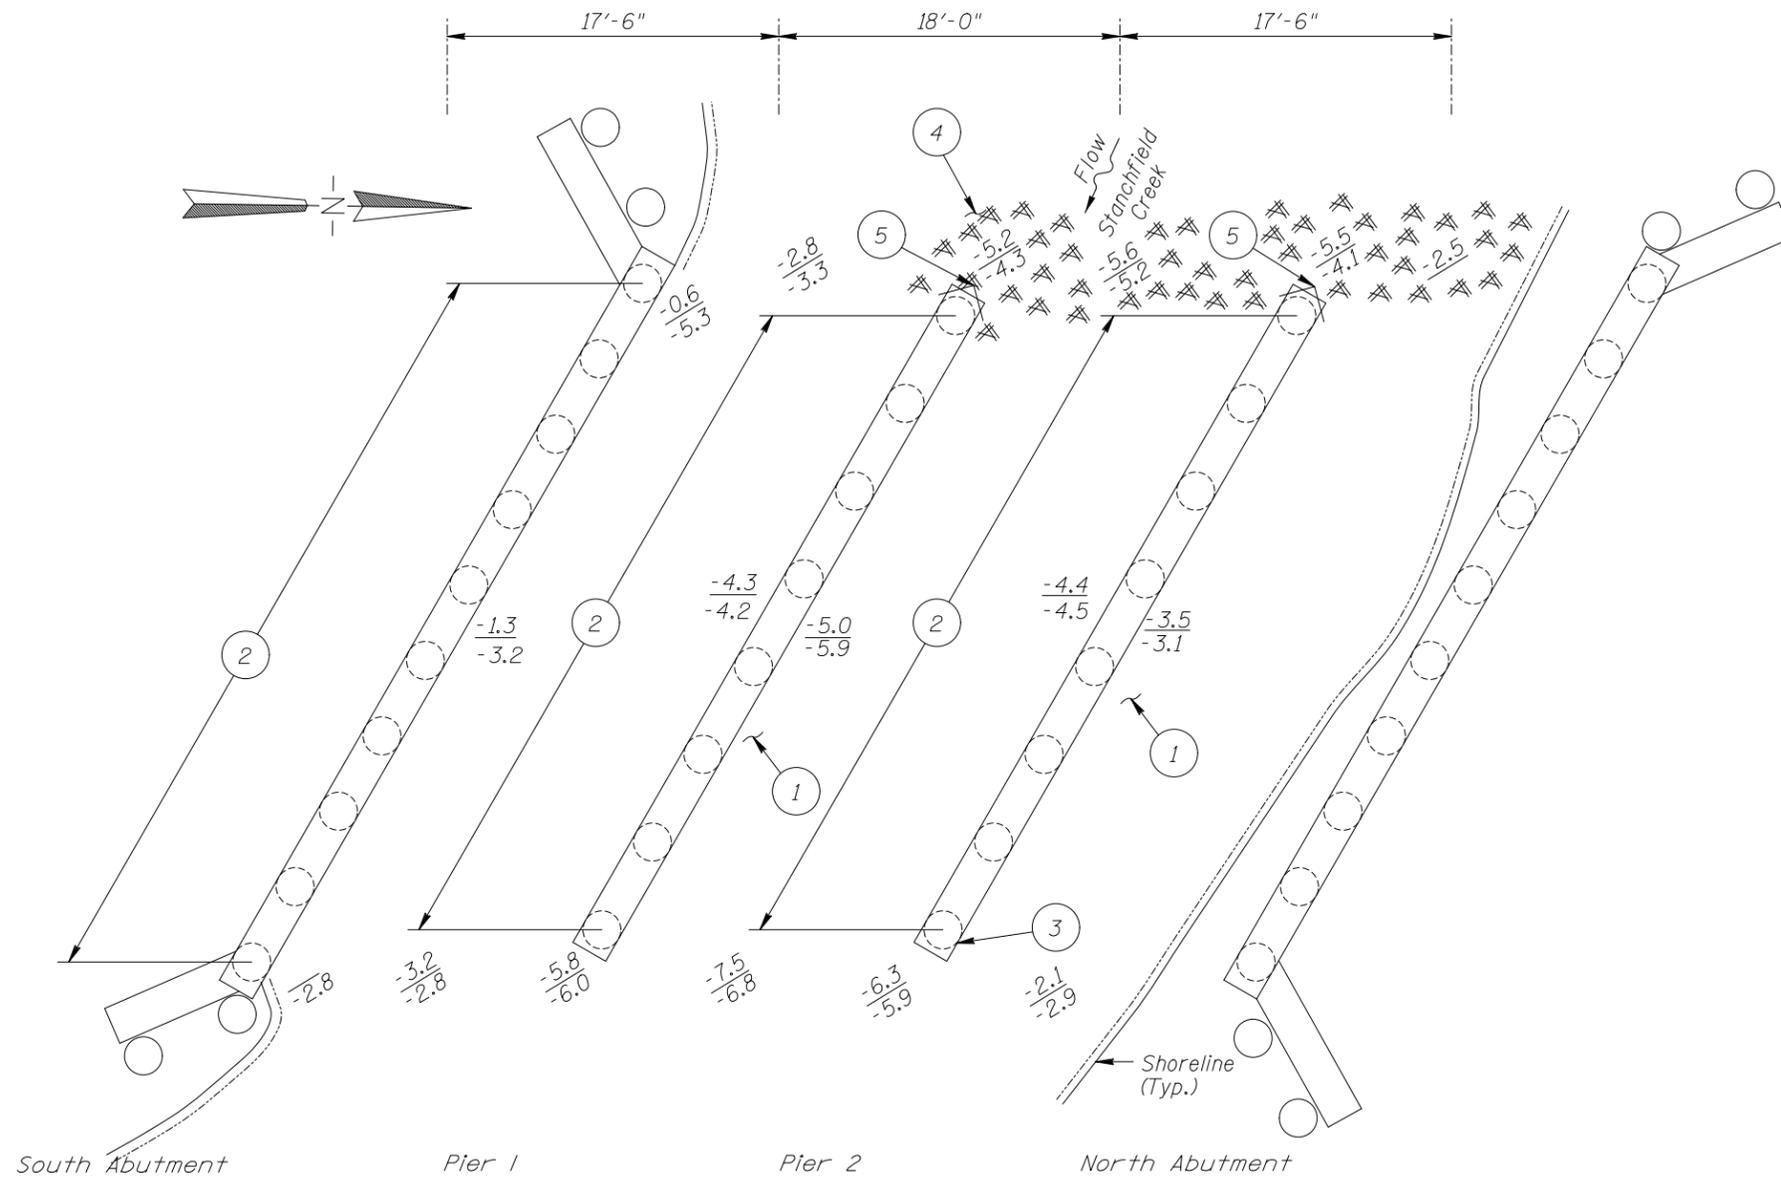
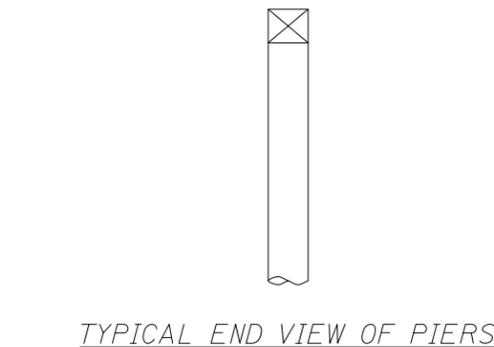
SOUNDING PLAN

- 1 The channel bottom consisted silty sand and of 6- to 8-inch-diameter cobbles with up to 1 inch of probe rod penetration.
- 2 The timber piles exhibited minor checking up to 1/4 inch wide.
- 3 The upper and lower cross bracing connection to the easternmost pile of Pier 2 exhibited minor splits.
- 4 A moderate accumulation of timber debris consisting of 12-inch-diameter and smaller logs along with some vegetation was observed at the upstream fascia from Pier 1 to the north shore, extending 5 feet upstream off the fascia and from the channel bottom to 1 foot above the waterline.
- 5 The upstream piles were protected with a steel ice breaker that exhibited moderate corrosion with rust nodules up to 1/4 inch in diameter with 1/16-inch-deep pitting from the channel bottom to the waterline.
