UNDERWATER BRIDGE INSPECTION REPORT

STRUCTURE NO. 30507

RUM RIVER

MINNESOTA DEPARTMENT OF TRANSPORTATION  
UNDERWATER BRIDGE INSPECTION

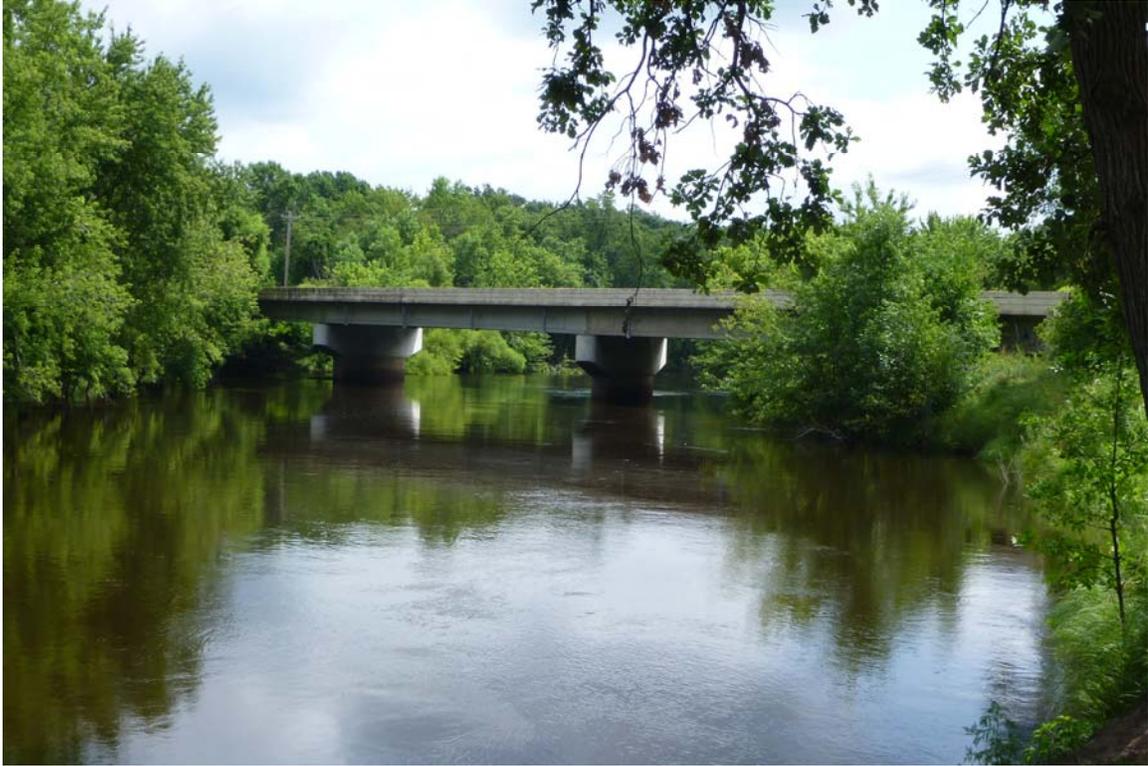
Photograph 1. Overall View of Structure, Looking South.

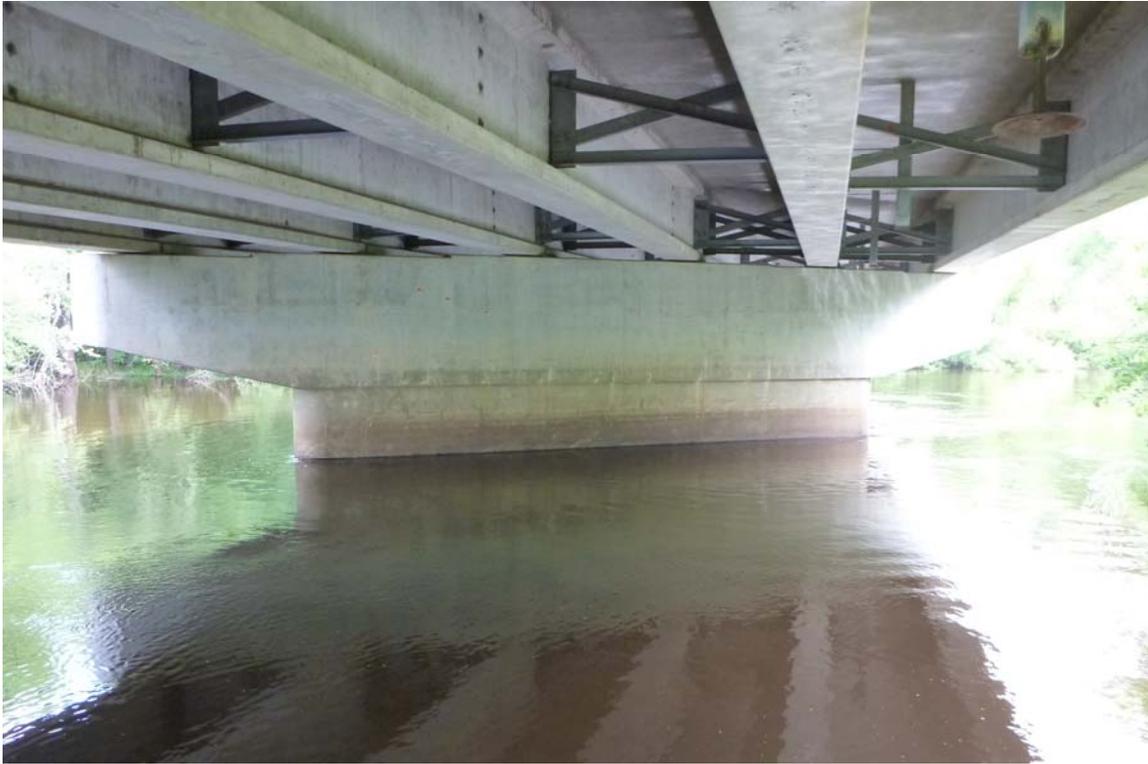
- (A) A 2-foot-long by 6-inch-high area of moderate scaling with a penetration of ½ inch was observed at the northwest corner of Pier 1 extending from 3.5 foot to 4 feet below the waterline.

- (B) Two 1 foot high areas of moderate to heavy scaling were observed on the east face of Pier 1, 5 feet below the waterline. The first one was 2 feet long with 1 inch penetration located 6 feet south of the upstream nose. The second area was 1 foot long with ½ inch penetration located 14 feet south of the upstream nose.

- (E) Light to moderate accumulations of timber debris were observed at Piers 1 and 2, with debris around the upstream nose at Pier 1 and along the west side at Pier 2.

Photograph 2. View of Pier 1, Looking East.

- (A) Monitor the timber drift that has accumulated around the piers, and if found to be progressing to the point of influencing or becoming excessive, then removal operations may become necessary.

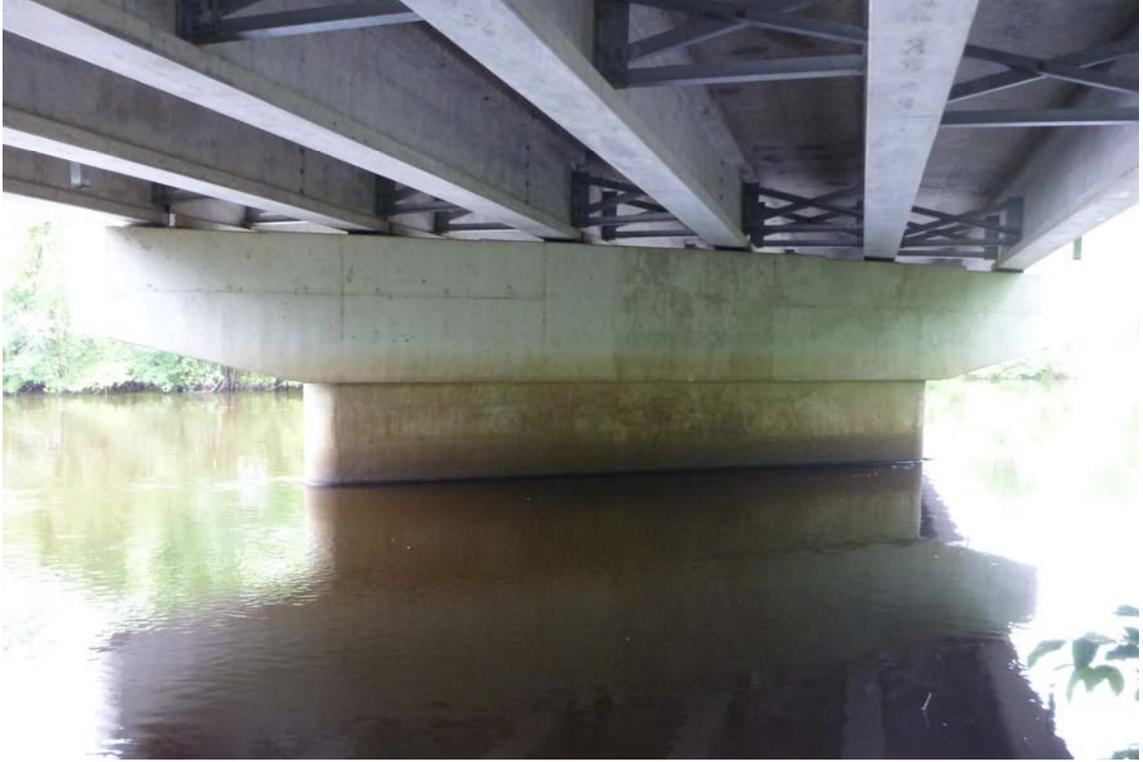
- (C) A 3 feet deep scour depression was present along the entire west face of Pier 2, extending up to 5 feet off the pier face.
- (D) A portion of the top of footing along the west side of Pier 2 was exposed, with no vertical exposure, extending from midpoint to the downstream quarter point of the pier shaft. The surface of the exposed footing exhibited moderate scaling with penetrations of up to 1/4 inch in depth.

Photograph 3. View of Pier 2, Looking West.

- (B) Reinspect the submerged substructure units at the normal maximum recommended (NBIS) interval of sixty (60) months. Continue to monitor the footing exposure at Pier 2 during future inspections.

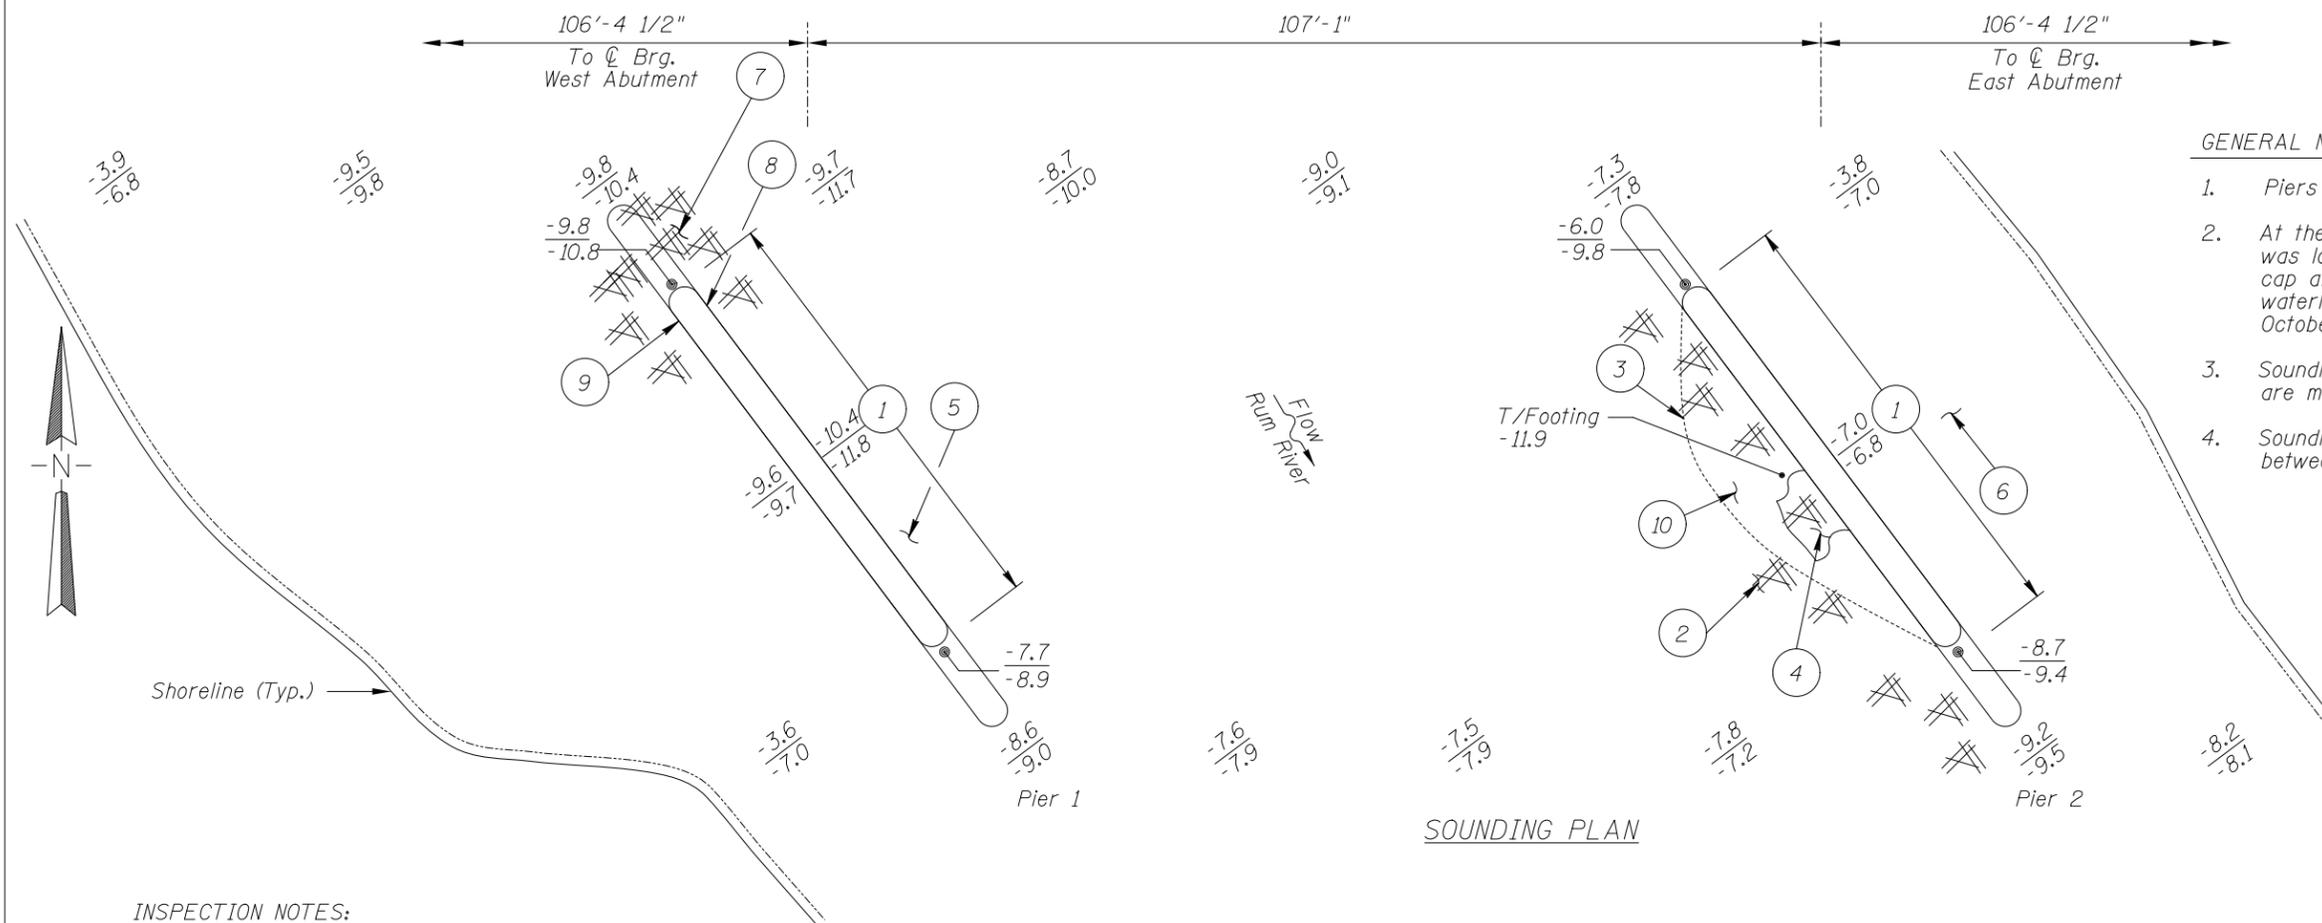
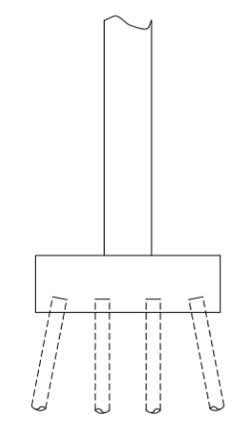
- All concrete surfaces from 3 feet below the waterline to the channel bottom exhibited light scaling with random pockets of poor consolidation with typical penetrations of 1/8 to 1/4 inch in depth.

- A light accumulation of timber debris consisting of 4-inch-diameter and smaller logs and branches extended along the entire west face of Pier 2 and from the channel bottom up 2 feet.

- A 5-foot-wide, 3-foot-deep scour pocket was observed along the entire west side of Pier 2.
- The top of the footing was partially exposed along the west side of Pier 2 from the midpoint of the shaft to the downstream 1/4 point, and the exposed surface exhibited light scaling with typical penetrations of 1/8 to 1/4 inch in depth.

- A light to moderate accumulation of 8-inch-diameter and smaller timber debris was observed at the upstream nose of Pier 1 and extended from the channel bottom up 4 feet.

- Two 1-foot-high areas of moderate scaling were located on the east face of Pier 1 at 5 feet below the waterline. One area was 2 feet long with up to 1 inch of penetration and was located 6 feet south of the upstream nose. The other area was 1 foot long with up to 1/2 inch of penetration and was located 14 feet south of the upstream nose.

- A 2-foot-long area of moderate scaling was located at the western upstream side of Pier 1 and extended from 3.5 to 4 feet below the waterline with up to 1/2 inches of penetration.
