UNDERWATER BRIDGE INSPECTION REPORT

STRUCTURE NO. 30508

RUM RIVER

JULY 27, 2012

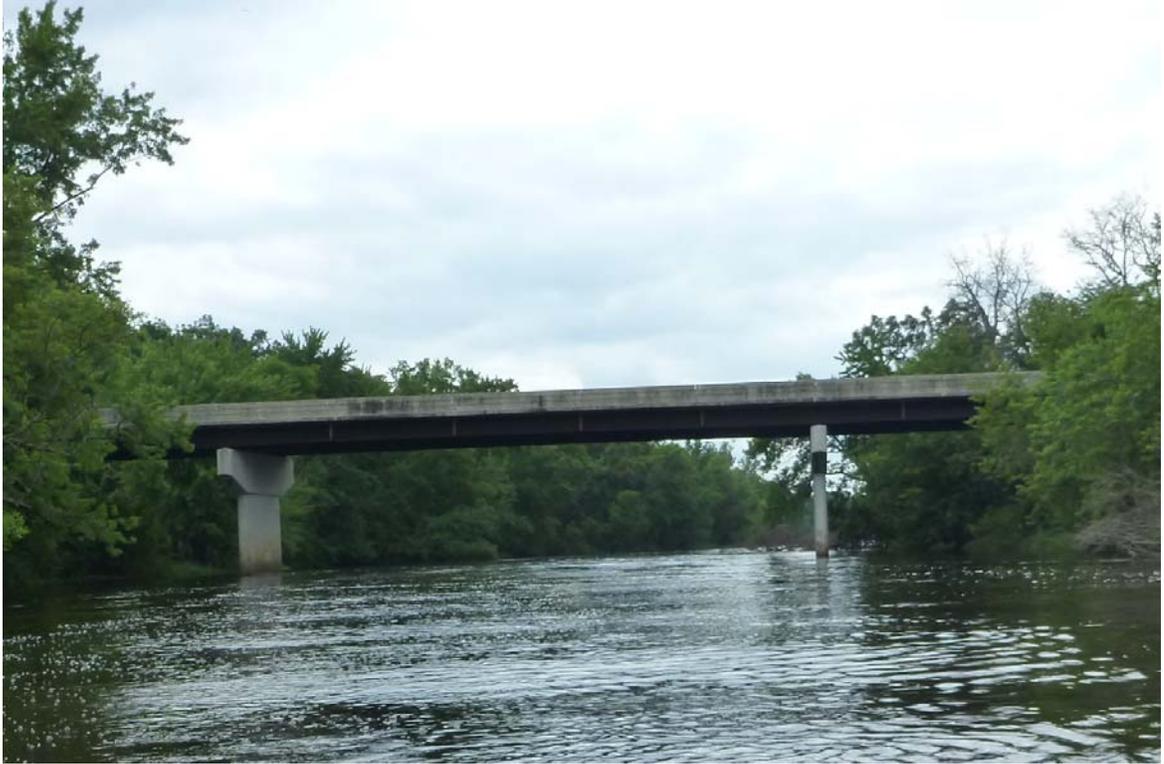
The substructure units inspected at Bridge No. 30508, Piers 1 and 2, were found to be in good and sound condition, similar to the findings of the last inspection, with no defects of structural significance. The channel bottom around both piers appeared stable with no significant scour and no exposed footings and with an overall configuration essentially the same as was found during the previous inspection.

Photograph 1. Overall View of the Structure, Looking South.

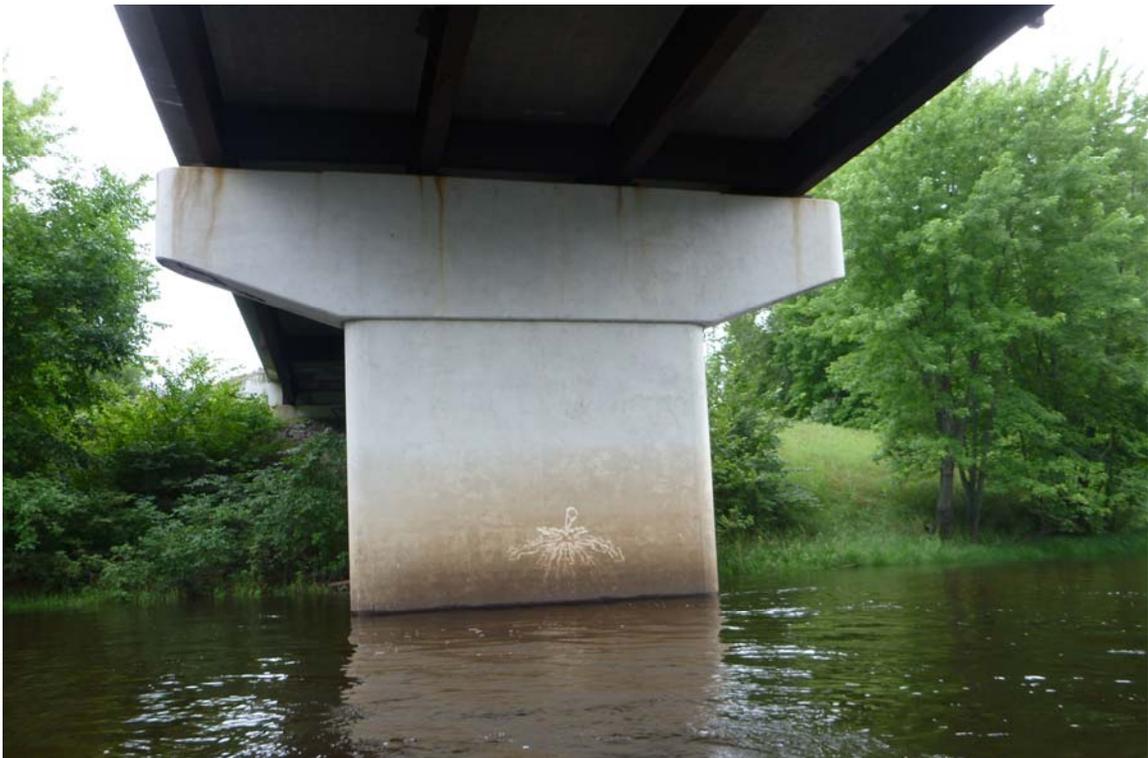
- (A) Overall, the submerged concrete of Piers 1 and 2 was in good and sound condition with light scaling having 1/8 inch typical penetrations from 2 feet below the waterline to the channel bottom
- (B) A light accumulation of timber debris was observed at the upstream nose of Pier 2 consisting of branches of 6 inches in diameter and smaller. The debris extended 8 feet around the entire nose of the pier and stretched from the channel bottom up 2 feet.

Photograph 2. View of Pier 1, Looking East.

- (A) Monitor the timber debris accumulation at both piers, in particular at Pier 2, during future inspections, and if found to be increasing to a more detrimental extent, removal operations may become warranted at that time.

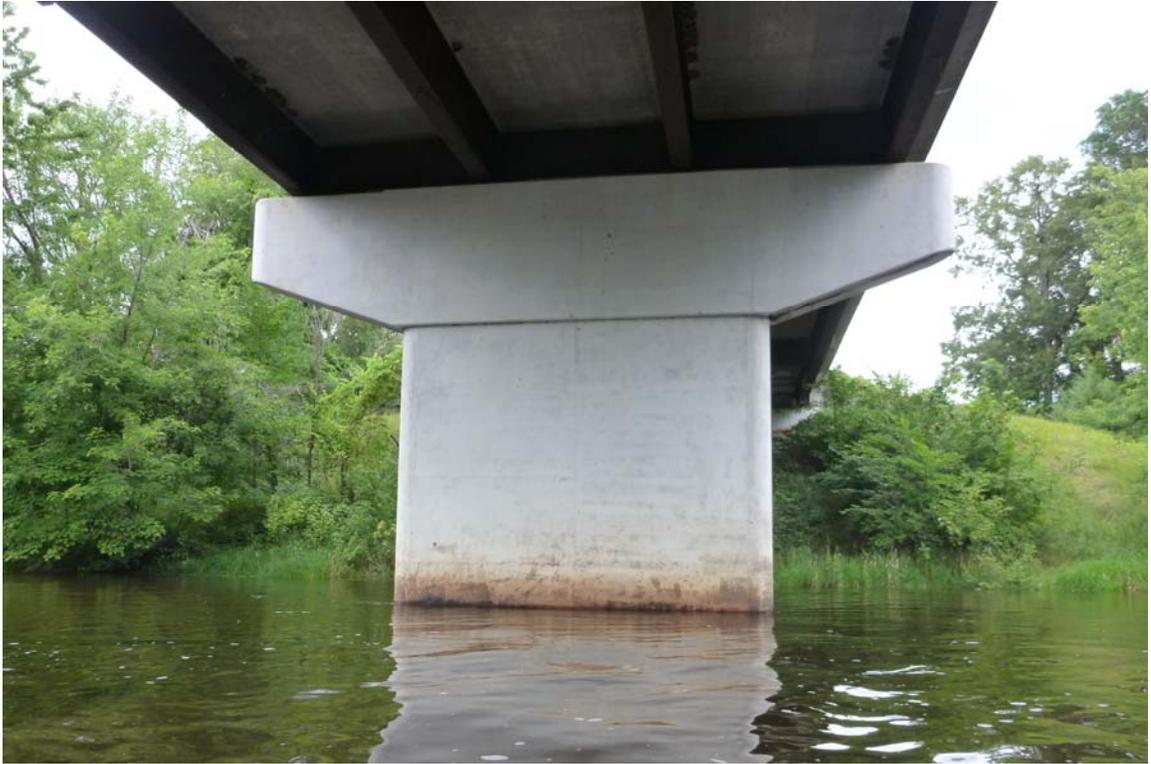
Photograph 3. View of Pier 2, Looking West.

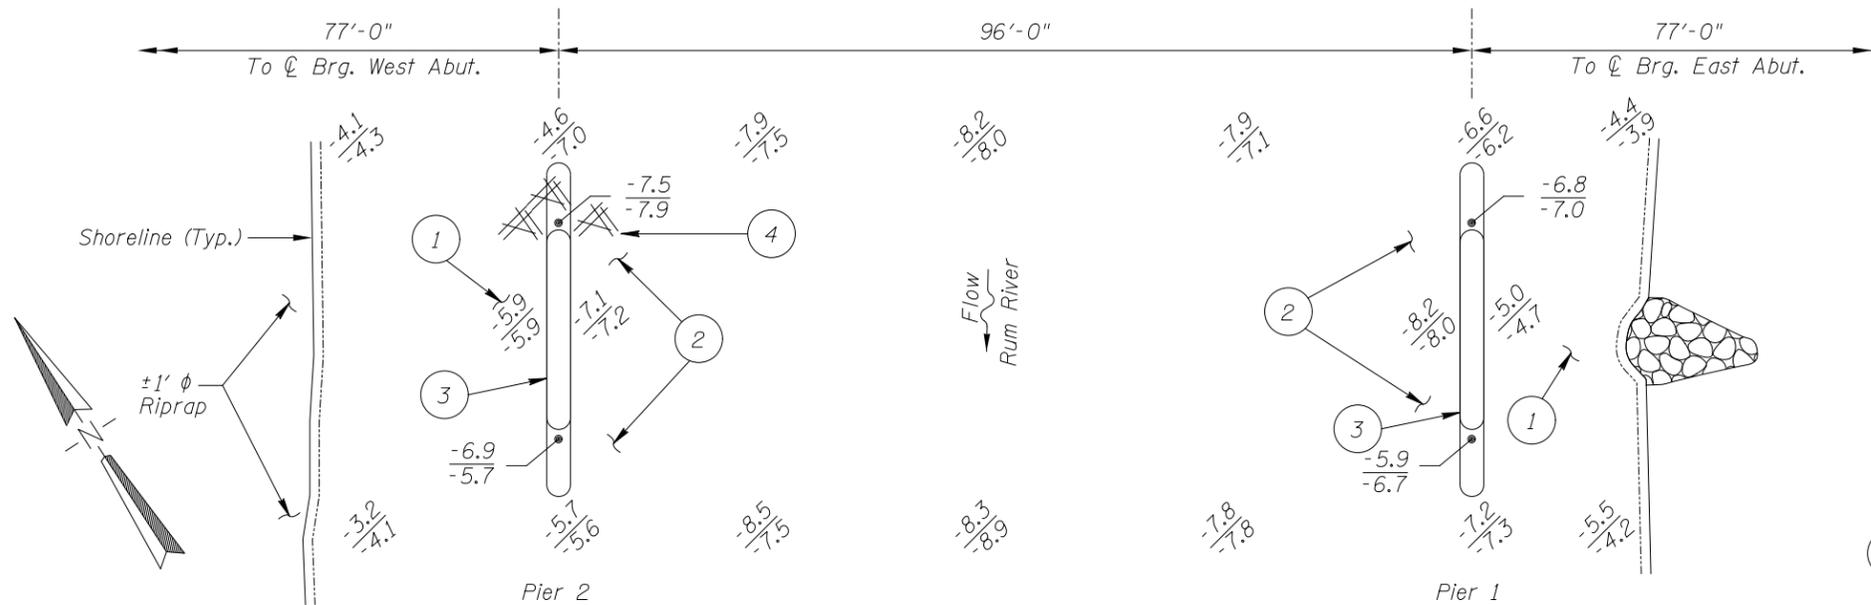
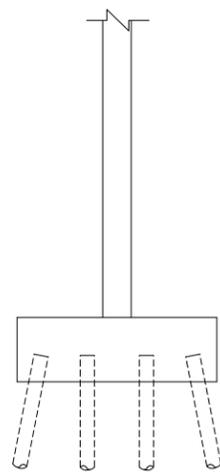
| INSPECTION AND SOUNDING PLAN | | |

- ① The channel bottom consisted of 8- to 12-inch-diameter riprap and sand, with no appreciable probe rod penetration.
- ② The channel bottom consisted of firm sandy gravel with probe rod penetrations of 2 to 3 inches.
- ③ The concrete surface was in smooth and sound condition with light scaling from 2 feet below the waterline to channel bottom with up to 1/8 inch of penetration.
- ④ Light timber debris accumulation, consisting of branches 6 inch diameter and smaller, was located at the upstream nose extending from channel bottom up 2 feet.
