UNDERWATER BRIDGE INSPECTION REPORT

STRUCTURE NO. 6518
MILL AVENUE (CSAH 3)
OVER THE
MISSISSIPPI RIVER
DISTRICT 3 – CROW WING COUNTY

OCTOBER 23, 2012

BY
COLLINS ENGINEERS, INC.

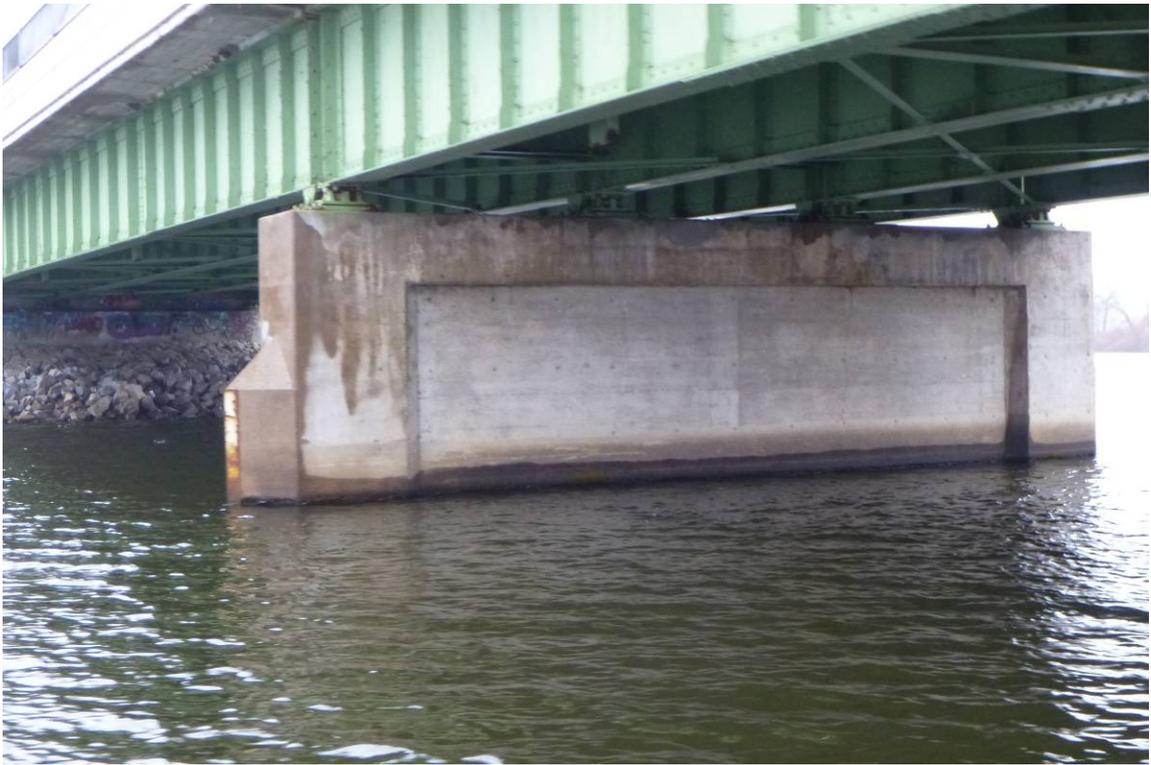
Photograph 1. View of Pier 1, Looking Southwest.

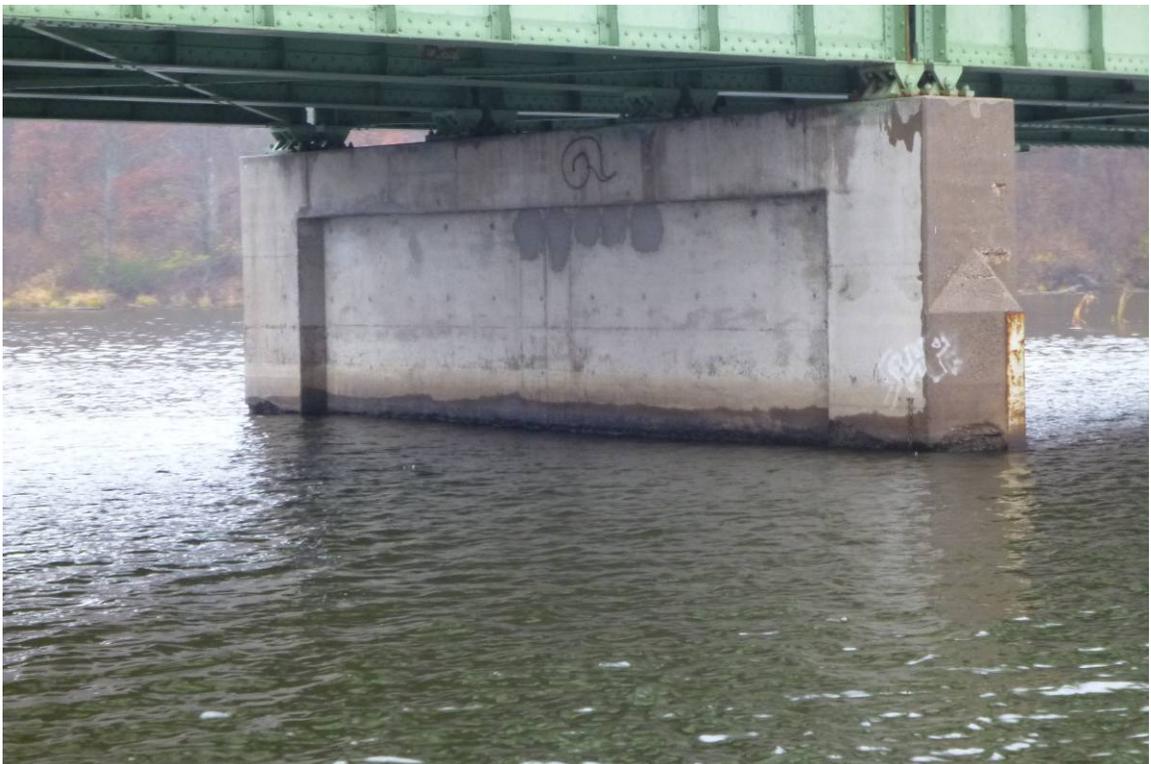
Photograph 2. View of Pier 2, Looking Northwest.

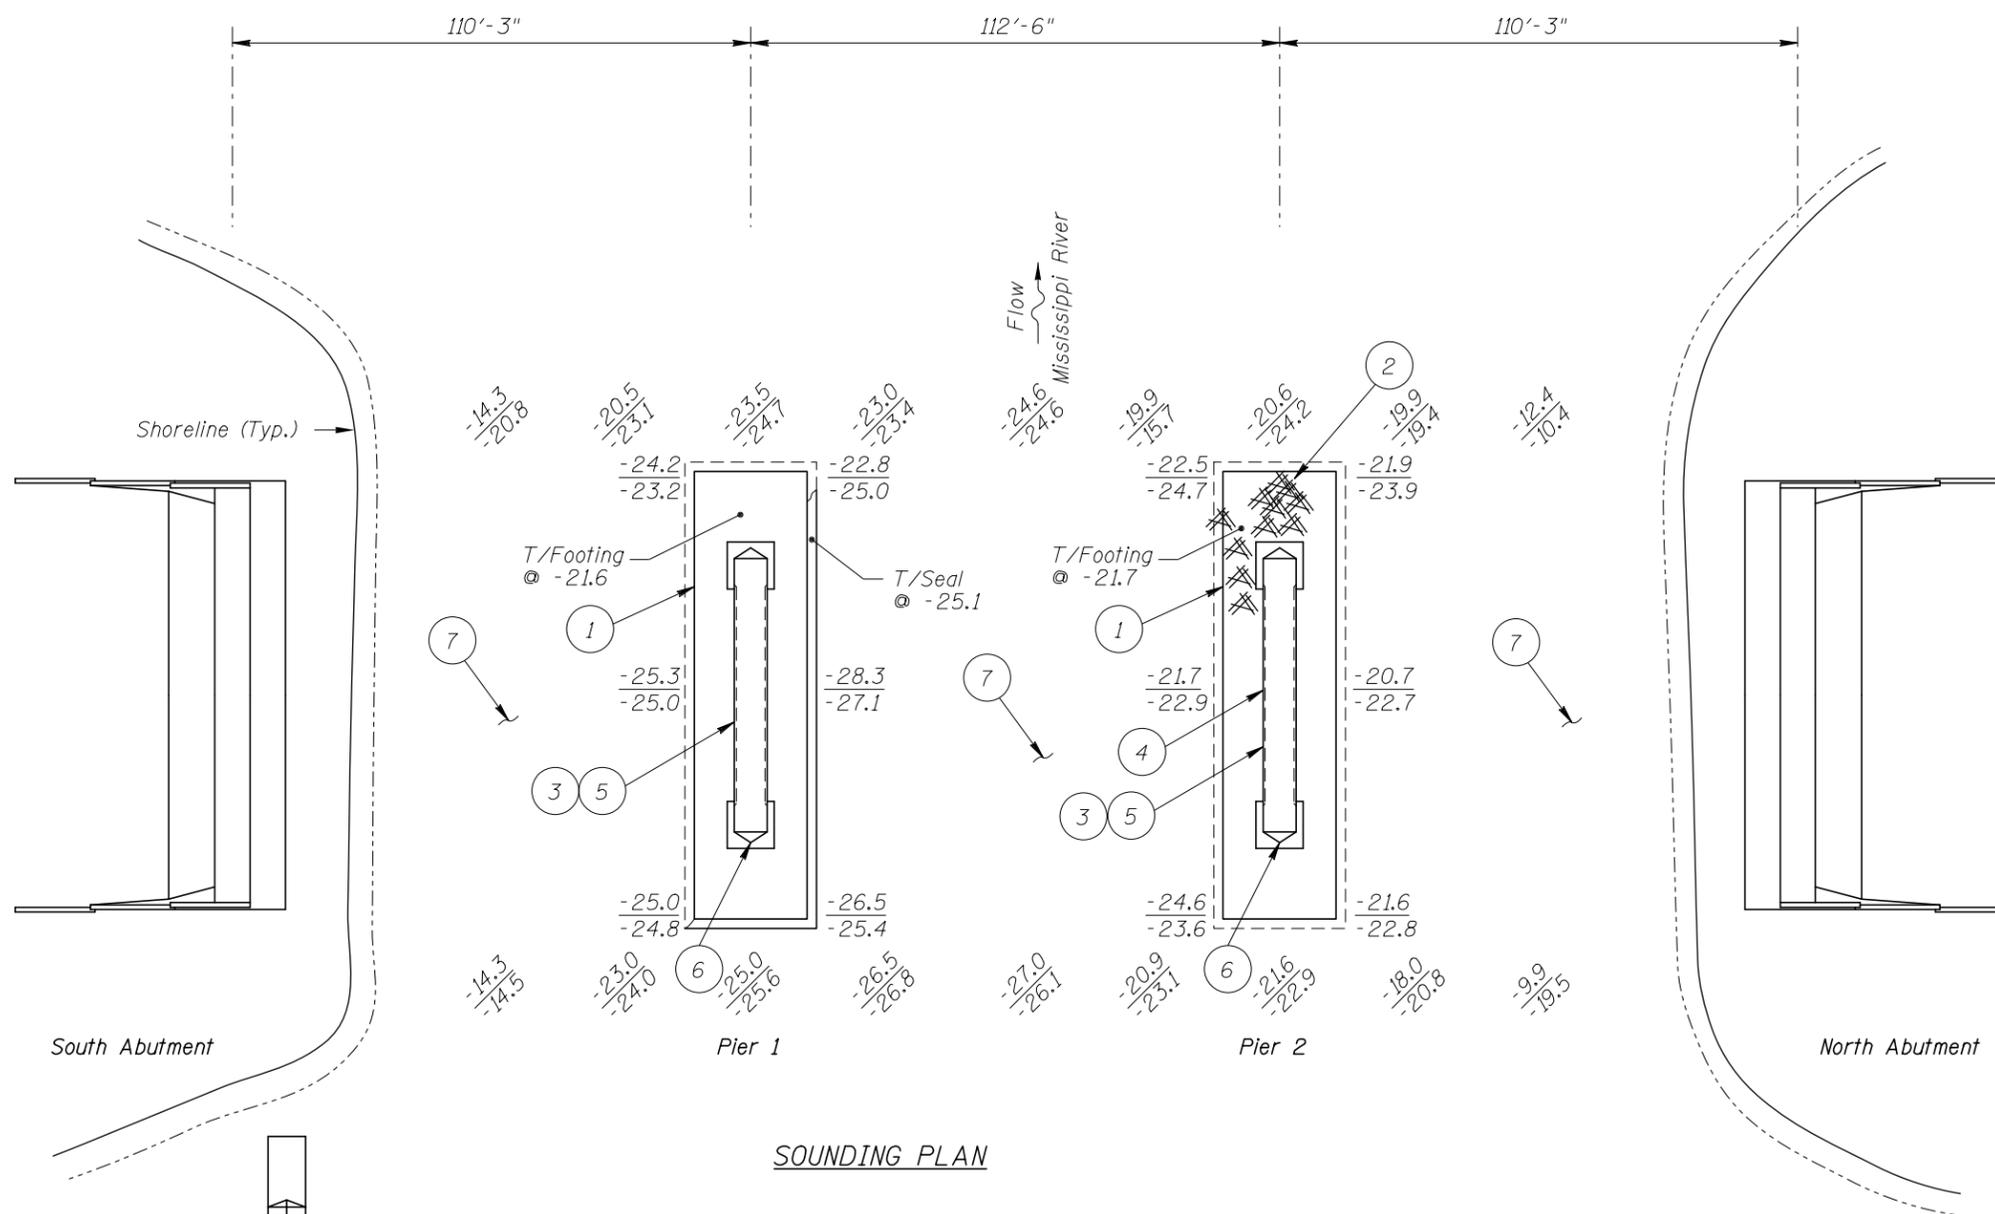
SOUNDING PLAN

- 1 There was footing exposure at both piers with a maximum vertical footing exposure of 3.5 feet and a maximum seal exposure (only present at Pier 1) of 2.5 feet. At Pier 1, the maximum seal exposure was located at the middle of the north side. At Pier 2, the 3 feet maximum footing exposure was located at the southeast corner.

- 2 There were logs up to 18-inch-diameter with associated branchy drift at the downstream nose of Pier 2 extending from the channel bottom up 4 feet, approximately 10 feet long and 10 feet wide.

- 3 There was moderate to heavy concrete scaling on both piers, typically from 6 inches above to 3 feet below the waterline with maximum penetration of 6 inches at the noses. Typical penetrations were up to 2 inches.

- 4 Spalls with 2 to 4 inches of penetration and exposed reinforcing steel were observed on the south face of Pier 2 from 6 feet above to 8 feet above the waterline.

- 5 Apart from the above mentioned scaling and spalls, the concrete of the pier faces and footings (where exposed) was typically smooth and sound with random minor areas of poor consolidation with up to 1/2 inch maximum penetration and random vertical hairline cracks from top of pier to channel bottom.

- 6 The steel ice breakers located at the upstream nose of both piers from 4 feet above the waterline to 6 inches below the waterline exhibited loss of coating and minor surface corrosion with no appreciable loss of section.

- 7 The channel bottom material consisted of sand and cobbles up to 6 inches in diameter allowing up to 4 inches of probe rod penetration.

Due to the presence of the piles under the footing, the extent of foundation exposure is not presently a concern and should only be monitored during subsequent inspections.

Repair the spalls at Pier 2 by removing all unsound concrete, cleaning the reinforcing steel, and patching with a concrete mix designed to promote high durability and low permeability.

The accumulation of timber debris at Pier 2 should be monitored during future underwater inspections, and if found to be progressing, removal measures may be warranted at that time.

Reinspect the submerged substructure units at the normal maximum recommended (NBIS) interval of sixty (60) months, and continue to monitor the extent of footing exposure at all piers.
