UNDERWATER BRIDGE INSPECTION REPORT

STRUCTURE NO. 73510

SAUK RIVER

JULY 29, 2012

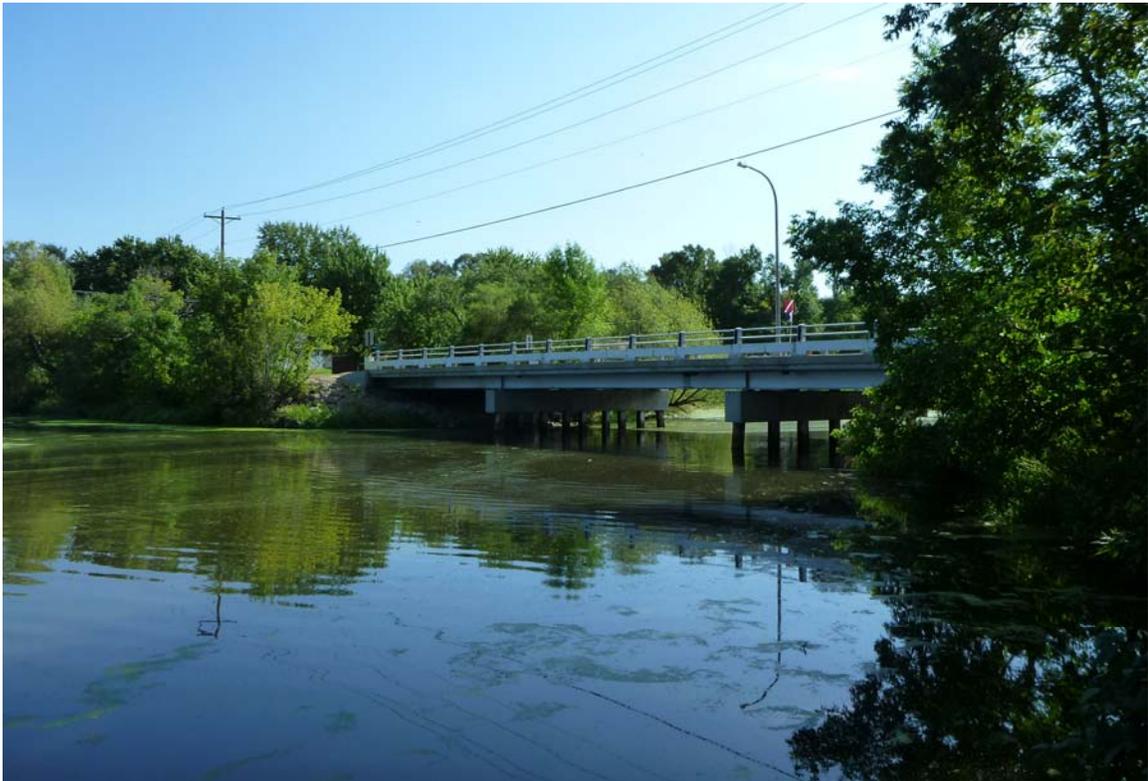
Photograph 1. Overall View of the Structure, Looking Northeast.

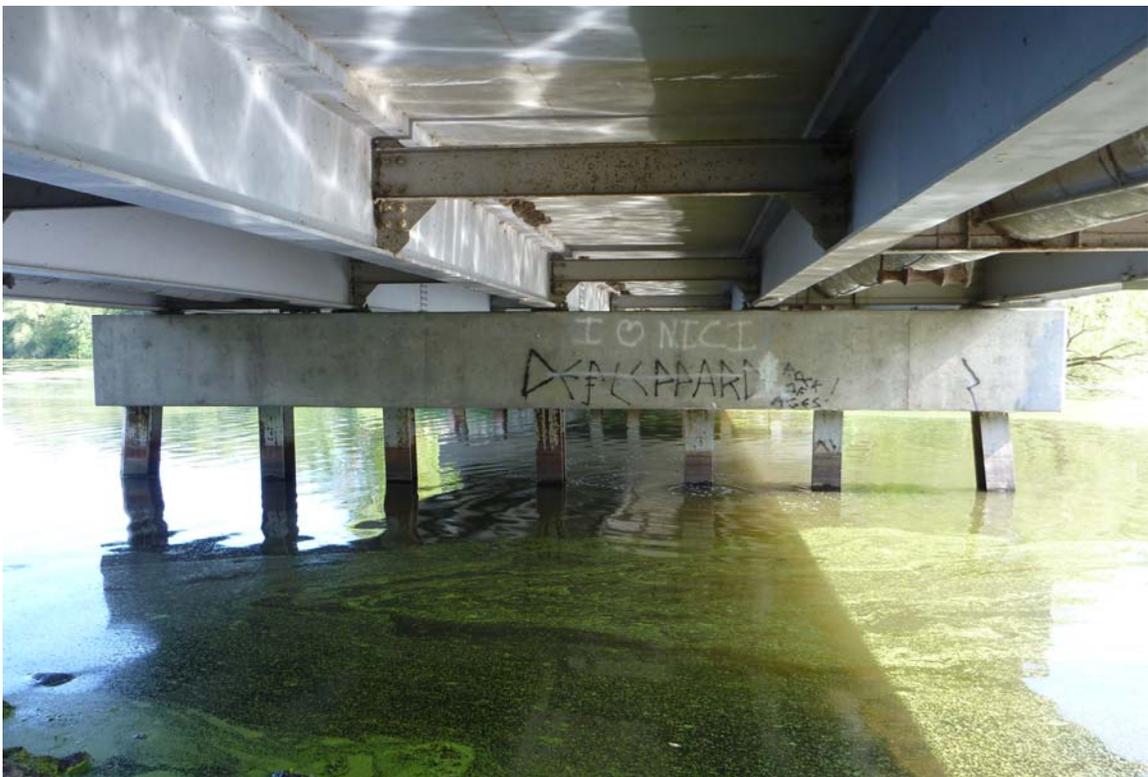
- (A) All steel H-piles of both piers exhibited light surface corrosion and pitting on 100 percent of the surface area from 1.0 foot above the waterline to the channel bottom, with rust nodules 1/2 inch in diameter and 1/16 inch deep pitting present on 25 to 50 percent of the surface area from the waterline to 1.0 foot above the waterline. This corrosion was related to the coating failure on the steel H-piles.

Photograph 2. View of Pier 1, Looking North.

- (A) Reinspect the submerged substructure units at the normal maximum recommended (NBIS) interval of sixty (60) months.

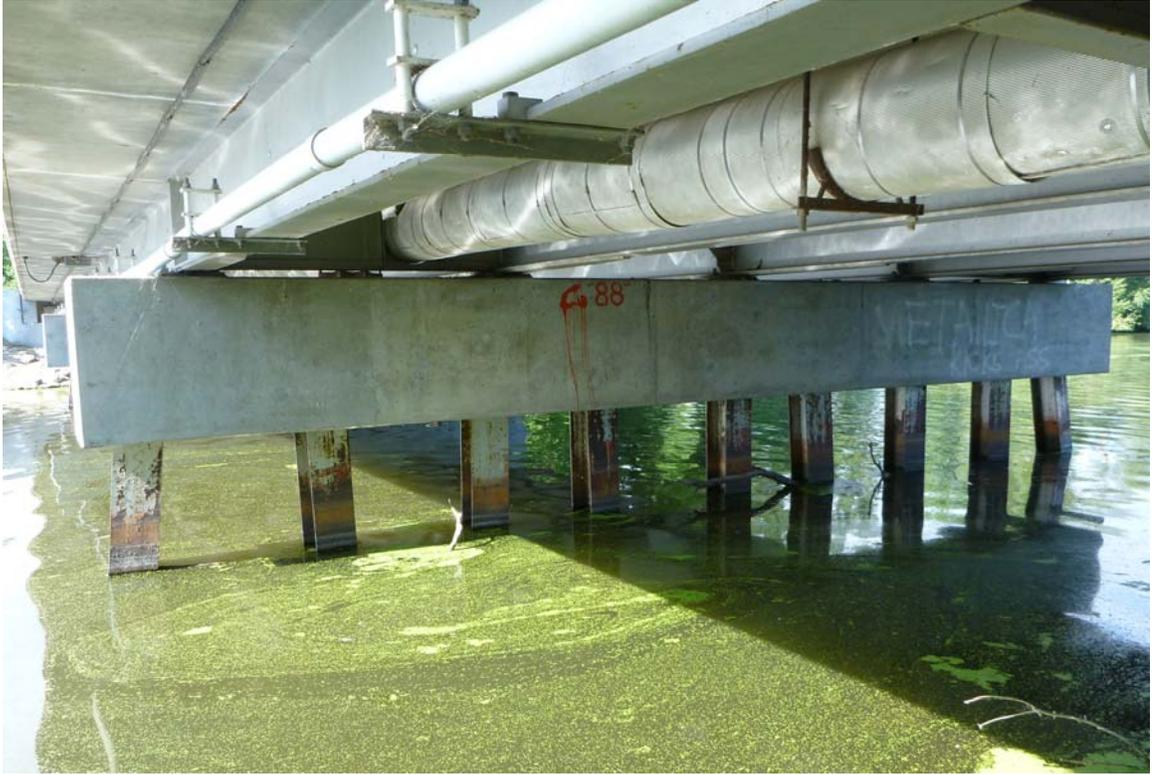
Photograph 3. View of Pier 2, Looking South.

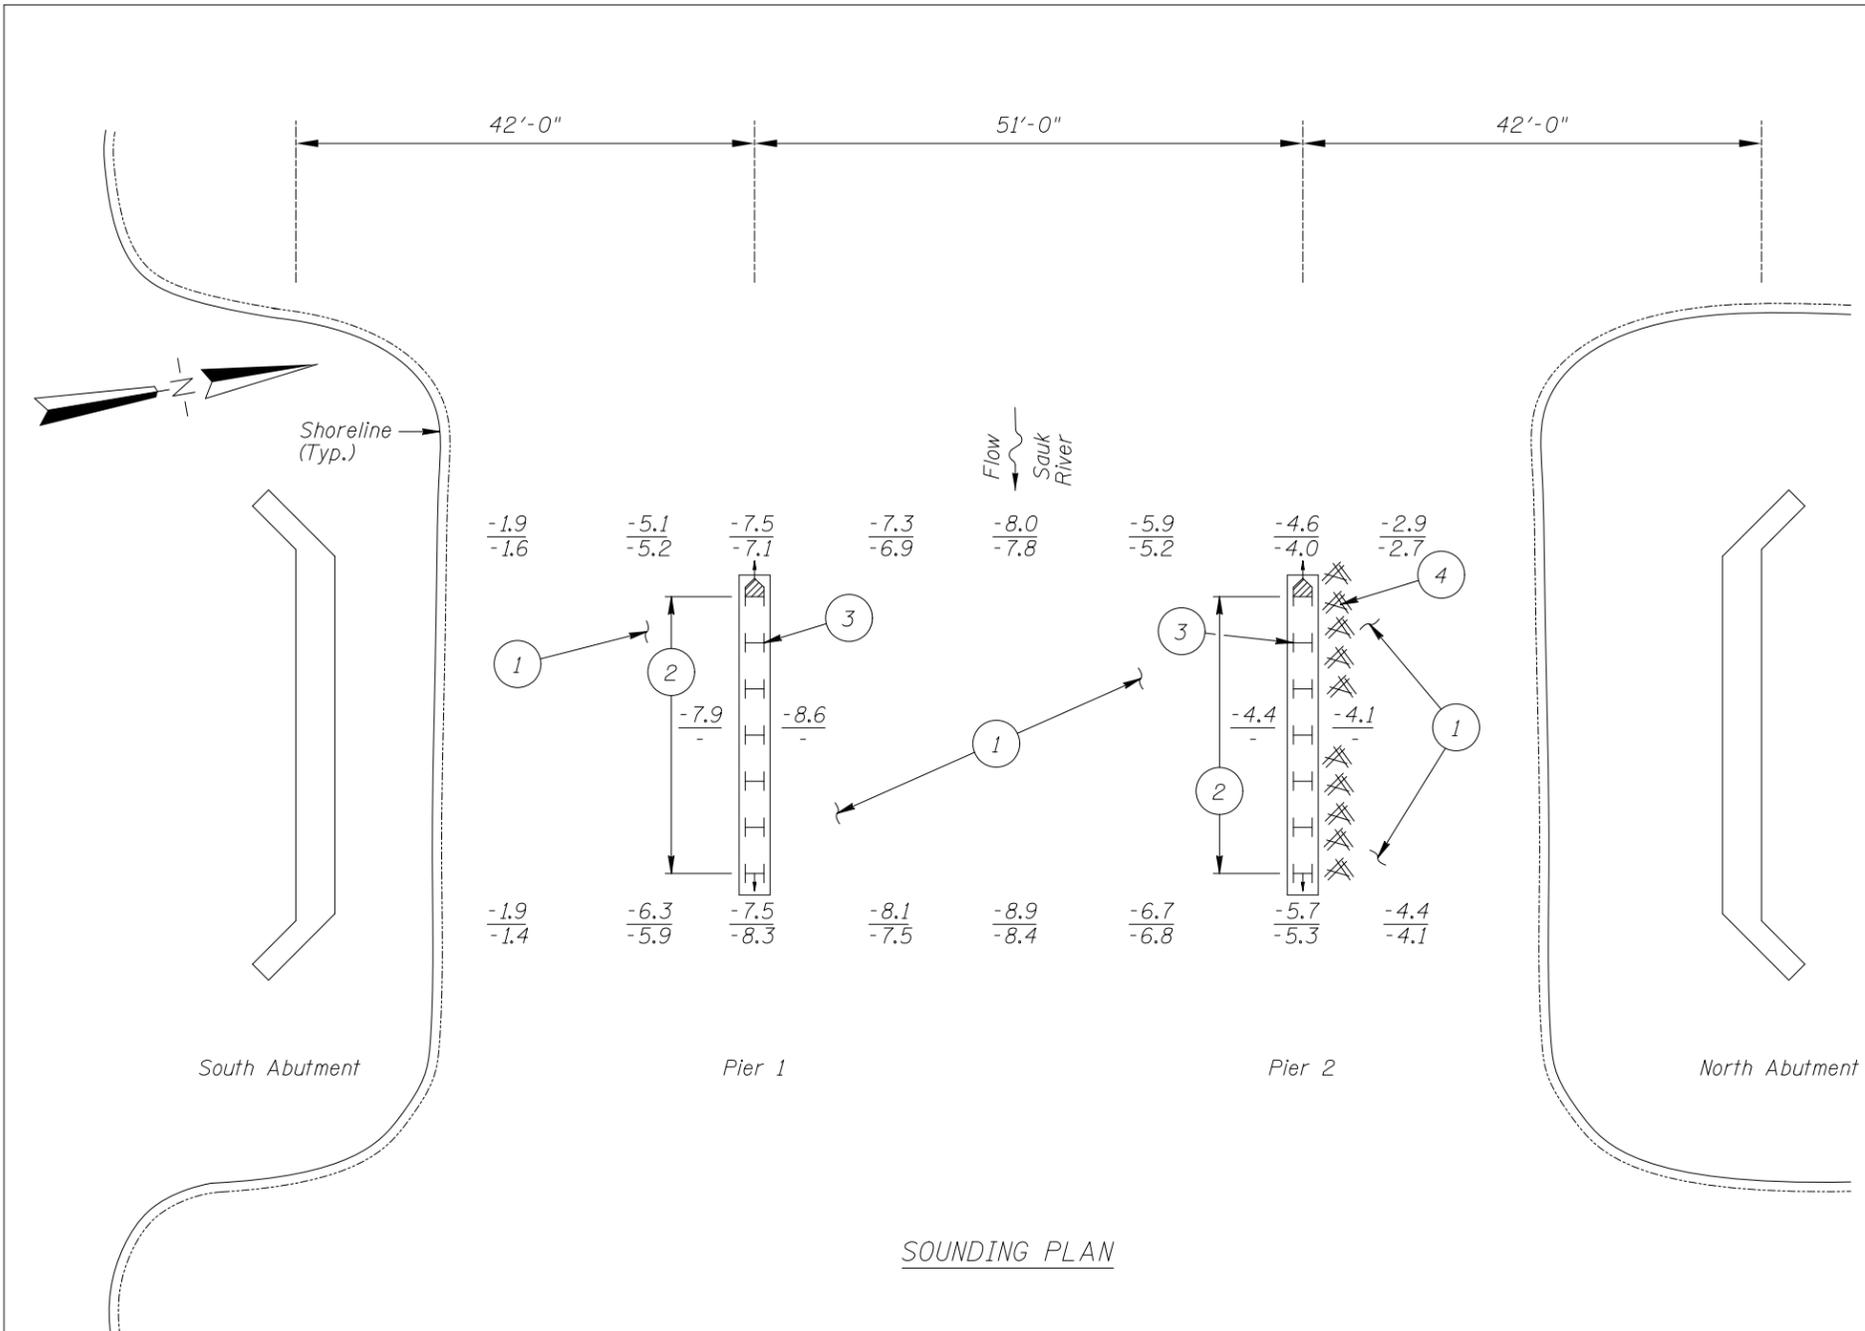
INSPECTION AND SOUNDING PLAN

- The channel bottom material consisted of sand and 1 to 1.5 foot diameter rock with minimal probe rod penetration.
- Minor surface corrosion and light pitting in conjunction with coating failure/absence was observed on 100 percent of the surface area of the piles from 1 foot above the waterline to the channel bottom, with nodules 1/2 inch in diameter and 1/16 inch deep pitting on 25 to 50 percent of the surface area from the waterline to 1 foot above. No appreciable section loss was associated with the deterioration.
- Light aquatic growth was observed on all piles below the waterline.
- Light timber debris accumulation, consisting of 6 inch diameter and smaller logs and branches, was observed along the north face of Pier 2, extending 4 feet off the face of the pier from channel bottom to waterline.
