UNDERWATER BRIDGE INSPECTION REPORT

STRUCTURE NO. 73536

SAUK RIVER

MINNESOTA DEPARTMENT OF TRANSPORTATION  
UNDERWATER BRIDGE INSPECTION

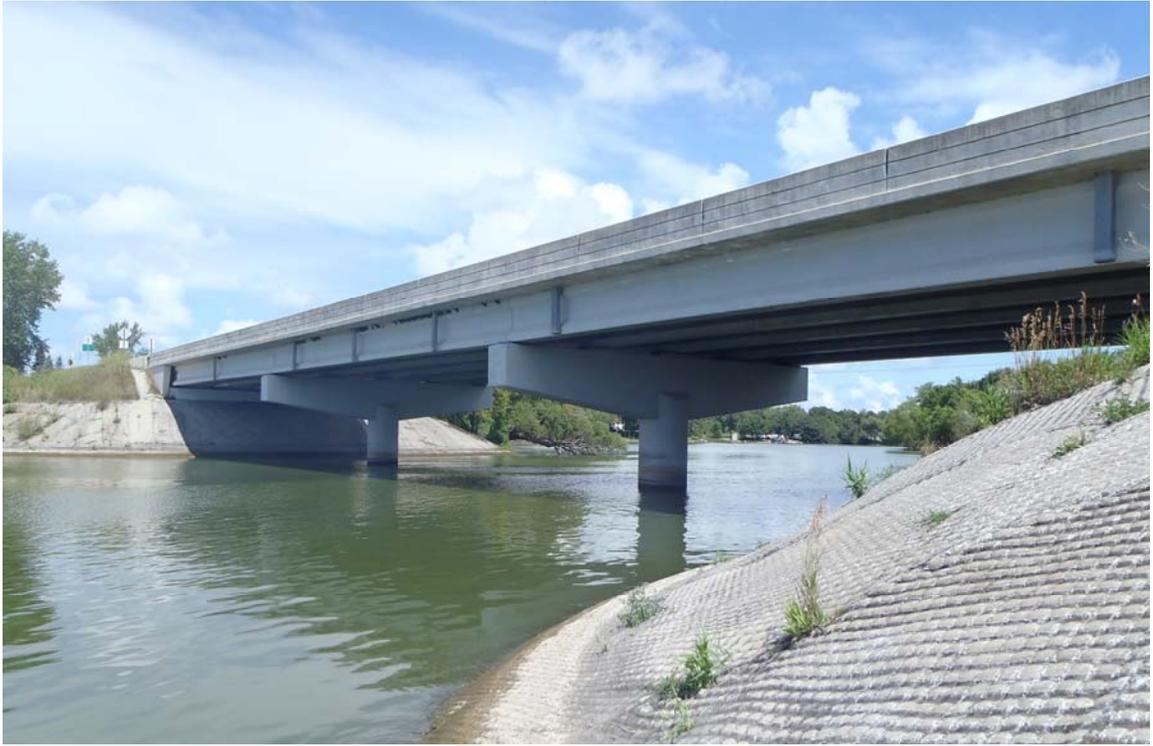
Photograph 1. Overall View of Structure, Looking North.

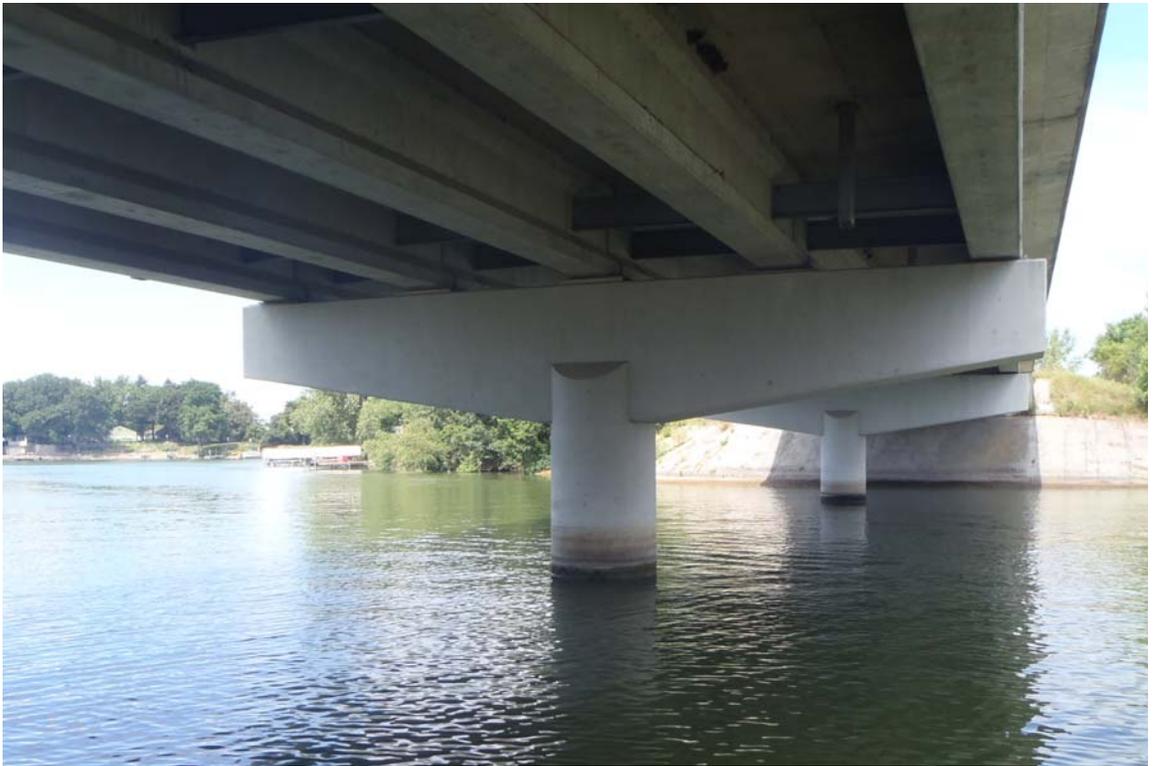
- (A) There was minor footing exposure encountered at both piers due to localized scour depressions. The footing at Pier 1 was detected at the western corner with no vertical face exposure. The footing at Pier 2 was exposed at the northern corner; with .8 feet of vertical exposure.

Photograph 2. View of Pier 1, Looking North.

- (B) Monitor exposed footings during future inspections.

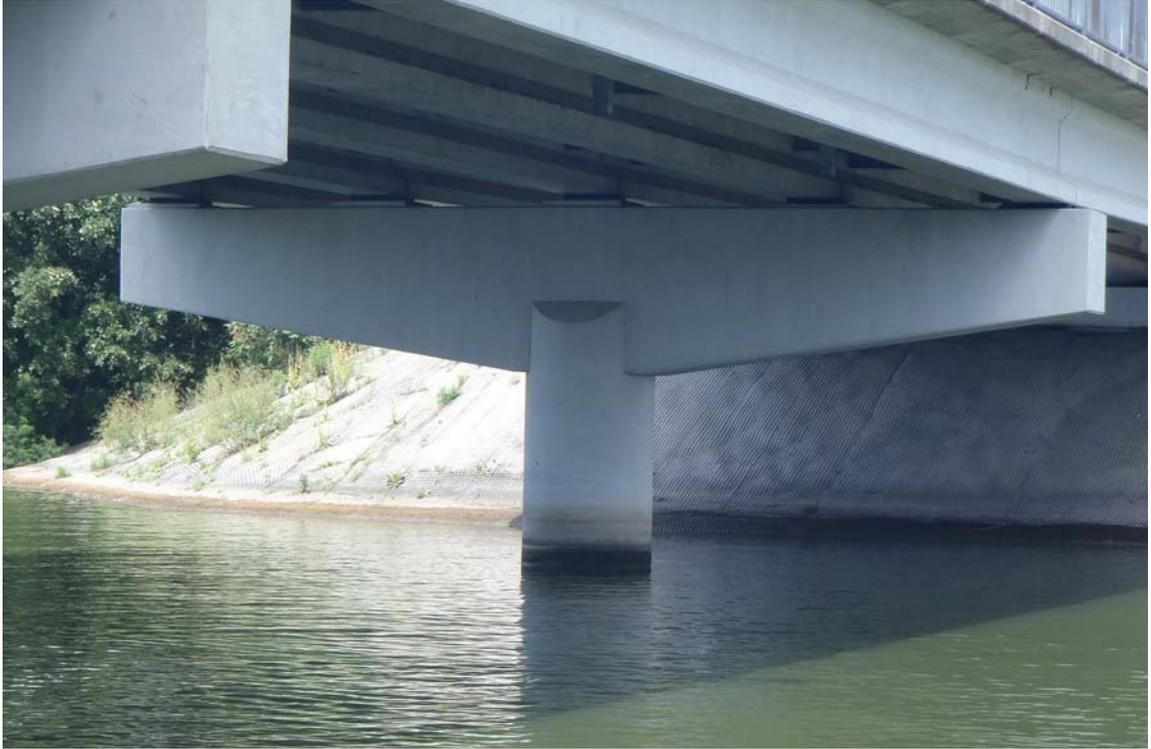
Photograph 3. View of Pier 2, Looking North.

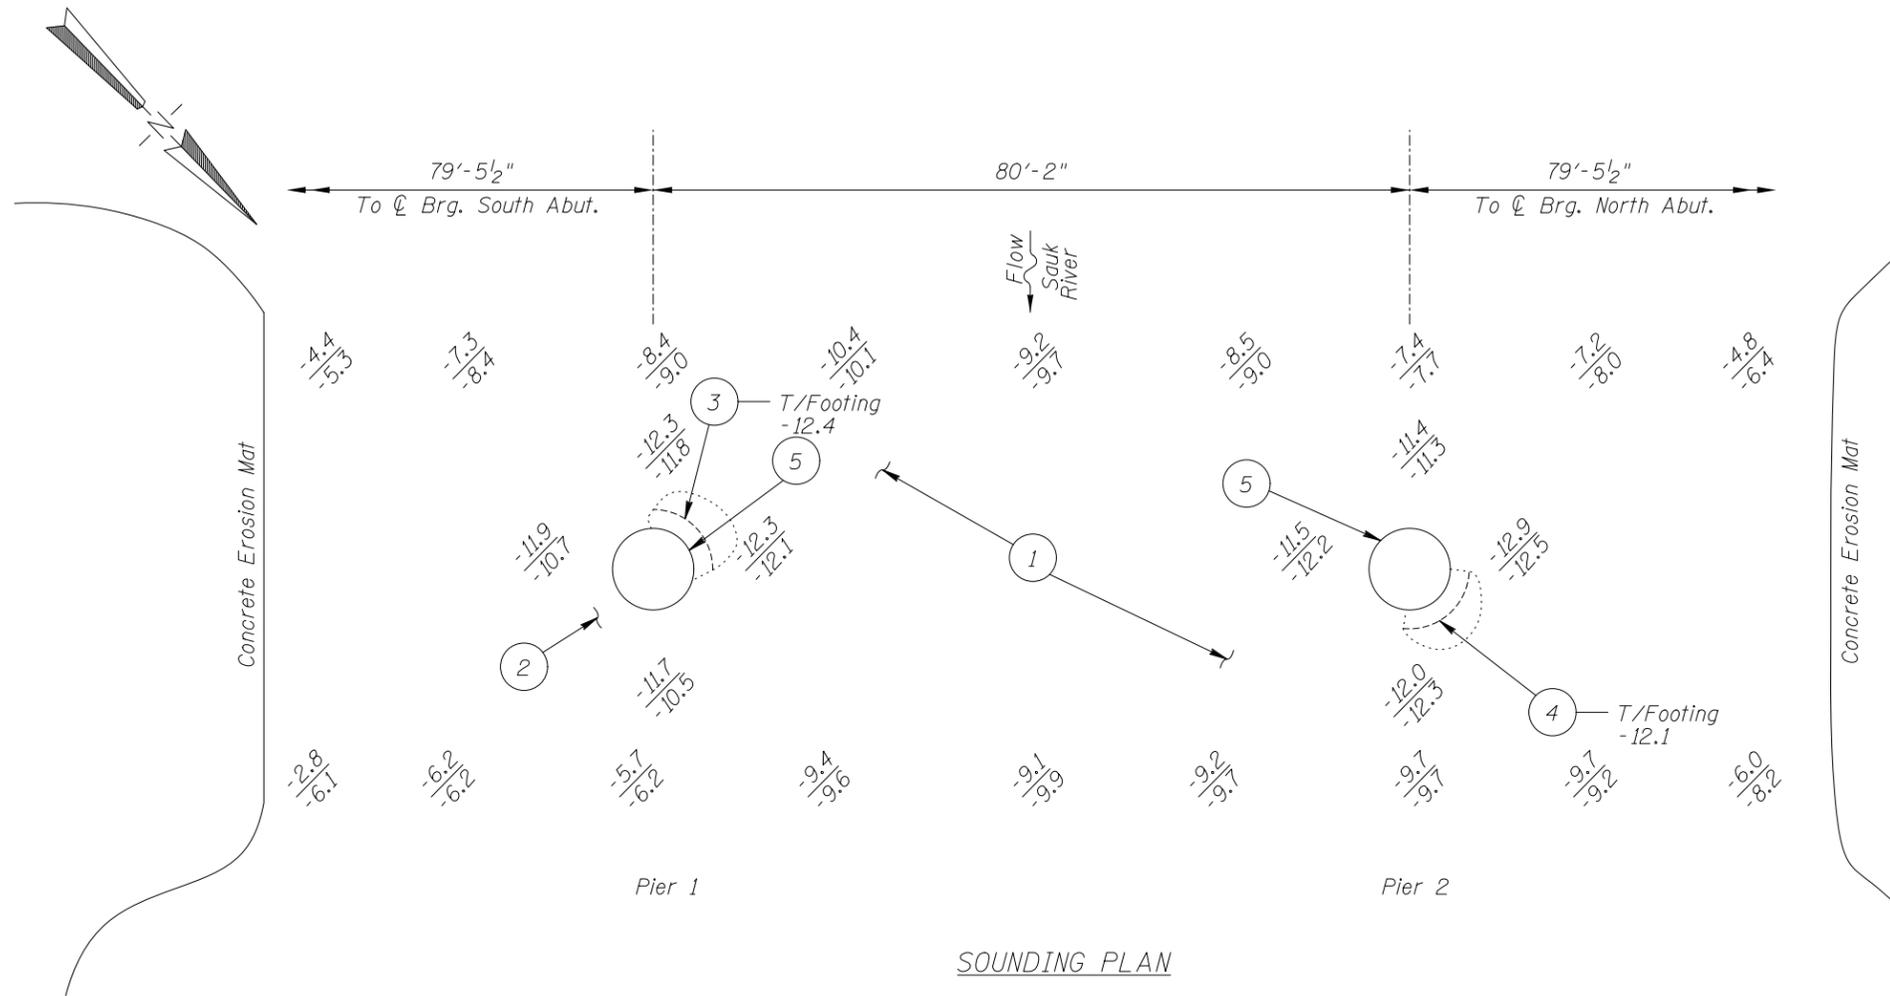
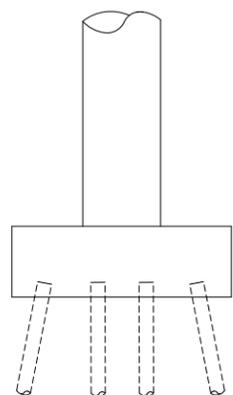
| INSPECTION AND SOUNDING PLAN | | |

- ① The channel bottom consisted of sandy gravel with up to 5 inches of probe rod penetration.
- ② The channel bottom consisted of sand with up to 8 inches of probe rod penetration.
- ③ The top of footing was detected under a 3 inch layer of silt at the western side of Pier 1 (a 2 foot wide section) with no vertical face exposed.
- ④ The footing was exposed around the column at Pier 2 with 0.8 foot of maximum vertical exposure on the north side of Pier 2.
- ⑤ The submerged concrete was in good, sound condition with a light layer of aquatic growth observed.
