UNDERWATER BRIDGE INSPECTION REPORT

STRUCTURE NO. 73540

10TH STREET BRIDGE (MSAS NO. 101)

MINNESOTA DEPARTMENT OF TRANSPORTATION
UNDERWATER BRIDGE INSPECTION

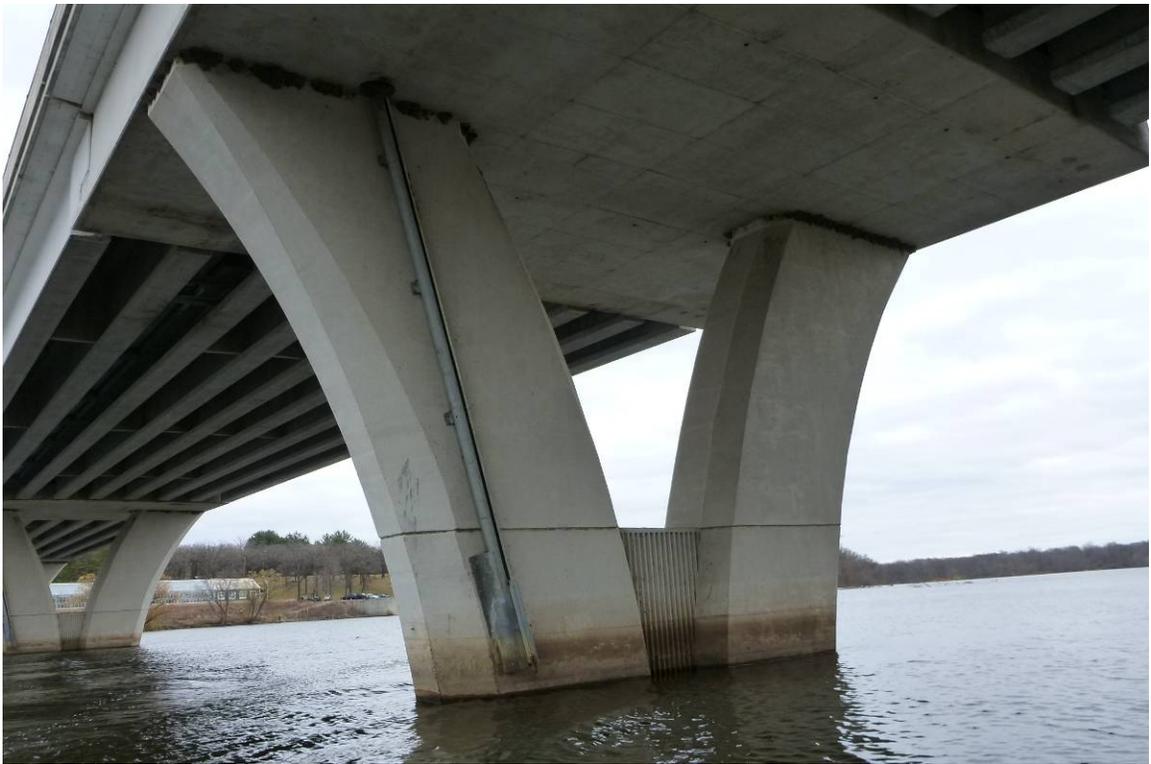
Photograph 2. View of Pier 2, Looking Southeast.

- ⑤ A light accumulation of 8-inch-diameter and smaller timber debris was observed around the entire perimeter of Piers 2 and 4 extending from the channel bottom up 6 feet and up to 3 feet off the pier noses and faces.

Consider removal of the timber debris accumulation during routine bridge maintenance.

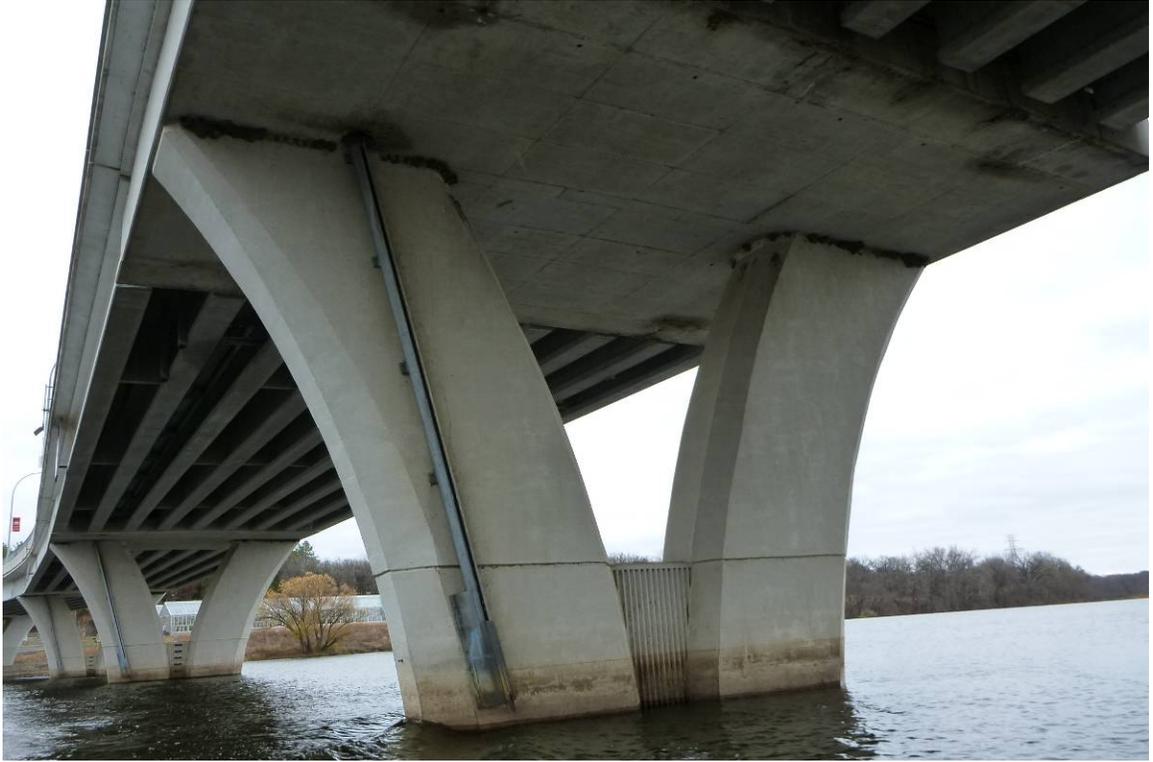
Photograph 3. View of Pier 3, Looking Southeast.

- ⑧ A light accumulation of timber debris, consisting of up to 8-inch-diameter branches, was observed at the upstream nose of Pier 3 from the channel bottom up 2 feet. The debris was approximately 8 feet long (E/W) by 3 feet wide (N/S).

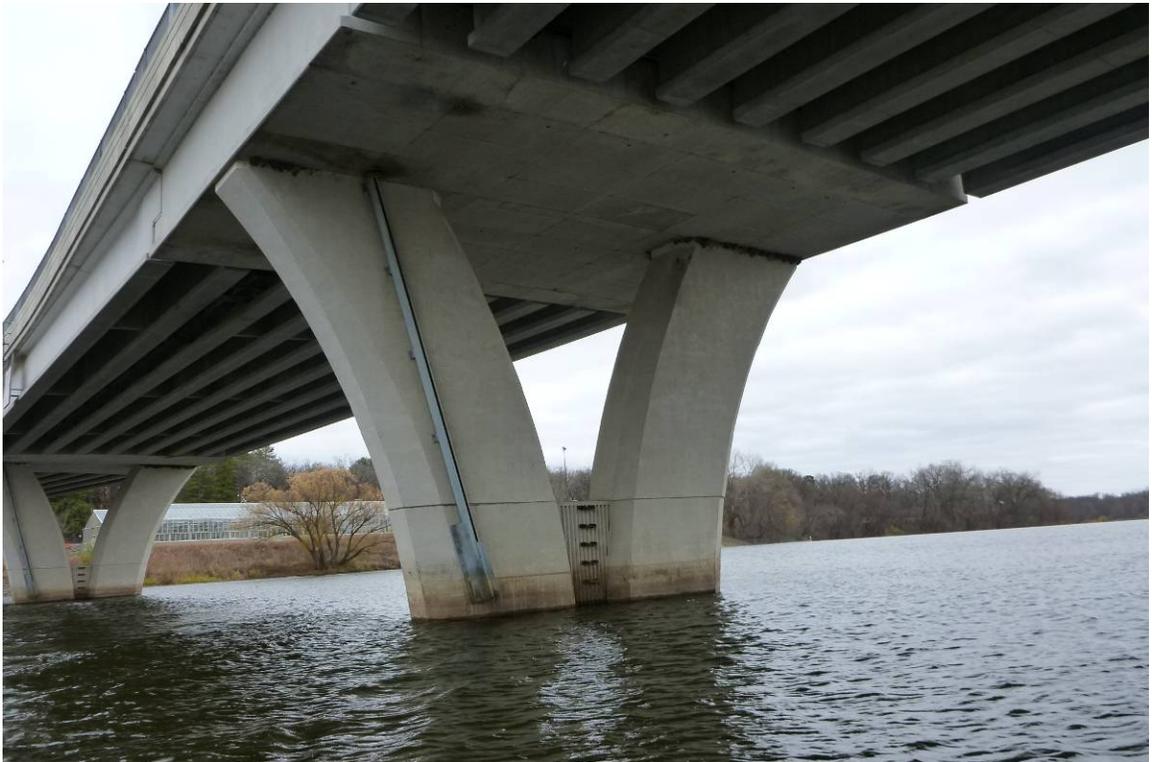
Photograph 4. View of Pier 4, Looking Southeast.

- ③ Footing exposure was observed at the upstream end of Pier 4, extending approximately 8 feet downstream on the east and west sides of the pier with a maximum vertical face exposure of 2.5 feet at the upstream nose.

- ⑥ Minor scour depressions, typically 5 feet in radius and 2 to 3 feet deep, were observed around the upstream ends of Piers 3, 4, and 5, resulting in footing exposure at Piers 4 and 5.

Scour screening assessment indicates stable rating, therefore, only monitor extent of scour and footing exposure during future inspections.

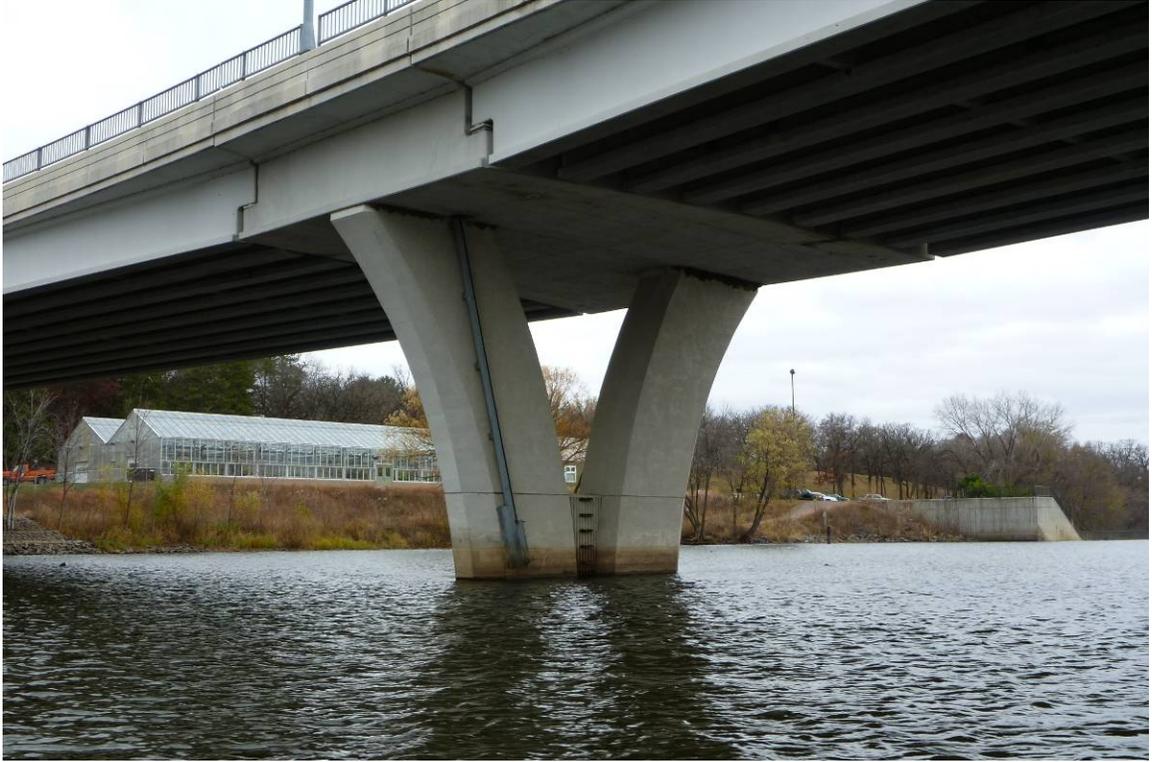
Photograph 5. View of Pier 5, Looking Southeast.

- ④ Footing exposure was observed at the upstream end of Pier 5, extending approximately 15 feet downstream on both sides of the pier, with a maximum vertical face exposure of 3 feet at the upstream nose.

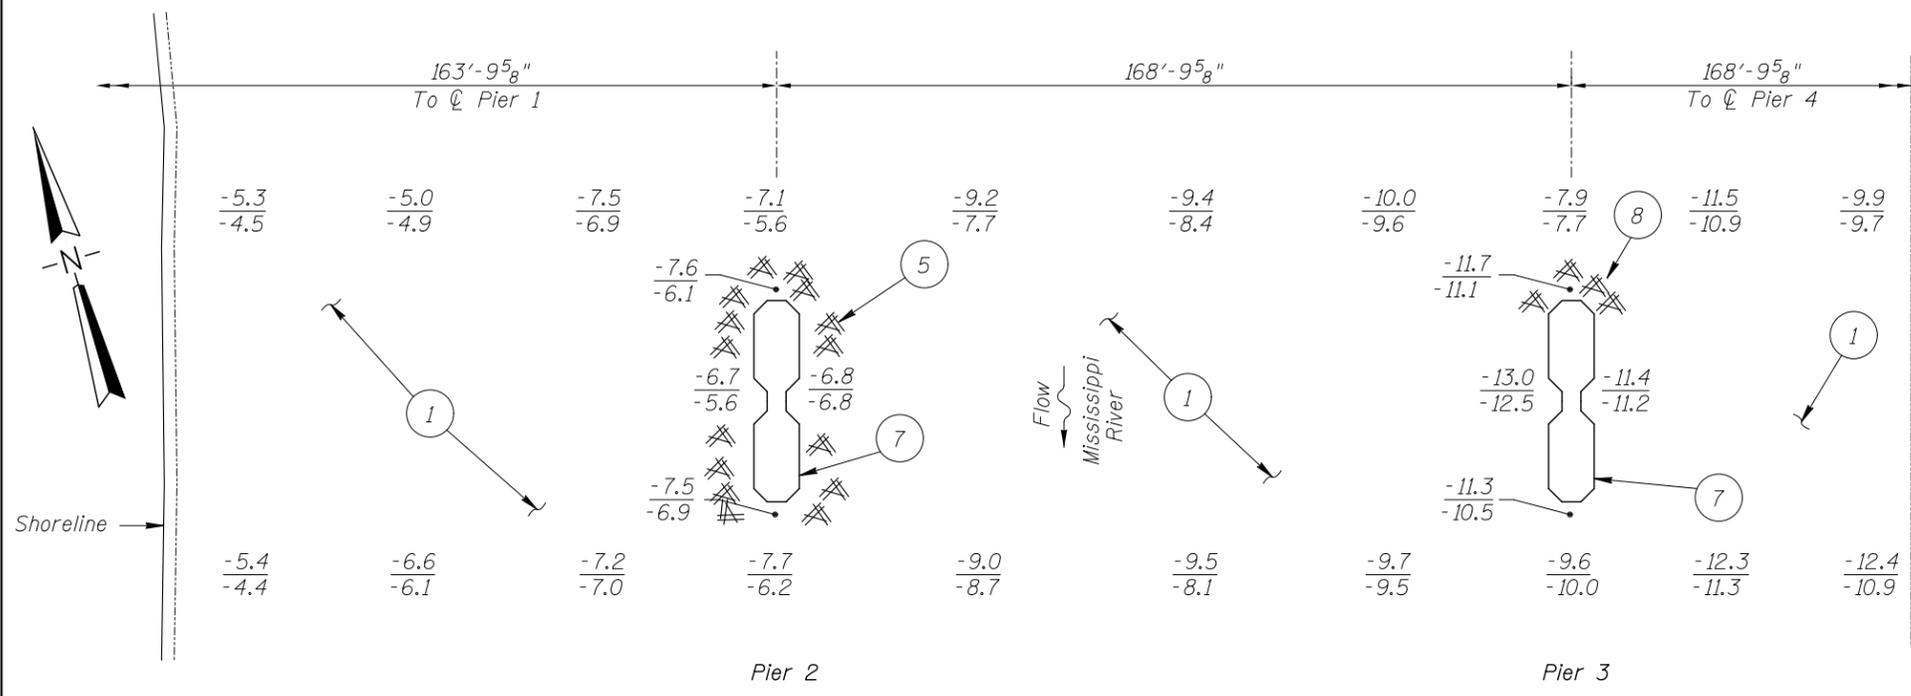
SOUNDING PLAN

- ① The channel bottom material consisted of sandy gravel and random cobbles allowing a maximum probe rod penetration of 6 inches.
- ② The channel bottom material consisted of silt allowing a maximum probe rod penetration of 2 feet at the upstream end of Pier 5.

- ⑦ The submerged concrete of the piers and exposed footings was in smooth and sound condition with minor random areas of poor consolidation with 1/4 inch maximum penetration.
