UNDERWATER BRIDGE INSPECTION REPORT

STRUCTURE NO. 73551

SAUK RIVER

DISTRICT 3 - STEARNS COUNTY

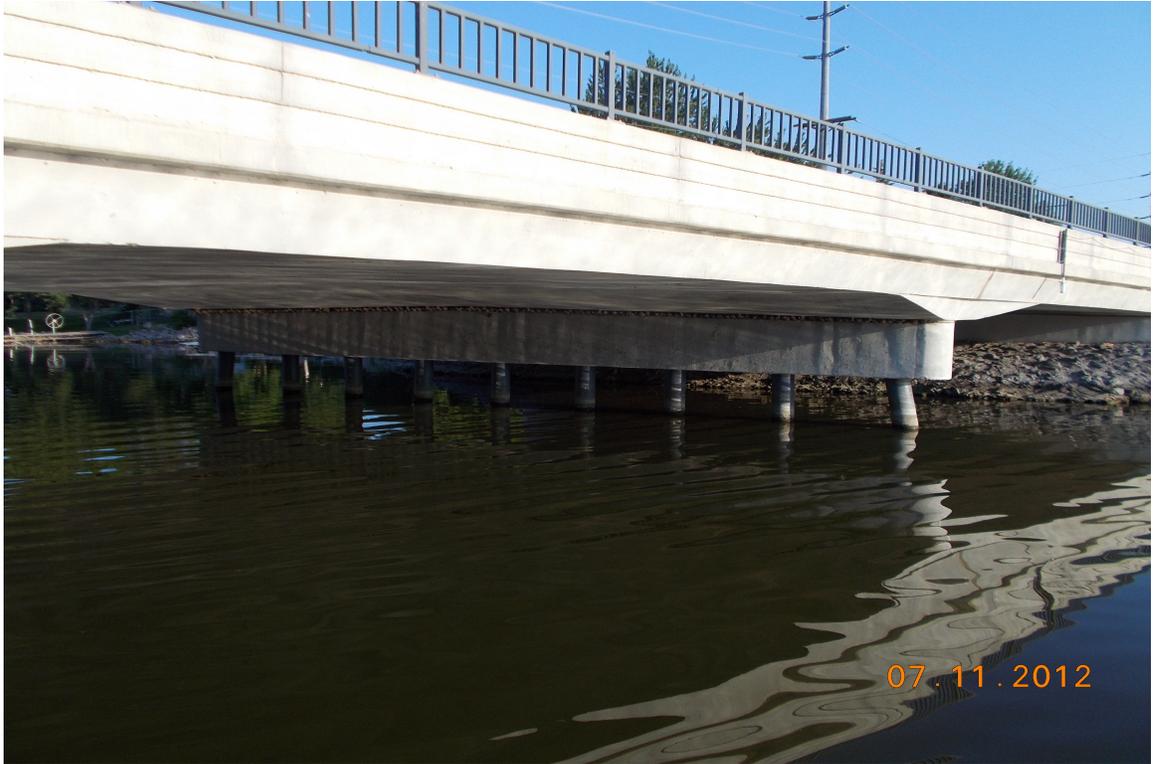
Photograph 1. View of Pier 1, Looking Northwest.

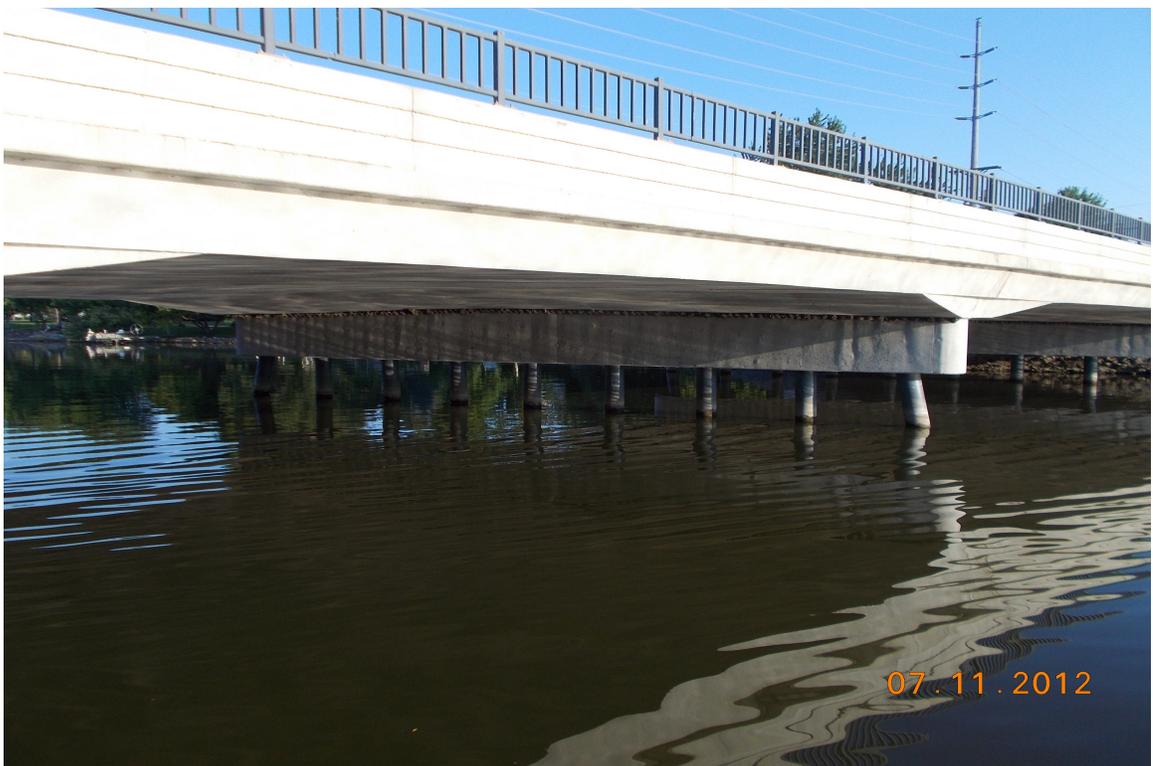
Photograph 2. View of the Pier 2, Looking Northwest.

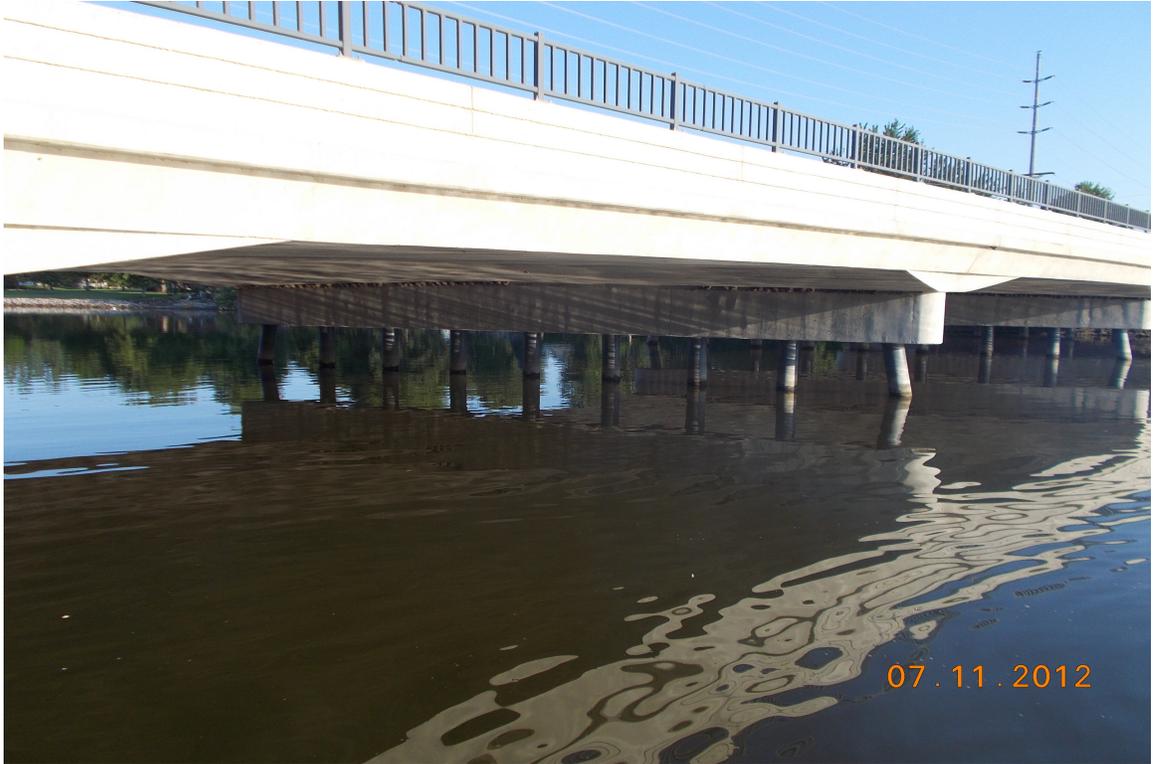
Photograph 3. View of Pier 3, Looking Northwest.

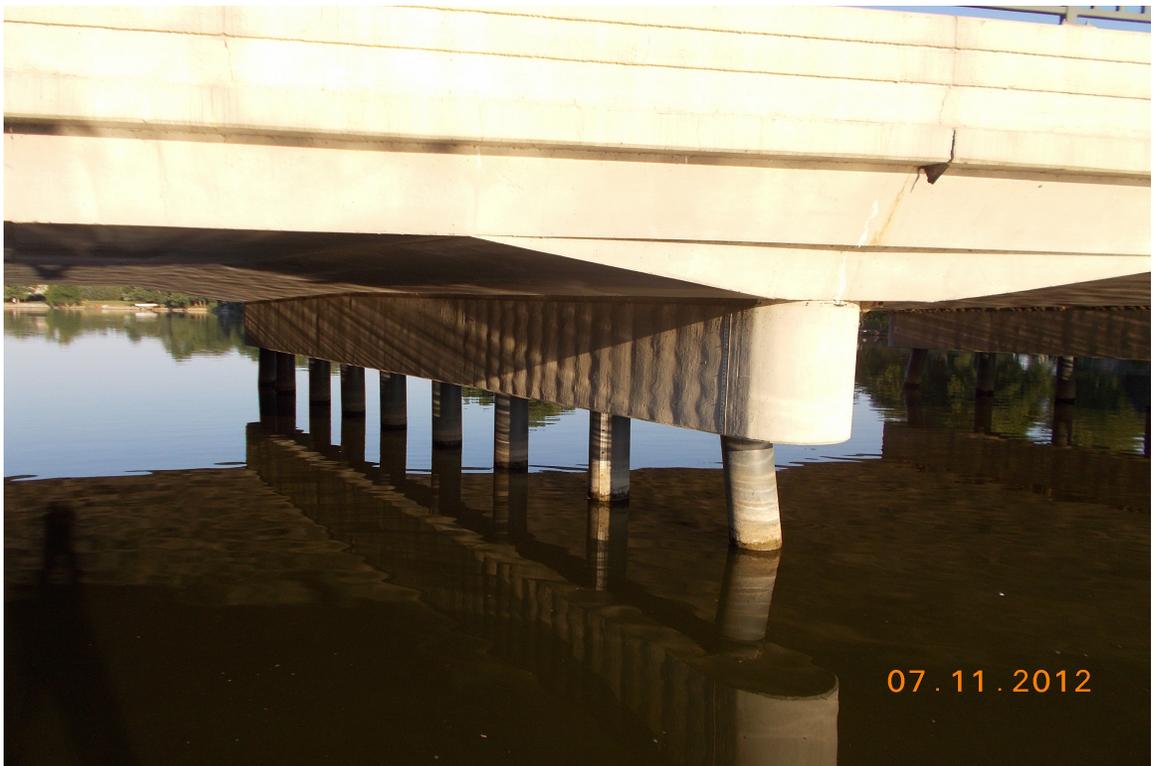
Photograph 4. View of Pier 4, Looking Northwest.

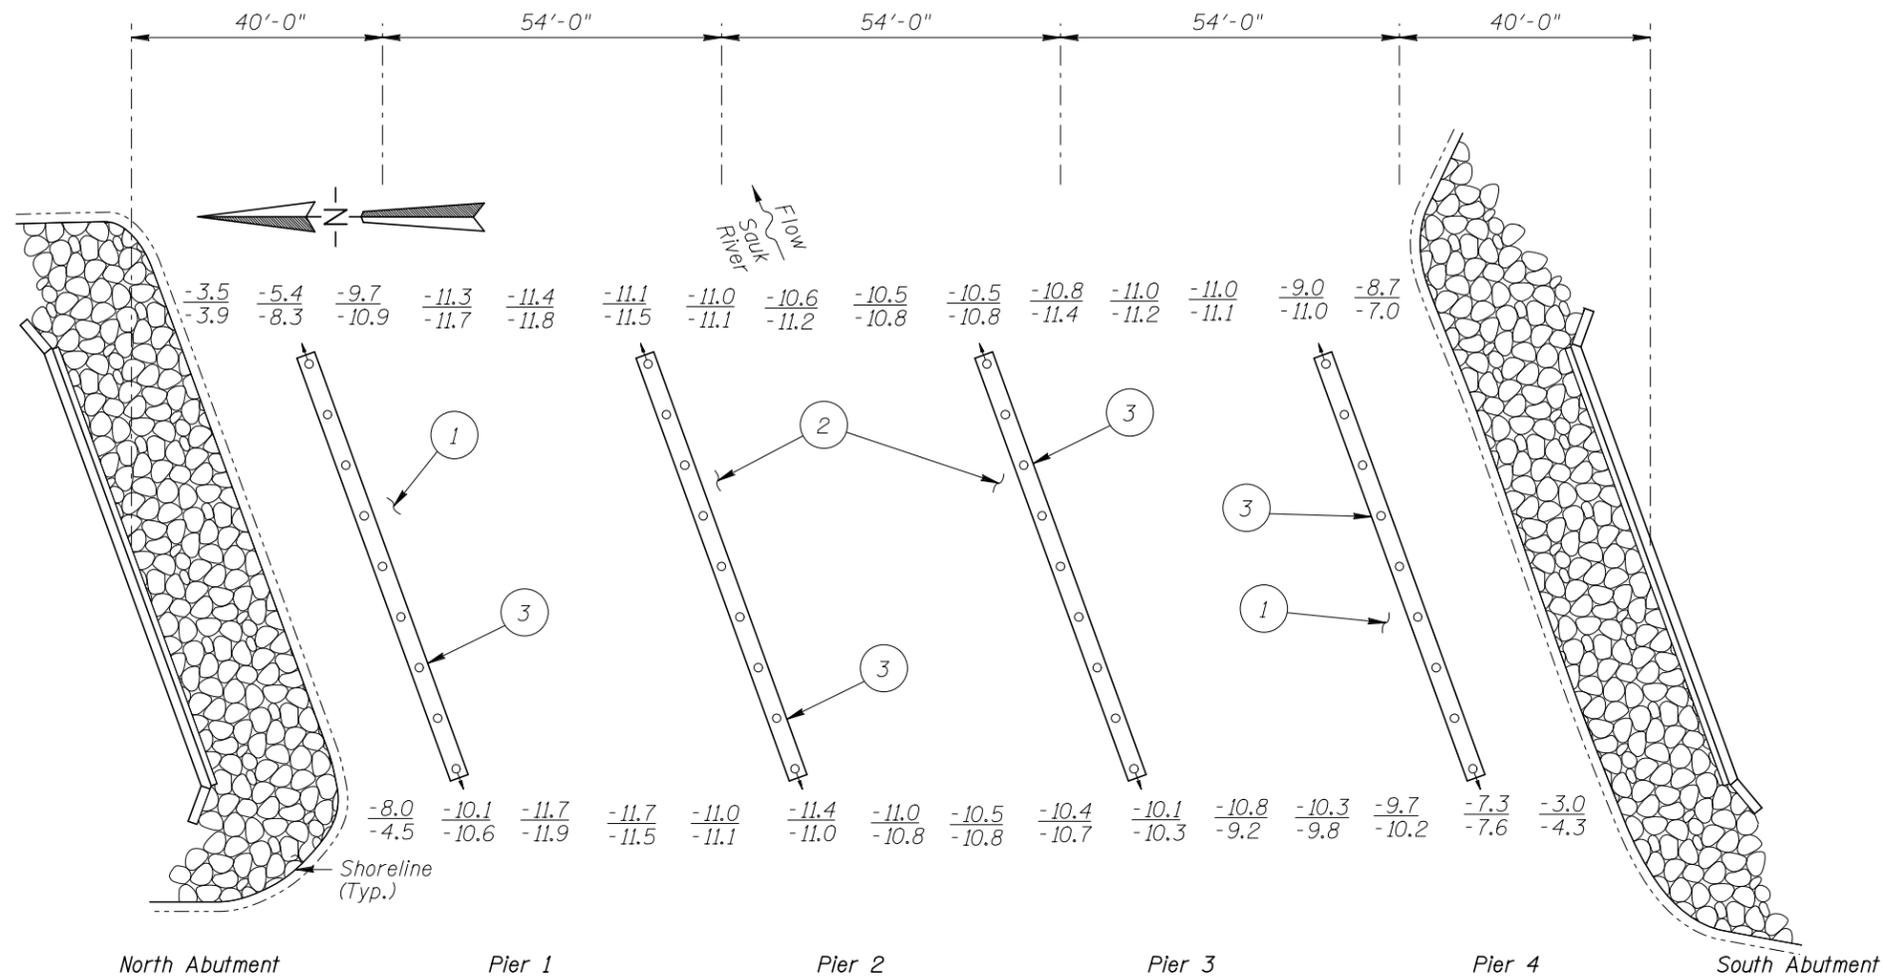
MINNESOTA DEPARTMENT OF TRANSPORTATION UNDERWATER BRIDGE INSPECTION	
STRUCTURE NO. 73551 OVER THE SAUK RIVER DISTRICT 3, STEARNS COUNTY	
INSPECTION AND SOUNDING PLAN	
Drawn By: JAC Checked By: BKS Code: 522173551	 Date: JULY 2012 Scale: NTS Figure No.: 1

- ① The channel bottom material around Piers 1 and 4 consisted of up to 1 foot diameter riprap and sand.
- ② The channel bottom material around Piers 2 and 3 consisted of sand and some stones with up to 4 inches of probe rod penetration.
- ③ All of the piles for Piers 1 through 4 had coating loss from 1 foot above the waterline to the channel bottom with minimal overall steel deterioration and with light aquatic growth on the surfaces below the waterline. Minor surface corrosion with small rust nodules, 1/8 inch in diameter, were observed below water on less than 10 percent of surface area with no related section loss.
