UNDERWATER BRIDGE INSPECTION REPORT

STRUCTURE NO. 86515
CSAH NO. 42
OVER THE
MISSISSIPPI RIVER
DISTRICT 3 - WRIGHT COUNTY

OCTOBER 27, 2012
PREPARED FOR THE
MINNESOTA DEPARTMENT OF TRANSPORTATION
BY
COLLINS ENGINEERS, INC.
JOB NO. 7423
MINNESOTA DEPARTMENT OF TRANSPORTATION

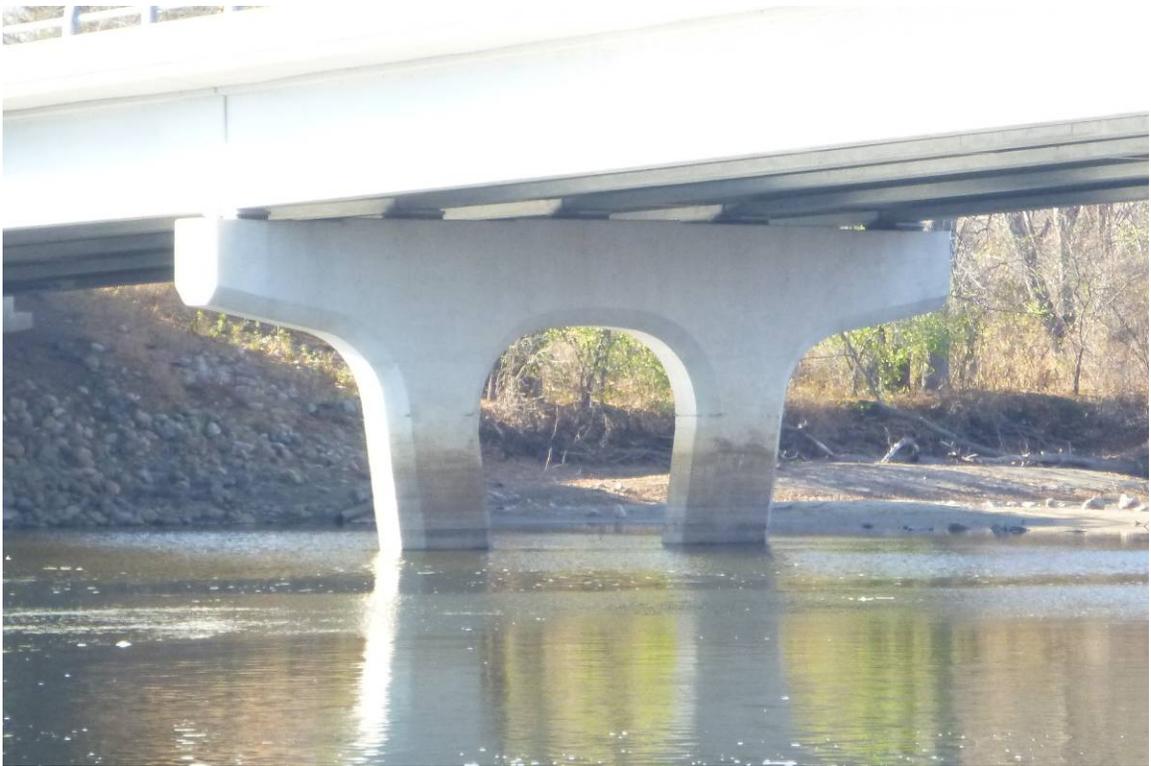
- (G) A light accumulation of 10 inch diameter and smaller timber debris was observed at the upstream end of the Pier 1. The debris extended from channel bottom to 2 feet above waterline and was approximately 5 feet wide in the East-West direction by 15 feet long in the North-South direction and also extended along the entire south face.

Photograph 2. View of Pier 1, Looking Southwest.

- (A) Monitor the accumulation of timber debris around the piers, and if found to be increasing, removal may become necessary during future routine bridge maintenance.
- (B) Scour screening evaluation indicates bridge is at low risk due to scour; therefore, monitor the scour and footing exposure during future inspections.
- (C) Reinspect the submerged substructure units at the normal maximum recommended (NBIS) interval of sixty (60) months.

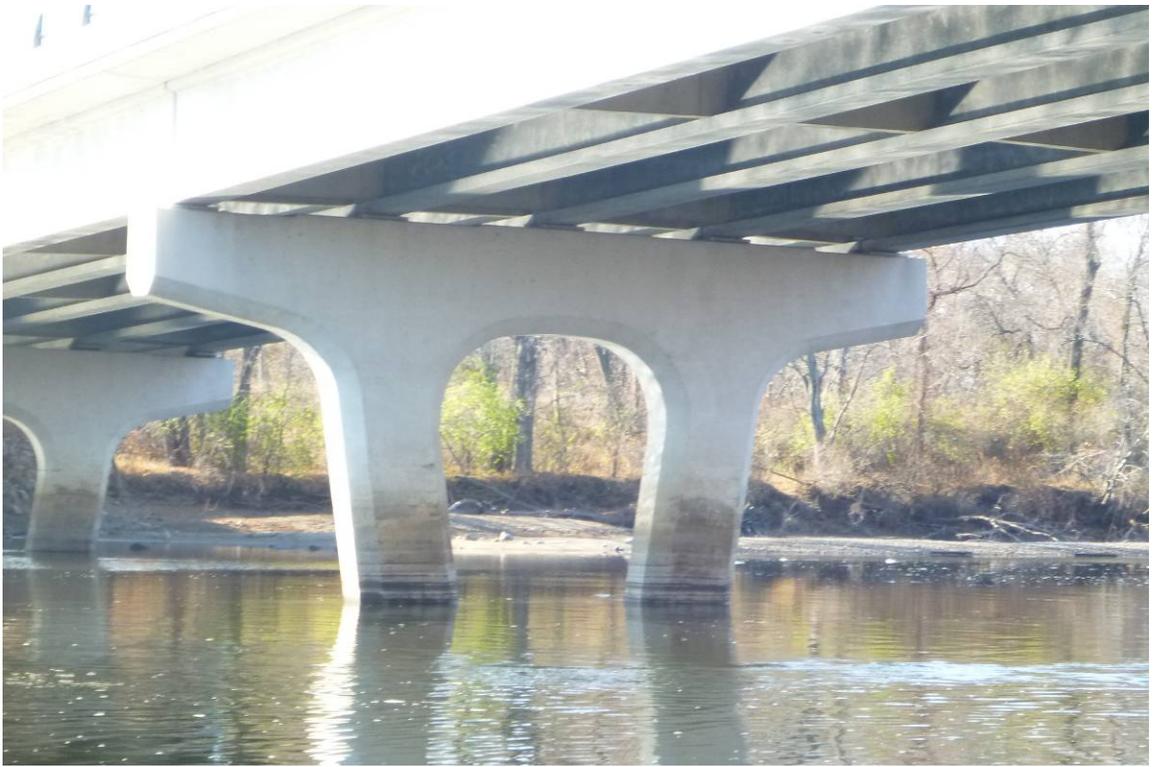
- (B) A light accumulation of timber debris consisting of logs 1 foot diameter or smaller was observed at the upstream nose of Pier 2. Accumulation extended from the channel bottom up 2 feet, 5 feet long in the North-South direction by 3 feet wide in the East-West direction.

- (D) A 4 foot radius, 3 feet deep scour pocket was observed at the upstream nose of the Pier 2 and extended 15 feet down the south face of the pier.
- (E) The embankments consisted of 1 to 2 foot diameter cobbles.

- (I) Area of impact damage observed in the Southeast corner of the upstream column of Pier 2. The impact damage extended from waterline to 1 foot above. It was 8 inches wide and exhibited a maximum penetration of 1 inch with no exposed rebar.

Photograph 3. View of Pier 2, Looking Southwest.

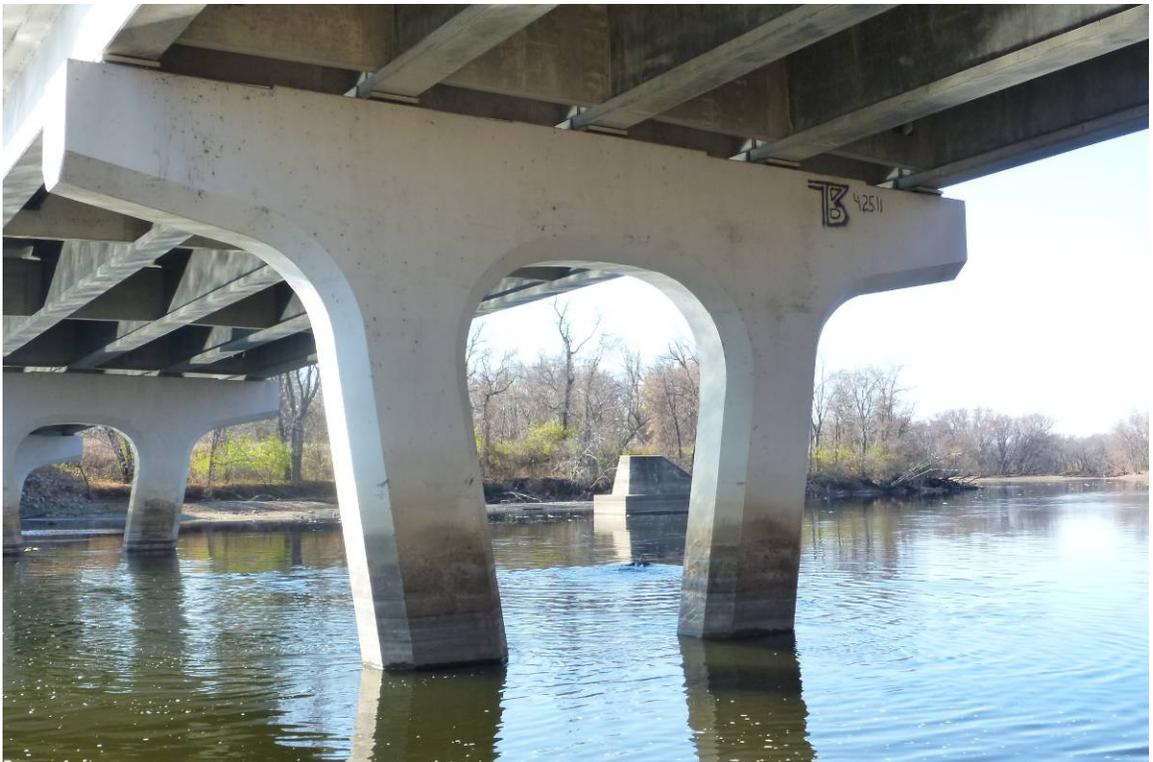
- (C) A moderate accumulation of 2 foot diameter and smaller timber debris was observed at the upstream nose of Pier 3 extending from the channel bottom up 10 feet, 10 feet long in the North-South direction and 4 feet wide in the East-West direction.

- (J) The concrete footing was exposed around the entire Pier 3 with up to 3.5 feet of vertical exposure along the south face of the pier.

Photograph 4. View of Pier 3, Looking Southwest.

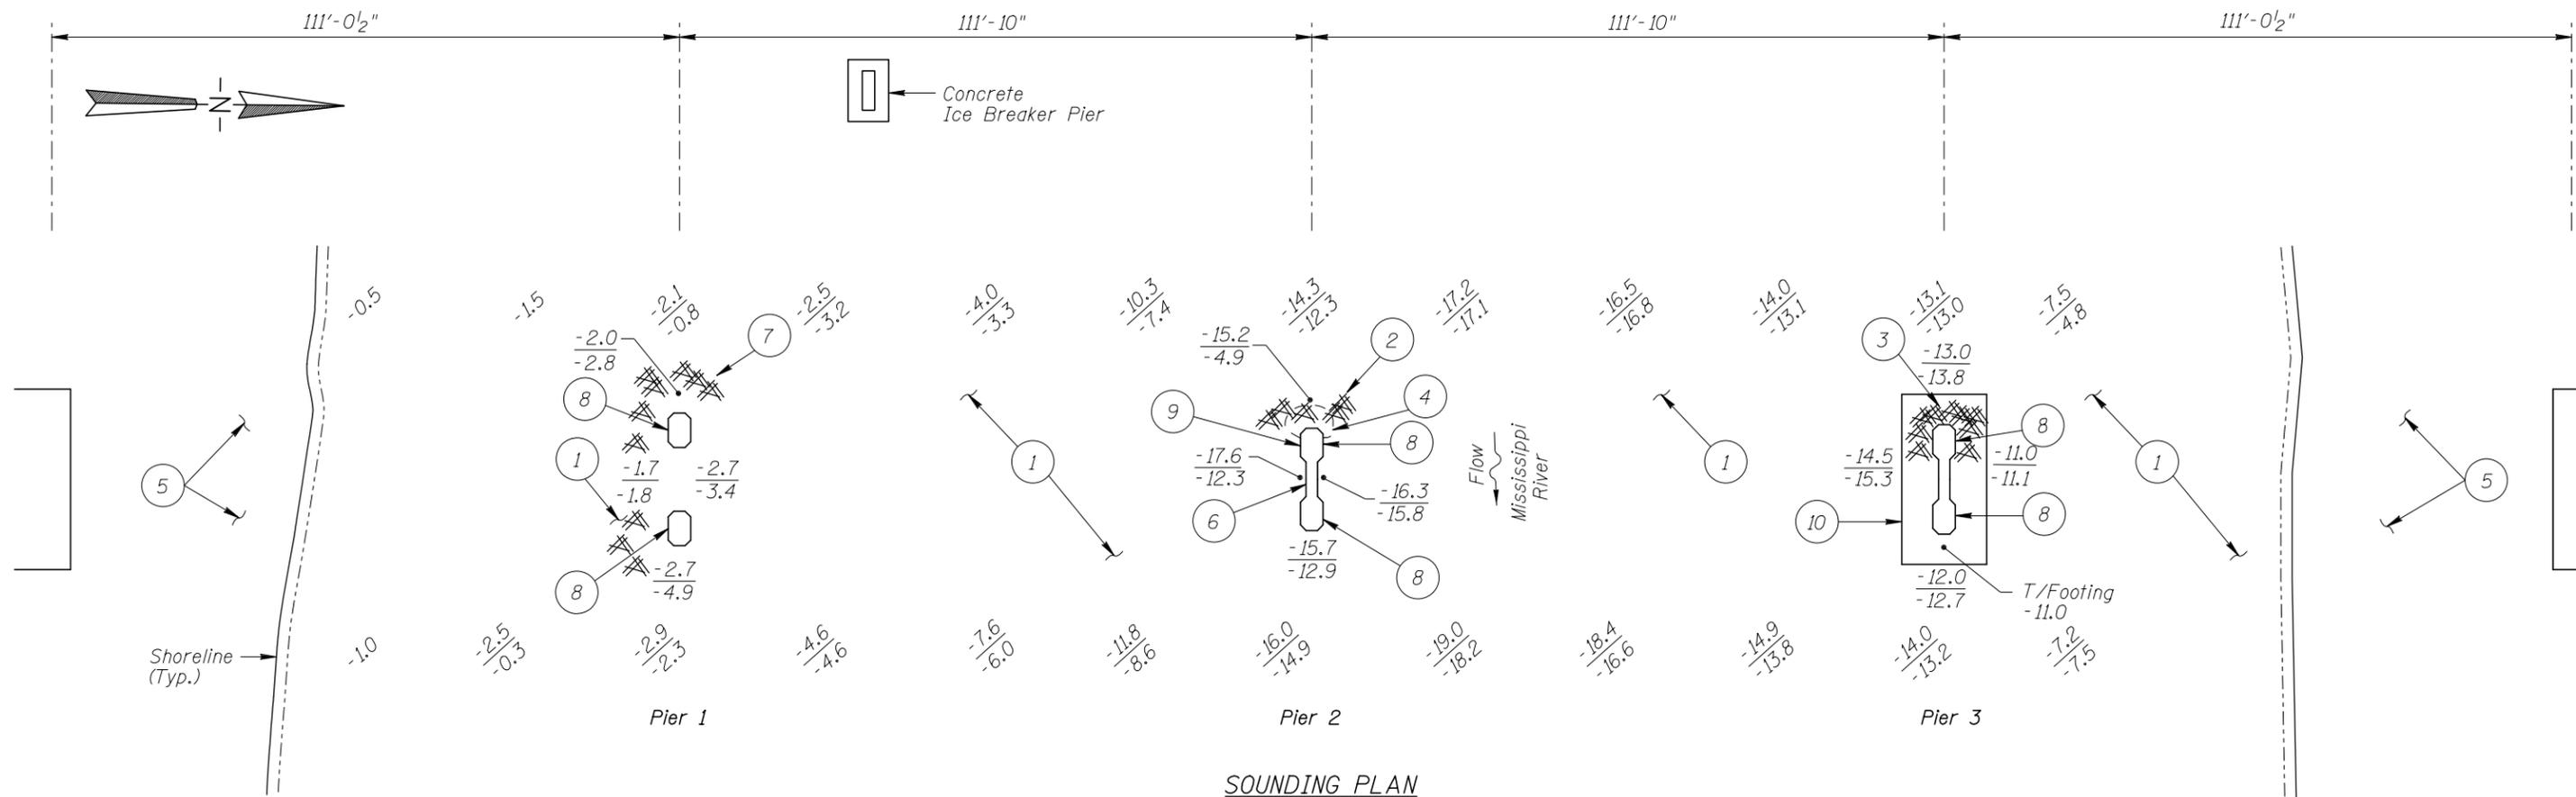
SOUNDING PLAN

- ① The channel bottom material consisted of sand, gravel and scattered cobbles, 1-foot-diameter and smaller, allowing 6 to 12 inches of probe rod penetration.

- ② A light accumulation of timber debris consisting of logs 1-foot-diameter or smaller was observed at the upstream nose of Pier 2. Accumulation extended from channel bottom up 2 feet, 5 feet long in the North-South direction by 3 feet wide in the East-West direction.

- ③ A moderate accumulation of 2-foot-diameter and smaller timber debris was observed at the upstream nose of Pier 3 extending from the channel bottom up 10 feet, 10 feet long in the North-South direction and 4 feet wide in the East-West direction.

- ④ A 4-foot-radius, 3-foot-deep scour pocket was observed at the upstream nose of the Pier 2 and extended 15 feet down the south face of the pier.
- ⑤ The embankments consisted of 1- to 2-foot-diameter cobbles.

- ⑥ A horizontal steel H-pile strut was observed 3 feet below the top of web wall and protruded 4 inches from each side of the web wall. There was no associated spalling present.

- ⑦ A light accumulation of 10-inch-diameter and smaller timber debris was observed at the upstream end of the Pier 1. The debris extended from the channel bottom to 2 feet above the waterline and was approximately 5 feet wide in the East-West direction by 15 feet long in the North-South direction and also extended along the entire south face of the pier.

- ⑧ The concrete of the columns and webwalls (Piers 1 through 3) and footing (Pier 3) was typically smooth and sound with random, minor areas of poor consolidation with penetration up to 1/2 inch.
- ⑨ Area of impact damage observed in the South-East corner of the upstream column of Pier 2. The impact damage extended from waterline to 1 foot above. It was 8 inches wide and exhibited a maximum penetration of 1 inch with no exposed rebar.
- ⑩ The concrete footing was exposed around the entire perimeter of Pier 3 with up to 3.5 feet vertical exposure at the midpoint of the south face.

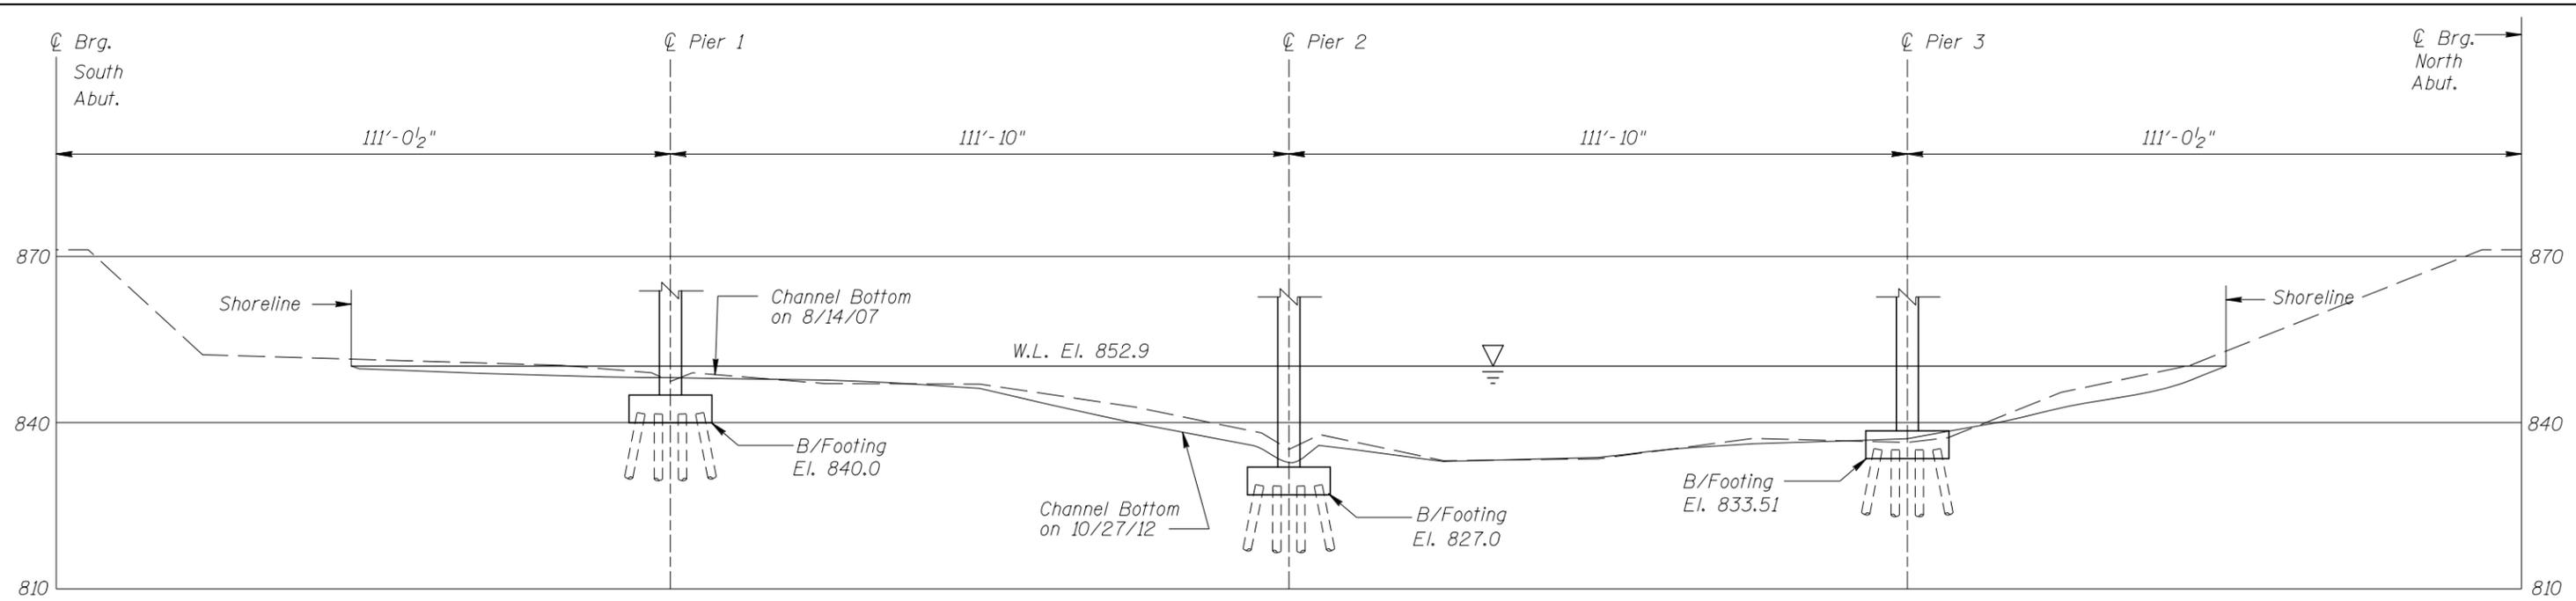
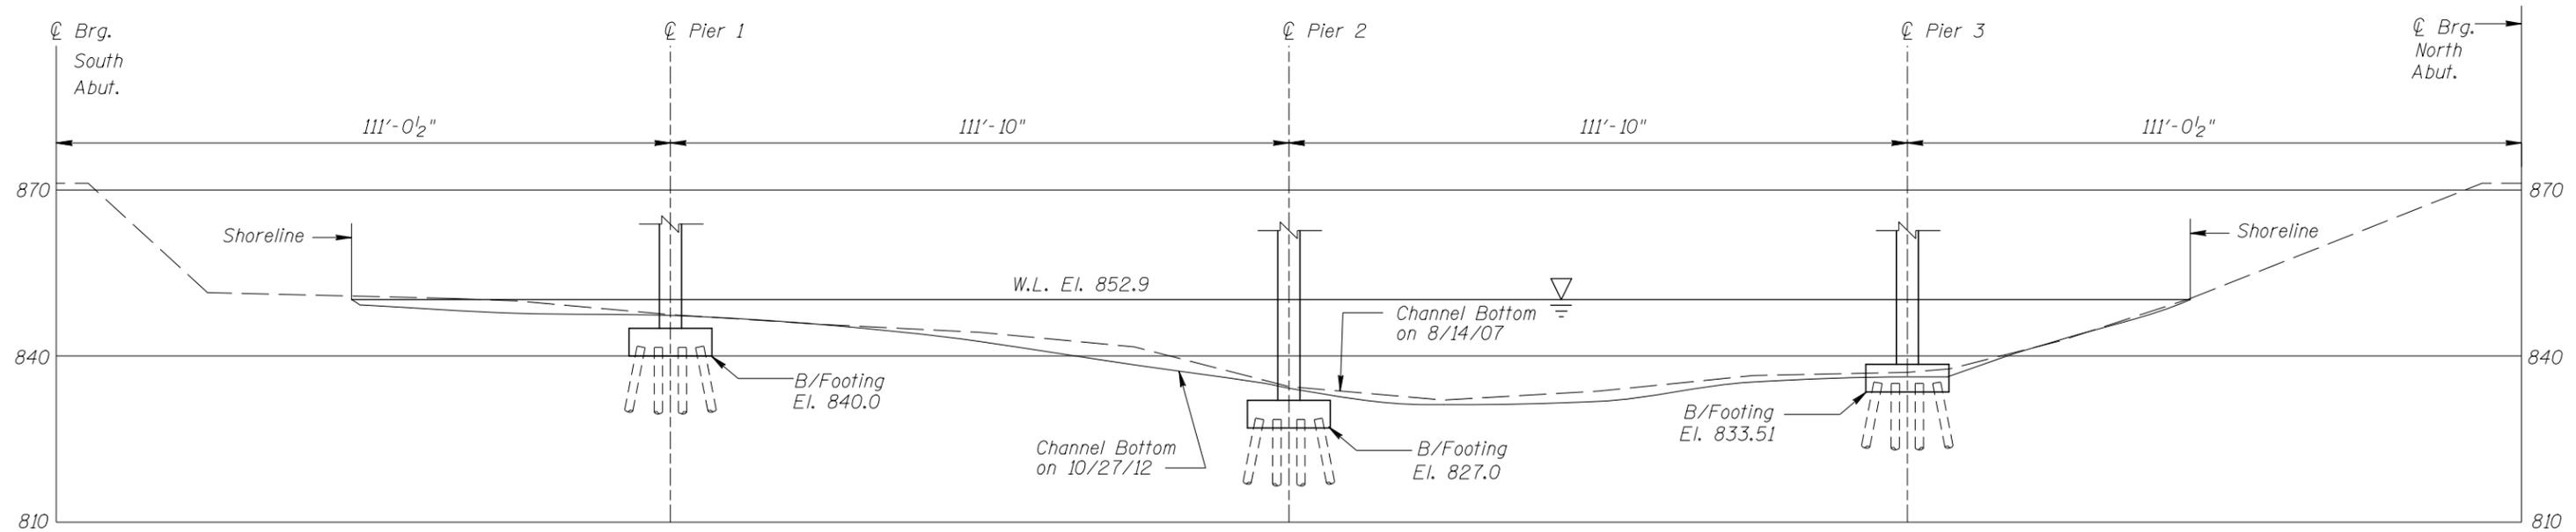
UPSTREAM FASCIA PROFILE

DOWNSTREAM FASCIA PROFILE
