UNDERWATER INSPECTION REPORT

DOUBLE CORRUGATED METAL PIPE CULVERT

HAWTHORN ROAD

RICE CREEK (PELKEY LAKE)

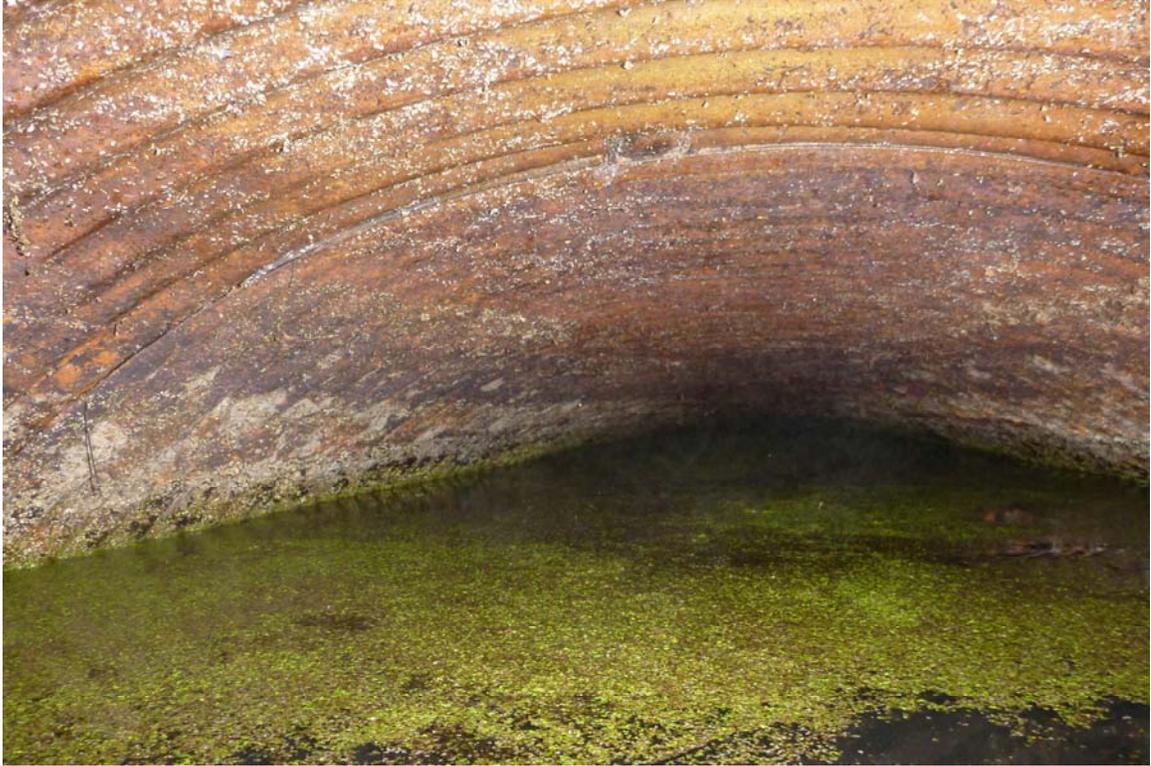
- (C) Both culverts exhibited a sag in the top (ceiling) at the CMP. The sag tapered from the ends of the culverts to the midpoint, where it had a maximum approximate displacement of 1 foot.

Photograph 1. View of the Steel Condition and Ceiling Sag in the West Culvert, Looking South.

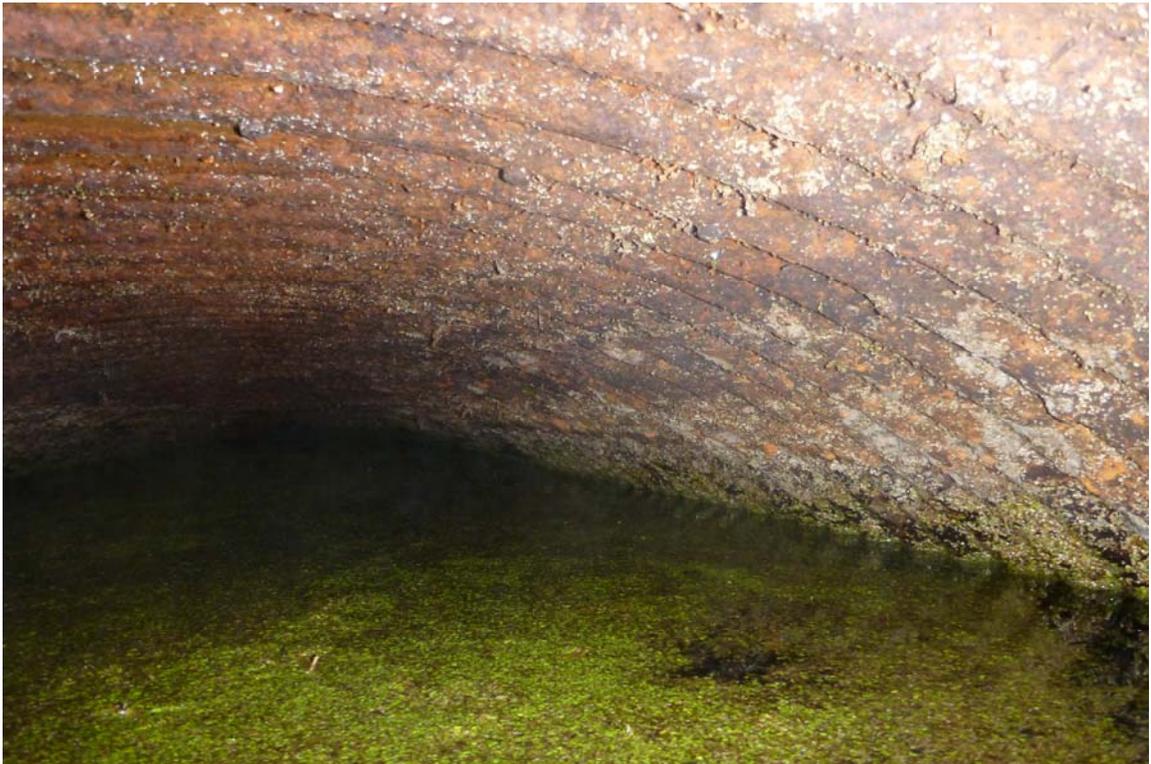
Photograph 2. View of the Steel Condition and Ceiling Sag in the East Culvert, Looking South.

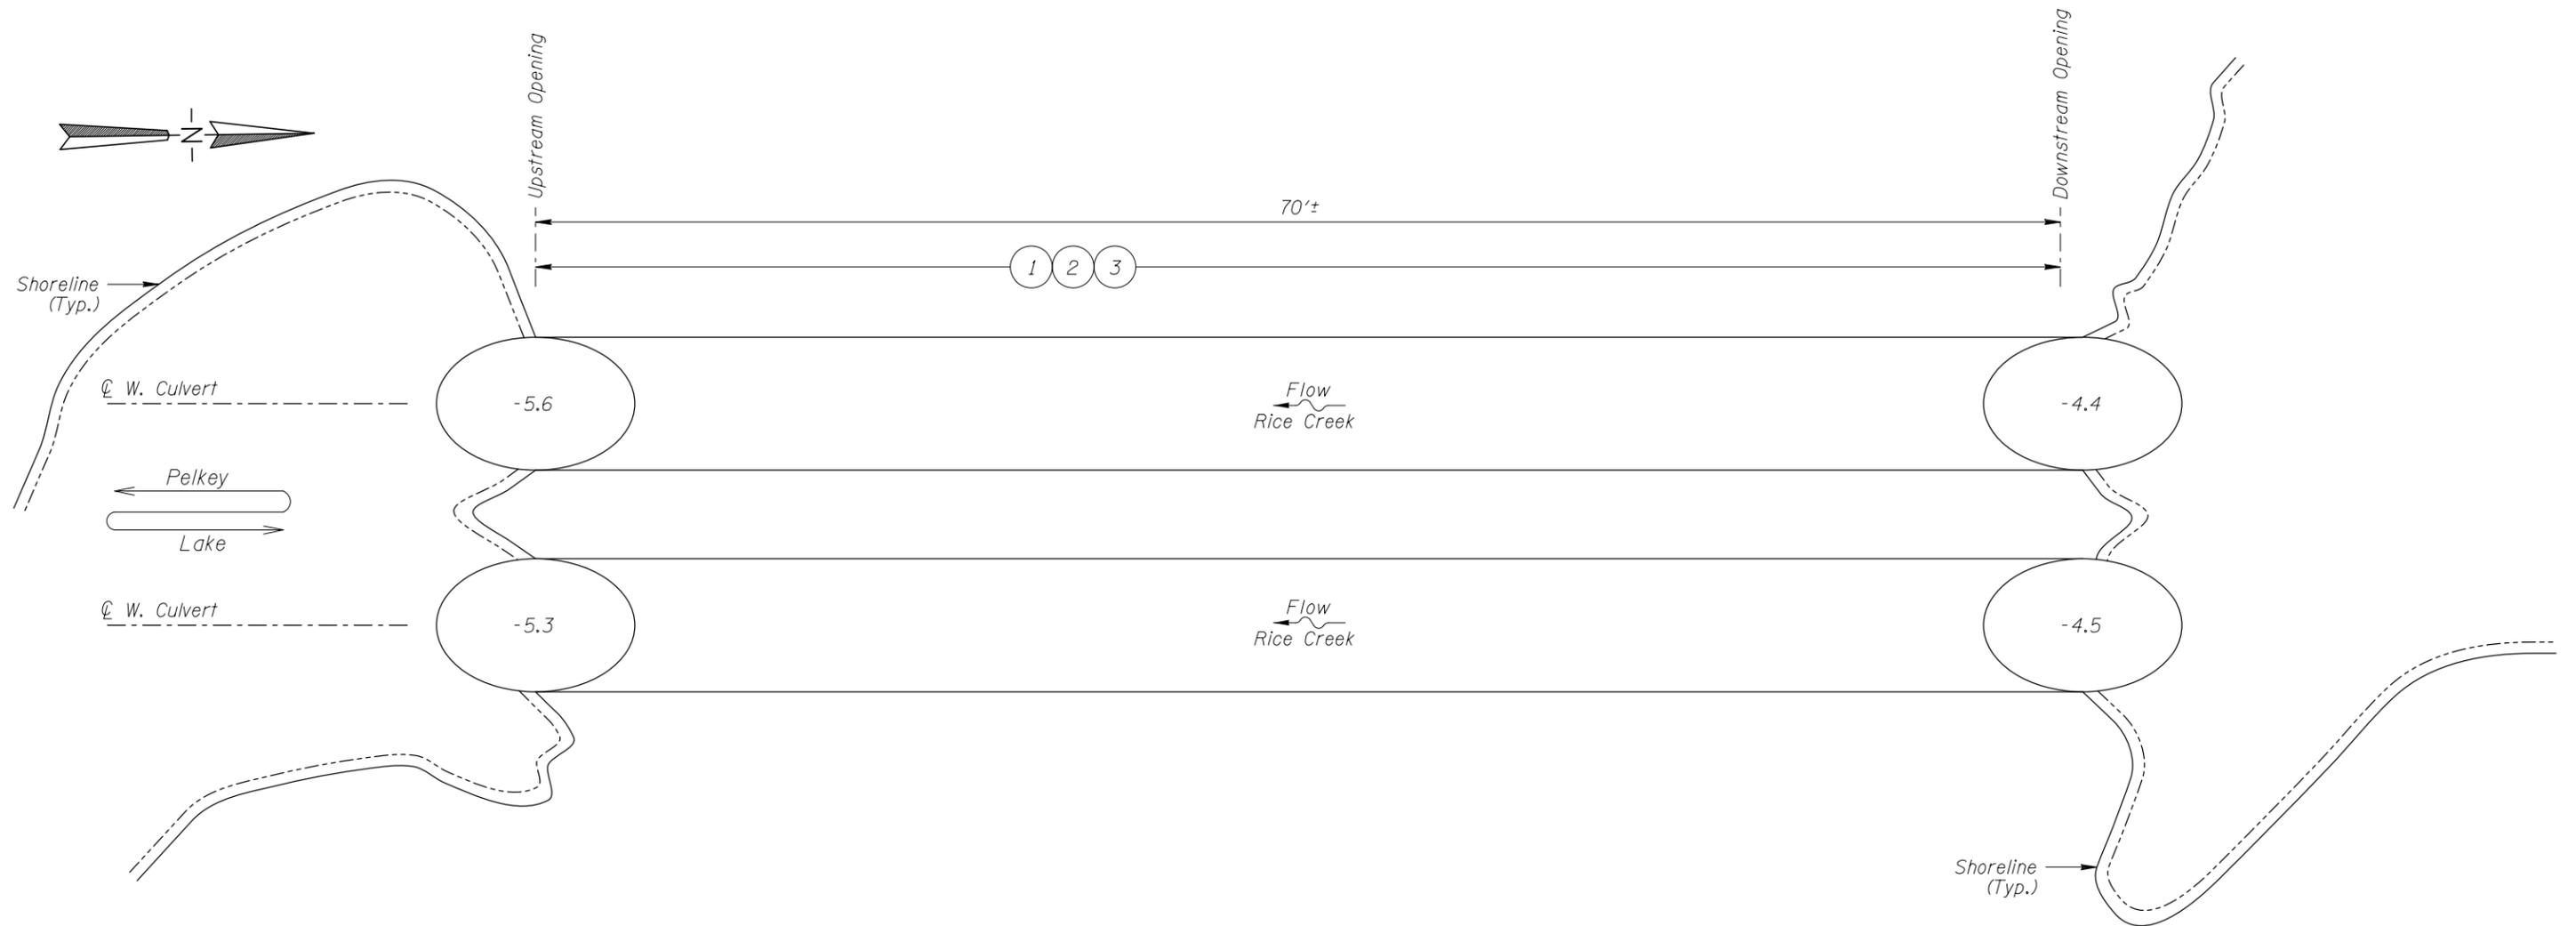
- 1 The corrugated metal pipes were clean of debris and silt build-up throughout the length of both culverts.
- 2 The steel of all culvert surfaces exhibited moderate surface corrosion with a maximum pitting depth of $\frac{1}{8}$ inch.
- 3 Both culverts exhibited a slight downward bow towards the center of the culvert length. The maximum deflection of the top of the culvert was approximately 0.5 to 1 foot downward. The roadway and shoulder above the culvert exhibited two cracks parallel to each culvert pipe. The roadway showed no other signs of settlement.
