UNDERWATER BRIDGE INSPECTION REPORT

STRUCTURE NO. 14511

RED RIVER OF THE NORTH

JOB NO. 3512 (CEI 45)

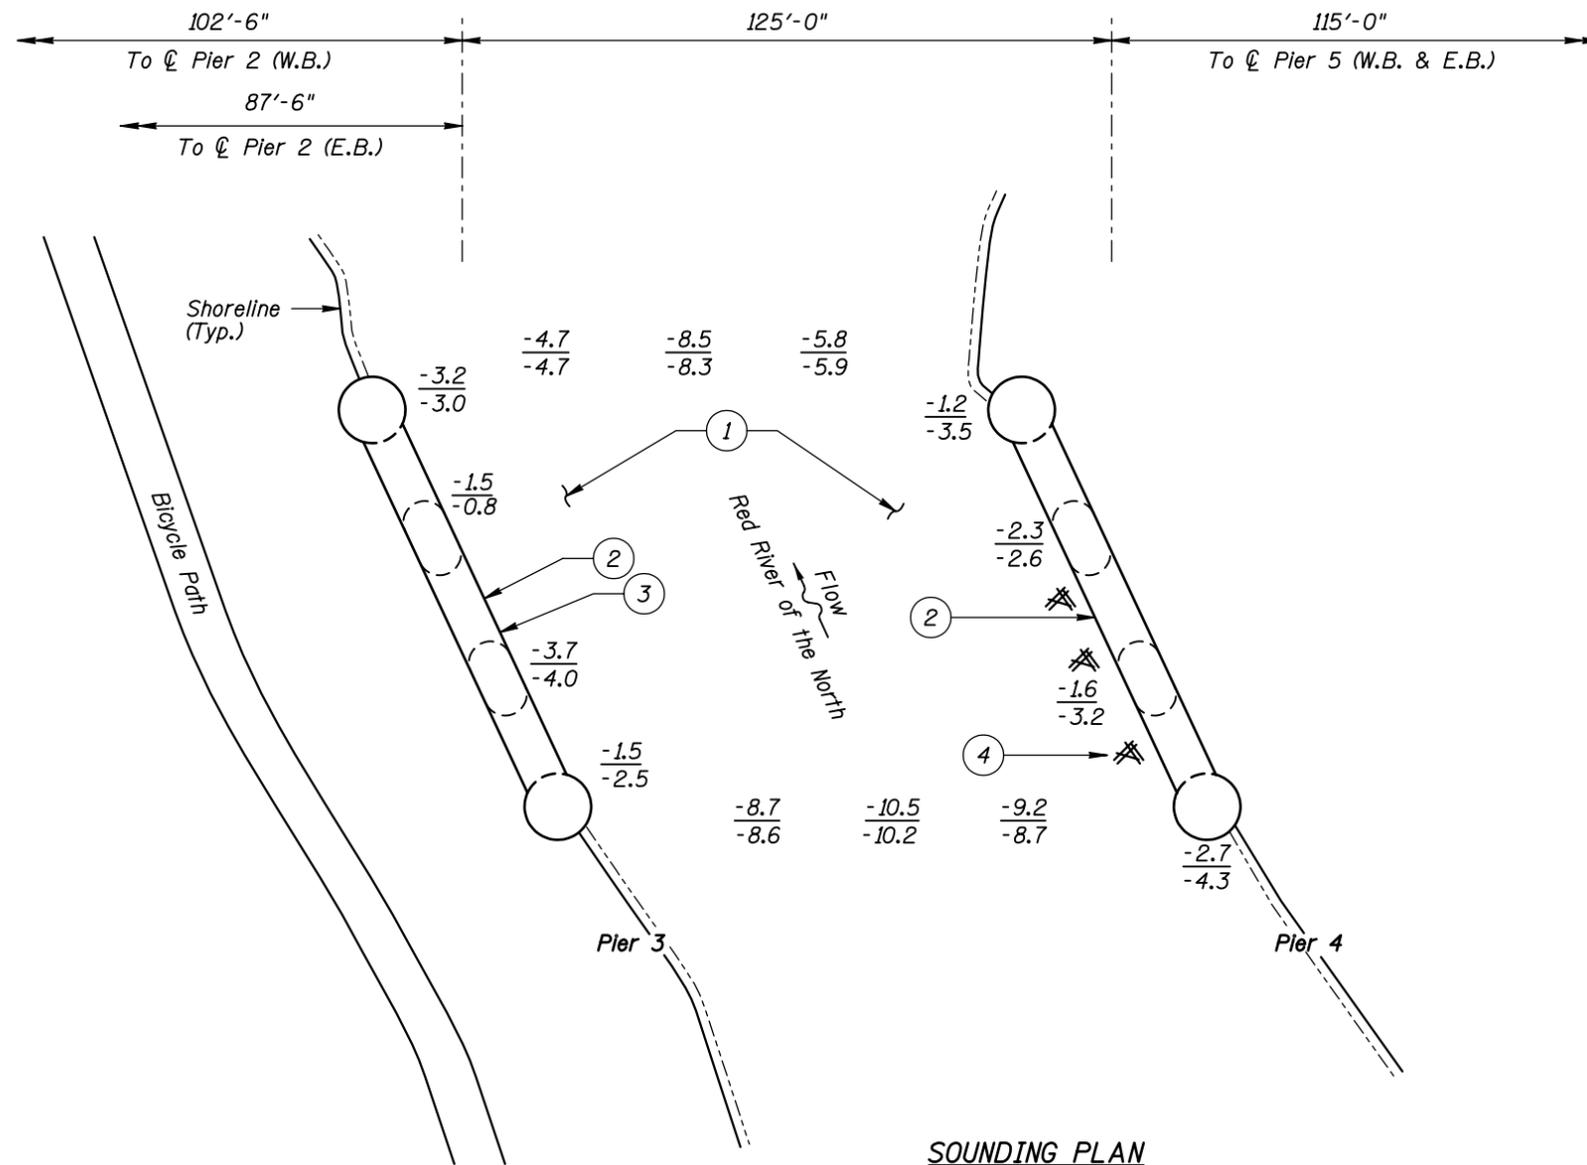
- The channel bottom material consisted of soft clay, gravel, and scattered branches with up to 1.5 feet of probe rod penetration.
- Random hairline to 1/16 inch wide vertical cracks were observed on the diaphragm wall of both piers, extending from the top of the diaphragm to the channel bottom.
- A 4 foot wide section of undermining was observed along the east side of the Pier 3 diaphragm exhibiting up to 6 inches of vertical exposure and 1.5 feet of maximum horizontal penetration at 3.2 feet below the waterline.
- A minor accumulation of timber debris, consisting of 6 inch diameter and smaller branches, was observed along the west side of Pier 4, extending from 0.5 feet below the waterline to the channel bottom.

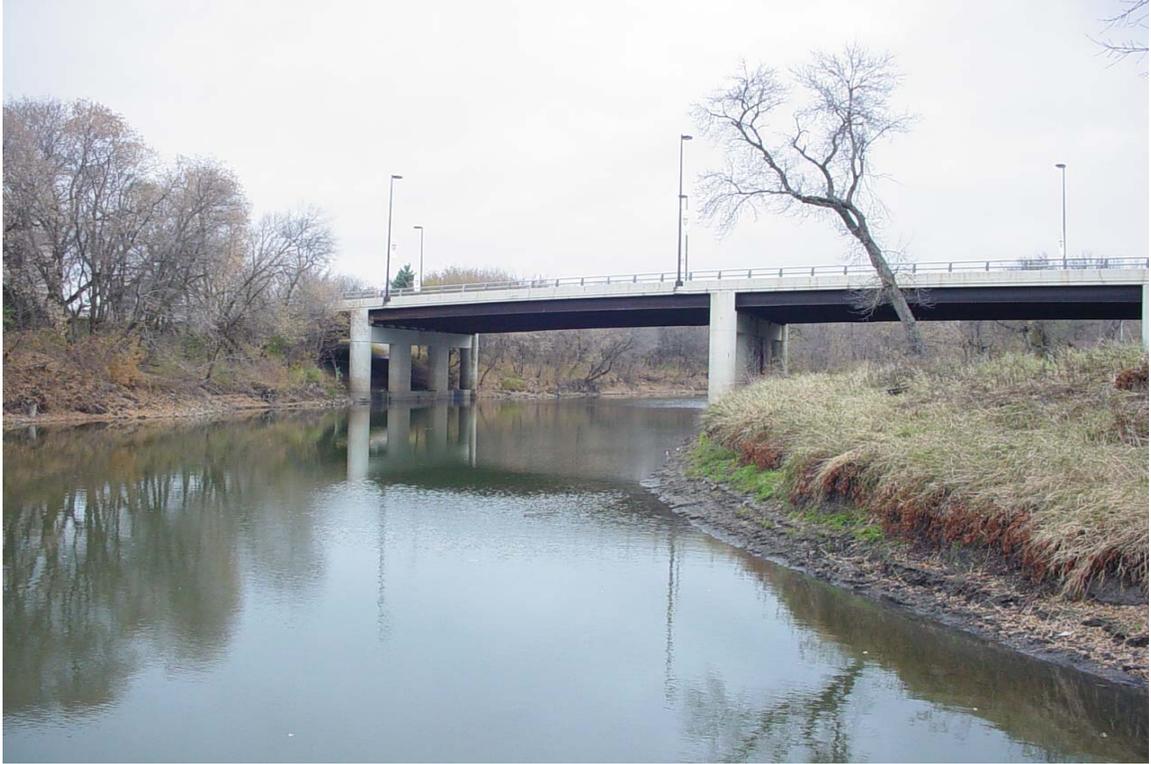
Photograph 1. Overall View of the Structure, Looking North.

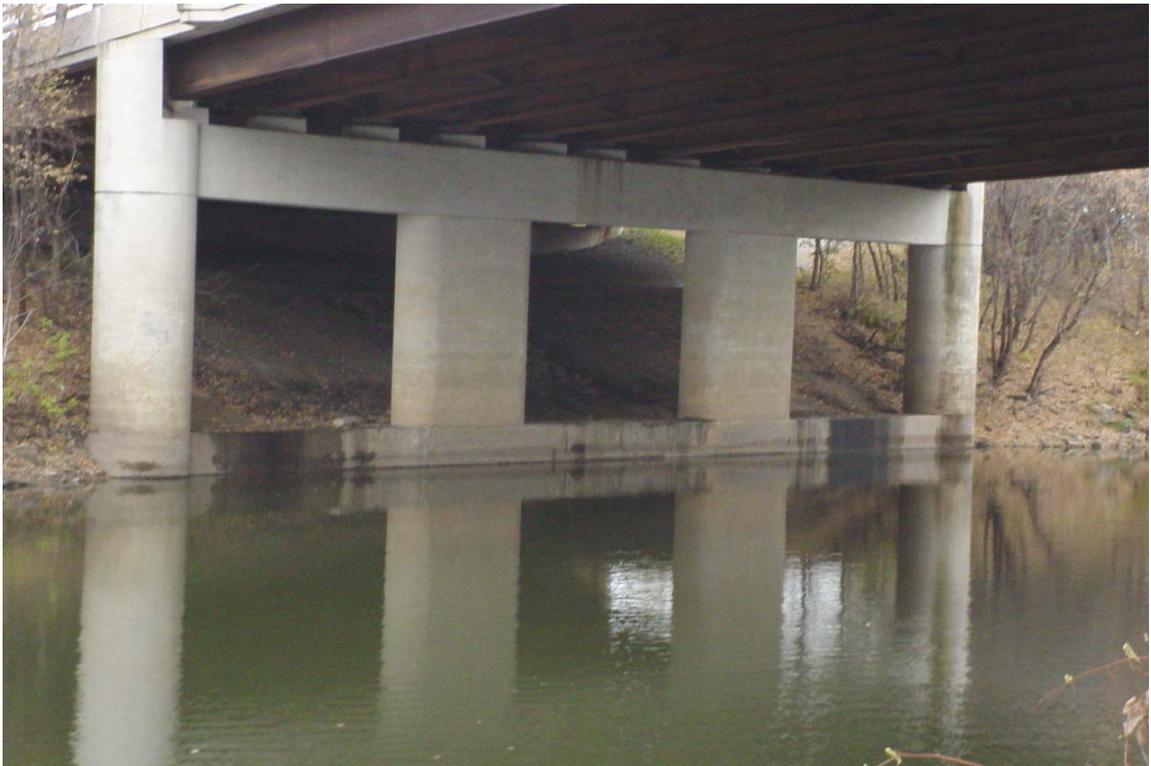
Photograph 2. View of Pier 3, Looking Northwest.

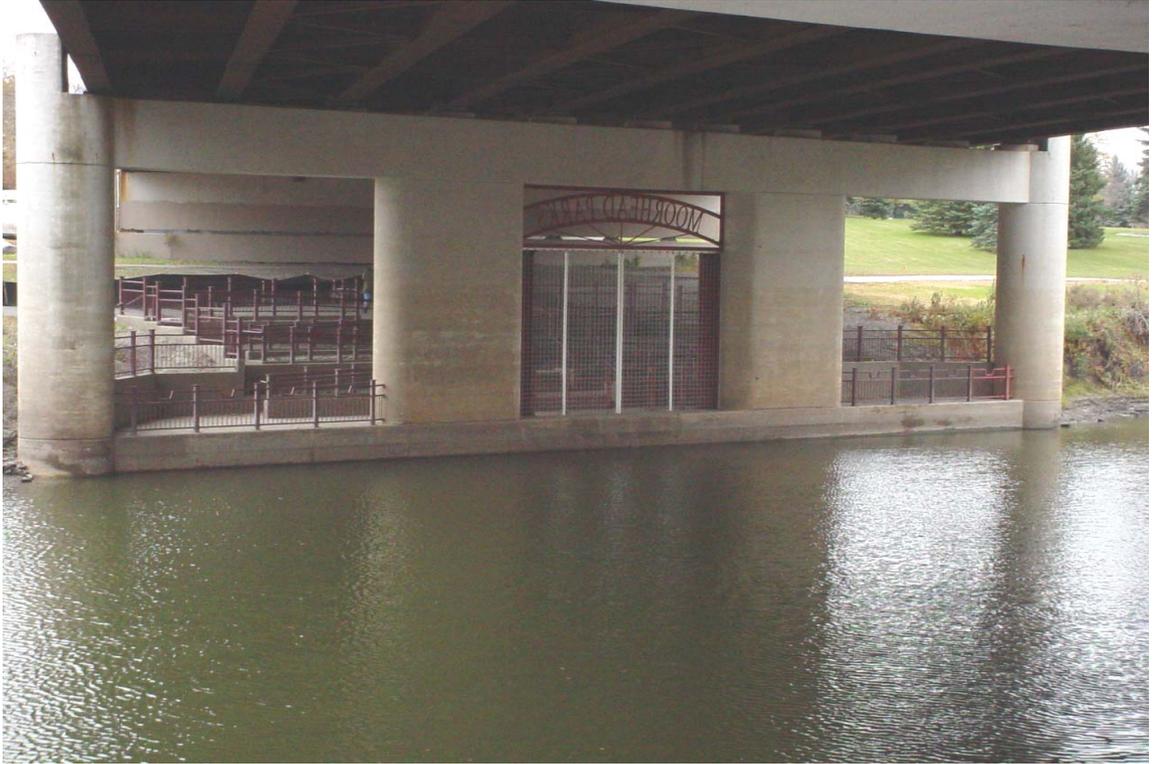
- (A) Random hairline to 1/16 inch wide vertical cracks were observed along the diaphragm of both piers, extending from the top of the diaphragm to the channel bottom.
- (B) A minor accumulation of timber debris was observed along the west side of Pier 4, extending from 0.5 feet below the waterline to the channel bottom.
- (C) The Pier 3 diaphragm was partially undermined along the east side of the pier, with up to 6 inches of vertical exposure and a maximum of 1.5 feet of horizontal penetration.

Photograph 3. View of Pier 4, Looking Southeast.

- (A) Monitor the timber debris, and if found to be increasing in the future, removal operations may become warranted.
