UNDERWATER BRIDGE INSPECTION REPORT

STRUCTURE NO. 7001

CASCADE STREET

OTTER TAIL RIVER

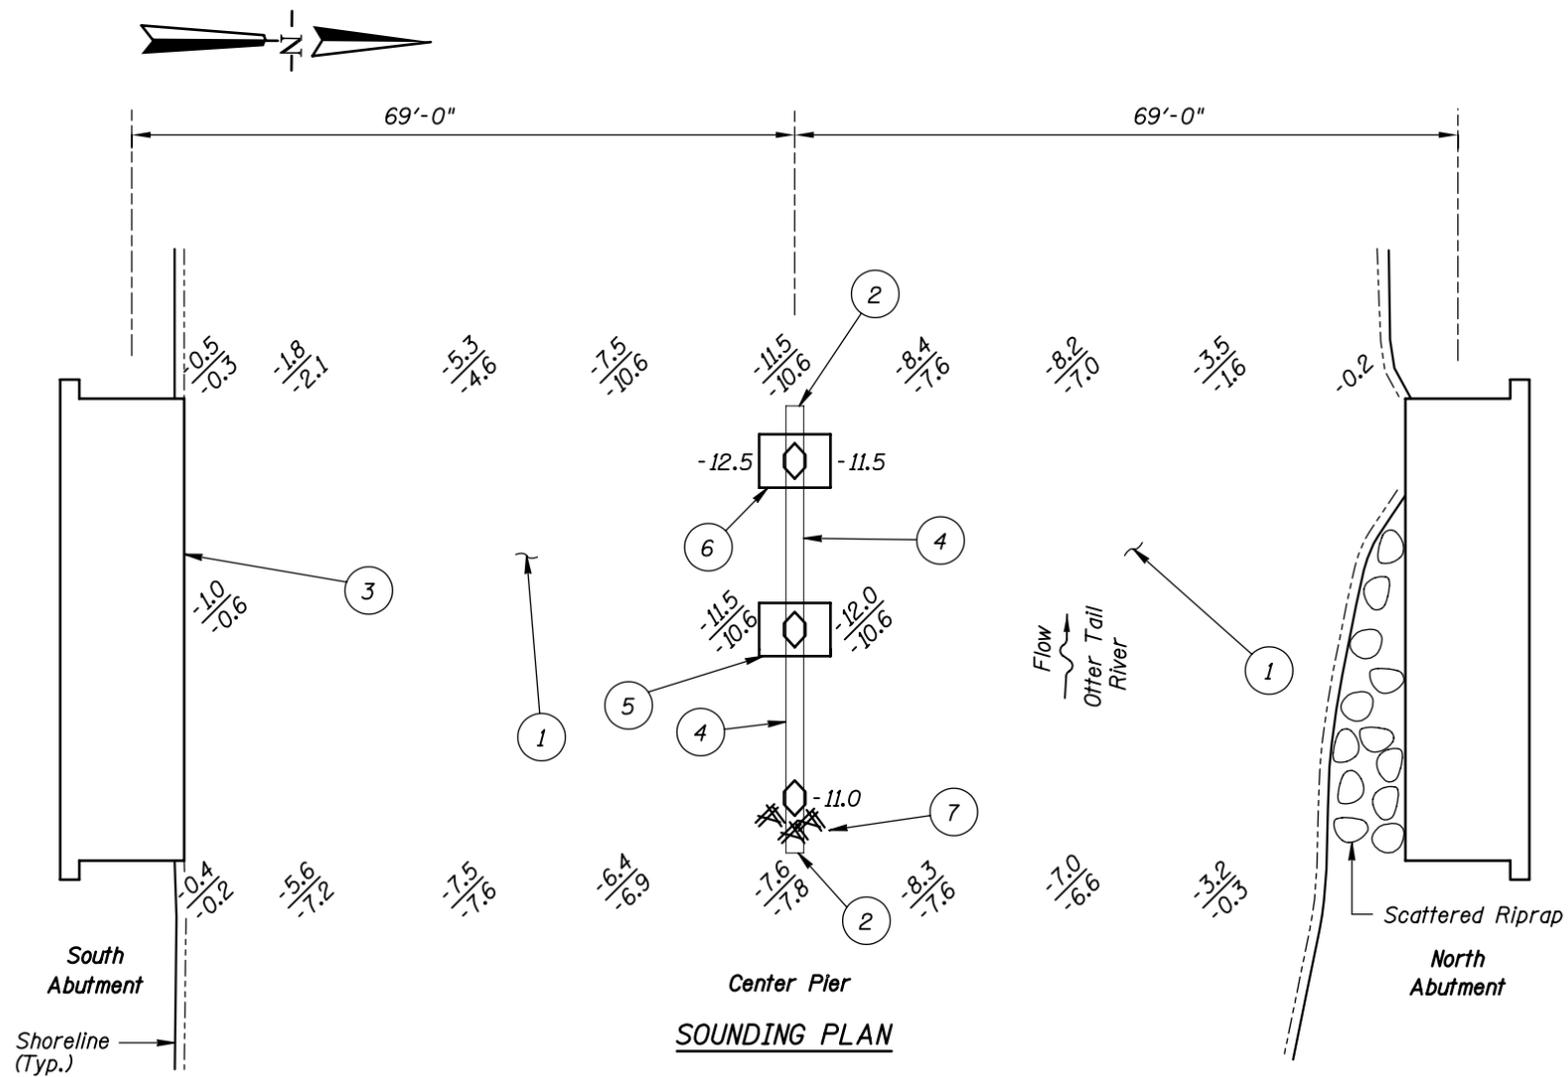
- ① The channel bottom consisted of silty gravel with scattered riprap up to 3 feet in diameter.
- ② The upstream and downstream ends of the pier cap exhibited heavy scaling from 1.5 feet below to 3.2 feet above the waterline with exposed and corroded reinforcing steel and up to 6 inches of penetration.

- ③ The downstream half of the South Abutment exhibited moderate scaling from 1 foot above the waterline to the channel bottom with up to 1 inch of penetration.

- ④ The bottom edge of the pier cap exhibited moderate scaling along the full length of the pier from 1 foot above to 1.5 feet below the waterline. The most extensive deterioration was near the upstream and downstream ends with exposed reinforcing steel and penetrations up to 1 inch.

- ⑤ The top of the footing was exposed around the entire center column with up to 6 inches of vertical face exposed along the north side.
- ⑥ The top of the footing was exposed around the entire downstream column with up to 1 foot of vertical face exposed along the south side.

- ⑦ A minor accumulation of branchy timber debris was observed at the upstream column of the Center Pier.

Repair the areas of scaling noted on the pier cap by removing all loose or deteriorated concrete and reforming or resurfacing as required with a concrete grout mix designed to promote high durability and low permeability.

The extent of the pier footing exposure should be monitored during future inspections.

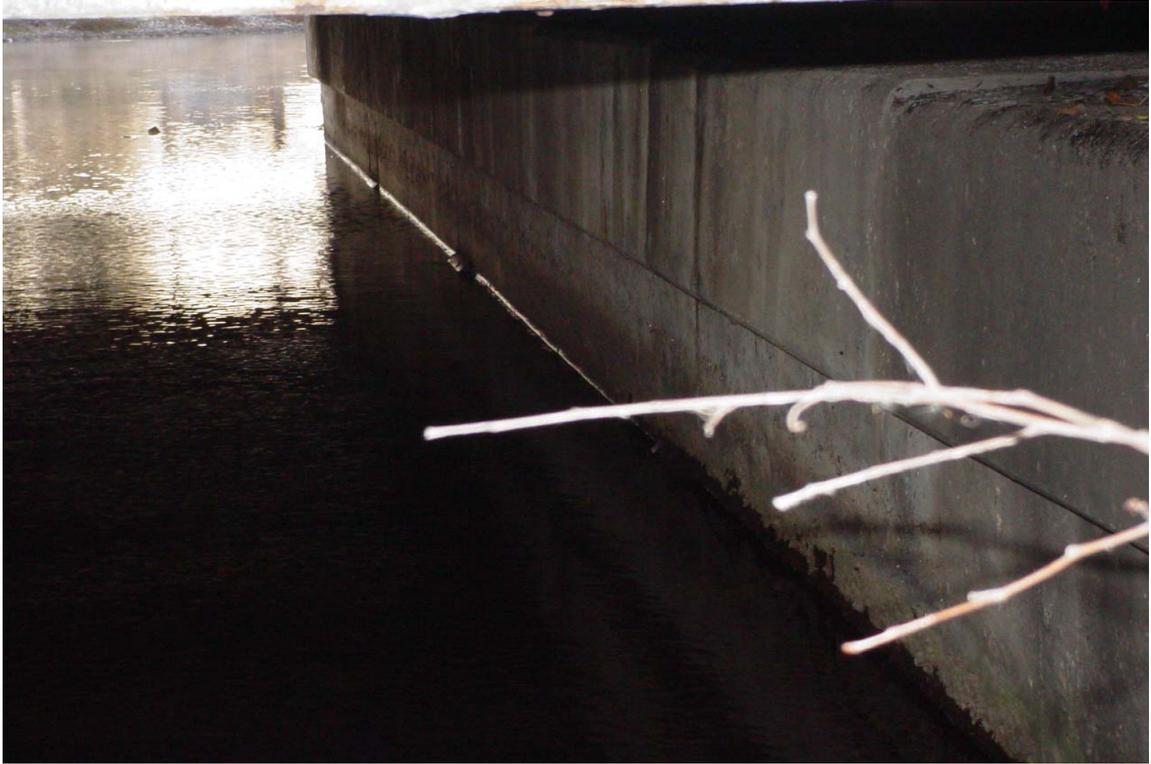
- (B) The downstream half of the South Abutment exhibited moderate scaling from 1 foot above the waterline to the channel bottom with up to 1 inch of penetration.

Photograph 3. View of South Abutment, Looking East.

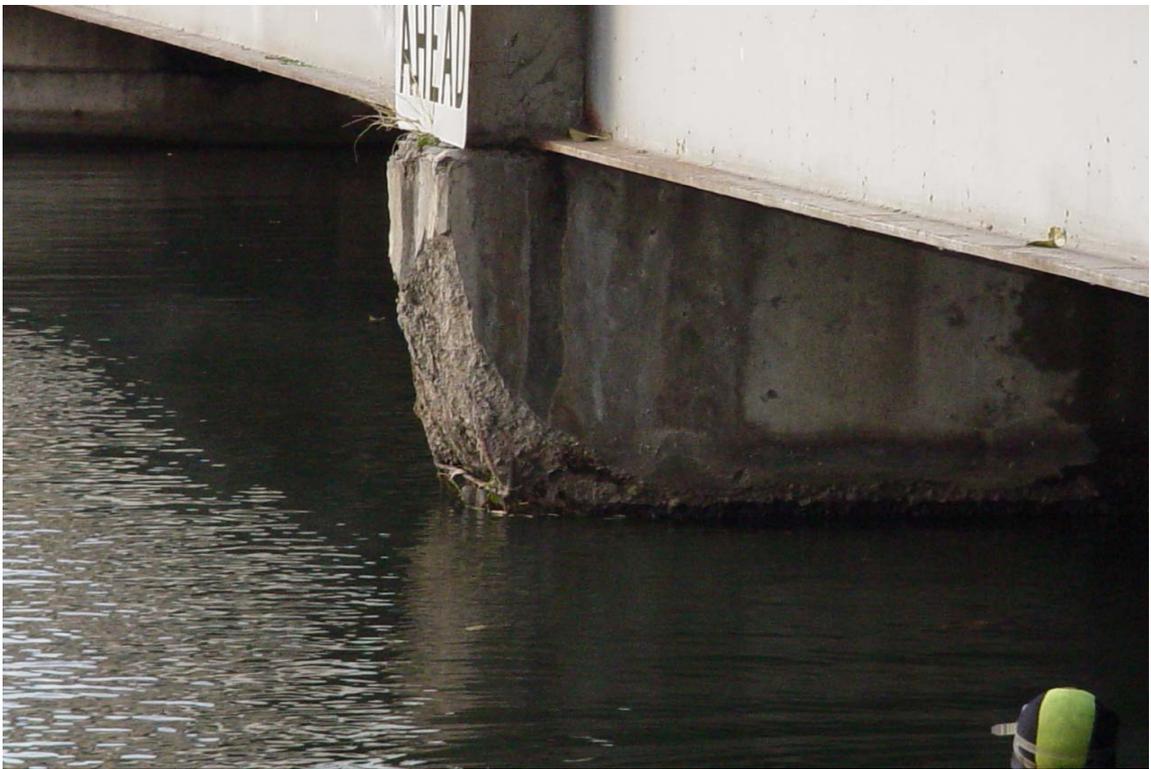
- (A) The upstream and downstream ends of the pier cap exhibited heavy scaling from 1.5 feet below to 3.2 feet above the waterline with exposed and corroded reinforcing steel and up to 6 inches of penetration. In addition, the bottom edge of the pier cap exhibited moderate scaling along the full length of the pier from 1 foot above to 1.5 feet below the waterline. The most extensive deterioration was near the upstream and downstream ends with exposed reinforcing steel and penetrations up to 1 inch.

Photograph 4. View of Upstream End of the Center Pier, Looking Southwest.

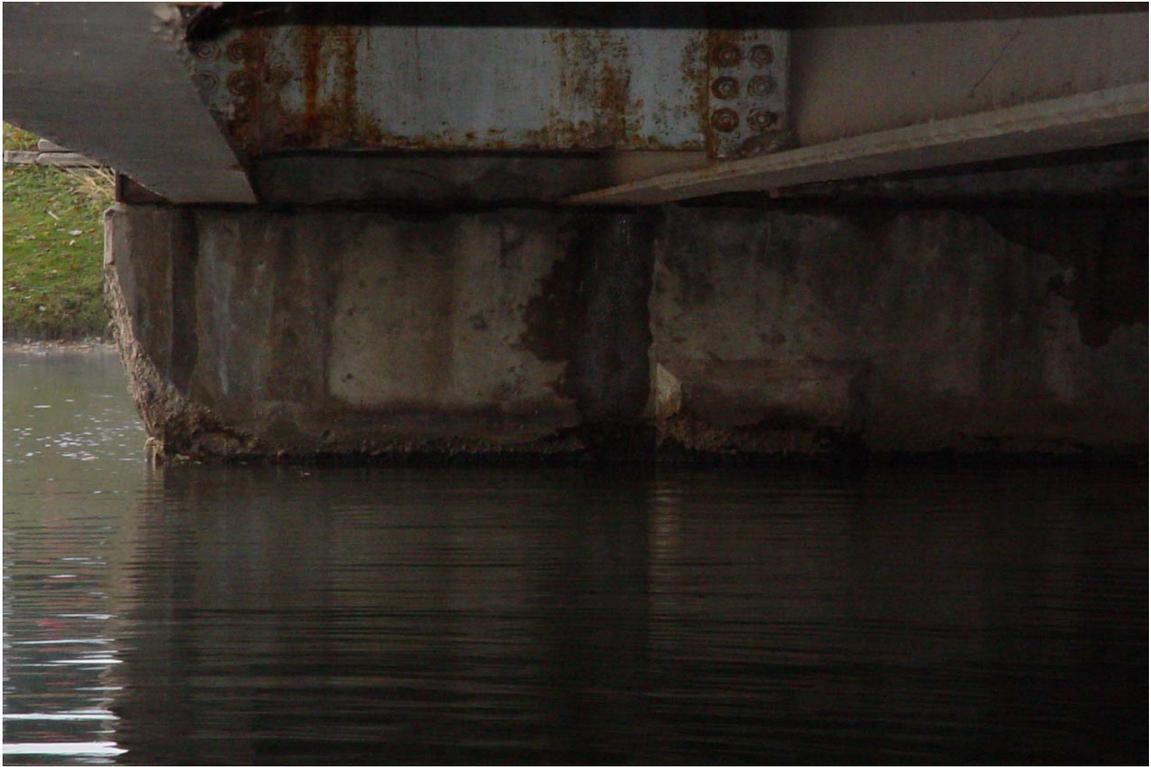
Photograph 5. View of Upstream End of the Center Pier, Looking South.

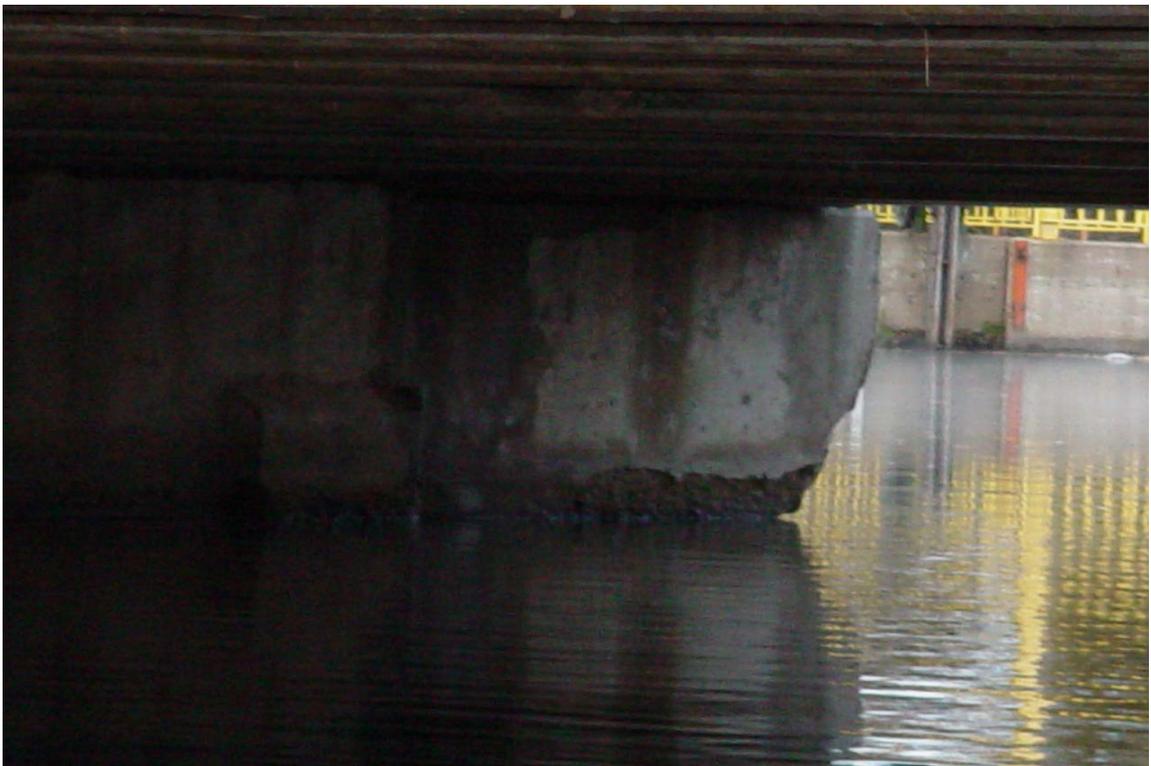
Photograph 6. View of Downstream End of the Center Pier, Looking Southwest.
