UNDERWATER BRIDGE INSPECTION REPORT

STRUCTURE NO. 84505  
CSAH NO. 14  
OVER THE  
THE OTTER TAIL RIVER  
DISTRICT 4 - WILKIN COUNTY

PREPARED FOR THE  
MINNESOTA DEPARTMENT OF TRANSPORTATION  
BY  
COLLINS ENGINEERS, INC.  
JOB NO. 3512 (CEI 58)

MINNESOTA DEPARTMENT OF TRANSPORTATION  
UNDERWATER BRIDGE INSPECTION

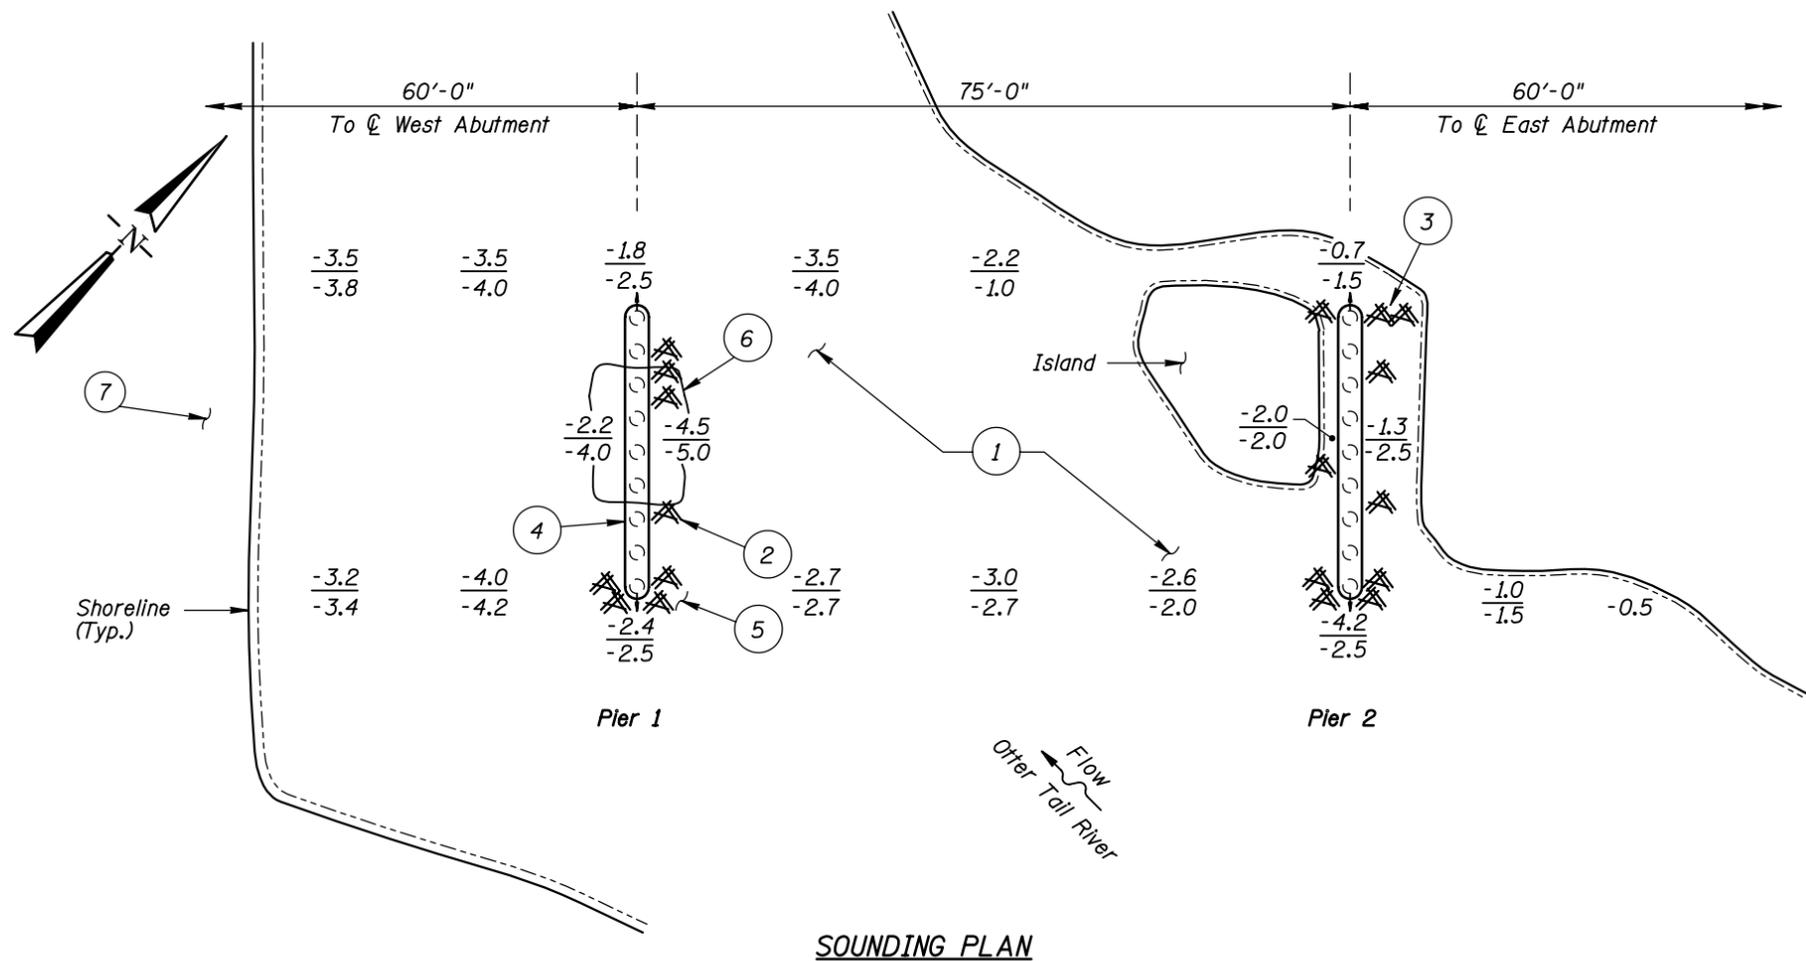
1. The channel bottom consisted of sand with up to 12 inches of probe rod penetration.
2. A minor accumulation of branchy timber debris, with pieces up to 3 inches in diameter, along with some minor steel debris was observed on the channel bottom at the upstream end of Pier 1 and extending along the north side of the pier.

3. Minor accumulations of branchy timber debris were observed all around Pier 2 with a moderate accumulation of larger timber debris, with pieces up to 8 inches in diameter, observed at the downstream end of the pier.

4. The concrete pier cap exhibited timber formwork embedded into the south face of Pier 1 with an area of concrete section loss observed along the formwork which was 2.5 feet long, 1 foot wide, and 4 inches deep.

5. The channel bottom consisted of riprap up to 3 feet in diameter at the upstream nose of Pier 1.
6. A large area of slop concrete was observed on the channel bottom along the center portion of Pier 1.

7. The west embankment was well armored with riprap up to 3 feet in diameter.

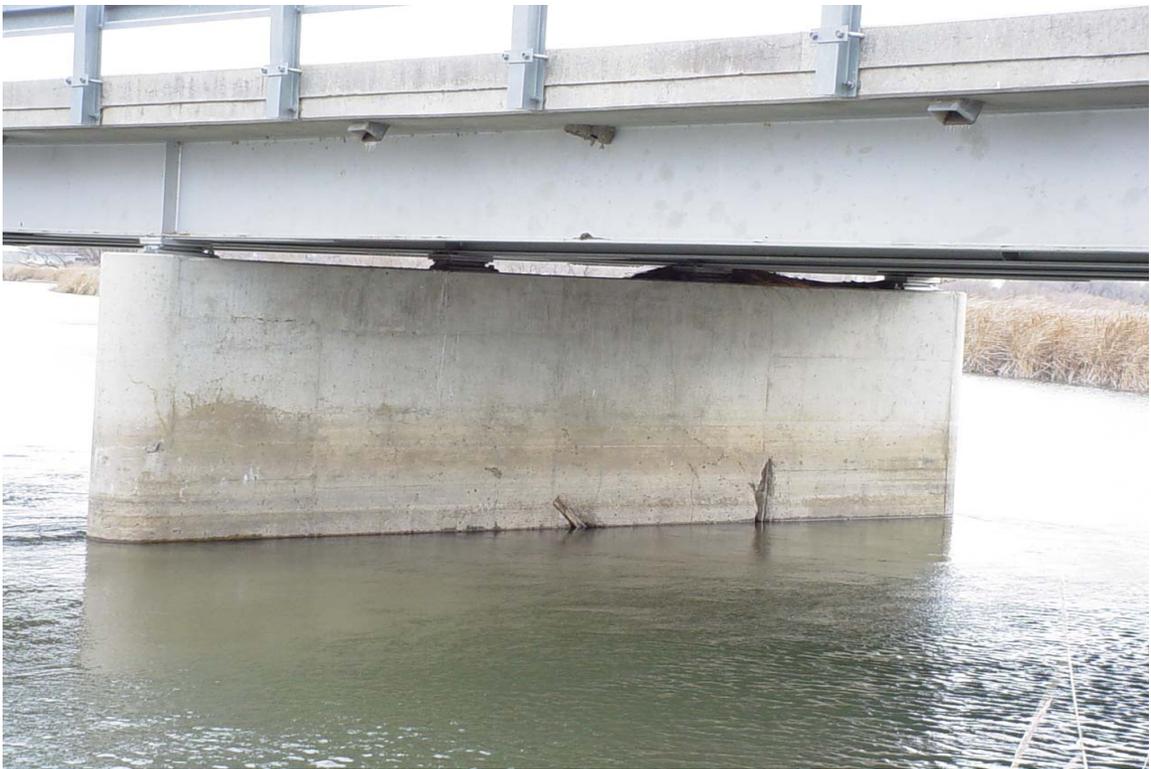
Photograph 2. View of Pier 1, Looking East.

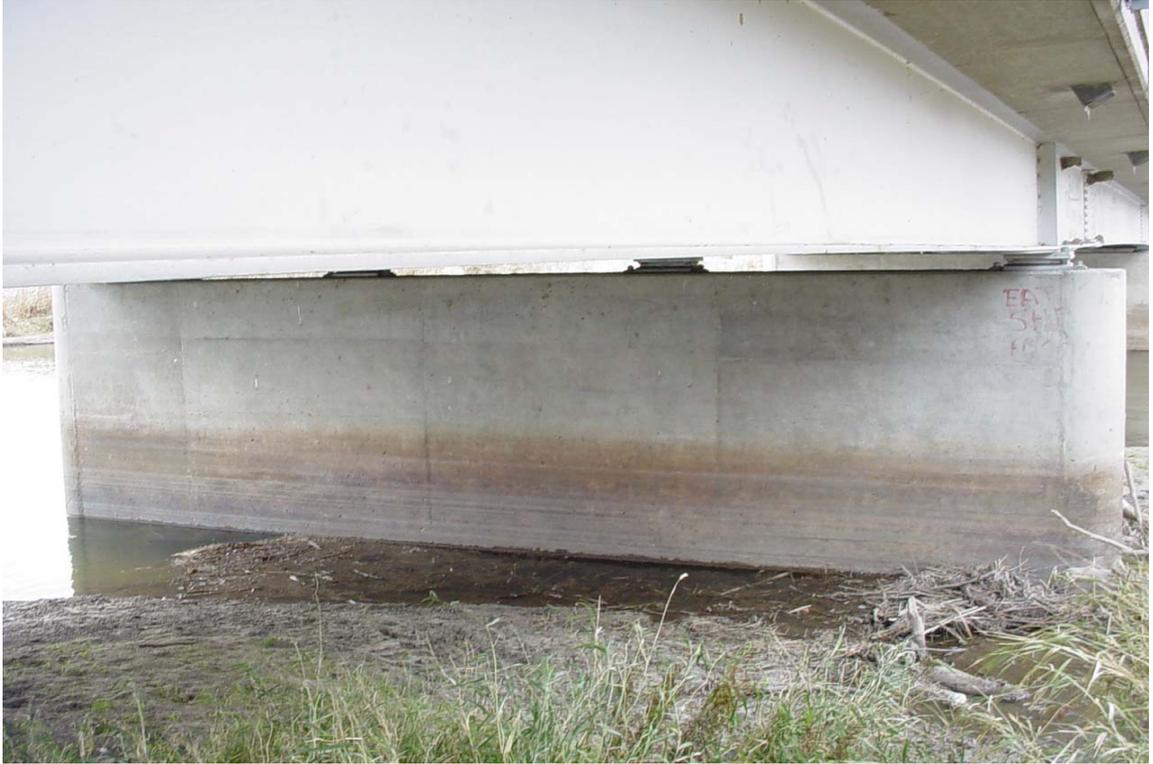
Photograph 3. View of Pier 2, Looking South.

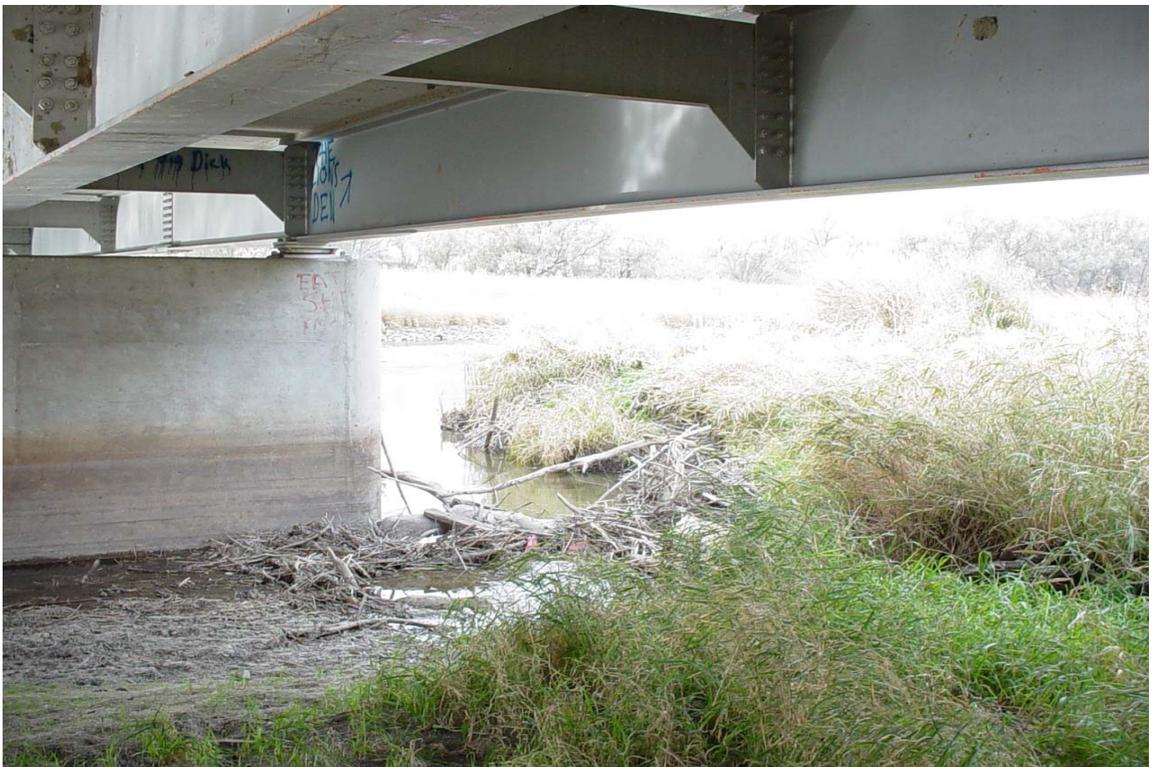
Photograph 4. View of Downstream Nose of Pier 2, Looking West.
