UNDERWATER BRIDGE INSPECTION REPORT

STRUCTURE NO. 92453
CSAH NO. 15
OVER THE
SOUTH BRANCH OF THE BUFFALO RIVER
DISTRICT 4 - CLAY COUNTY

PREPARED FOR THE
MINNESOTA DEPARTMENT OF TRANSPORTATION
BY
COLLINS ENGINEERS, INC.
JOB NO. 3512 (CEI 53)

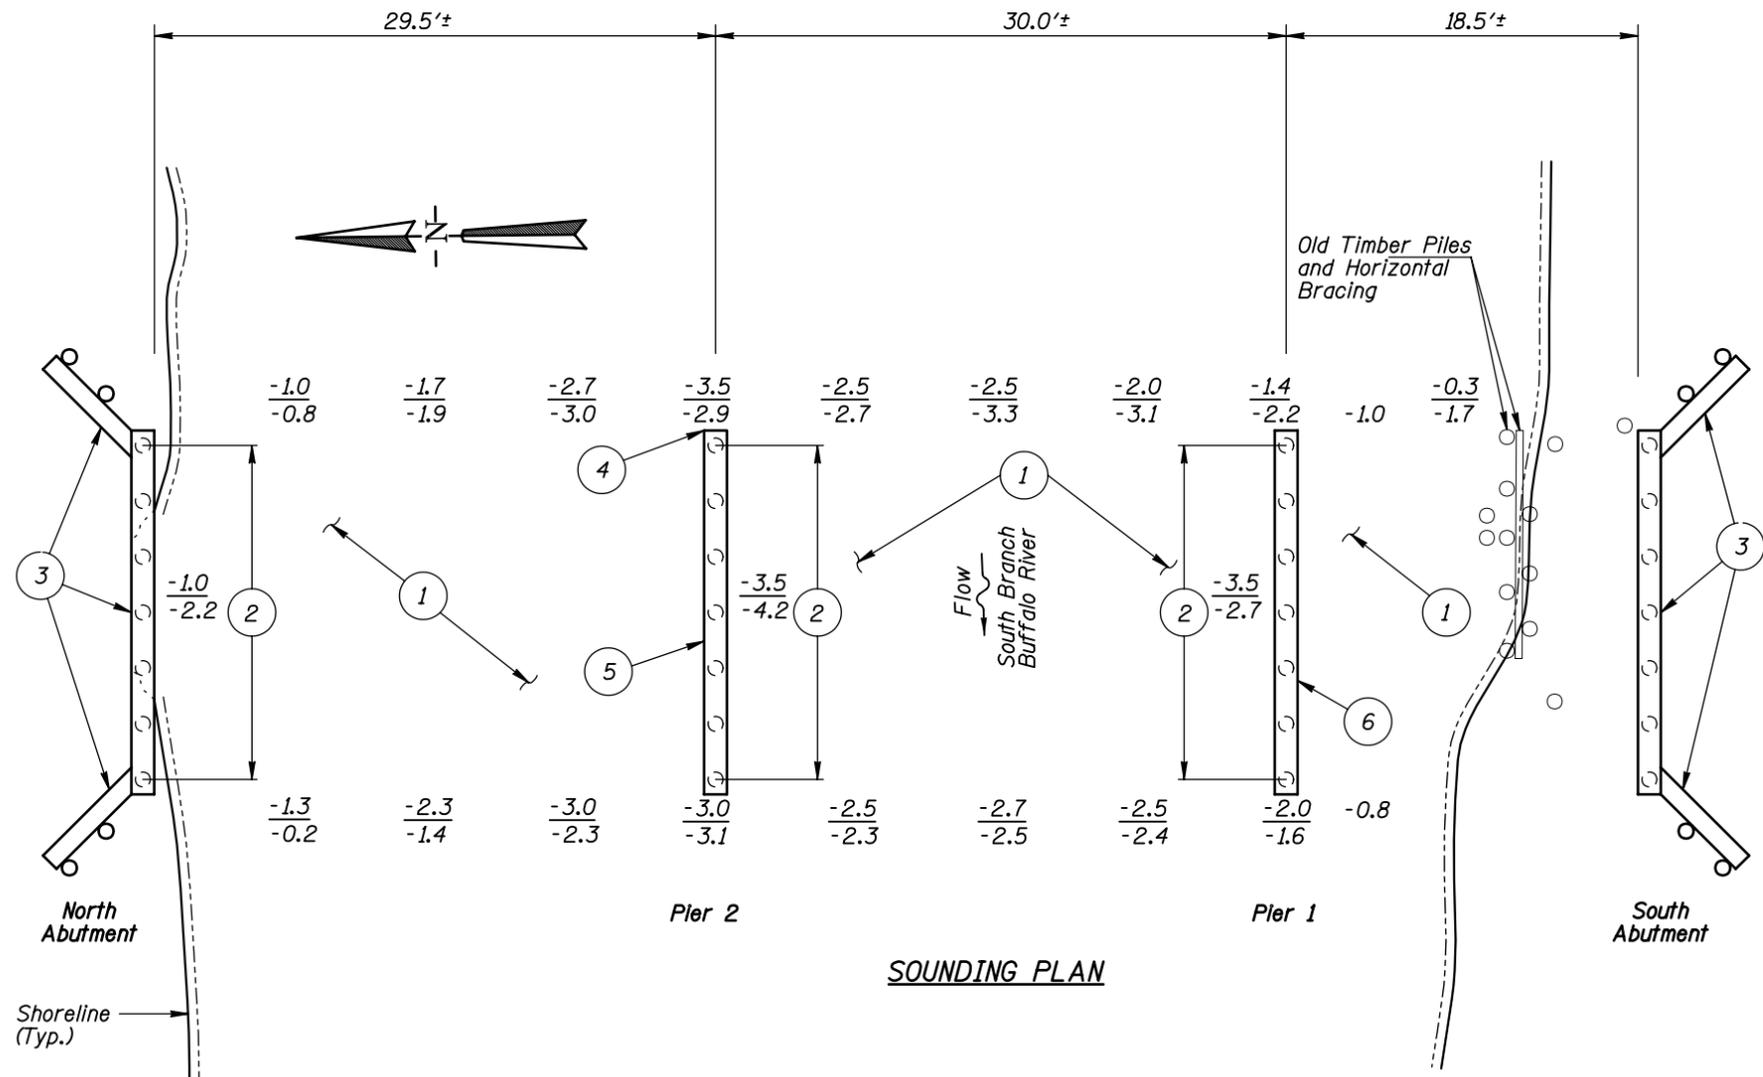
SOUNDING PLAN

- 1 The channel bottom consisted of firm, silty clay with up to 2 inches of probe rod penetration.
- 2 The timber piles exhibited vertical checking with a typical width of 1/16 and a maximum width of 1/8 inch.
- 3 The gaps between the timber planking along the backwall and wingwalls have been repaired with metal bands to halt backfill loss.
- 4 The horizontal timber brace directly below the pier cap was broken and no longer engaged at the upstream pile at Pier 2.
- 5 The diagonal timber bracing at Pier 2 was completely missing.
- 6 The diagonal timber brace at Pier 1 was attached only at the upstream pile and no longer contributed to the lateral stability of the structure.

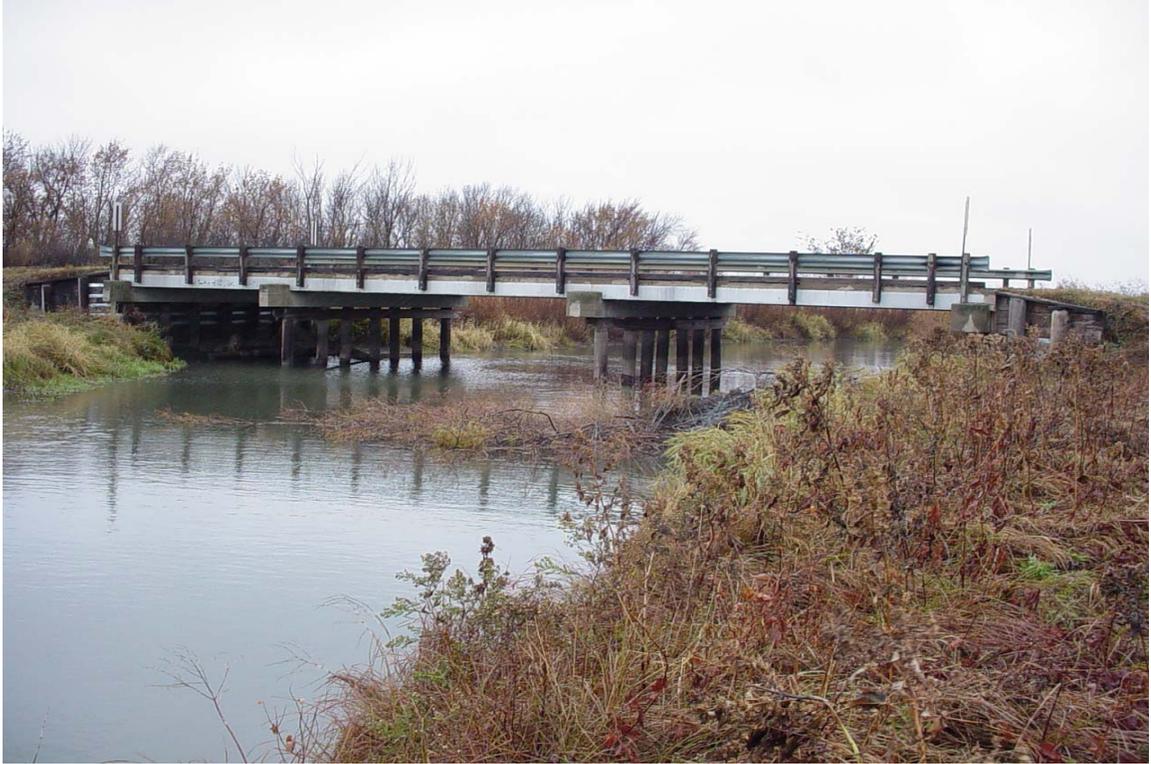
Photograph 1. View of Overall Structure, Looking West.

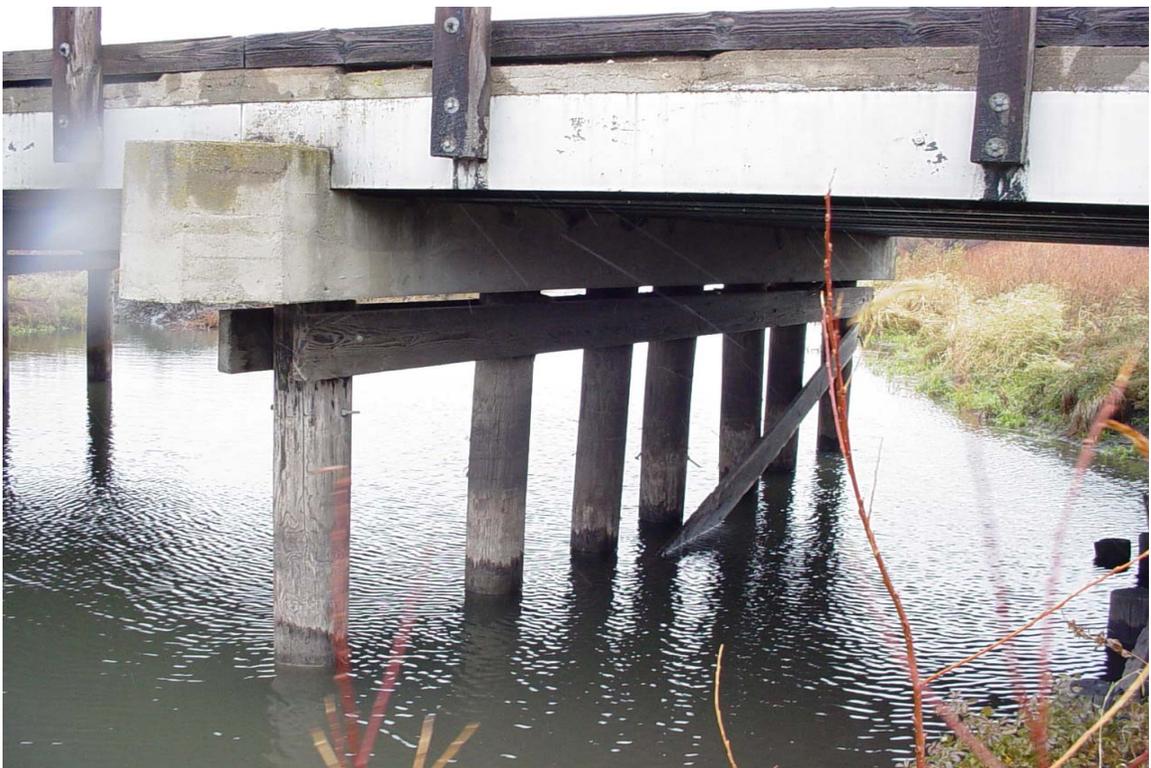
Photograph 2 View of Pier 1, Looking Northeast.

- (A) Repair missing and/or broken timber bracing at Piers 1 and 2 to reestablish the lateral stability of the structures.

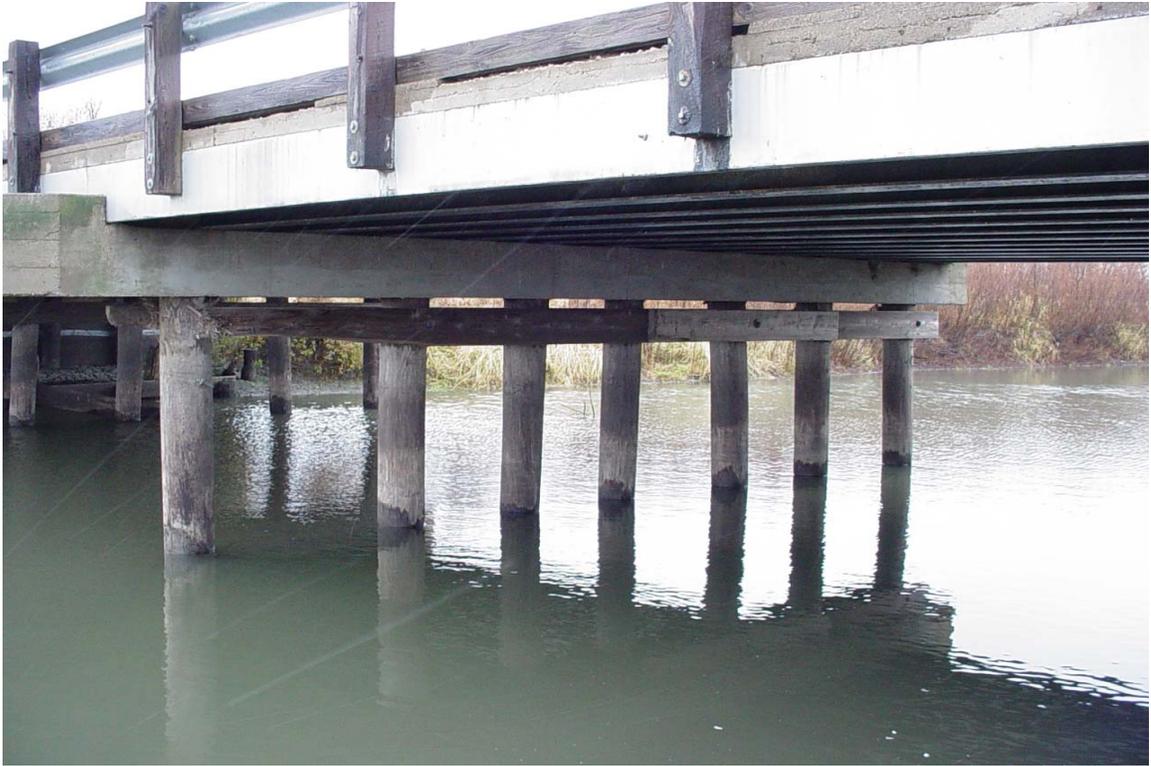
Photograph 3. View of Pier 2, Looking Southwest.

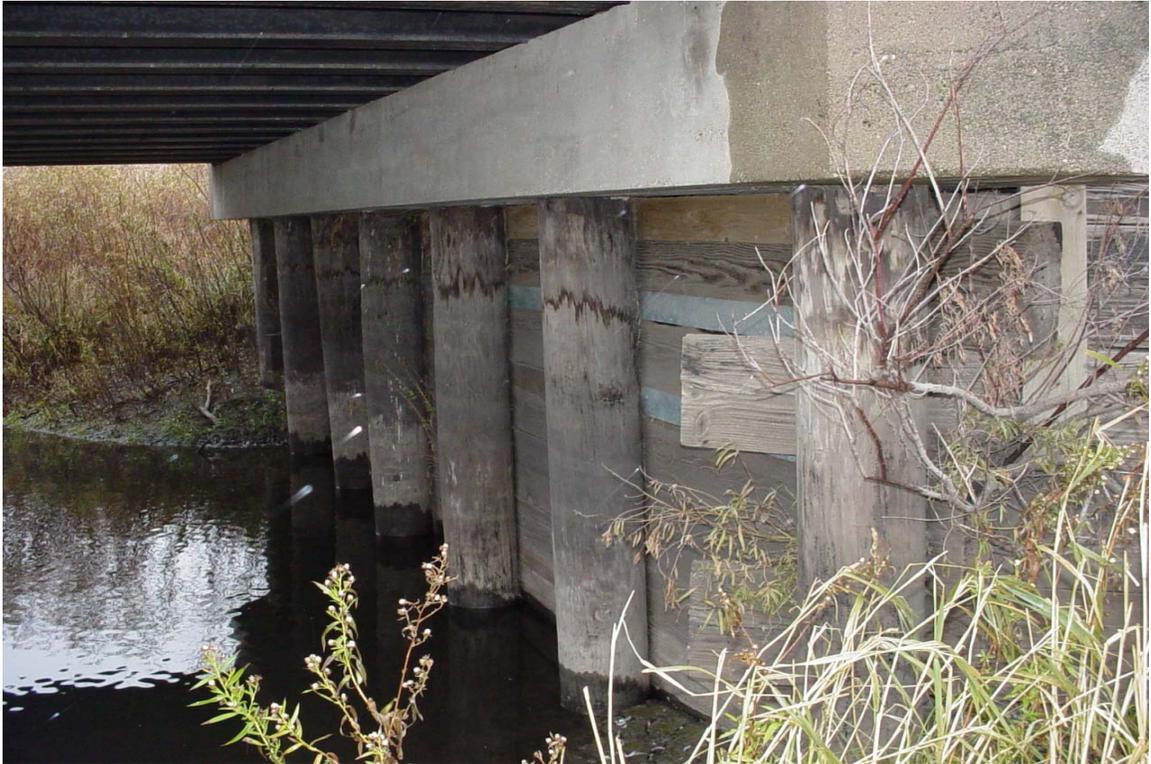
Photograph 4. View of North Abutment, Looking Northwest.
