UNDERWATER BRIDGE INSPECTION REPORT

STRUCTURE NO. L0888  
DIVERSION STREET  
OVER THE  
CHANNEL TO THE OTTER TAIL POWER COMPANY  
DISTRICT 4 – OTTER TAIL COUNTY

PREPARED FOR THE  
MINNESOTA DEPARTMENT OF TRANSPORTATION  
BY  
COLLINS ENGINEERS, INC.  
JOB NO. 3512

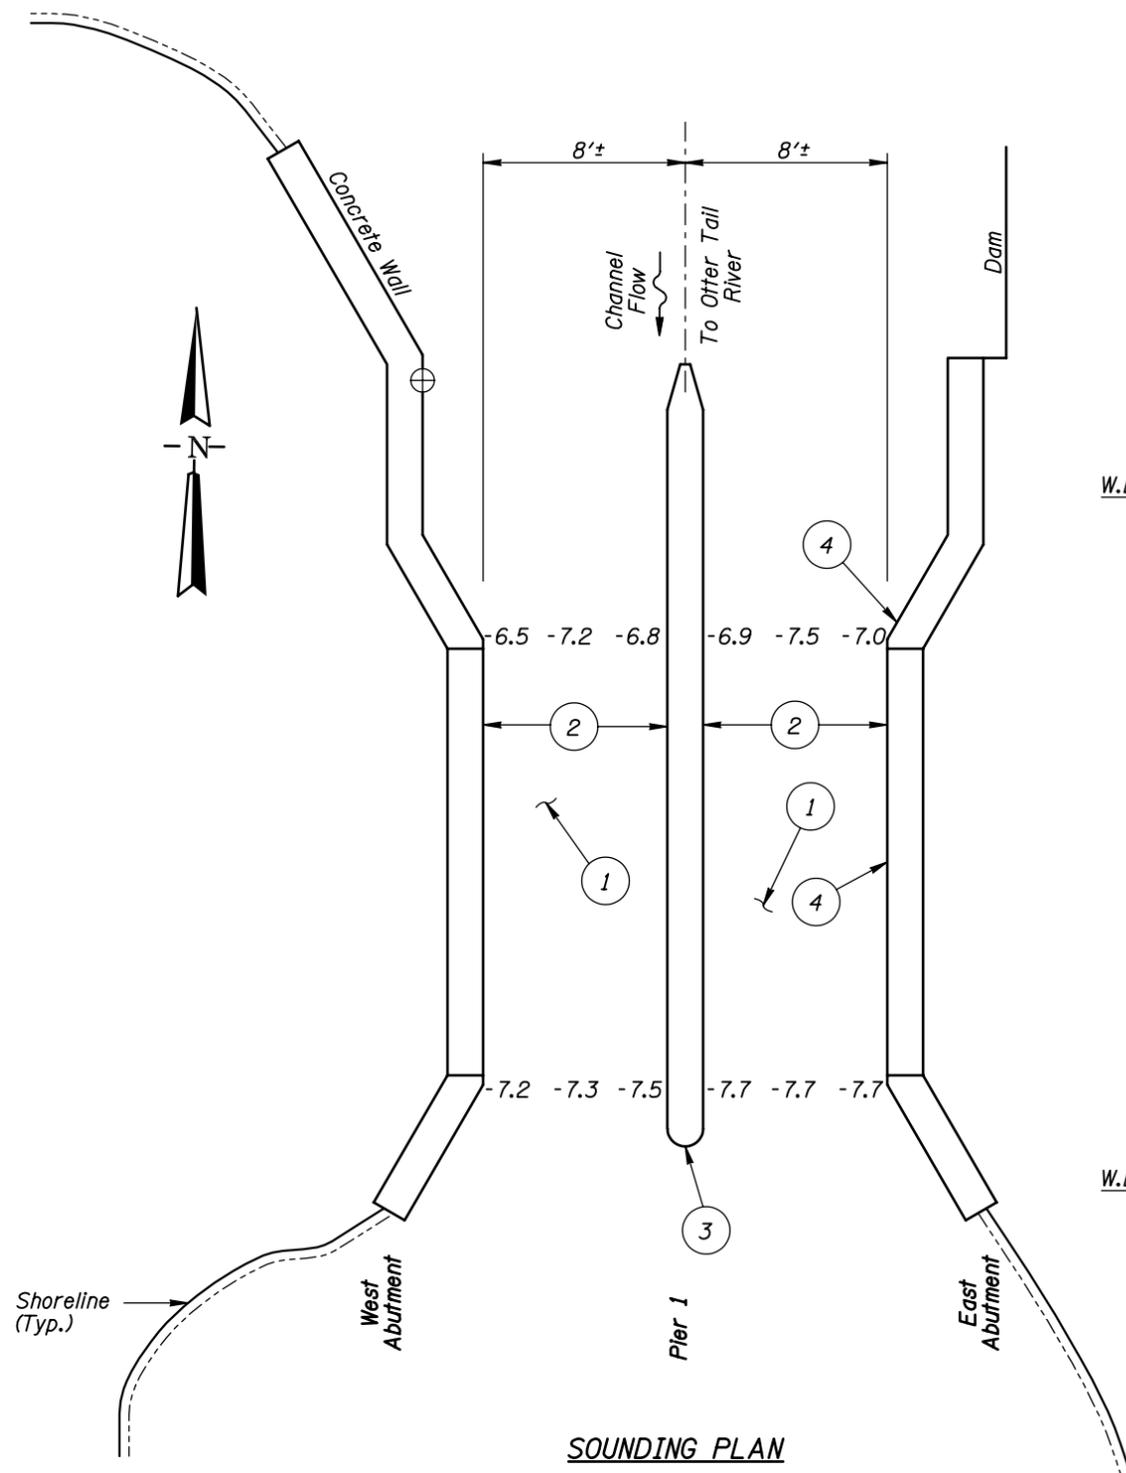
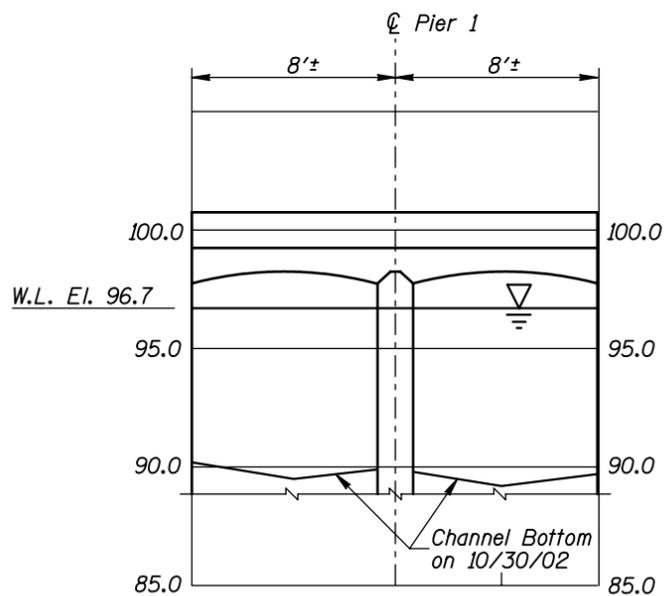
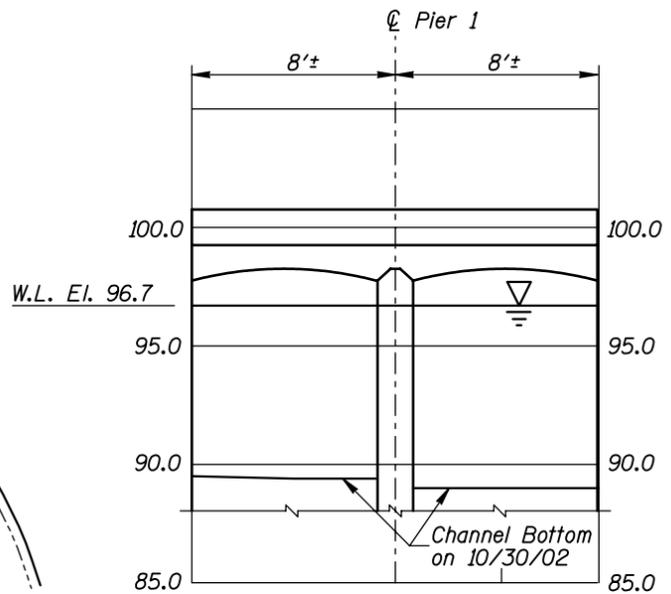
<b>COLLINS ENGINEERS, INC.</b> 300 W. WASHINGTON, STE. 600 CHICAGO, ILLINOIS 60606 (312) 704-9300	Date: OCT. 2002
Checked By: MDK		Scale: NTS
Code: 35120888		Figure No.: 1

- 1 The channel bottom material consisted of gravel with 8 to 12 inch diameter stones allowing minimal probe rod penetration.
- 2 The concrete along the pier and abutments exhibited heavy scaling from 1 foot above the waterline to 2 feet below the waterline with 3 inches of penetration typical and maximum penetrations of 6 inches.
- 3 The entire top corner of the pier exhibited heavy section loss with up to 12 inches of penetration, but with no exposed reinforcing steel.
- 4 A 1/4 inch wide vertical crack was observed from 2 feet to 5 feet below the waterline.

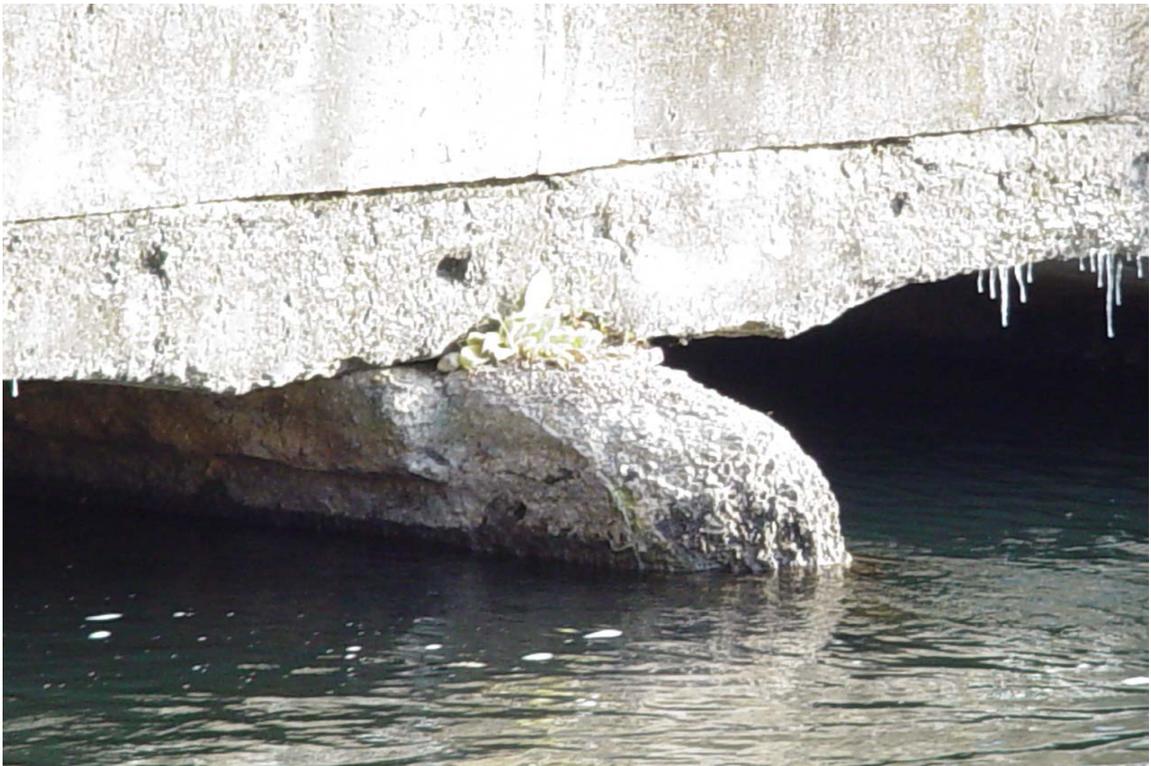
- (A) The concrete around Pier 1 and along both abutments exhibited heavy scaling from 1 foot above the waterline to 2 feet below the waterline with 3 inches of penetration typical and maximum penetrations of 6 inches.
- (B) The entire top corner of the downstream nose of Pier 1 exhibited heavy section loss with up to 12 inches of penetration, but with exposed reinforcing steel.
- (C) A 1/4 inch wide vertical crack was observed at the north end of the East Abutment extending from 2 feet to 5 feet below the waterline.

Photograph 2. View of Downstream End of Pier 1, Looking Northeast.

- (A) Since there is still sufficient capacity and no exposed reinforcing steel, monitor the concrete deterioration on all of the substructure units, and if found to be worsening in the future, repair operations may become warranted.

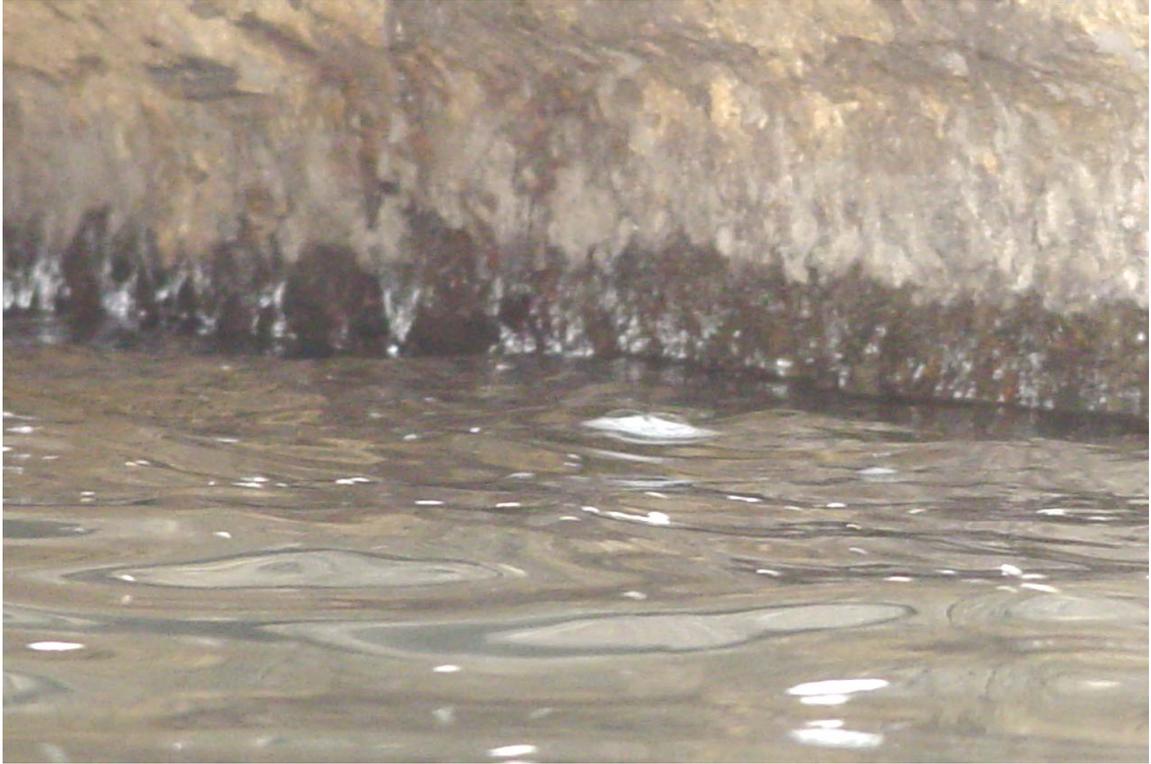
Photograph 3. View of Typical Scaling at Pier 1, Looking Northeast.

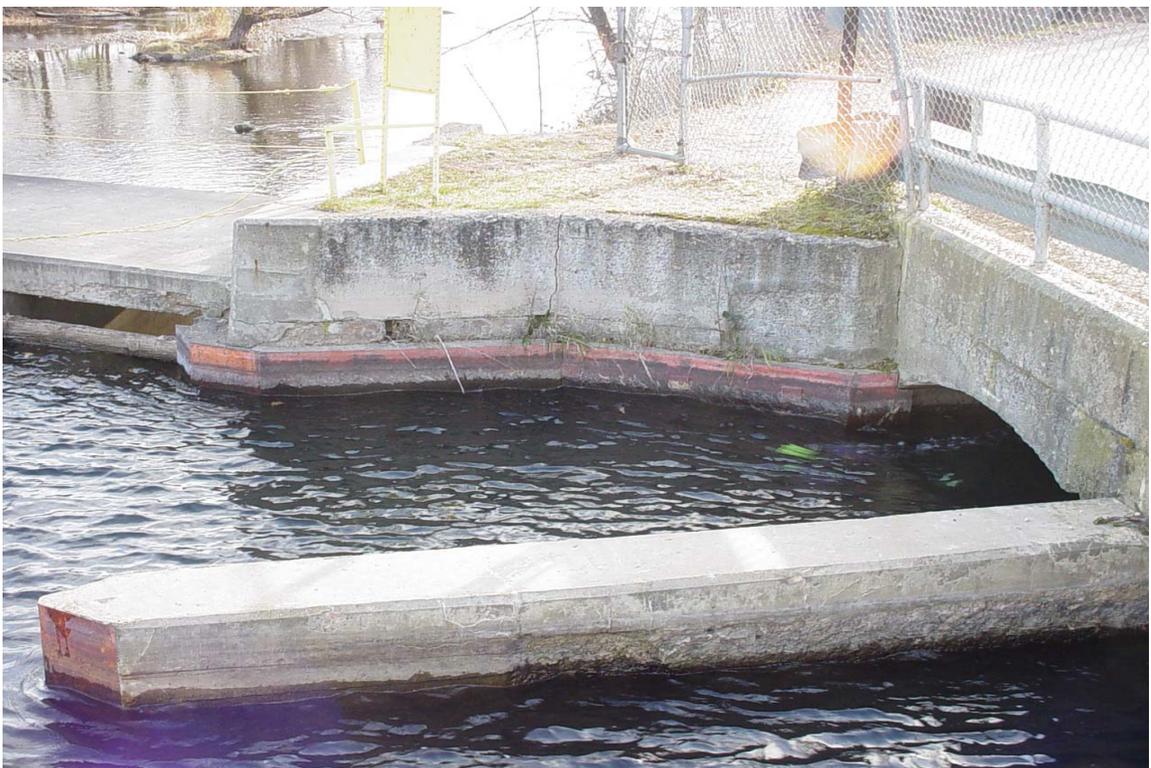
Photograph 4. View of the Upstream End of Pier 1, Looking East.
