UNDERWATER BRIDGE INSPECTION REPORT

STRUCTURE NO. L7352

RABBIT RIVER

MINNESOTA DEPARTMENT OF TRANSPORTATION  
UNDERWATER BRIDGE INSPECTION

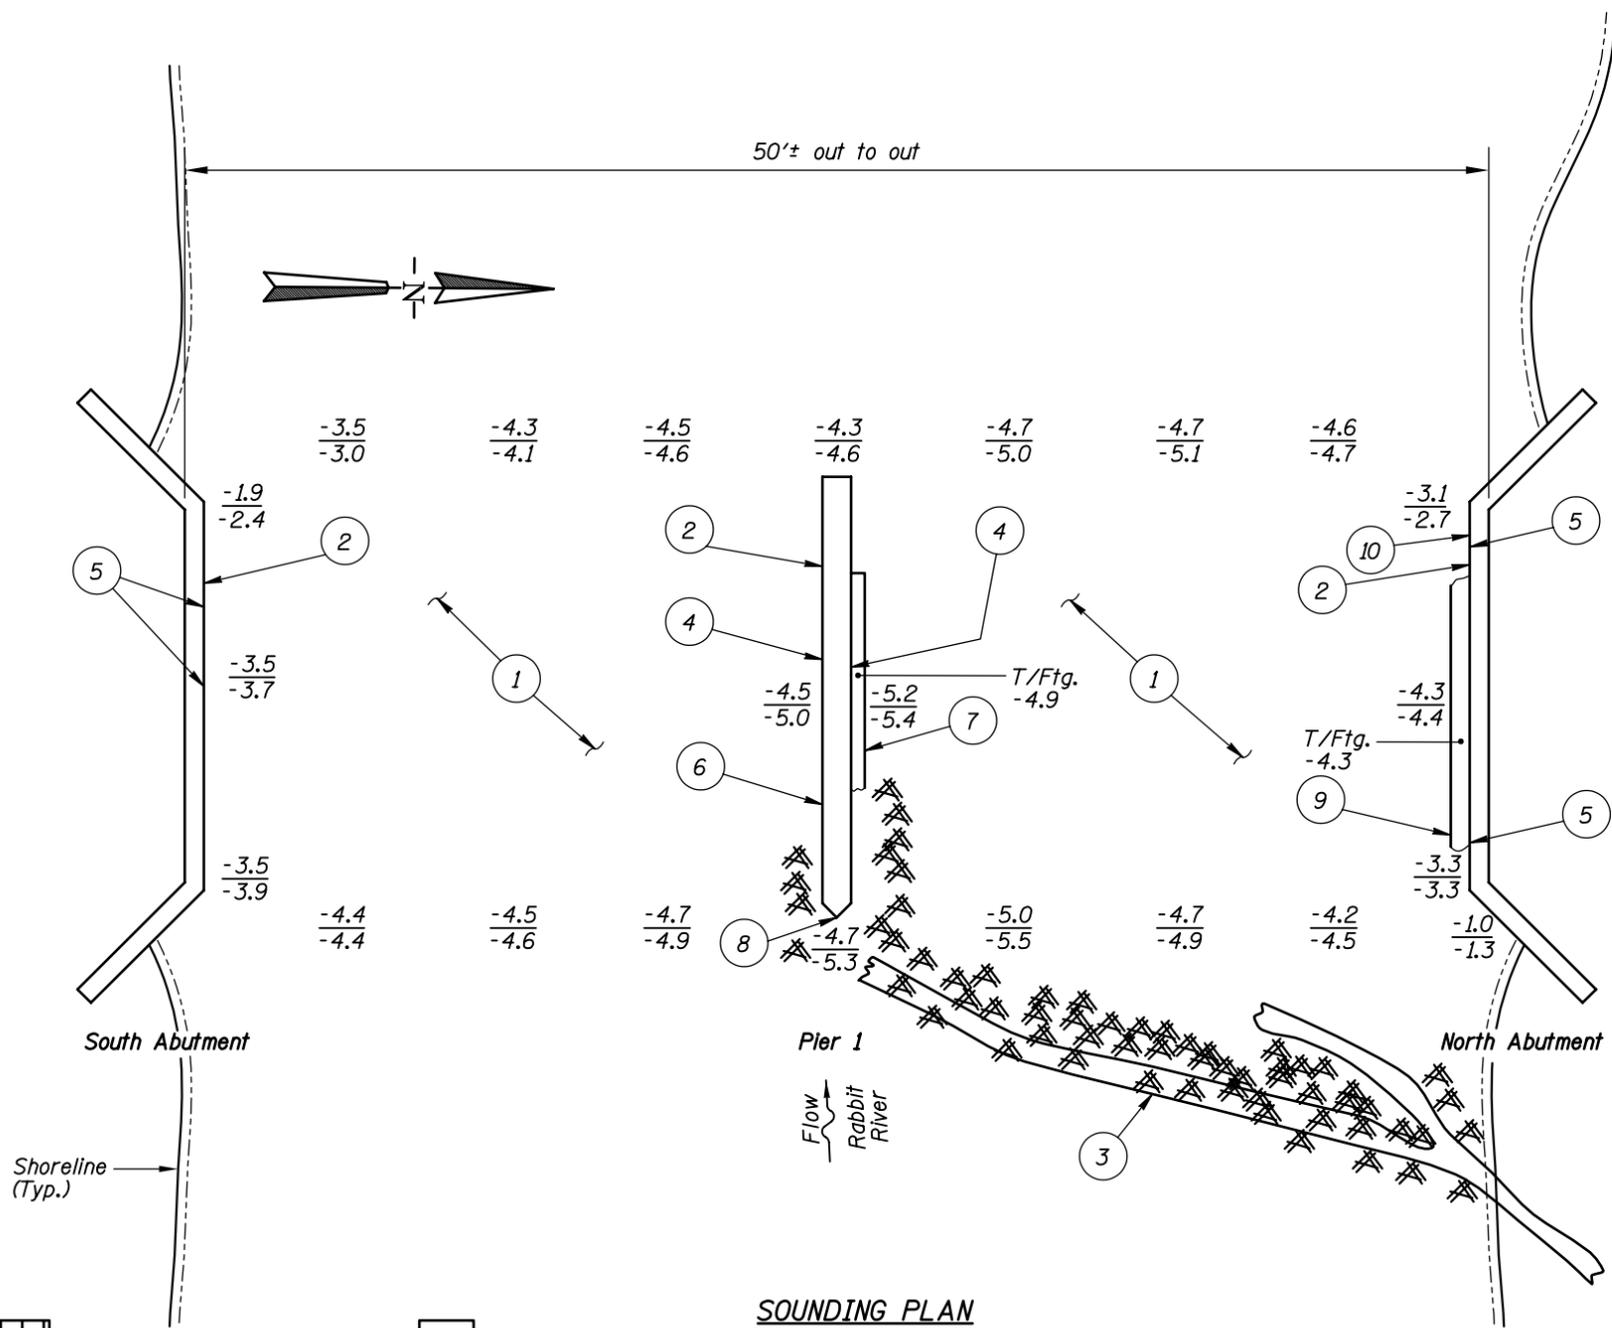
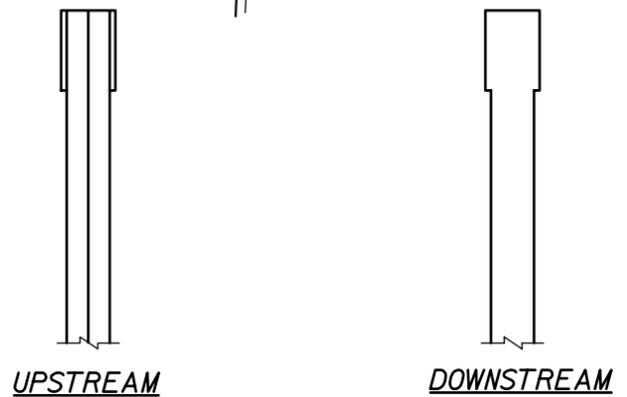
- ① The channel bottom material consisted of hard clay overlaid with silt and random gravel with a maximum probe rod penetration of 2 inches.
- ② Light to moderate scaling was observed around the perimeter of the pier and along the breastwalls of both abutments, with a maximum penetration of 1 inch, extending from 6 inches below to 6 inches above the waterline.

- ③ A 25-foot-diameter tree along with a heavy accumulation of timber debris extended from the north embankment to Pier 1.
- ④ Vertical crack, extending from the beam seat to the channel bottom with a maximum width of 1/8 inch, was observed on both sides of the pier.

- ⑤ Vertical crack, extending from the beam seat to the channel bottom with a maximum width of 1/16 inch, was observed on the breast wall.
- ⑥ A construction joint 3 inches below the waterline exhibited areas of section loss around the entire perimeter of the pier with a maximum penetration of 1 inch.

- ⑦ Footing exposure was detected at Pier 1 with a maximum vertical face exposure of 4 inches along the north side. Timber forms were exposed along the footing face.

- ⑧ Steel ice damage nosing protection extended from the top of the pier cap to 1 foot above the waterline.
- ⑨ Footing exposure was observed along the North Abutment with no vertical face exposure observed.

- ⑩ Area of section loss, 6 inches in diameter, was observed at the waterline with a penetration of 1 inch.

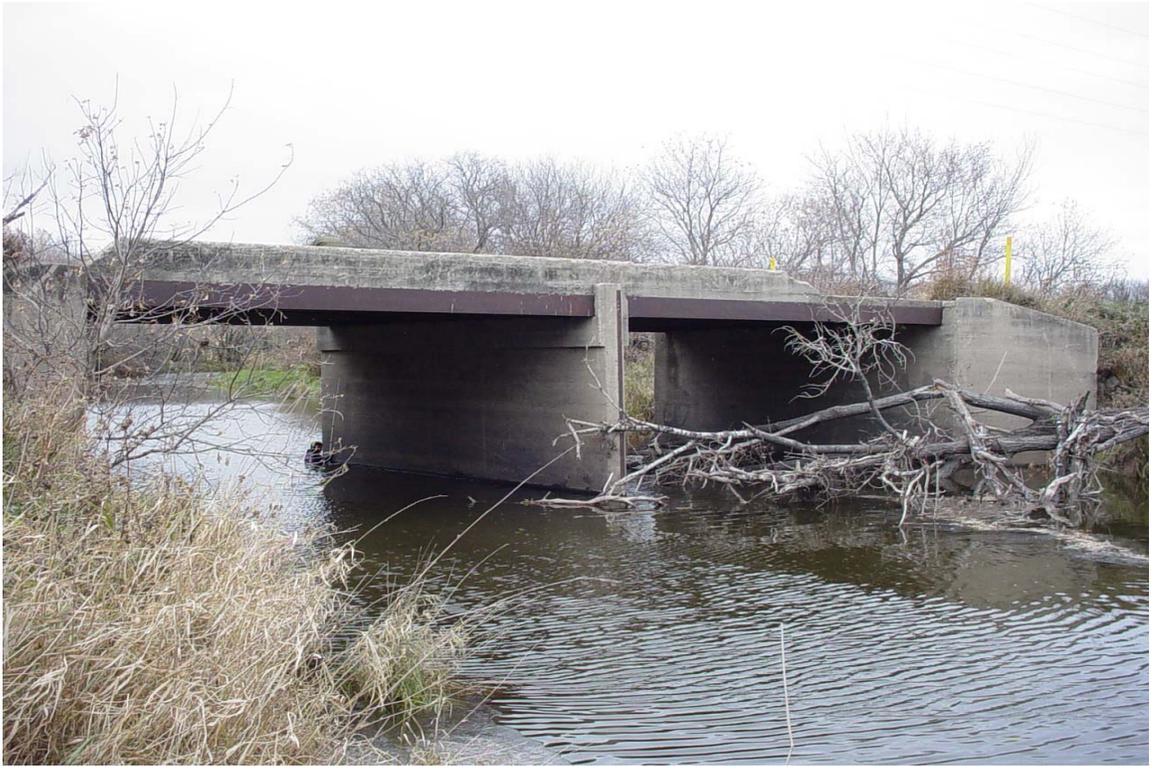
Photograph 1. Overall View of Structure, Looking Northwest.

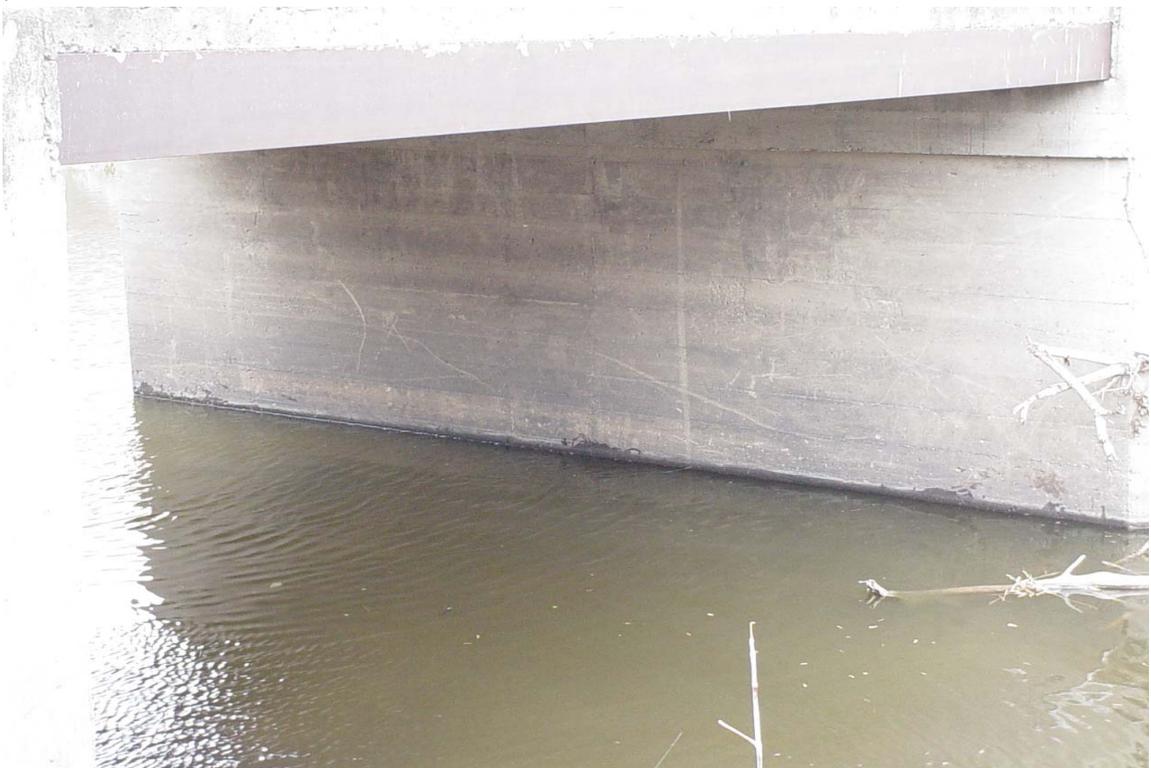
Photograph 2. View of Pier 1, Looking Northwest.

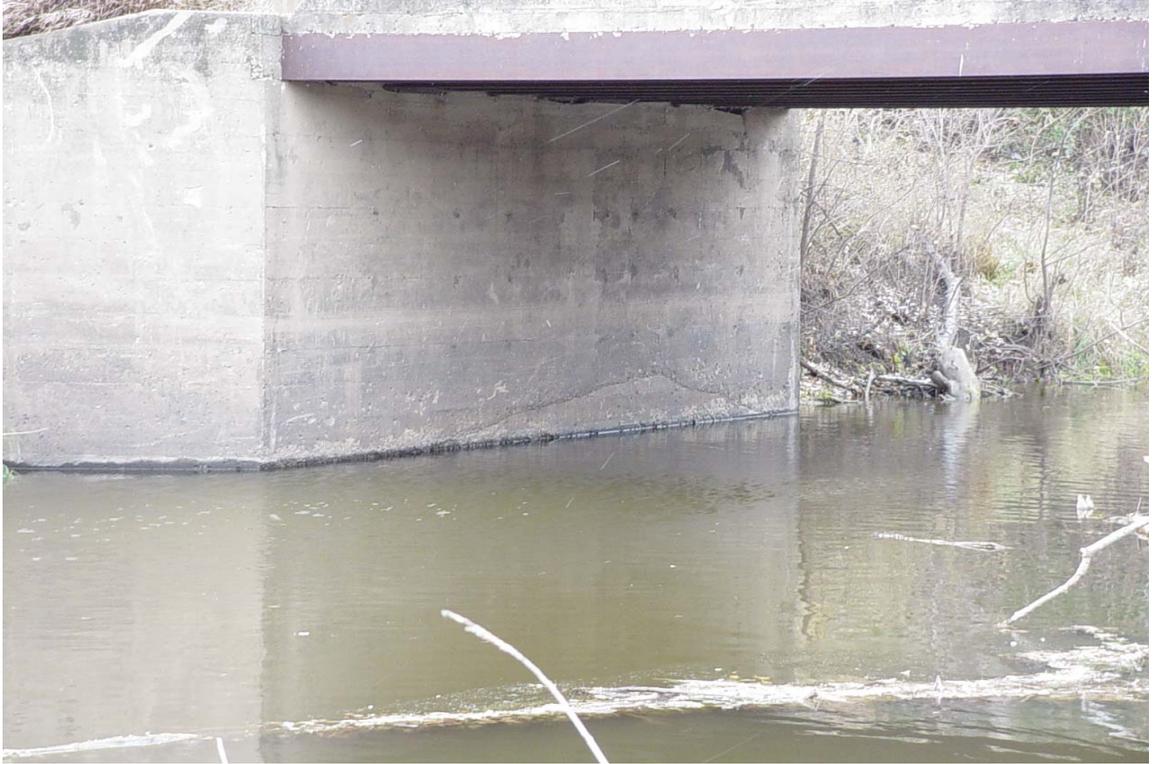
Photograph 3. View of South Abutment, Looking Southwest.

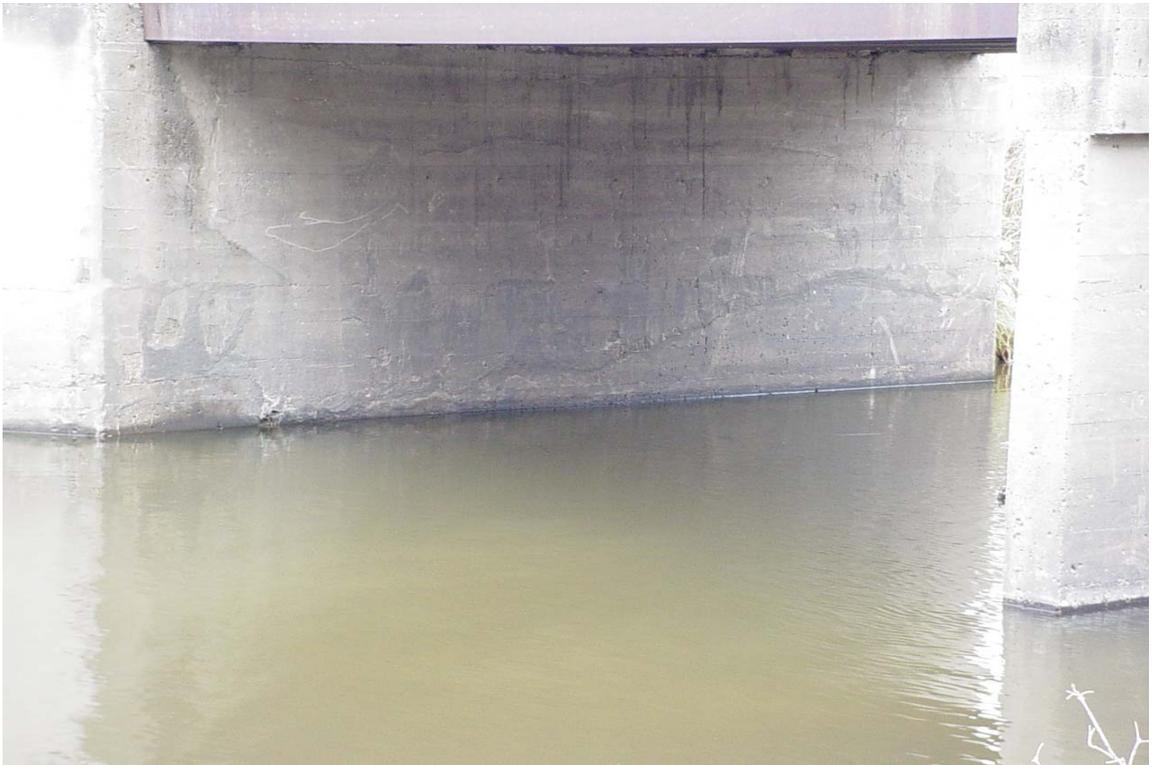
Photograph 4. View of North Abutment, Looking North.
